Land

Cliffs and Overhangs

METROPOLITAN COAL - ENVIRONMENTAL MONITORING SUMMARY

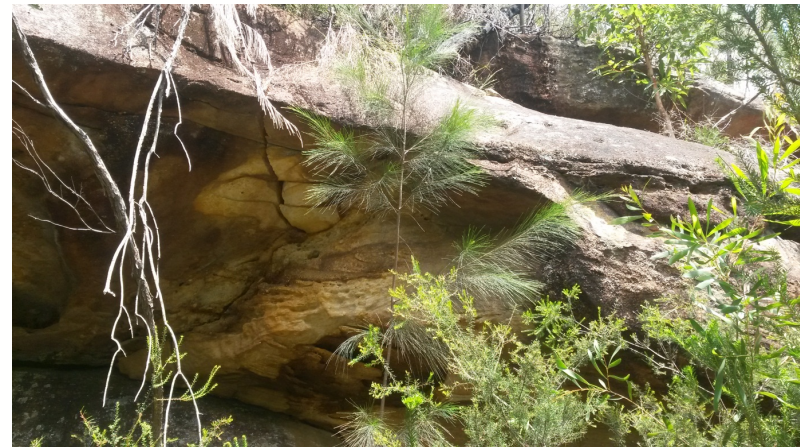
On the 17 December 2013, a vertical tension crack (approximately 50 millimetres wide and 15 m in length) was noted on the cliff face of site COH2 (Plate 1) along with a small rock fall (approximately 1.5 m long, 0.5 m wide and approximately 0.5 m³) (Plate 2). No water seepage was observed. Neither of the subsidence impacts were considered to represent a safety or environmental hazard and no management measures were considered necessary.

Plate 1 Tension Crack on Cliff Face at Site COH2 (Looking West toward Cliff)

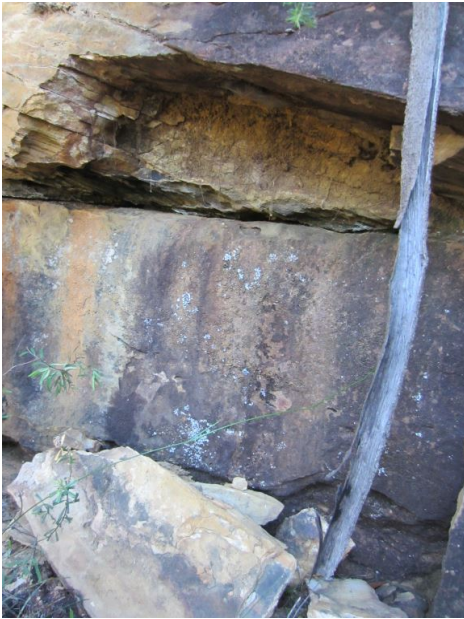
Plate 2 Rock Fall on Cliff Face at Site COH2 (Looking toward Cliff)
