Aboriginal Heritage

METROPOLITAN COAL - ENVIRONMENTAL MONITORING SUMMARY

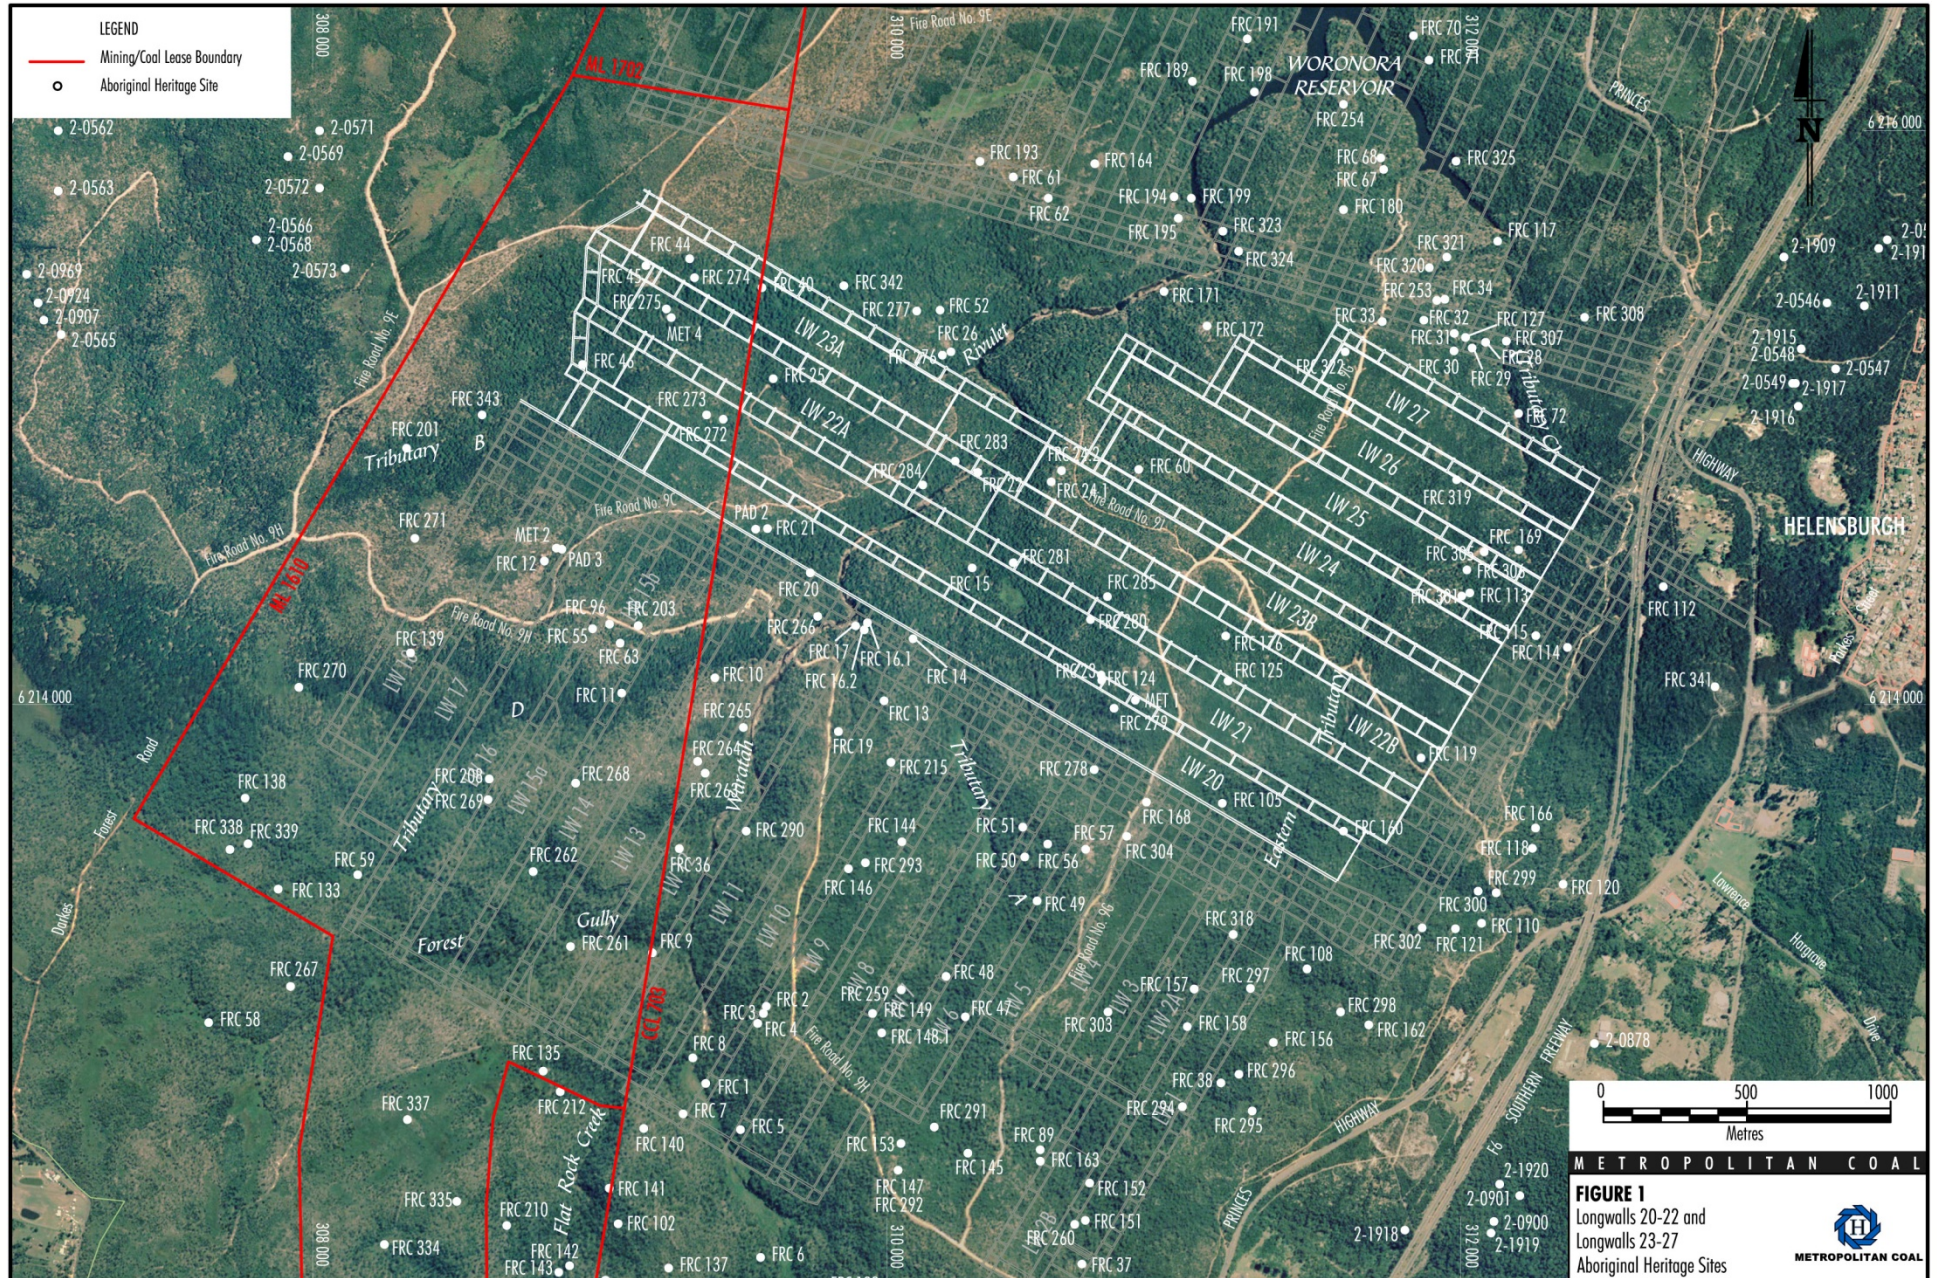
A number of Aboriginal heritage sites have been identified within 600 metres (m) of Longwalls 20-22 and Longwalls 23-27 secondary extraction and are shown on Figure 1.

The third round of monitoring (Round 3) was conducted in November 2014 and included all Aboriginal heritage sites located within the 35° Angle of Draw for Longwalls 21 and 22 and sites at which Round 2 monitoring indicated change due to mining induced subsidence (Table 1). Three Aboriginal heritage sites were observed during the Round 3 survey to have changes attributable to mine subsidence: sites FRC 283, MET 1 and FRC 15 (Figure 1 and Table 1).

To date, five sites have been observed to have changes attributable to mine subsidence, namely sites FRC 15, FRC 284, FRC 281, FRC 283 and MET 1:

- At site FRC 15 (an overhang with artefacts and deposit), the vertical crack noted on the back wall during Round 1 monitoring was observed to have increased in width and shifted laterally during Round 2 monitoring. During the Round 3 survey, the previously identified fine cracking along the margins of the larger fissure were observed to have increased and at the southern end of the shelter there was an increased number of fine cracks.

- At site FRC 284 (an overhang with artefacts and deposit), displacement of a small section of exfoliated shelter surface associated with a fractured corner of the shelter was observed during the Round 2 monitoring. This change is consistent with the types and scale of subsidence effects (cracking, displacement and slumping/falling of exfoliated pieces) noted during Round 1 monitoring. No change in the shelter condition at site FRC 284 was identified during Round 3 monitoring, suggesting the site has stabilised.

- At site FRC 281 (an overhang with art, artefacts and deposit), the changes due to mine subsidence recorded during Round 1 monitoring (multiple cracks ranging from large, medium and small recorded in the shelter wall either running through or next to the motifs) were observed at the site during the Round 2 and Round 3 surveys. However, there had been no change in the shelter condition since Round 1 monitoring, suggesting the site has stabilised.

- Site FRC 283 (an overhang with art) was noted as having some increase in joint movement along the back wall bedding planes of the shelter in the Round 3 survey. As a result of natural processes, water seepage through the sandstone has formed a mineral accretion (silica) over the art panel.

- Site MET 1 (an overhang with art, artefacts and deposit) was also identified as having vertical cracking along the back wall of the shelter as well as some small cracking in the shelter in the Round 3 survey.
