# Wilpinjong Coal Mine Aboriginal Rock Art Monitoring and Assessment Program

## Report on December 2014 site inspection

Wilpinjong, NSW

July 2015

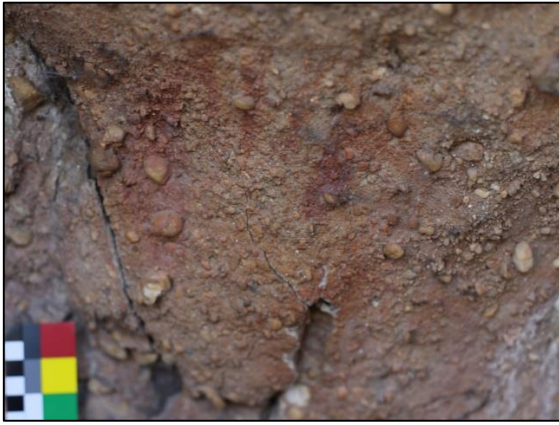
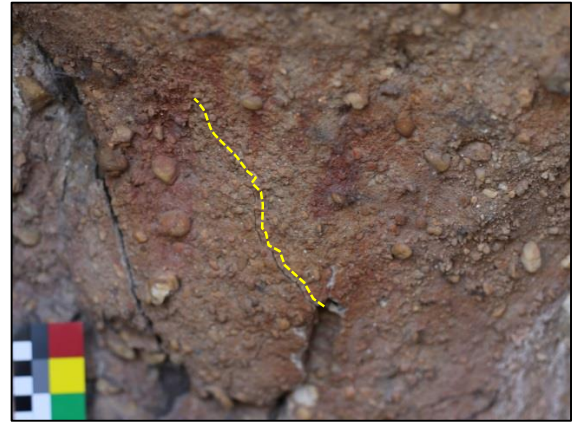
**Figures 4.3 and 4.4** 2014 image – a fine crack through a rock panel with a hand stencil. During the field inspection, this crack (indicated by the yellow dashed line), was provisionally identified as possibly post 2006 in origin. However close inspection of the baseline record indicates no discernible change in either the extent or width of the crack.

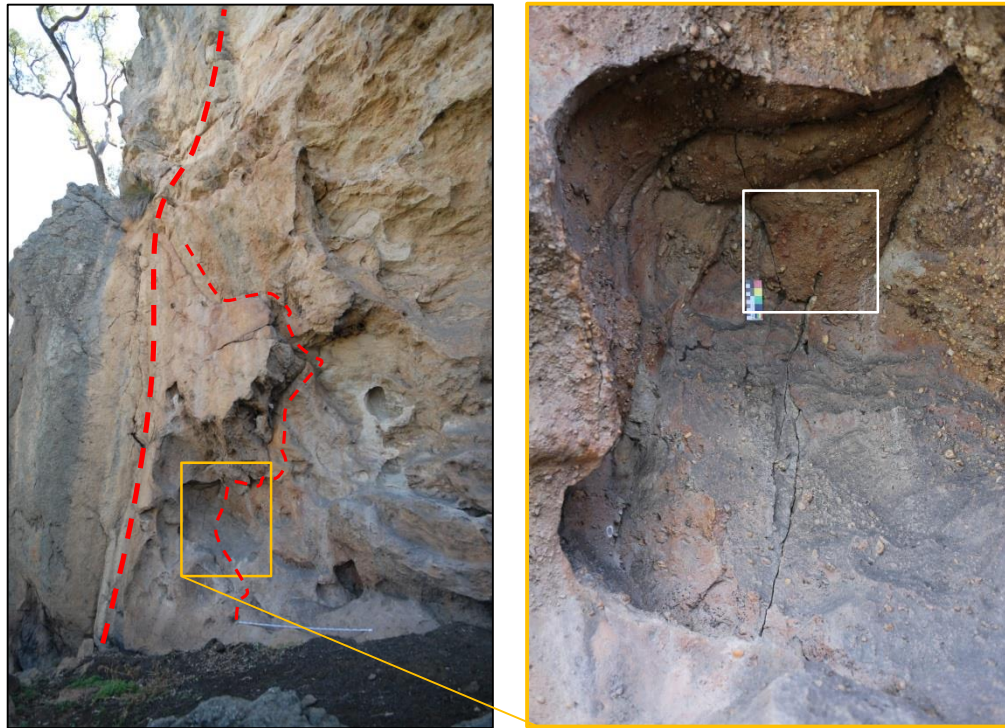
**Figures 4.6 and 4.7** 2014 images – showing the wider context of the cracks illustrated in Figure 4.3 (area indicated by white rectangle). The affected art panel is situated within a complex of cracks associated with a near vertical natural joint or fault line which extends the full height of the exposed rock escarpment near the southern end of the rock shelter (red dashed lines). The observed cracks across the art panel were evident in 2006 and are the result of (pre-mining) differential movement on either side of the rock joint.

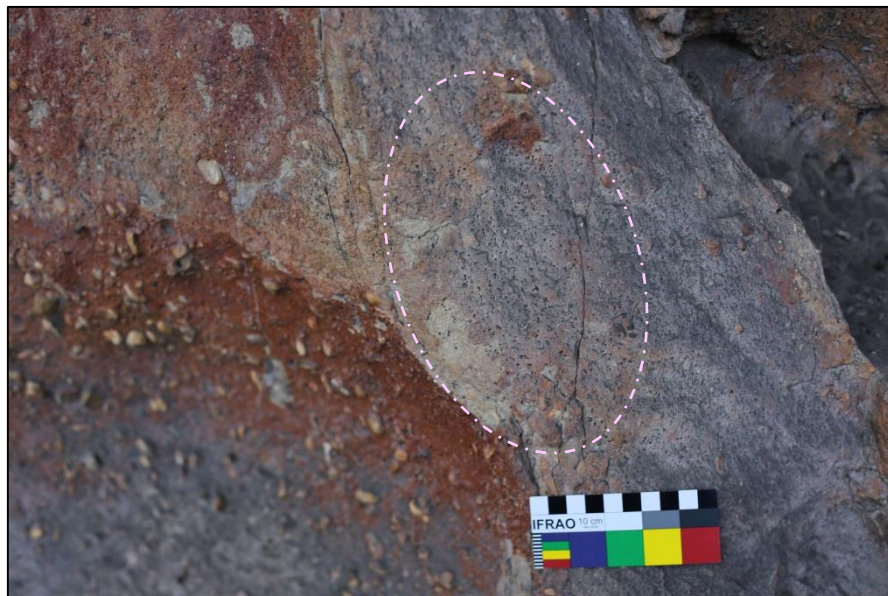
**Figure 4.9** 2014 image – area of lichen growth not specifically identified in 2006 record, and now visually more prominent (area outlined).

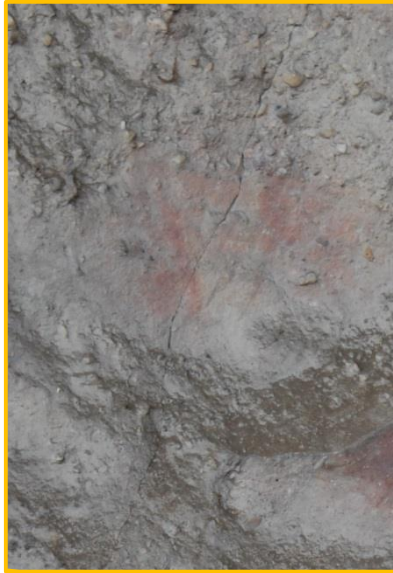
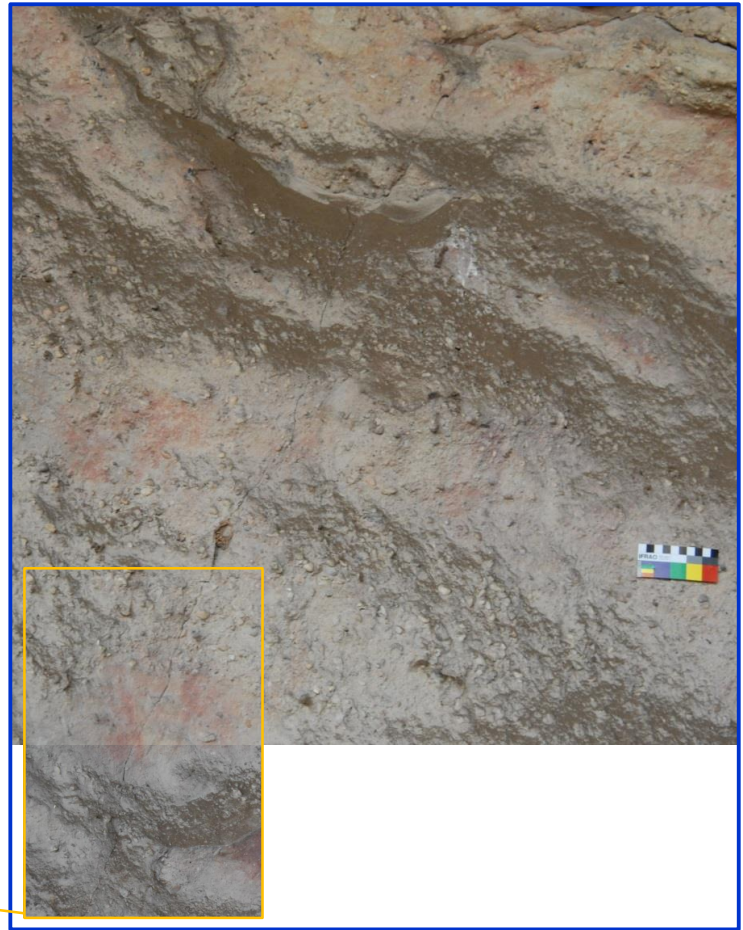
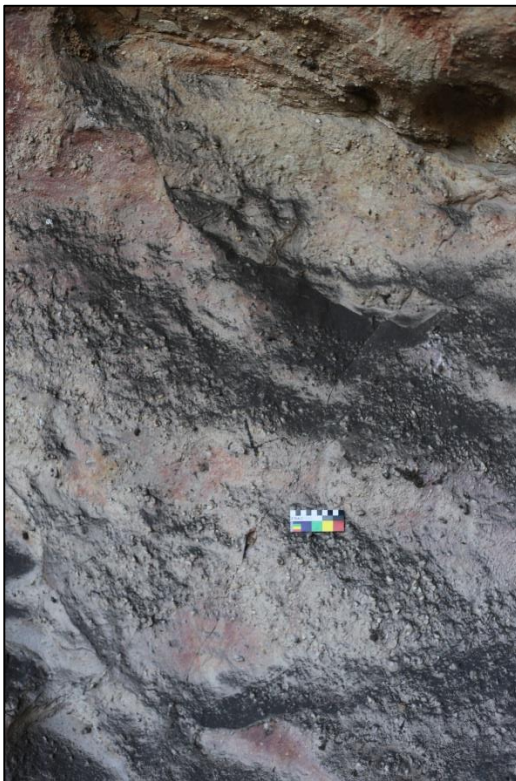
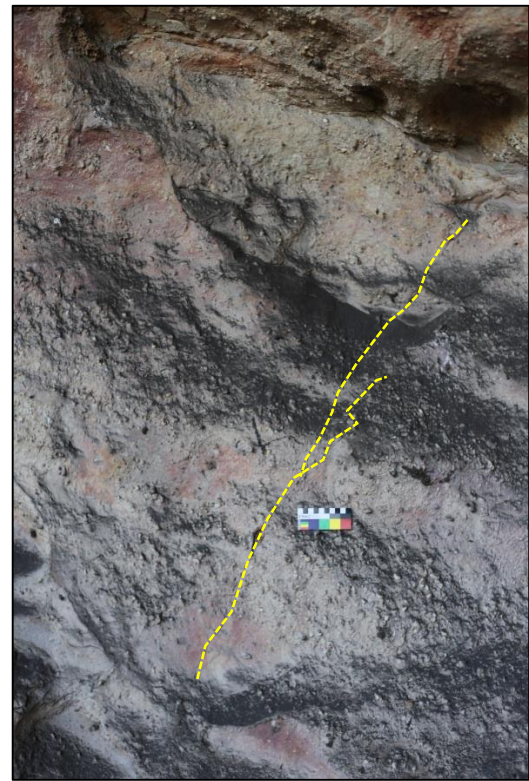
**Figures 4.12 and 4.13** 2014 image – fine crack through stencil panel (yellow dotted line on right). Comparison with the baseline record shows no change in the extent of the crack or its discernible width. Enlargements of the stencil area are present in Appendix 1.

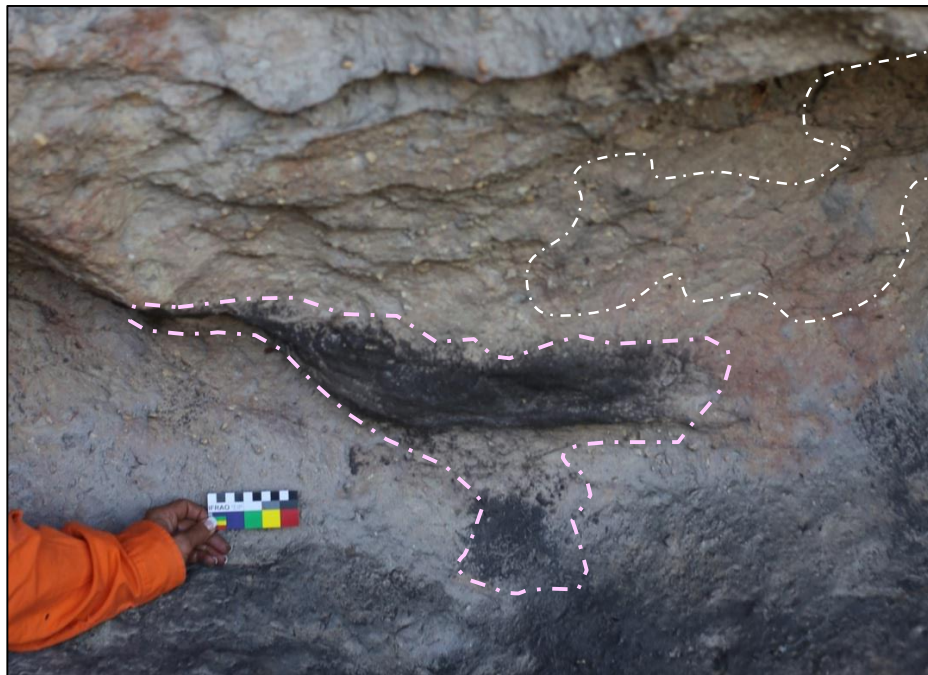
**Figure 4.15** 2014 image of same area shown in Figure 4.13, showing pre and post-2006 areas of animal rubbing with an associated dark grey/black surface residue including animal hair (outlined).

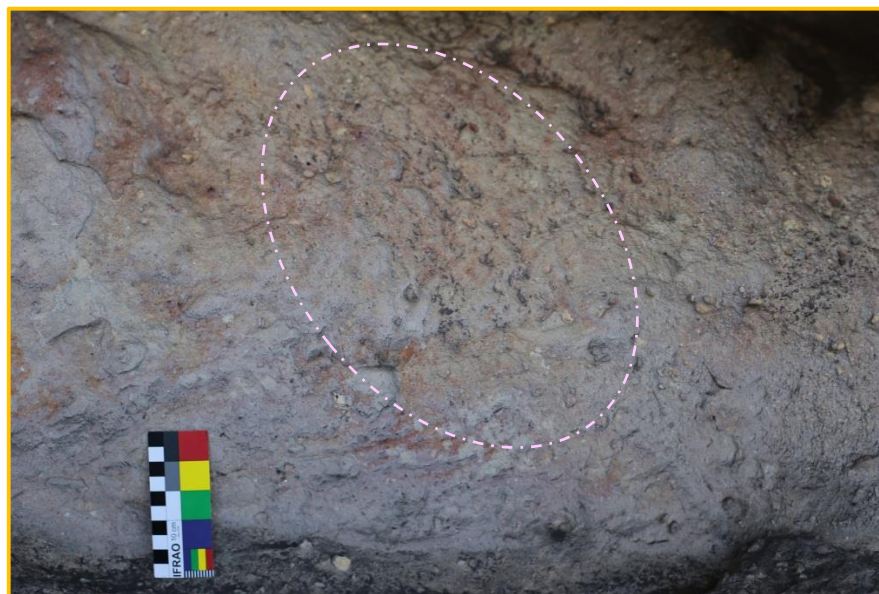
**Figure 4.18** 2014 image – post 2006 area of surface deposition. Although this feature looks similar to lichen growth found elsewhere in the shelter, it is more likely to be material deposited by animal rubbing (area outlined).

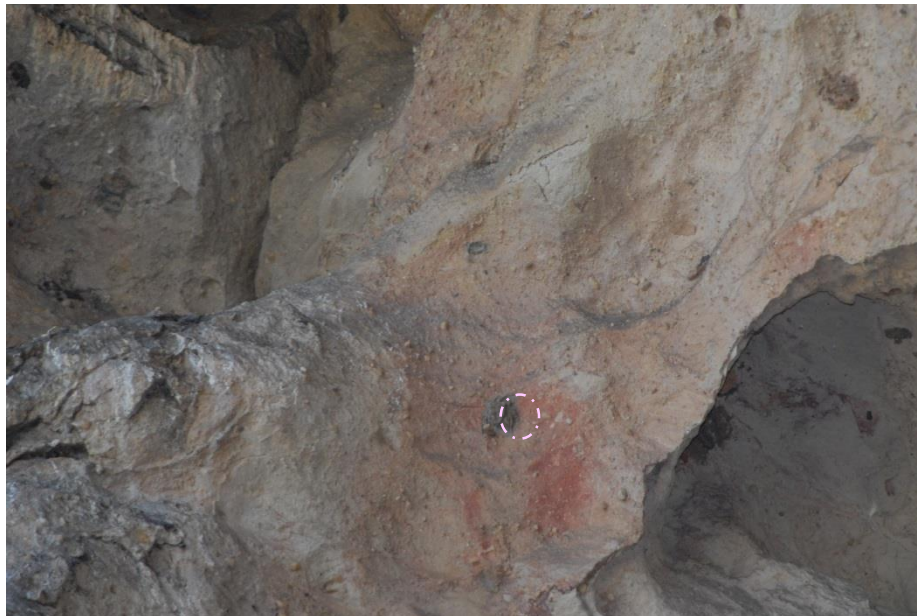
**Figure 4.20** 2014 image – post 2006 mud-daubing wasp nest (outlined) situated over hand stencil pictured in Figure 4.19.

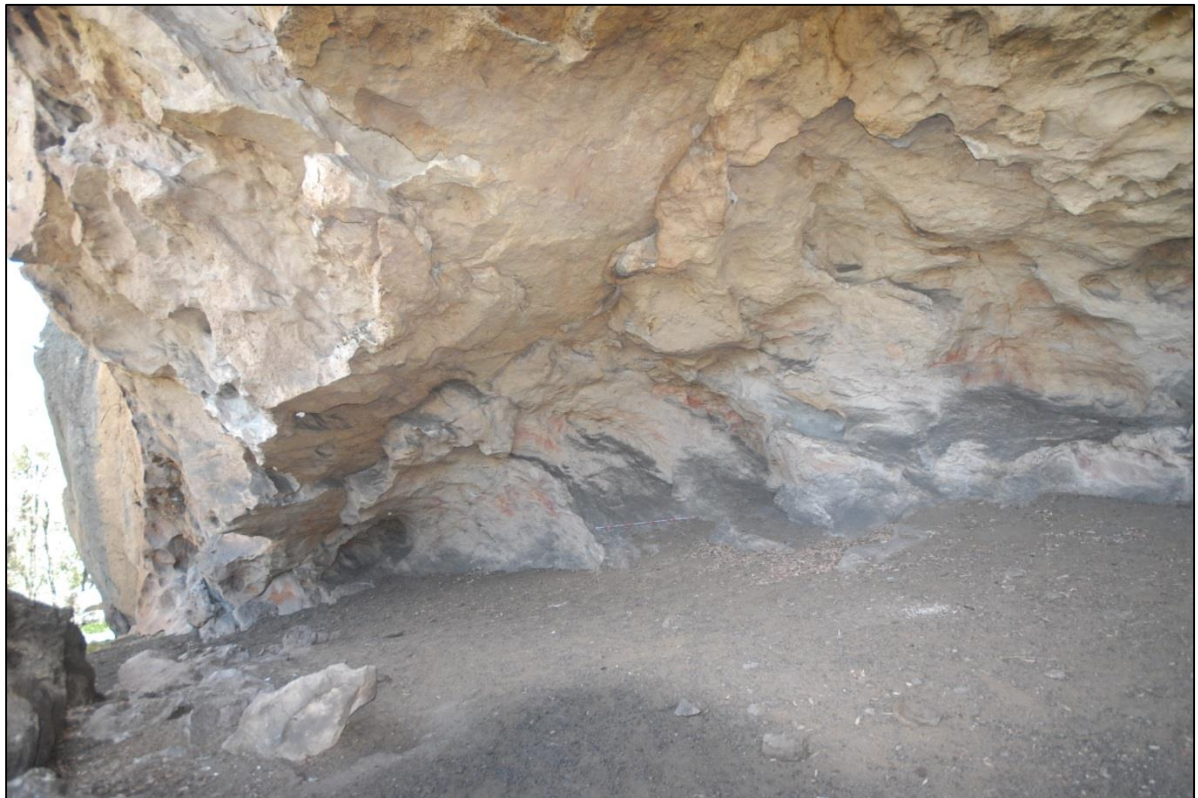
- The dust affected rock surfaces are visually darker in hue and colour than in 2006. The apparent change in colour is from a yellow-brown to a brown-grey. This creates a visually obtrusive effect, making it harder to see or appreciate the remaining visible rock art within the shelter;
- The spatial extent of the dust appears to be the same as in 2006.

**Figure 4.22** 2014 image (using flash light source) – showing same area as shown in Figure 4.21. Note that the pattern and extent of dust affected rock surfaces is the same as shown in the baseline, but are now darker in colour and hue.

1. A program of research be conducted with the objective of identifying:
  - a. The composition and source of the dust deposits present on rock art panels within WCP72;
  - b. The cause of the change in colour and hue in the dust deposits, noted since 2006;
  - c. The vectors involved in the generation and deposition of dust within WCP72 (for example wind, or animal treadage of the dung deposit);

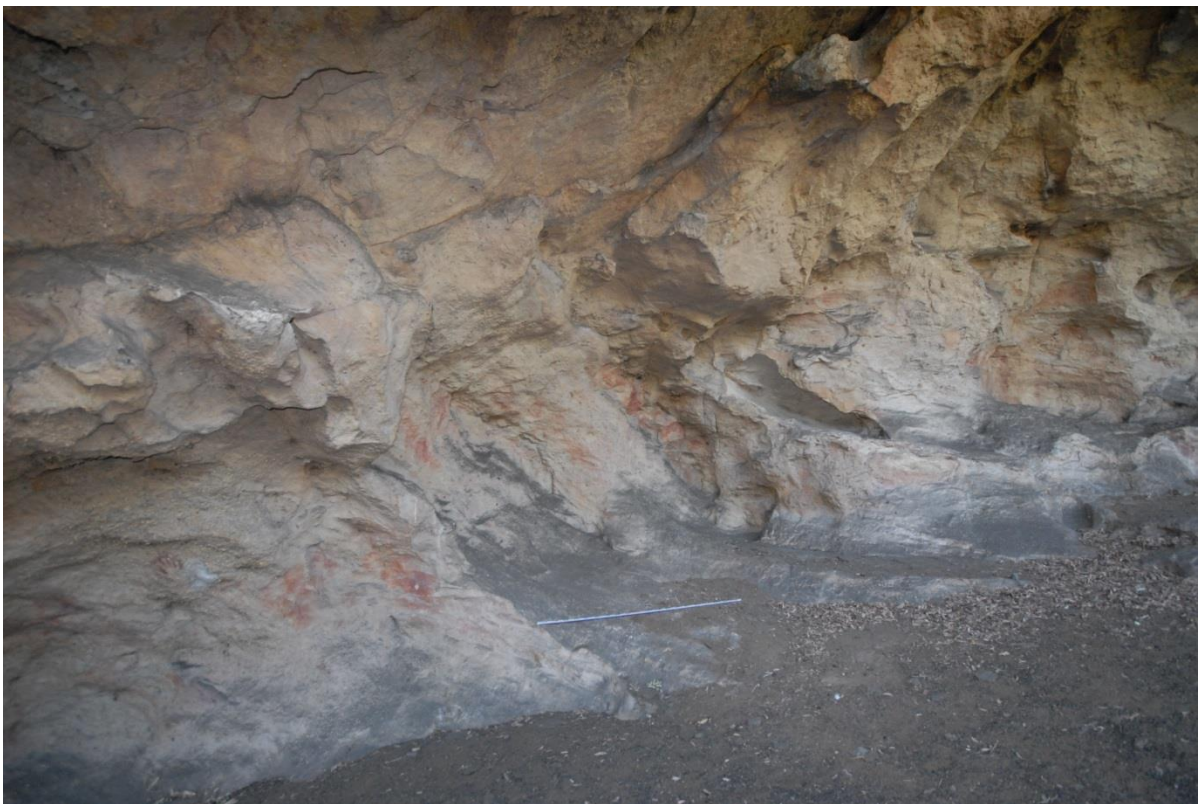
**Figure 4.24** 2014 image (using flash light source) – showing same area as shown in Figure 4.23. Note that the pattern and extent of dust affected rock surfaces is the same as shown in the baseline, but are now darker in colour and hue.

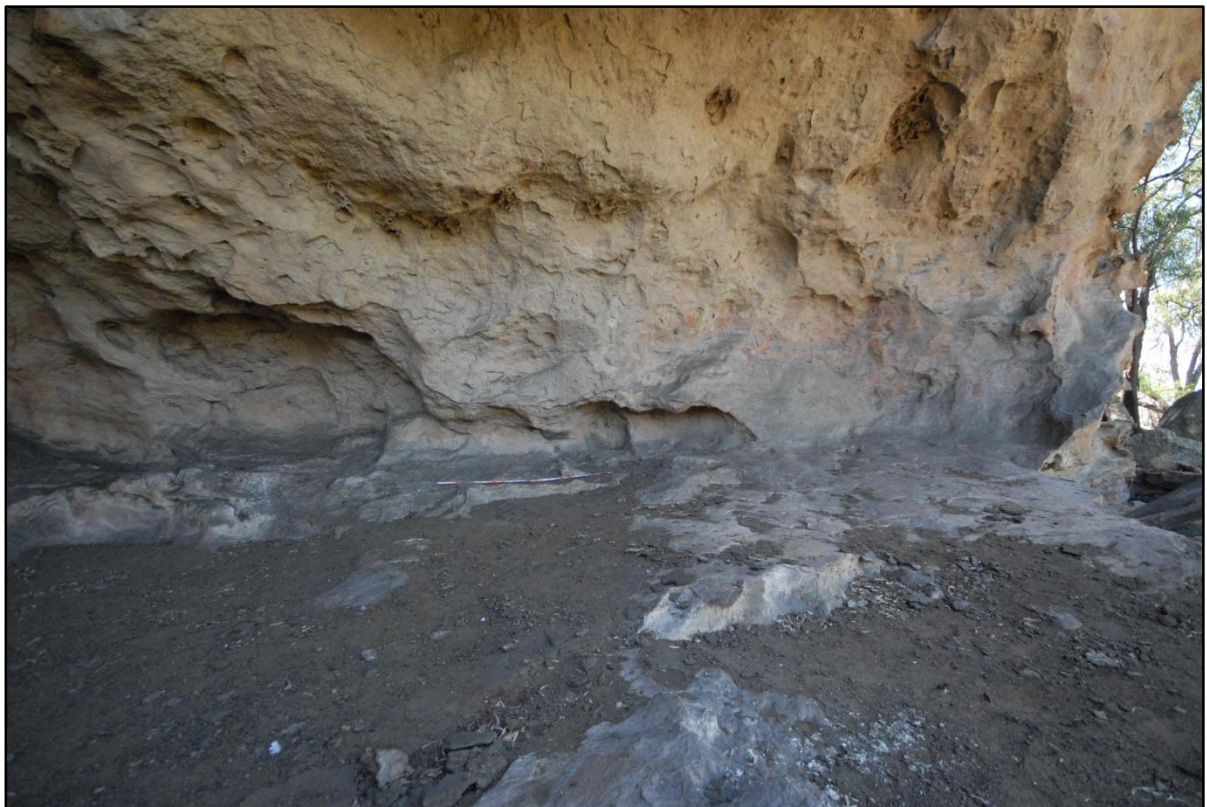
**Figure 4.26** 2014 image – showing same area as shown in Figure 4.25. Note that the area of dung on the shelter floor has receded on the right hand (eastern), and upslope end of the shelter. Also the area of dust affected rock floor appears to be greater on the left hand (western) side. The pattern and extent of dust affected rock surfaces across the back wall is the same as shown in the baseline. The areas of dust deposition are now darker in colour and hue, and as a result are more visually intrusive.

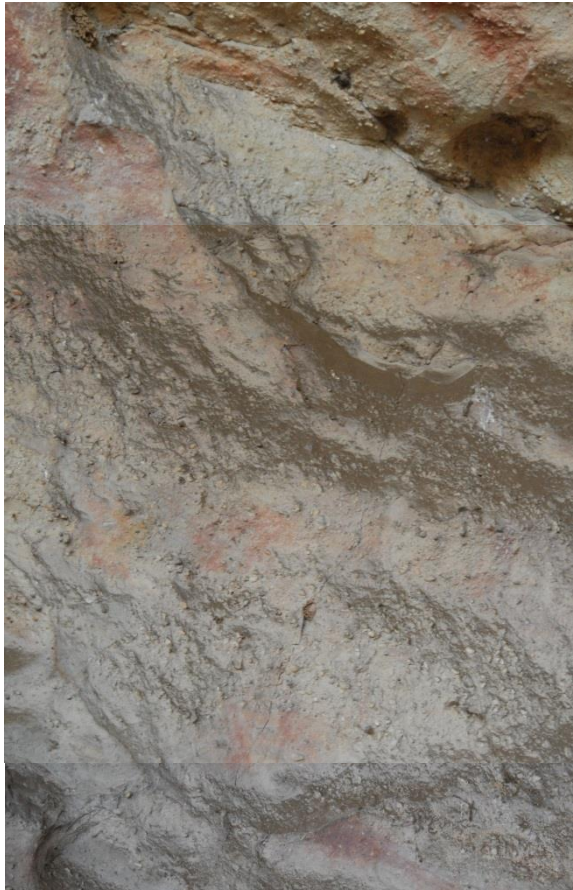
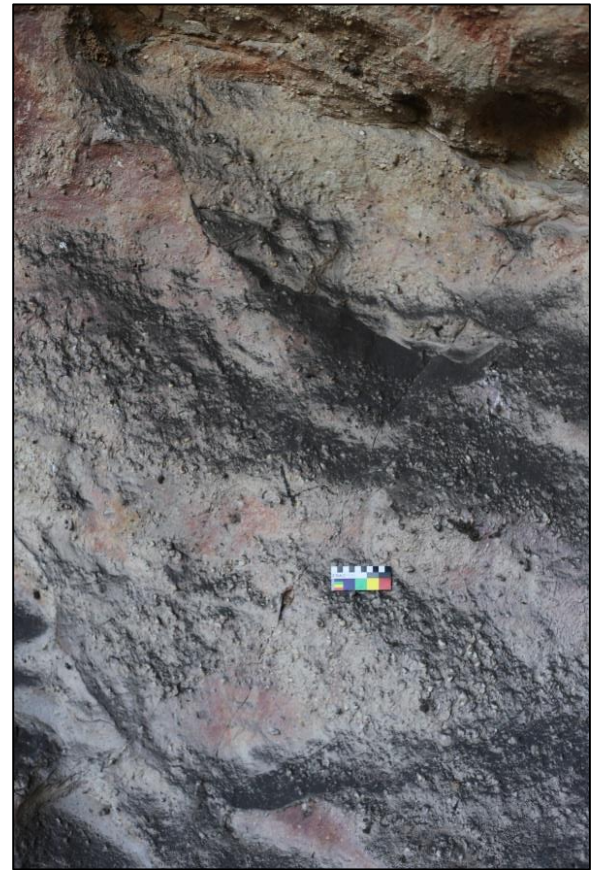
**Figures 4.27 and 4.28** Comparison of 2006 baseline (left) and 2014 (2015) (natural light) images of the same dust affected rock surface, showing the change in colour and hue, from yellow-brown to brown-grey (WCP72:256, 257 and 258).

A consensus was reached amongst the group to recommend that a sample of the dust deposits be analysed to determine its composition and the reason for the colour change. It was suggested that the dust sample could be compared with surrounding potential dust sources such as mining overburden, coal, and the dung on the shelter floor.

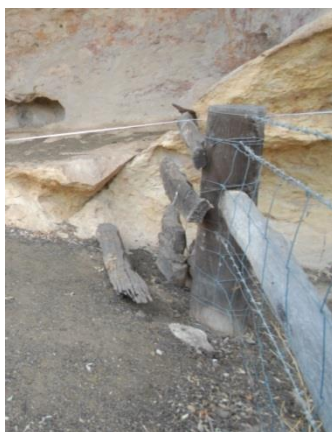
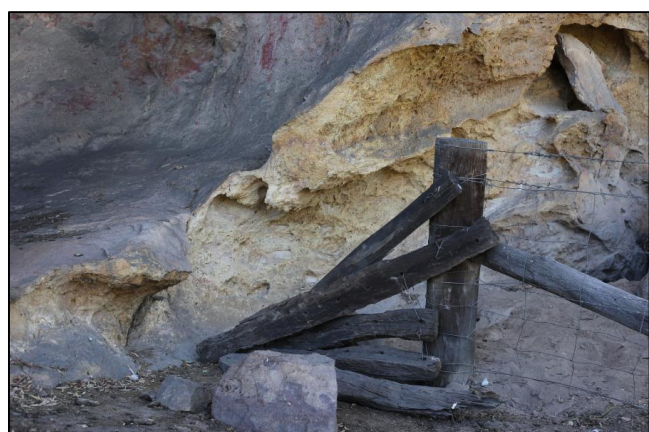
**Figures 4.29 and 4.30** The shelter end of the stock fence in 2006 (left), compared with the current partially deconstructed condition (WCP72:56).

A discussion was undertaken on the visual impact of this fencing, its impact on human access to the site, and the potential fire hazard the pine wood fencing poses to the rock shelter. An agreement was made by the group to recommend that this redundant fenceline be removed. Its removal would make visitor access to the site easier and safer, would remove the fire risk posed by the close proximity of the wood to the rock shelter rock surfaces, and would increase the aesthetic quality of the site surrounds.

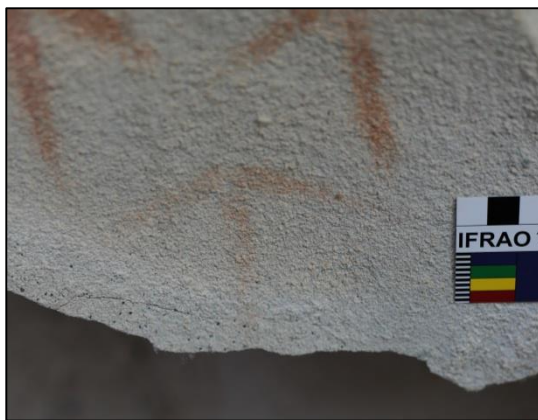
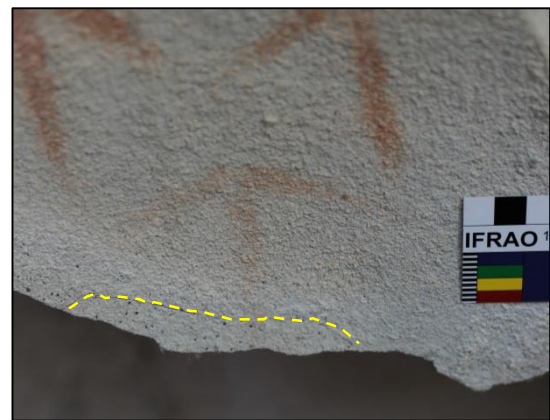
**Figure 4.35 and 4.36** 2014 image of a post-2006 hairline crack (yellow dashed line) across an undercut section of this panel edge. The creation, cracking, and likely future dislodgement of this fragile and undercut edge are a consequence of natural erosion processes.

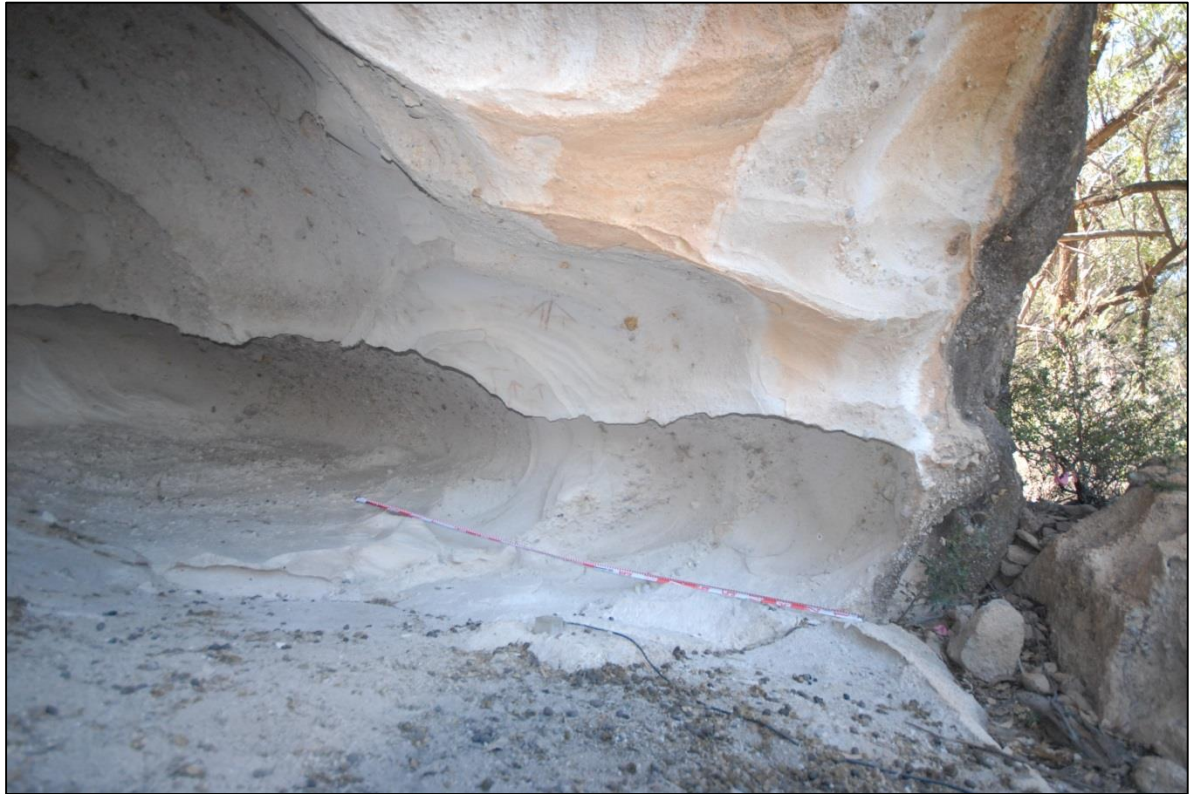
**Figure 4.37** 2014 (flash light) image of the southern end of the WCP152 rock shelter, showing the eroded, protruding, and fragile nature of the lower edge of the remaining art panel support. Scale is 2 m. Note vibration monitor on rock floor.

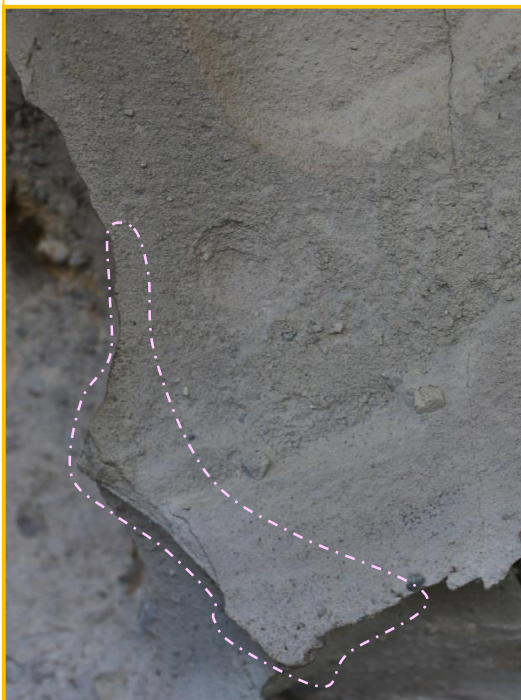
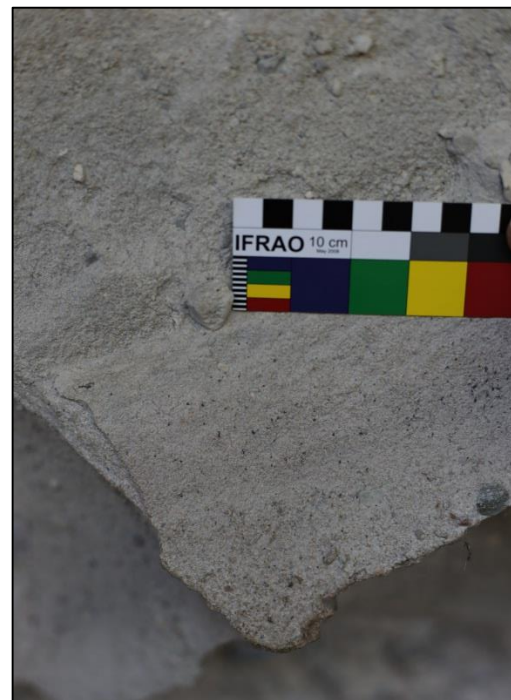
**Figure 4.40 and 4.41** Area of animal rubbing and associated deposition of material (outlined) (left), and close up (right)

The protruding edge of this rock panel has been rubbed against by animals using the shelter, leaving behind a residue. The impacted area is not directly associated with rock art.

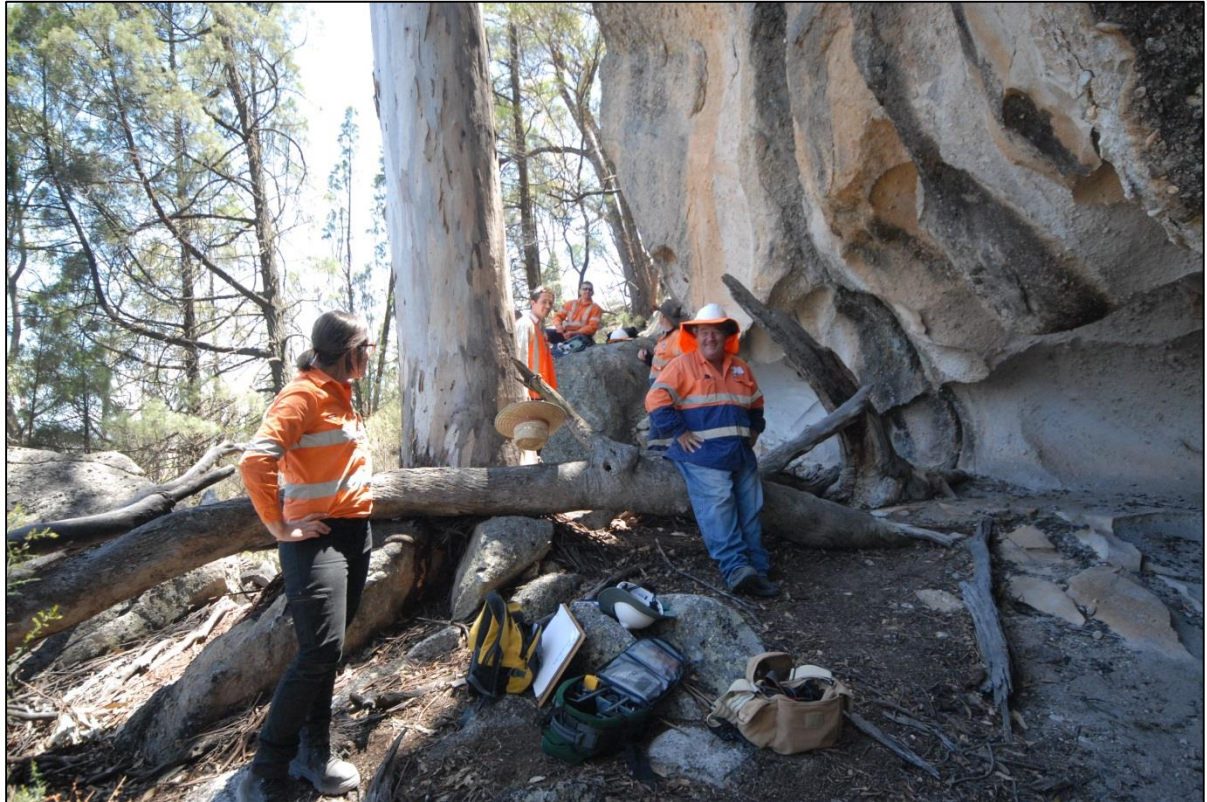
A build-up of dead wood was noted outside of the northern end of the shelter (Figure 4.42). It was noted that this can be a fire hazard (the radiant heat from wild fires can cause the exfoliation of rock art surfaces in shelters). There was a consensus to provide a recommendation that the dead wood be removed from the vicinity of the site.

**Figure 4.42** Aboriginal stakeholders and Sam Harper at WCP152, looking north.  
Note the build-up of dead wood within and just outside of the shelter.

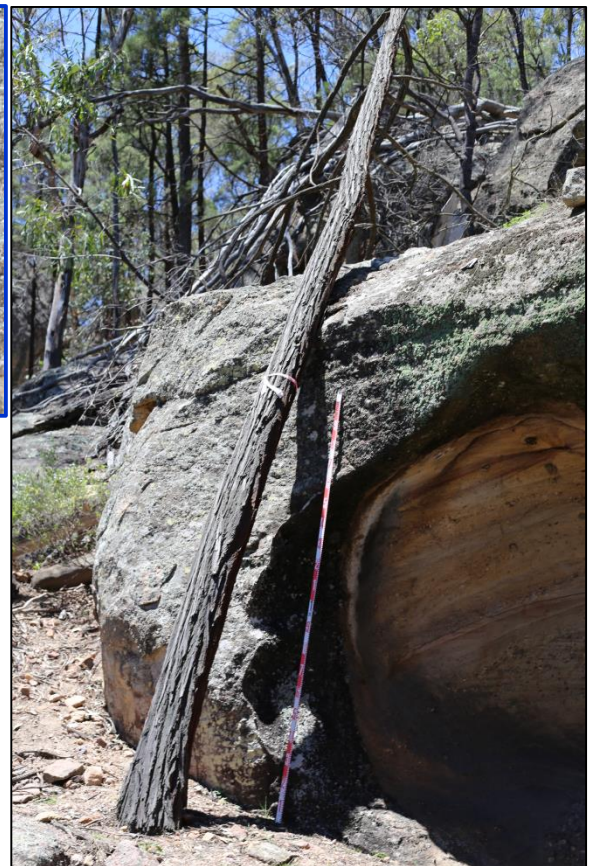
- A small amount of burnable forest litter is accumulating outside the shelter on the right;
- One tall tree leaning on the front left of the shelter has died since 2006 (Figure 4.44).

**Figure 4.44** Dead tree near entrance to WCP153 (scale is 2m).
