# Wilpinjong & Cumbo Creek Stability Assessment, 2014

Wilpinjong Coal Mine

Mar-15  
(Our Reference: 21977\_E01)

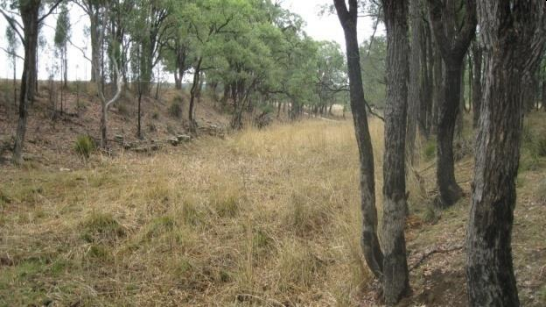
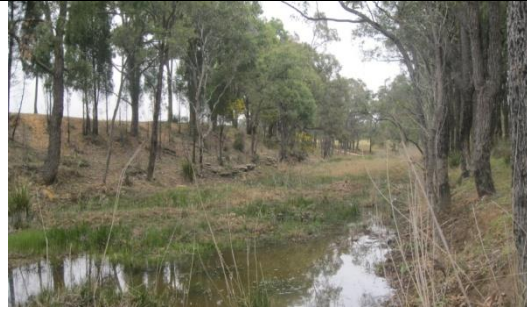
<ul style="list-style-type: none"> <li>• A reduction in in-stream growth;</li> <li>• Increase in wombat activity in the general area;</li> <li>• Increased groundcover over the reporting period;</li> <li>• Stock activity noted.</li> </ul>
3

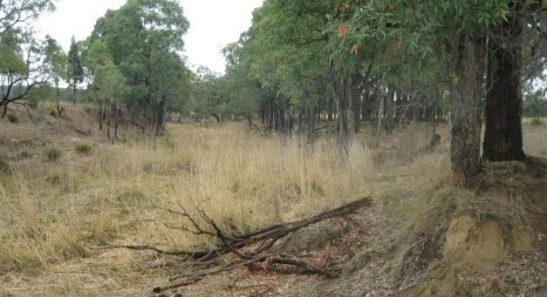
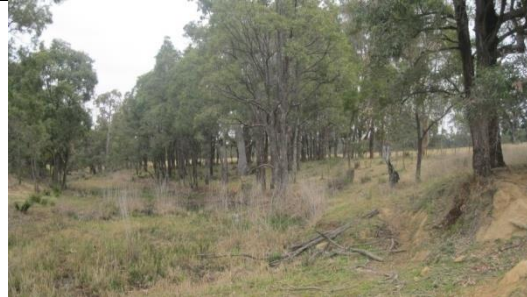
<ul style="list-style-type: none"> <li>• Increased soil exposure and erosion of the left bank;</li> <li>• Increased growth and regeneration of instream flora;</li> <li>• Reduction in leaf litter on the creek bank faces.</li> </ul>
4

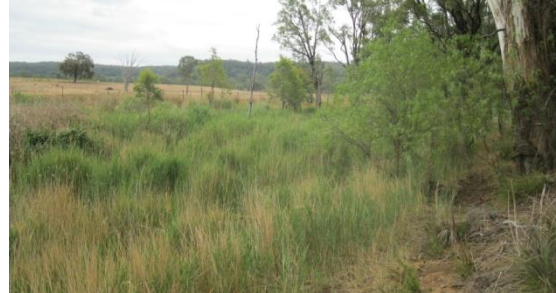
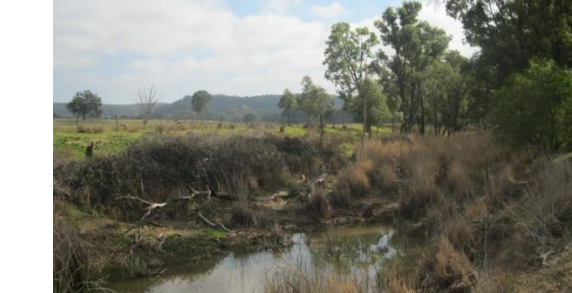
<ul style="list-style-type: none"> <li>• Large reduction in instream flora growth;</li> <li>• Increased exposure of the bank faces;</li> <li>• Reduction in green growth on the creek banks and in the riparian areas;</li> <li>• Evidence of stock in the area;</li> <li>• Blackberry noted.</li> </ul>

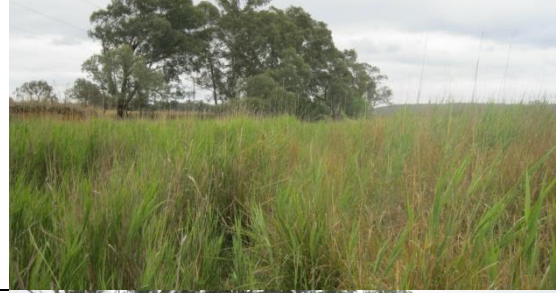
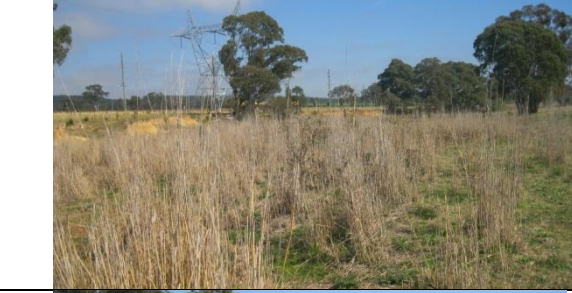
<ul style="list-style-type: none"> <li>• Large reduction in instream flora growth;</li> <li>• Increased exposure of the bank faces;</li> <li>• Increased bleaching of exposure soils of the bank faces;</li> <li>• Reduction in green growth on the creek banks and in the riparian areas.</li> </ul>
10

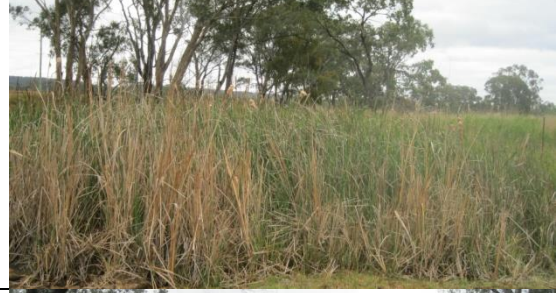
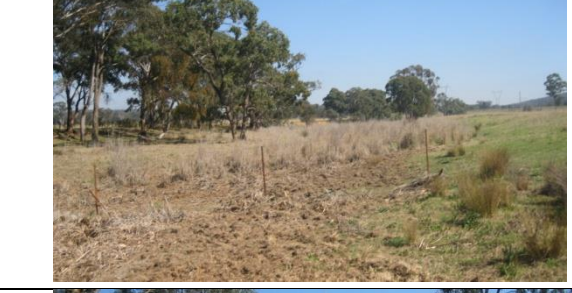
<ul style="list-style-type: none"> <li>• Large reduction in instream flora growth;</li> <li>• Increased exposure of the bank faces;</li> <li>• Reduction in green growth on the creek banks and in the riparian areas;</li> <li>• Evidence of stock in the area;</li> <li>• Blackberry noted.</li> </ul>
11

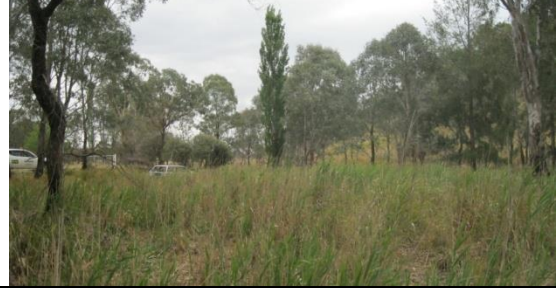
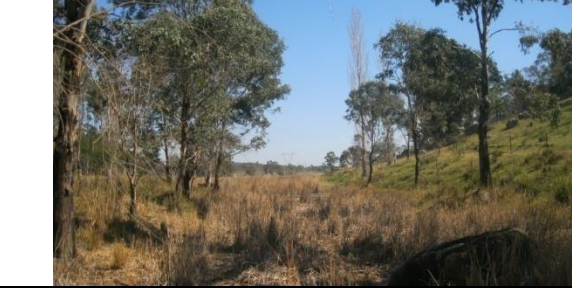
<ul style="list-style-type: none"> <li>• Large reduction in instream flora growth;</li> <li>• Reduction in the active channel;</li> <li>• Reduction in green growth on the creek banks and in the riparian areas;</li> <li>• Evidence of stock in the area.</li> </ul>

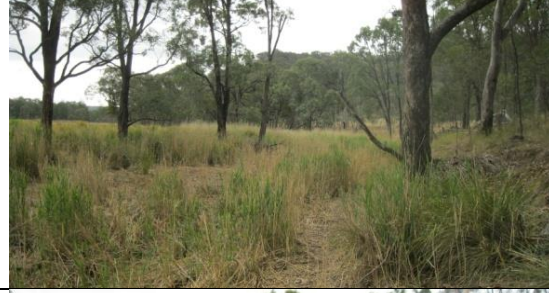
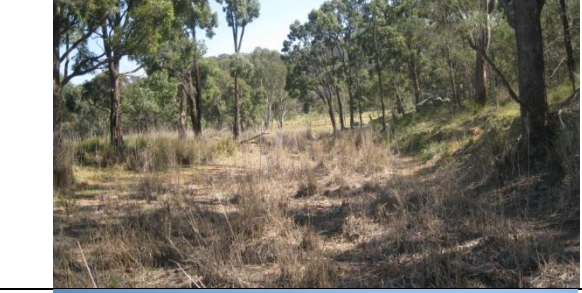
<ul style="list-style-type: none"> <li>• Large reduction in instream flora growth;</li> <li>• Increased exposure of the creek bed with some bed erosion noted;</li> <li>• A reduction in the active creek width;</li> <li>• A reduction in groundcover on the creek bank faces;</li> <li>• Banks relatively stable;</li> <li>• Blackberry present;</li> <li>• Evidence of wombats.</li> </ul>
16

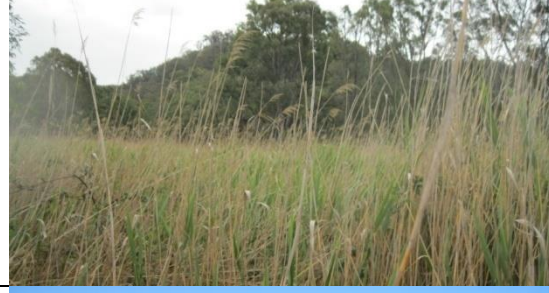
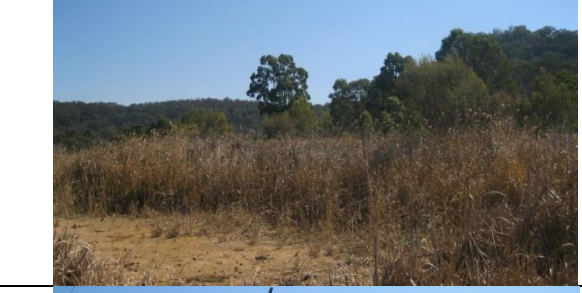
<ul style="list-style-type: none"> <li>• Large reduction in instream flora growth;</li> <li>• Increased exposure of the creek bed;</li> <li>• Banks stable.</li> </ul>
17

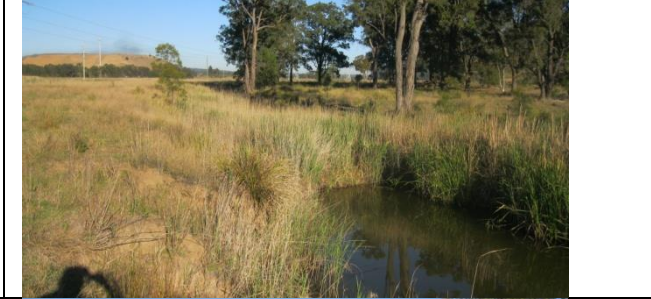
<ul style="list-style-type: none"> <li>• Reduction in instream flora health;</li> <li>• Reduction in green growth on the creek banks and in the riparian areas;</li> <li>• Increased exposure of the left bank face;</li> <li>• Right bank appears to be suffering slippage;</li> <li>• Little to no riparian zone.</li> </ul>
19

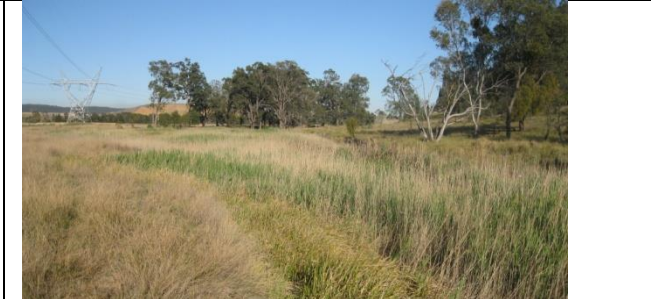
<ul style="list-style-type: none"> <li>• Reduction in healthy instream flora;</li> <li>• Sight remains stable;</li> <li>• Little to no riparian zone.</li> </ul>
20

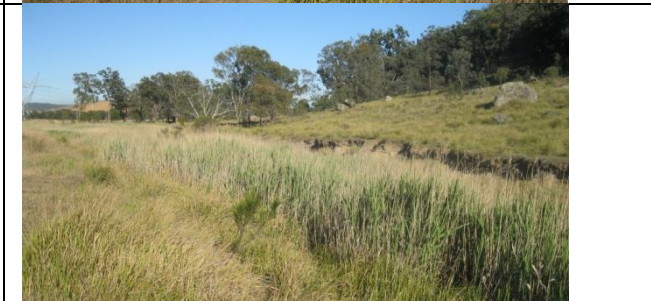
<ul style="list-style-type: none"> <li>• Reduction in healthy instream flora;</li> <li>• Increased bleaching of exposed soils on the left bank face;</li> <li>• Right bank remains stable;</li> <li>• Little to no riparian zone.</li> </ul>
21

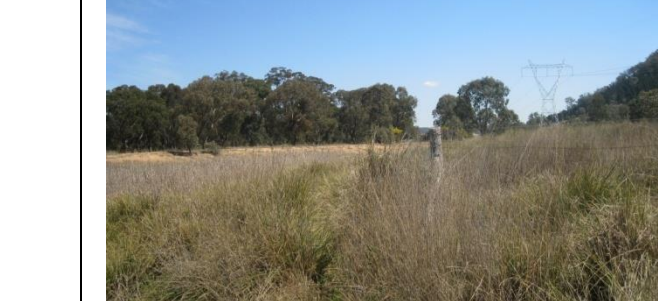
<ul style="list-style-type: none"> <li>• Reduction in healthy instream flora;</li> <li>• Increased bleaching of exposed soils on the right bank face;</li> <li>• An increase in sheet erosion of the right bank;</li> <li>• Left bank remains stable;</li> <li>• Reduction of the active channel;</li> <li>• Little to no riparian zone.</li> </ul>
25

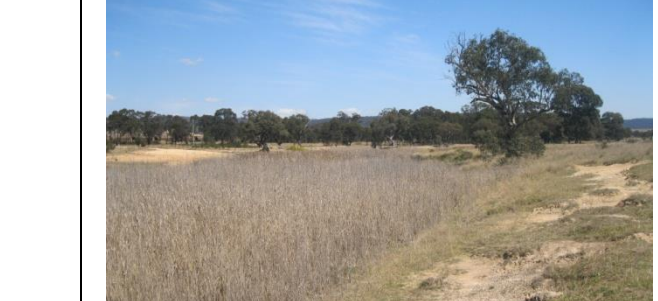
<ul style="list-style-type: none"> <li>• Reduction in healthy instream flora;</li> <li>• Site remains similar.</li> </ul>
26

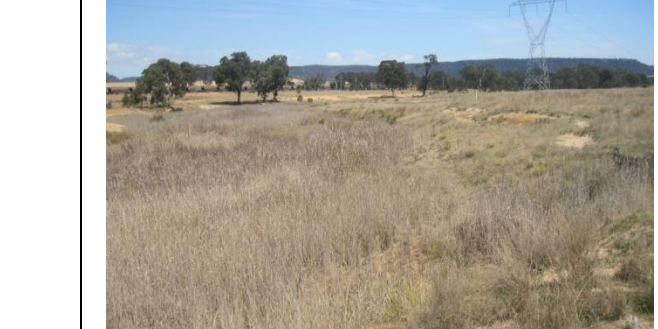
<ul style="list-style-type: none"> <li>• Reduction in healthy instream flora;</li> <li>• Stabilisation of the left bank face, with a minor decrease in groundcover;</li> <li>• Right bank exposure remains stable.</li> </ul>
27

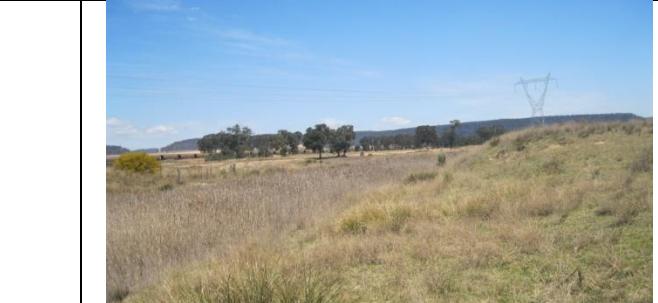
<ul style="list-style-type: none"> <li>• Reduction in healthy instream flora;</li> <li>• Site remains similar.</li> </ul>

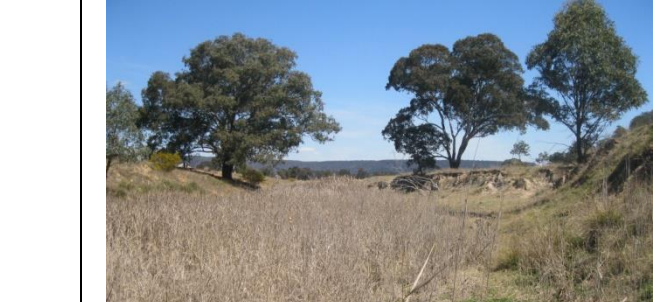
<ul style="list-style-type: none"> <li>• Reduction in healthy instream flora;</li> <li>• Increased stability of the right bank;</li> <li>• Site remains similar.</li> </ul>

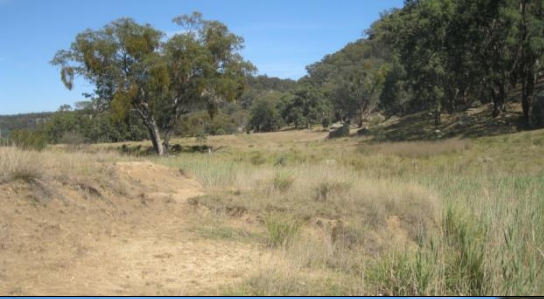
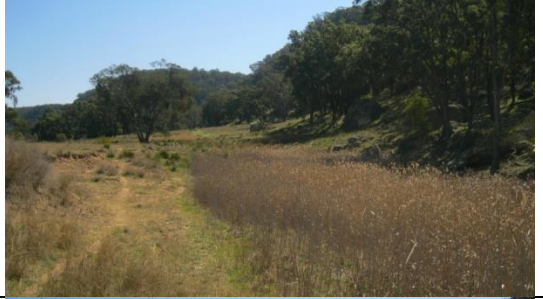
<ul style="list-style-type: none"> <li>• Increased regeneration of the left bank as a result of destocking;</li> <li>• Decreased surface soil exposure on the left bank as a result of improved ground cover;</li> <li>• Right bank remains similar;</li> <li>• Reduction in healthy instream flora;</li> <li>• Reduction in the active channel width;</li> <li>• Prickly pear noted in the vicinity of the site.</li> </ul>
36

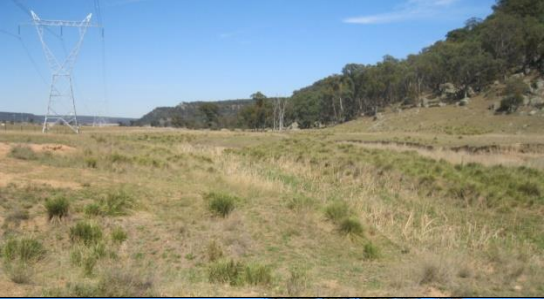
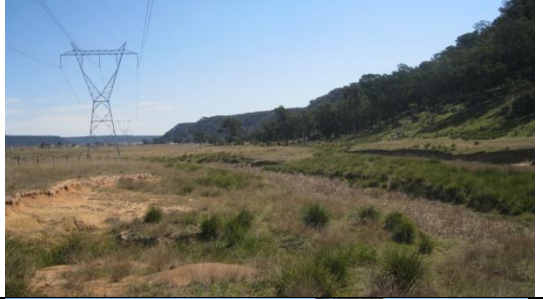
<ul style="list-style-type: none"> <li>• Reduction in healthy instream flora;</li> <li>• Reduction in the active channel width;</li> <li>• Continued regression and erosion of the right and left banks;</li> <li>• Continued exposure of surface soils on the right and left banks due to increased dryness during 2014;</li> </ul>
37

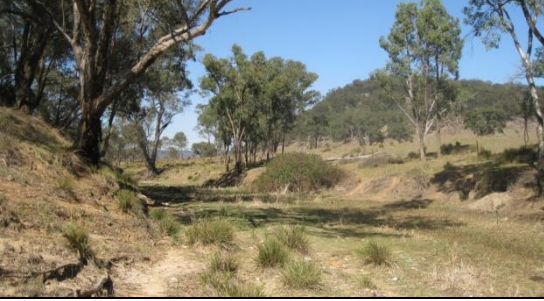
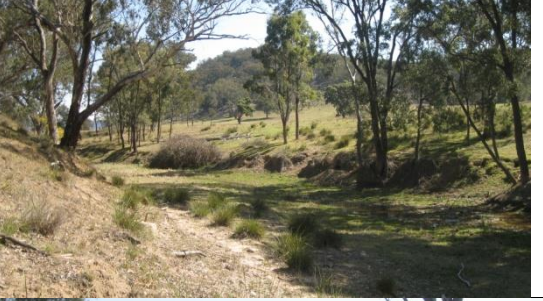
<ul style="list-style-type: none"> <li>• Reduction in abundance of instream flora at the site;</li> <li>• Continued regression and erosion of the right banks;</li> <li>• Continued exposure of surface soils on the right banks due to increased dryness during 2014;</li> <li>• Left bank remains well vegetated and stable;</li> <li>• Blackberry noted upstream of the site.</li> </ul>
39	No Access

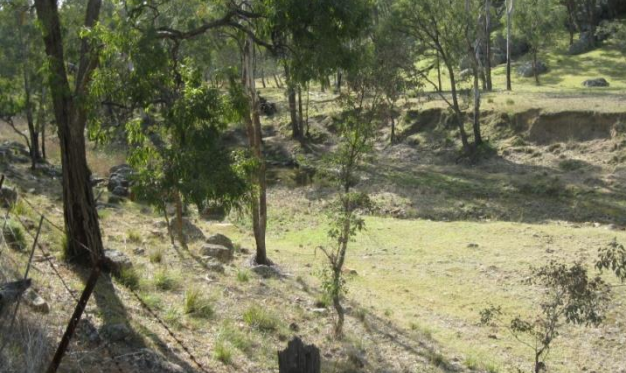
<ul style="list-style-type: none"> <li>• Reduction in the active channel width;</li> <li>• Increased undercutting and gullyng of the left bank face, however vegetation coverage has increased over the year;</li> <li>• Soil exposure remains stable instream and on the right bank face. There has been an increase in groundcover on the right bank face as result of natural regeneration;</li> </ul>
49

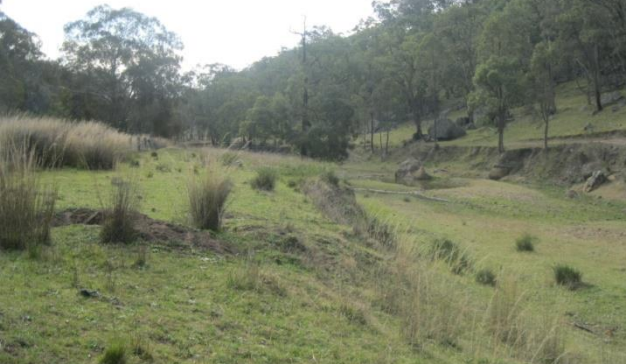
<ul style="list-style-type: none"> <li>• A reduction in the active channel width;</li> <li>• There has been a significant increase in groundcover within the creek bed, resulting in a reduction of soil and bed exposure;</li> <li>• There is an increase in groundcover on both bank faces, as a result of natural regeneration;</li> <li>• Site continues to regenerate.</li> </ul>

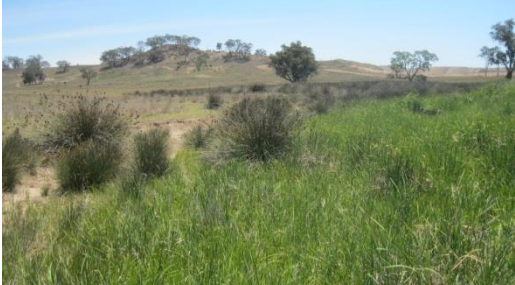
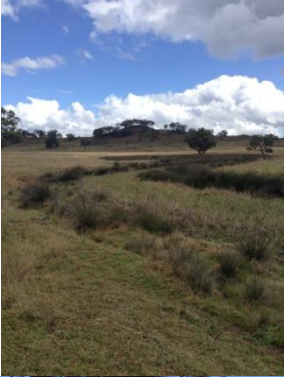
<ul style="list-style-type: none"> <li>• A reduction in 'green' groundcover within the creek bed, on the bank faces and within riparian areas between 2013-2014.</li> <li>• An increase in soil exposure of both bank faces is noted during 2014.</li> </ul>
3

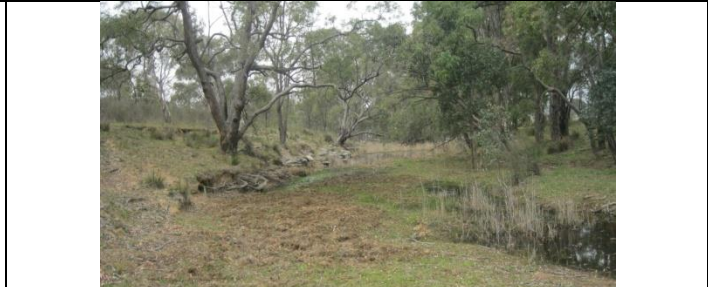
<ul style="list-style-type: none"> <li>• A reduction in in stream flora growth;</li> <li>• An increase in the active channel width;</li> <li>• Increased stock activity in the area;</li> <li>• Increased stability of the creek banks;</li> <li>• Increase in blackberry.</li> </ul>
7

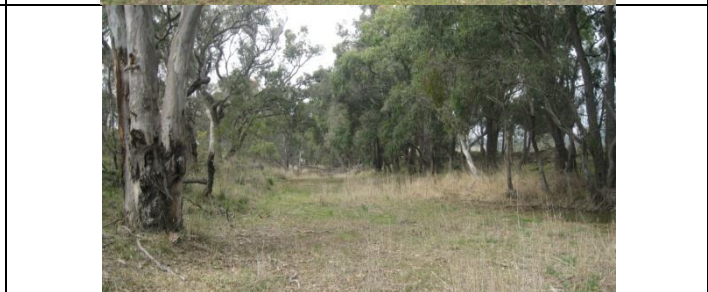
<ul style="list-style-type: none"> <li>• A reduction in instream flora growth;</li> <li>• Increase in bank undercutting;</li> <li>• Stability of banks similar.</li> </ul>
8

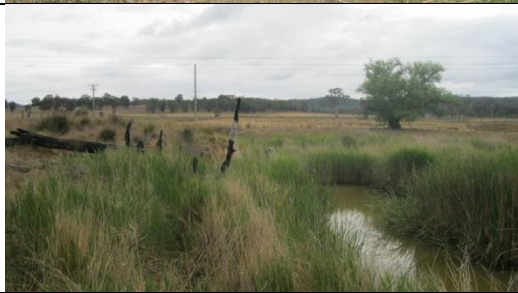
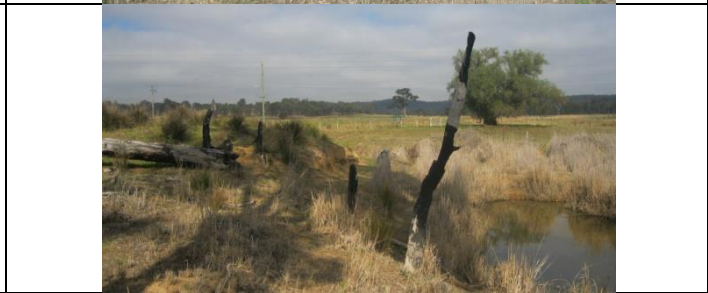
<ul style="list-style-type: none"> <li>• Large reduction in instream flora growth;</li> <li>• Increased exposure of the bank faces;</li> <li>• Reduction in green vegetation on the creek banks and riparian areas;</li> <li>• Evidence of stock in the area;</li> <li>• Blackberry noted.</li> </ul>
9

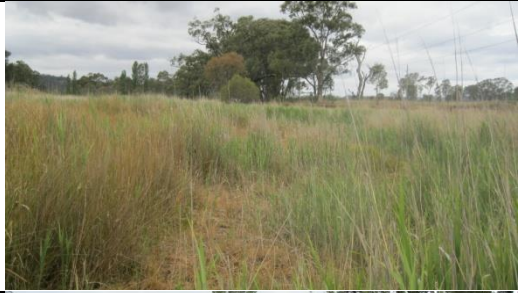
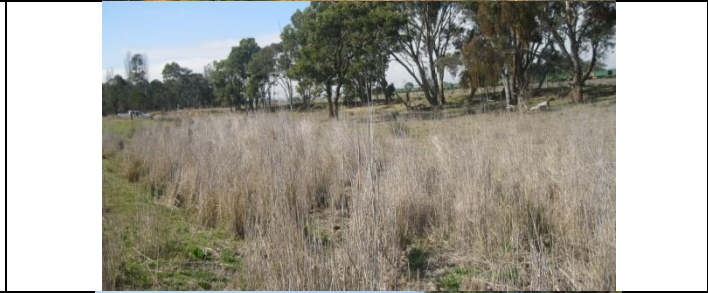
<ul style="list-style-type: none"> <li>• Large reduction in instream flora growth;</li> <li>• Increased exposure of the bank faces;</li> <li>• Reduction in green growth on the creek banks and in the riparian areas.</li> </ul>

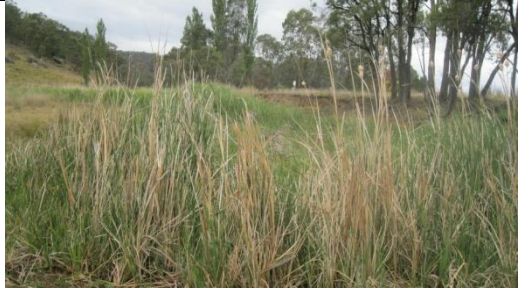
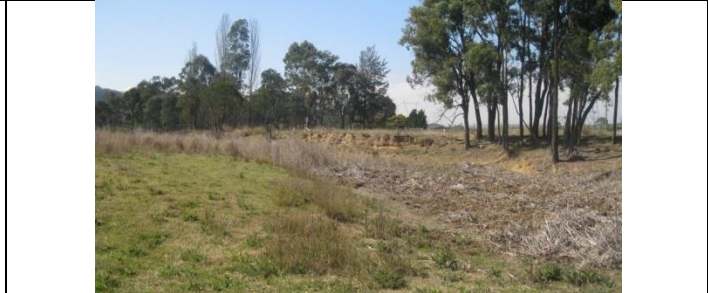
<ul style="list-style-type: none"> <li>• Large reduction in instream flora growth;</li> <li>• Increased exposure of the bank faces;</li> <li>• Increased erosion of the left bank;</li> <li>• Reduction in green growth on the creek banks and in the riparian areas;</li> <li>• Evidence of stock in the area;</li> <li>• Blackberry noted.</li> </ul>
11

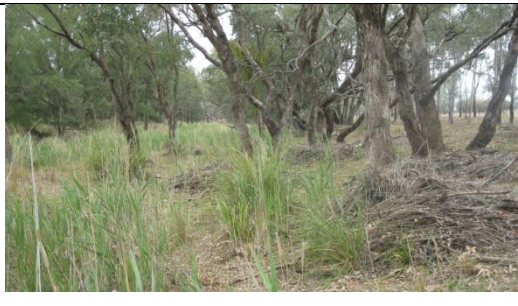
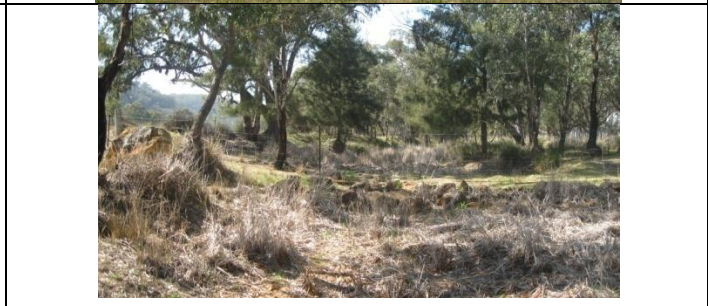
<ul style="list-style-type: none"> <li>• Large reduction in instream flora growth;</li> <li>• Reduction in the active channel;</li> <li>• Increase in soil exposure of the creek bank faces;</li> <li>• Reduction in green growth on the creek banks and in the riparian areas;</li> <li>• Evidence of stock in the area.</li> </ul>

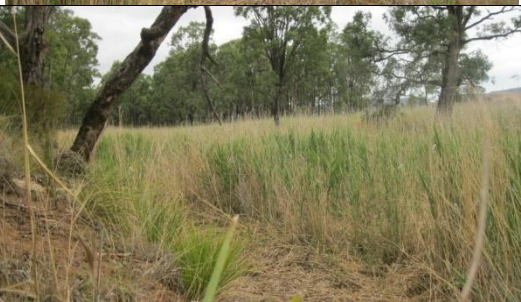
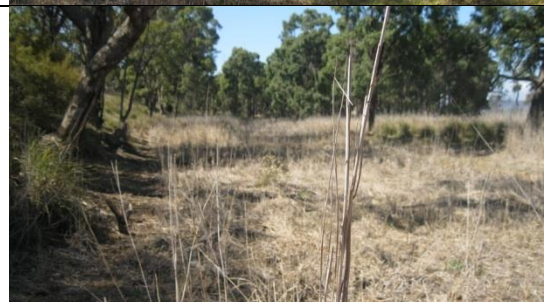
<ul style="list-style-type: none"> <li>• Large reduction in instream flora growth;</li> <li>• Increased exposure of the creek bed with some bed erosion noted;</li> <li>• A reduction in the active creek width;</li> <li>• A reduction in groundcover on the creek bank faces;</li> <li>• Banks relatively stable;</li> <li>• Blackberry present;</li> <li>• Evidence of wombats.</li> </ul>

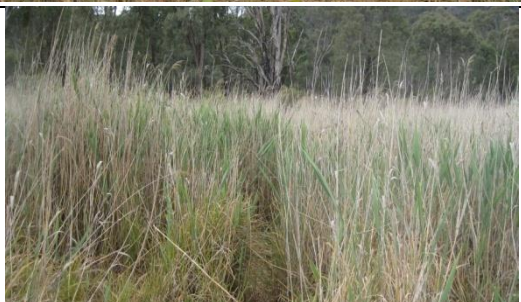
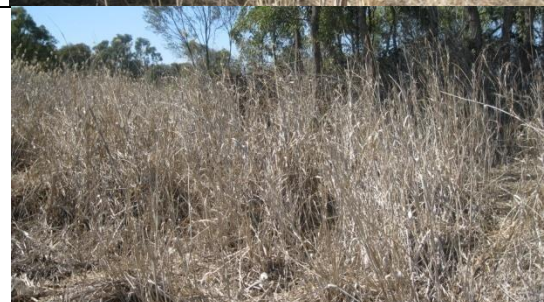
<ul style="list-style-type: none"> <li>• Instream flora abundant, however is in poor health;</li> <li>• Evidence of wombats in the creek bed;</li> <li>• Banks stable with no soil exposure.</li> </ul>
17

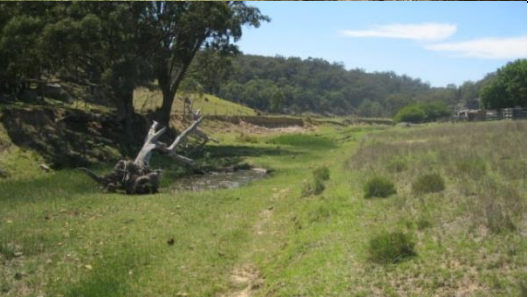
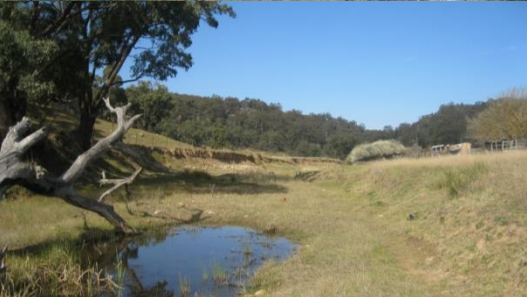
<ul style="list-style-type: none"> <li>• An increase in bed exposure and water pooling in 2014;</li> <li>• An increase in the active channel width over the year;</li> <li>• Banks stability and ground coverage remains similar.</li> </ul>

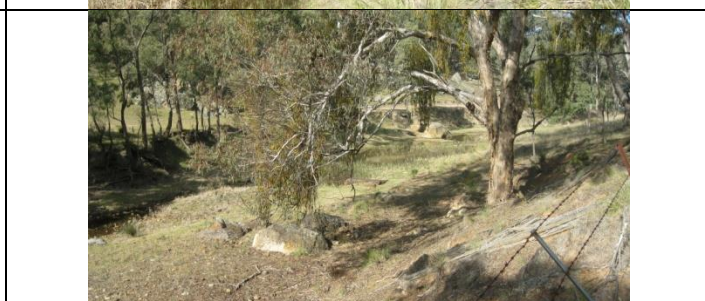
<ul style="list-style-type: none"> <li>• Reduction in the active channel width;</li> <li>• Increased undercutting of the left inner bank, however the outer embankment is well vegetated;</li> <li>• Soil exposure remains stable instream and on the right bank face. There has been an increase in groundcover on the right bank face as result of natural regeneration;</li> </ul>

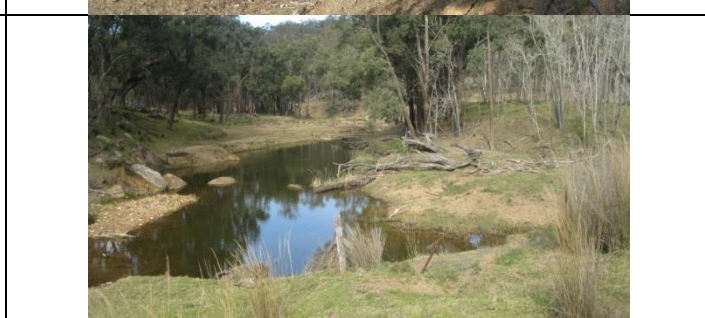
<ul style="list-style-type: none"> <li>• A reduction in the active channel width;</li> <li>• Instream flora remains minimal with continued deposition of sands and pebbles;</li> <li>• Inner banks remain sparsely vegetated as a result of a dry 2014;</li> </ul>
