# Wilpinjong & Cumbo Creek Stability Assessment, 2012-2013

Wilpinjong Coal Mine

Mar-14  
(Our Reference: 20366\_E02)

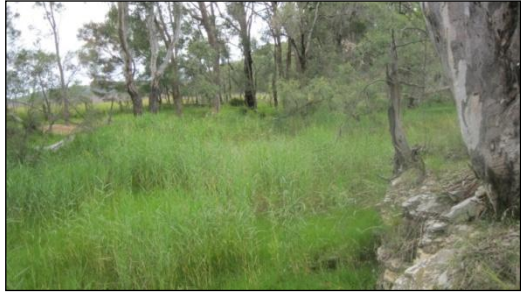
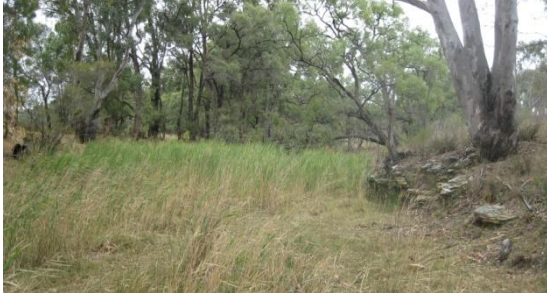
| 7 | | | | <ul style="list-style-type: none"> <li>• A reduction in 'green' groundcover within the creek bed, on the bank faces and within riparian areas between 2011-13.</li> <li>• An increase in soil exposure of the creek bed and bank face between 2012-2013.</li> <li>• A reduction in the active channel width during 2012-2013.</li> <li>• An increase in bed debris and woody material during 2012-2013.</li> </ul> |

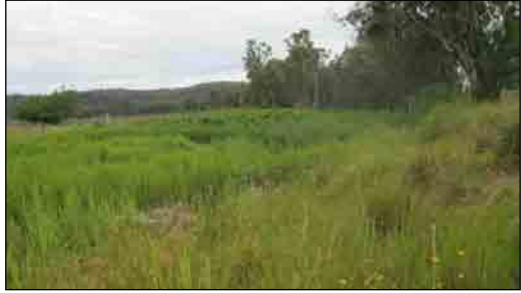
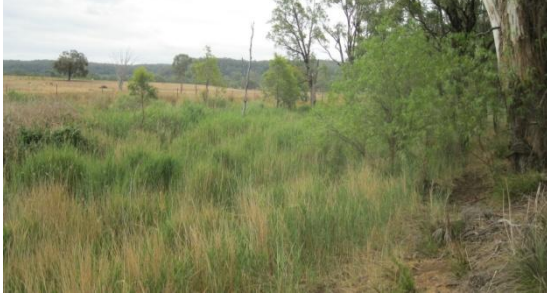
| 8 | | | | <ul style="list-style-type: none"> <li>• A reduction in 'green' groundcover within the creek bed, on the bank faces and within riparian areas between 2011-12.</li> <li>• In increase in plant growth within the creek bed and on the creek bank during 2013.</li> <li>• An increase in groundcover on the creek banks during 2013.</li> </ul> |

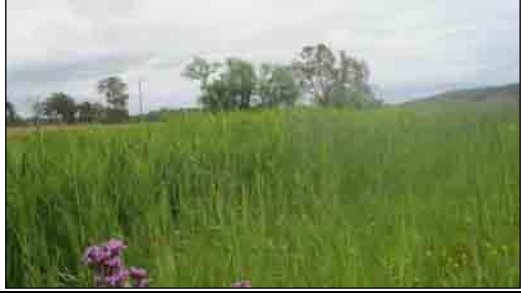
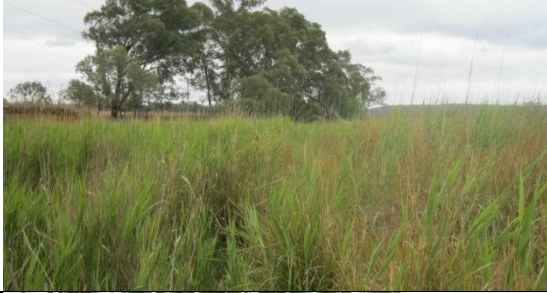
| 9 | | | | <ul style="list-style-type: none"> <li>• No considerable differences in the creek bed or bank observed at this site during 2011-2013.</li> </ul> |

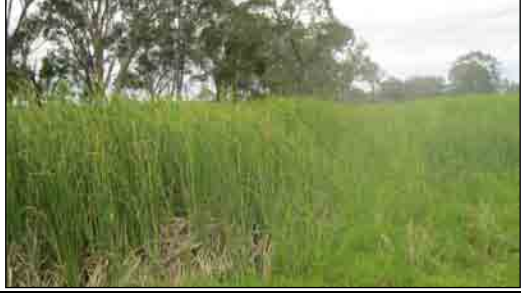
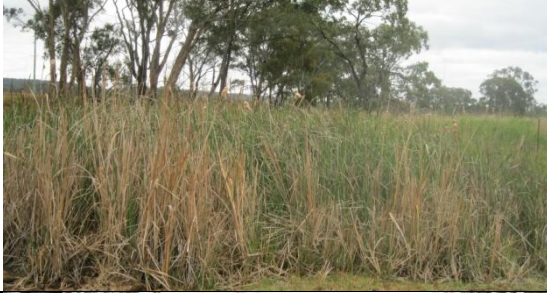
| 10 | | | | <ul style="list-style-type: none"> <li>• No considerable differences in the creek bed or bank observed at this site during 2011-2013.</li> </ul> |

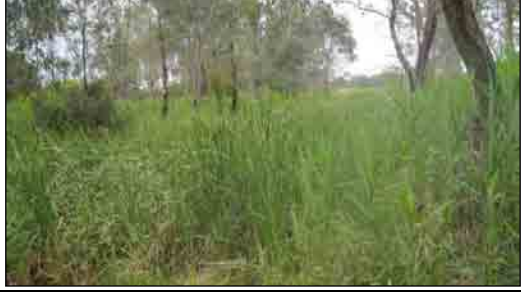
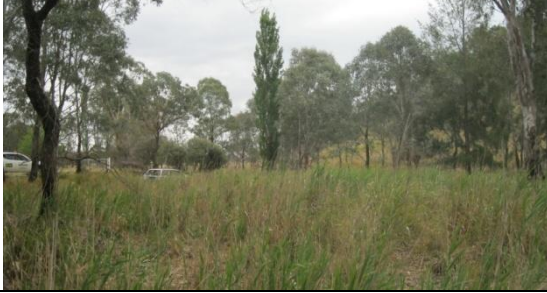
| 11 | | | | <ul style="list-style-type: none"> <li>• A reduction in 'green' groundcover within the creek bed, on the bank faces and within riparian areas between 2011-13.</li> <li>• A reduction in the active channel between 2011-2013.</li> </ul> |

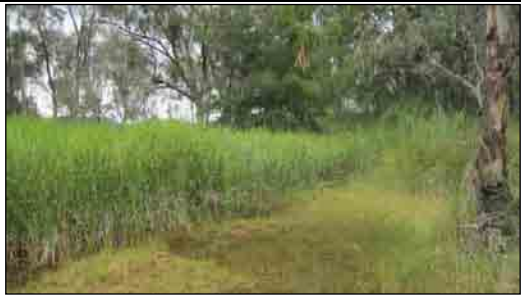
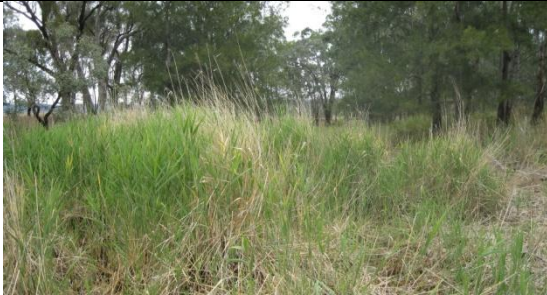
| 12 | | | | <ul style="list-style-type: none"> <li>• A reduction in 'green' groundcover within the creek bed, on the bank faces and within riparian areas between 2011-13.</li> <li>• An increase in soil exposure of the creek bed and bank face between 2011-2013.</li> <li>• A reduction in the active channel width during 2012-2013.</li> <li>• An increase in bed debris during 2011-2013.</li> </ul> |

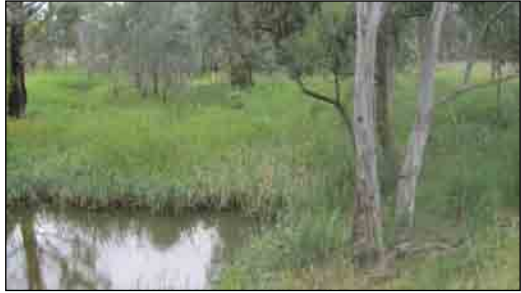
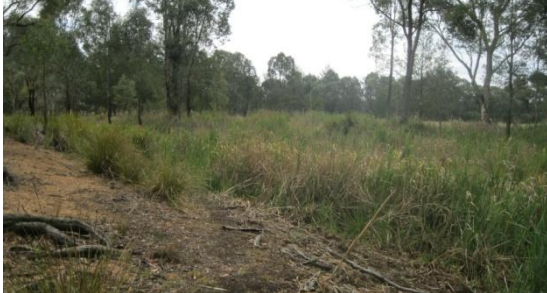
| 13 | | | | <ul style="list-style-type: none"> <li>• A reduction in 'green' groundcover within the creek bed, on the bank faces and within riparian areas between 2011-13.</li> <li>• An increase in soil exposure of the creek bank face between 2012-2013.</li> <li>• A reduction in the active channel width during 2012-2013.</li> <li>• An increase in bank debris and woody material during 2012-2013.</li> </ul> |

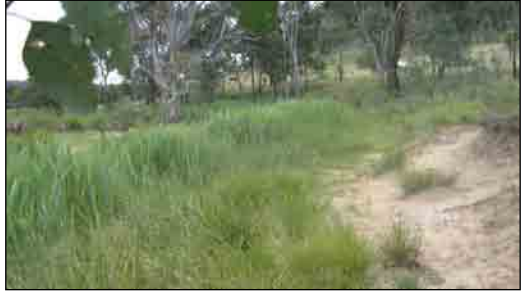
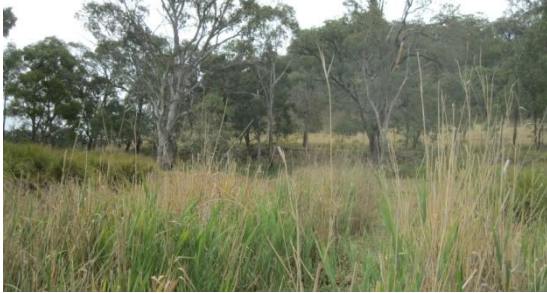
| 14 | | | | <ul style="list-style-type: none"> <li>• No considerable differences in the creek bed or bank observed at this site during 2011-2013</li> </ul> |

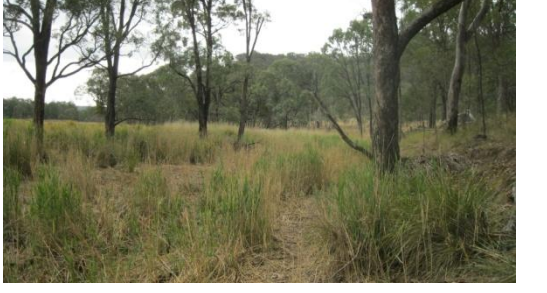
| 15 | | | | <ul style="list-style-type: none"> <li>• Slightly different locations in 2012 to 2011 and 2013.</li> <li>• A reduction in 'green' groundcover within the creek bed, on the bank faces and within riparian areas between 2011-13.</li> <li>• An increase in soil exposure of the creek bank face between 2012-2013.</li> <li>• A reduction in the active channel width during 2012-2013.</li> </ul> |

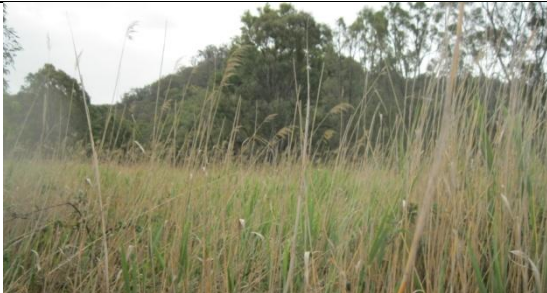
| 16 | | | | <ul style="list-style-type: none"> <li>• A reduction in 'green' groundcover within the creek bed, on the bank faces and within riparian areas between 2012-13.</li> <li>• No considerable differences in the creek bed or bank observed at this site during 2012-2013</li> </ul> |

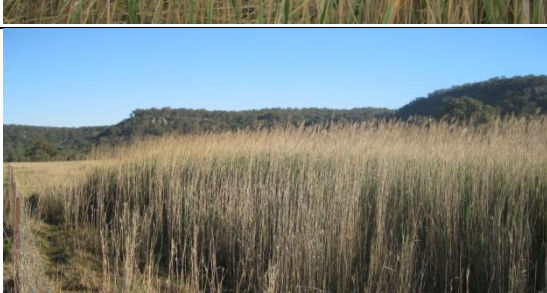
| 17 | | | | <ul style="list-style-type: none"> <li>• A reduction in 'green' groundcover within the creek bed, on the bank faces and within riparian areas between 2011-13.</li> <li>• Creek bed and banks remain stable.</li> </ul> |

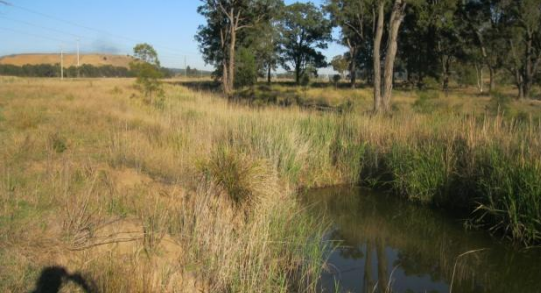
| 18 | | | | <ul style="list-style-type: none"> <li>• A reduction in 'green' groundcover within the creek bed, on the bank faces and within riparian areas between 2011-13.</li> <li>• Increase soil exposure during 2012. However this remained stable in 2013.</li> <li>• A reduction in the active channel width during 2012-2013.</li> </ul> |

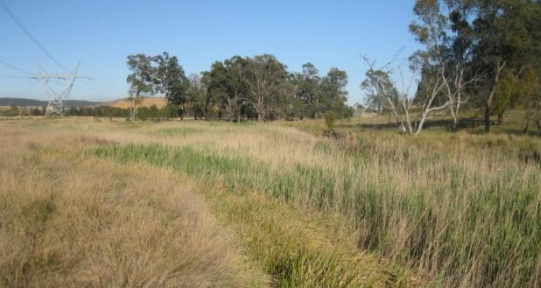
| 19 | | | | <ul style="list-style-type: none"> <li>• A reduction in 'green' groundcover within the creek bed, on the bank faces and within riparian areas between 2011-13.</li> <li>• A reduction in the active channel width during 2011-2013.</li> </ul> |

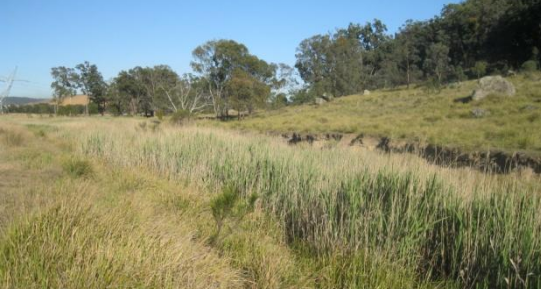
| 20 | | | | <ul style="list-style-type: none"> <li>• A reduction in 'green' groundcover within the creek bed, on the bank faces and within riparian areas between 2011-13.</li> <li>• Increase soil exposure and erosion of the right bank during 2012. This continued in 2013.</li> <li>• A reduction in the active channel width during 2012-2013.</li> </ul> |

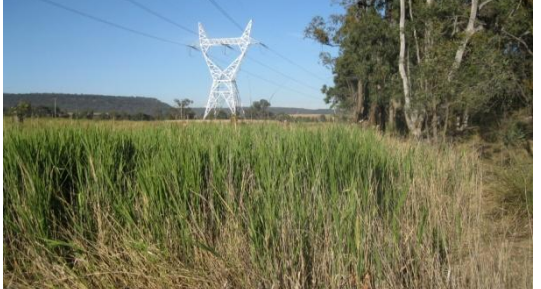
| 21 | | | | <ul style="list-style-type: none"> <li>• A reduction in 'green' groundcover within the creek bed, on the bank faces and within riparian areas between 2011-12.</li> <li>• A reduction in the active channel width during 2011-2012.</li> <li>• No considerable differences in the creek bed or bank observed at this site during 2012-2013.</li> </ul> |

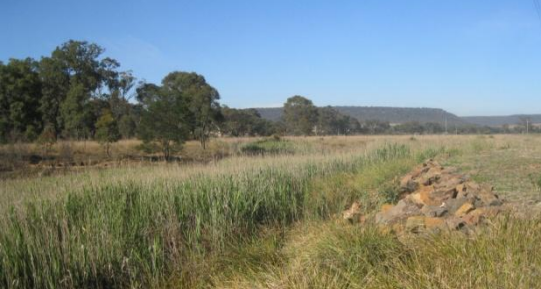
| 22 | | | | <ul style="list-style-type: none"> <li>• A reduction in 'green' groundcover within the creek bed, on the bank faces and within riparian areas between 2011-12.</li> <li>• Increase soil exposure on the creek bank faces during 2012. However this remained stable in 2013, with an increase in groundcover observed in 2013.</li> <li>• A reduction in the active channel width during 2011-2012.</li> </ul> |

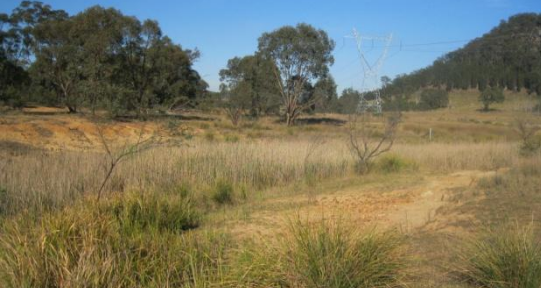
| 23 | | | | <ul style="list-style-type: none"> <li>• A reduction in 'green' groundcover within the creek bed, on the bank faces and within riparian areas between 2011-12.</li> <li>• Increase soil exposure on the left creek bank face during 2012, which is evident by an area of surface sheet erosion. A reduction of sheet erosion in 2013, with an increase in groundcover noted.</li> <li>• An increase in soil exposure on the right bank resulting in sheet erosion and gulying between 2011-2012. This remained stable in 2013.</li> </ul> |

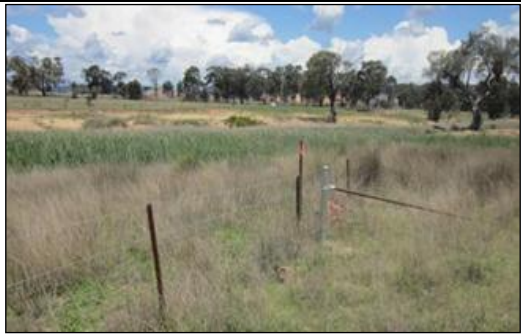
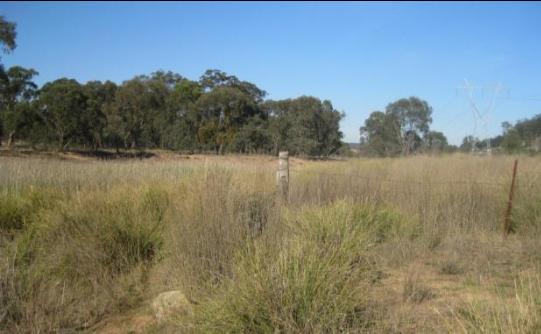
| 24 | | | | <ul style="list-style-type: none"> <li>• A reduction in 'green' groundcover within the creek bed, on the bank faces and within riparian areas between 2011-12.</li> <li>• Increase soil exposure on the left top of bank during 2012, which is evident by an area of surface sheet erosion. This is reduced in 2013.</li> </ul> |

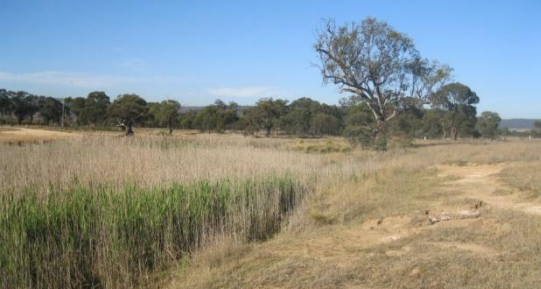
| 25 | | | | <ul style="list-style-type: none"> <li>• A reduction in 'green' groundcover within the creek bed, on the bank faces and within riparian areas between 2011-12.</li> <li>• Increase soil exposure on the left creek bank face during 2012, which is evident by an area of surface sheet erosion along the bank face. This has reduced in 2013, with an increase in groundcover noted.</li> </ul> |

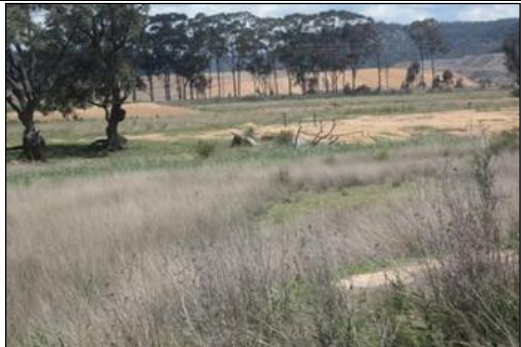
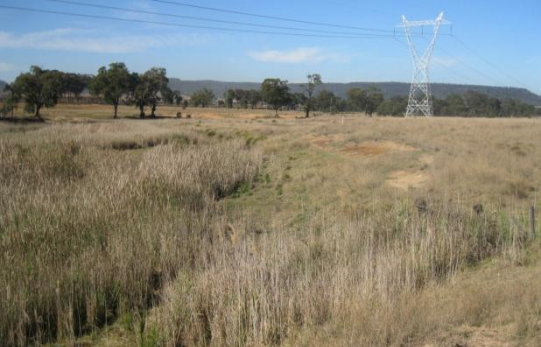
| 26 | | | | <ul style="list-style-type: none"> <li>• A reduction in 'green' groundcover within the creek bed, on the bank faces and within riparian areas between 2011-12.</li> <li>• An increase in active channel width in 2013, as noted by an increase in instream flora from 2012.</li> <li>• Increase soil exposure on the left creek bank face during 2012, which is evident by an area of surface sheet erosion along the bank face. This has reduced in 2013, with an increase in groundcover noted.</li> </ul> |

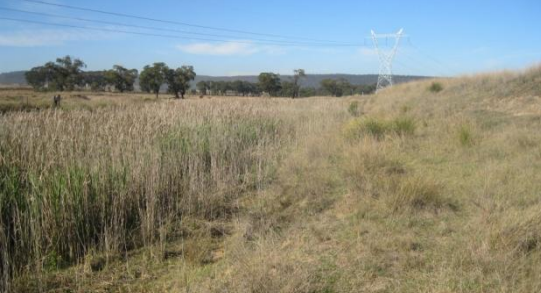
| 27 | | | | <ul style="list-style-type: none"> <li>• A reduction in 'green' groundcover within the creek bed, on the bank faces and within riparian areas between 2011-12.</li> <li>• No considerable differences in the creek bed or bank observed at this site during 2012-2013.</li> </ul> |

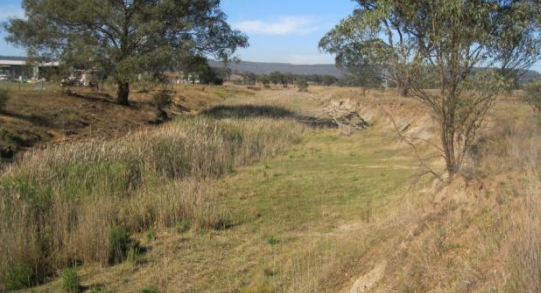
| 28 | | | | <ul style="list-style-type: none"> <li>• A reduction in 'green' groundcover within the creek bed, on the bank faces and within riparian areas between 2011-12.</li> <li>• Increase soil exposure and erosion on both creek bank faces during 2012. This has reduced in 2013, with an increase in groundcover noted.</li> <li>• A reduction in the active channel width during 2011-2013.</li> </ul> |

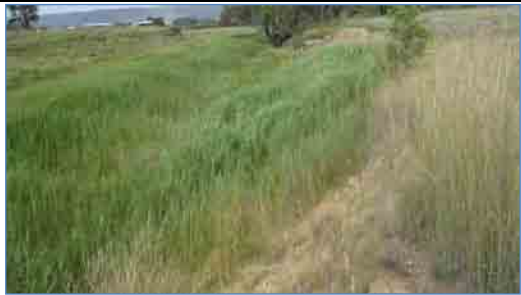
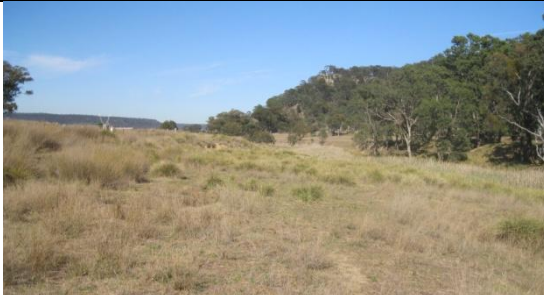
| 29 | | | | <ul style="list-style-type: none"> <li>• A reduction in 'green' groundcover within the creek bed, on the bank faces and within riparian areas between 2011-12.</li> <li>• No considerable differences in the creek bed or bank observed at this site during 2012-2013.</li> </ul> |

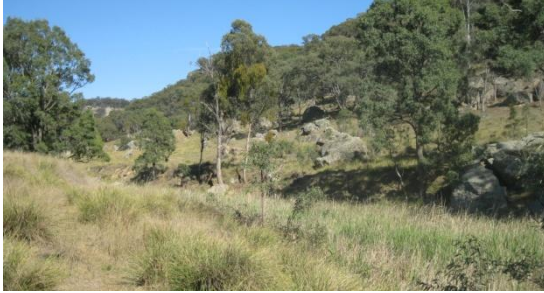
| 30 | | | | <ul style="list-style-type: none"> <li>• A reduction in 'green' groundcover within the creek bed, on the bank faces and within riparian areas between 2011-13.</li> <li>• Site relatively stable between 2011-2013 with good ground cover and minimal exposed surfaces.</li> </ul> |

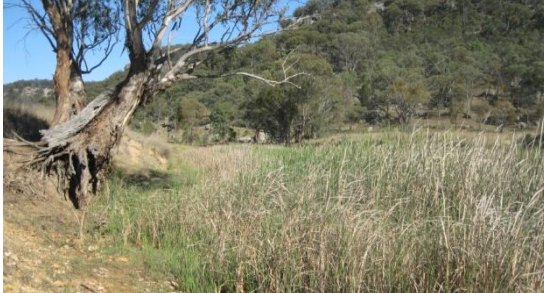
| 31 | | | | <ul style="list-style-type: none"> <li>• A reduction in 'green' groundcover within the creek bed, on the bank faces and within riparian areas between 2011-13.</li> <li>• Increase soil exposure on the right creek bank face during 2013, however site remains stable.</li> </ul> |

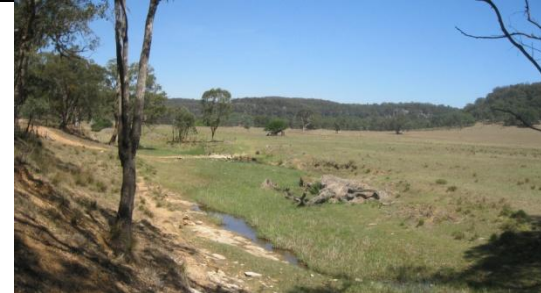
| 42 | | | | <ul style="list-style-type: none"> <li>• A reduction in 'green' groundcover within the creek bed, on the bank faces and within riparian areas between 2011-13.</li> <li>• Increase soil exposure of both creek bank faces during 2012, and this exposure remains stable during 2013.</li> <li>• Continued increase in debris within the creek channel with woody material during 2012 and 2013.</li> </ul> |

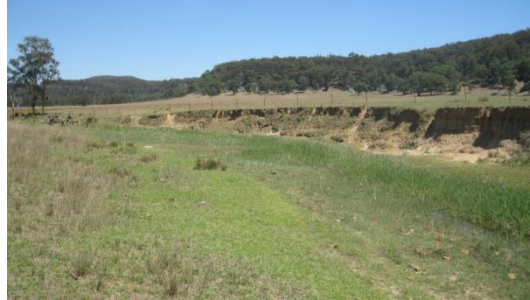
| 43 | | | | <ul style="list-style-type: none"> <li>• A reduction in 'green' groundcover within the creek bed, on the bank faces and within riparian areas between 2011-13.</li> <li>• Increase soil exposure of the left creek bank faces during 2012, however regeneration occurred during 2013 with the bank being more stable as a result of an increase in groundcover.</li> <li>• and this exposure</li> <li>• A reduction in the active channel width during 2011-2013.</li> </ul> |

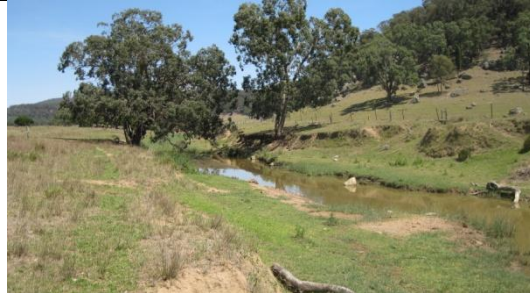
| 44 | | | | <ul style="list-style-type: none"> <li>• Photo is slightly downstream of previous location.</li> <li>• A reduction in 'green' groundcover within the creek bed, on the bank faces and within riparian areas between 2011-13.</li> <li>• Increase soil exposure of both creek bank faces during 2012, however regeneration occurred during 2013 with the bank being more stable as a result of an increase in groundcover.</li> <li>• Increase in inner bank undercutting noted during 2013 of the left bank.</li> </ul> |

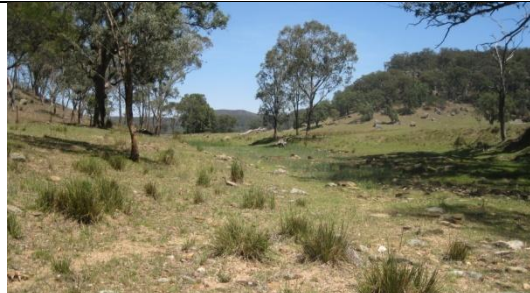
| 45 | | | | <ul style="list-style-type: none"> <li>• A reduction in 'green' groundcover within the creek bed, on the bank faces and within riparian areas between 2011-13.</li> <li>• Increase soil exposure of both creek bank faces during 2012, and this exposure remains stable during 2013.</li> <li>• Bedrock material exposure remains stable.</li> </ul> |

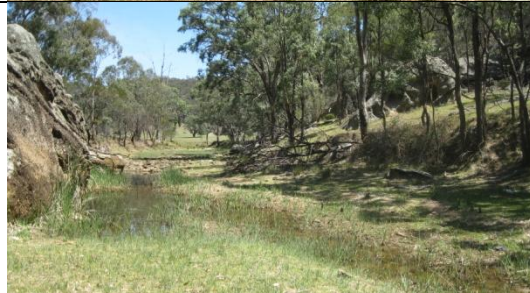
| 46 | | | | <ul style="list-style-type: none"> <li>• A reduction in 'green' groundcover within the creek bed, on the bank faces and within riparian areas between 2011-12.</li> <li>• A reduction in the active channel width during 2012-2013.</li> <li>• An increase in woody debris deposition during 2013.</li> </ul> |

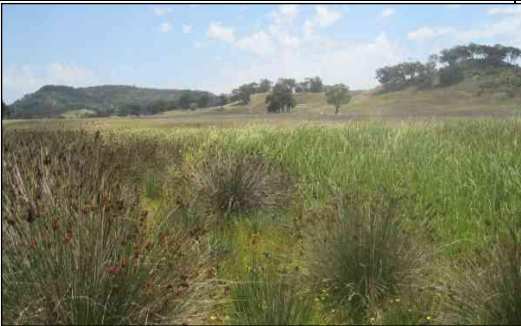
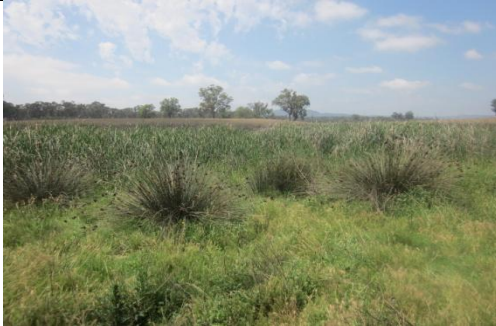
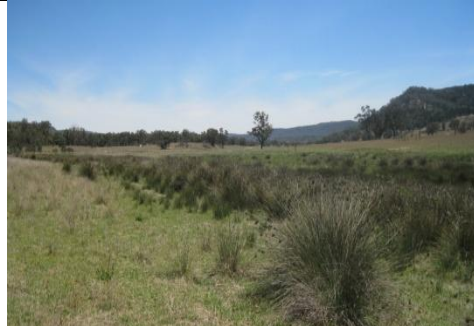
| Site | Upstream December 2011 | Upstream December 2012 | Upstream December 2013 | Main Comparison |
|---|---|---|---|---|
| 1 | | | | <ul style="list-style-type: none"> <li>A reduction in 'green' groundcover within the creek bed, on the bank faces and within riparian areas between 2011-13.</li> <li>Site remains well vegetated and stable.</li> </ul> |

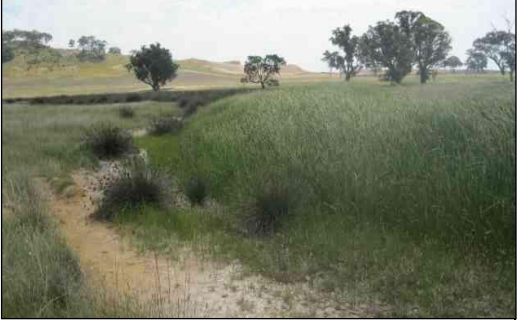
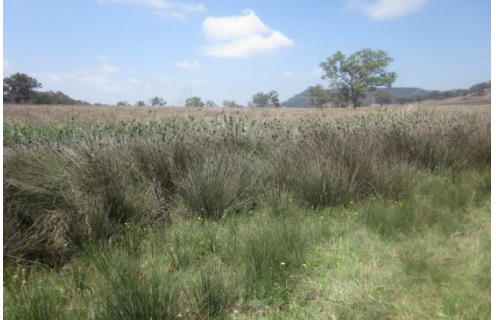
| Site | Upstream December 2011 | Upstream December 2012 | Upstream December 2013 | Main Comparison |
|---|---|---|---|---|
| 2 | | | | <ul style="list-style-type: none"> <li>Slightly different location in 2012.</li> <li>A reduction in 'green' groundcover within the creek bed, on the bank faces and within riparian areas between 2011-13.</li> <li>An increase in soil exposure of both bank faces is noted during 2013.</li> </ul> |

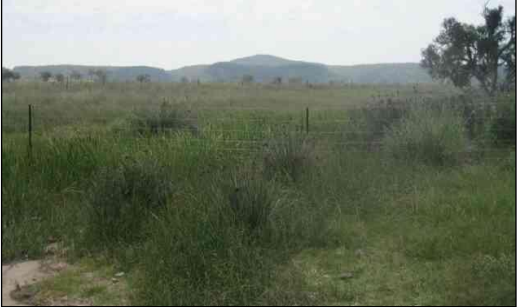
| Site | Upstream December 2011 | Upstream December 2012 | Upstream December 2013 | Main Comparison |
|---|---|---|---|---|
| 3 | | | | <ul style="list-style-type: none"> <li>A reduction in 'green' groundcover within the creek bed, on the bank faces and within riparian areas between 2011-13.</li> <li>A reduction in the active channel width during 2012-2013.</li> <li>Site remains well vegetated and stable.</li> </ul> |

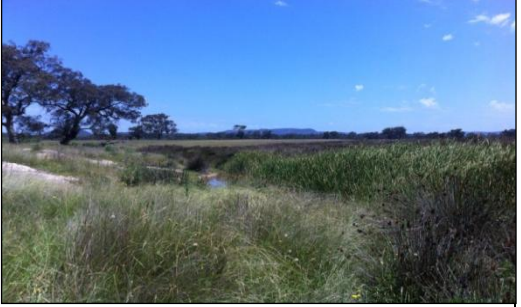
| Site | Upstream December 2011 | Upstream December 2012 | Upstream December 2013 | Main Comparison |
|---|---|---|---|---|
| 4 | | | | <ul style="list-style-type: none"> <li>A reduction in 'green' groundcover within the creek bed, on the bank faces and within riparian areas between 2011-13.</li> <li>An increase in soil exposure and instability is noted on the right bank in 2012. This is reduced in 2013.</li> <li>A reduction in the active channel width during 2012-2013.</li> </ul> |

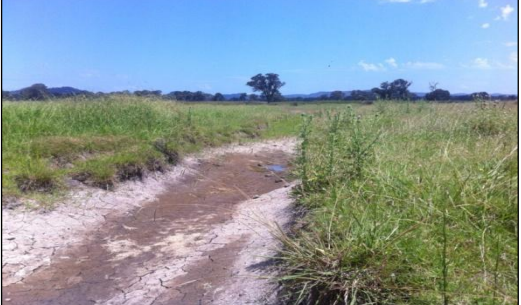
| Site | Upstream December 2011 | Upstream December 2012 | Upstream December 2013 | Main Comparison |
|---|---|---|---|---|
| 5 | | | | <ul style="list-style-type: none"> <li>A reduction in 'green' groundcover on the bank faces and within riparian areas between 2011-12.</li> <li>An increase in soil exposure and instability is noted on the bank faces in 2012. This is reduced in 2013.</li> <li>A reduction in the active channel width during 2012-2013, with an increase in revegetation.</li> </ul> |

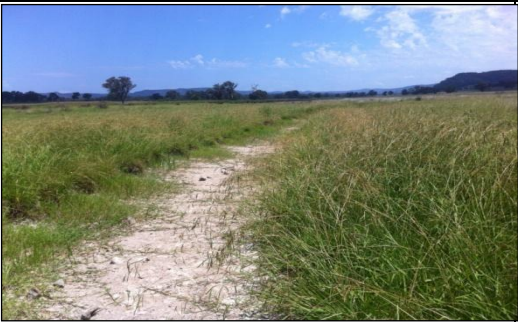
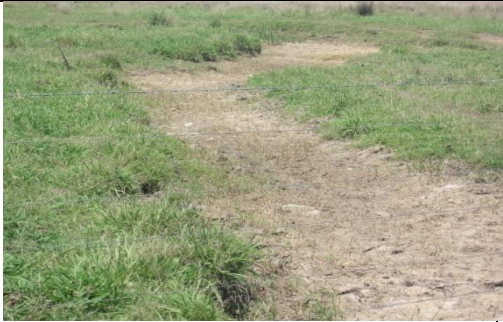
| 6 | | | | <ul style="list-style-type: none"> <li>• A reduction in 'green' groundcover on the bank faces and within riparian areas between 2011-12.</li> <li>• An increase in soil exposure and instability is noted on the bank faces in 2012. This is reduced in 2013.</li> <li>• A reduction in the active channel width during 2012-2013, with an increase in revegetation.</li> </ul> |

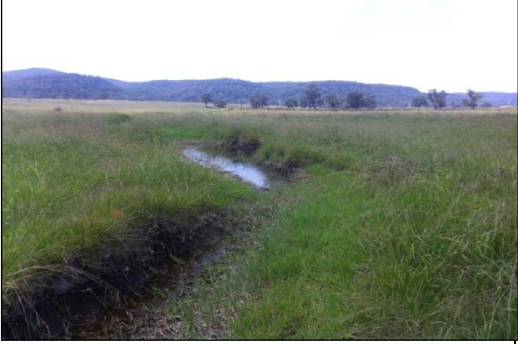
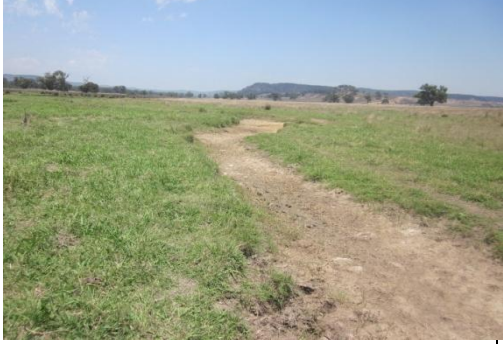
| 7 | | | Removed from survey due to works in area. | <ul style="list-style-type: none"> <li>• A reduction in 'green' groundcover within the creek bed, and on the bank faces and within riparian areas between 2011-12.</li> <li>• An increase in soil exposure and instability is noted on the bank faces in 2012. This is reduced in 2013.</li> <li>• A reduction in the active channel width during 2012-2013, with an increase in revegetation</li> </ul> |

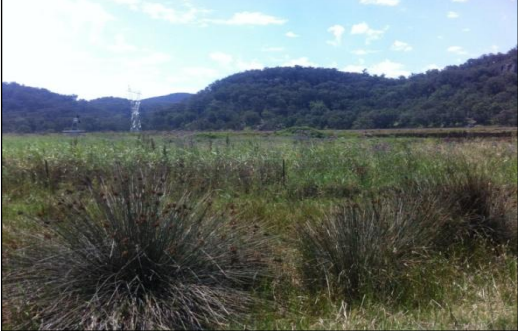
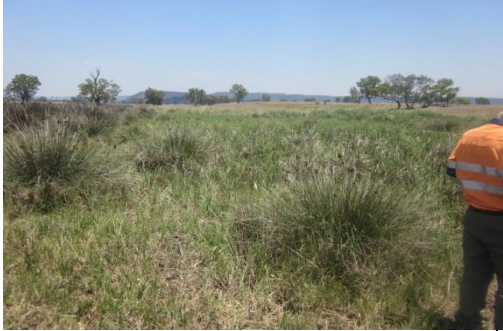
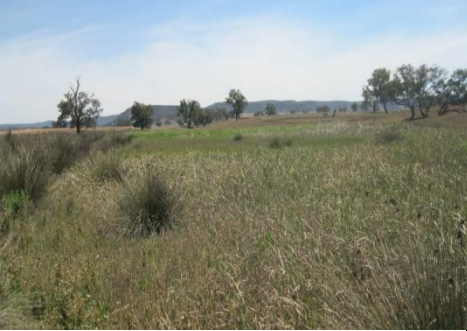
| 8 | | | | <ul style="list-style-type: none"> <li>• A reduction in 'green' groundcover on the bank faces and within riparian areas between 2011-12.</li> <li>• Site remain well vegetated and stable.</li> </ul> |

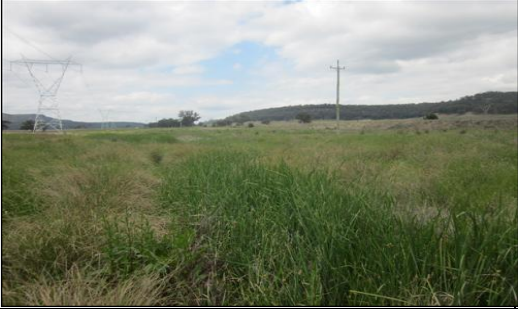
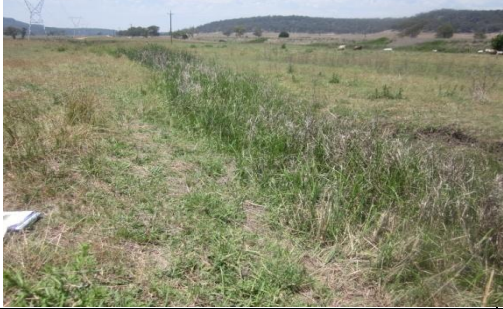
| 9 | | | | <ul style="list-style-type: none"> <li>• A reduction in 'green' groundcover on the bank faces and within riparian areas between 2011-12.</li> <li>• Site remain well vegetated and stable.</li> </ul> |

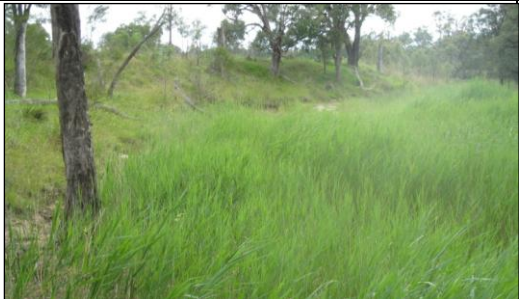
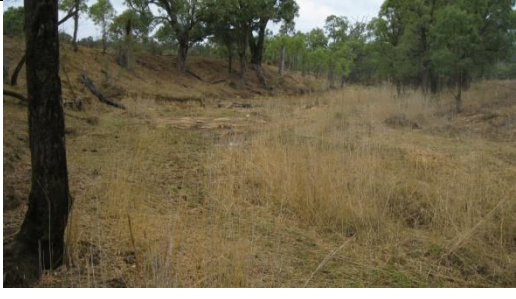
| Site | Downstream December 2011 | Downstream December 2012 | Downstream December 2013 | Main Comparisons |
|---|---|---|---|---|
| 1 | | | | <ul style="list-style-type: none"> <li>A reduction in 'green' groundcover within the creek bed, on the bank faces and within riparian areas between 2011-13.</li> <li>An increase in soil exposure on the bank face between 2011-2012.</li> <li>A reduction in creek width over the 2 year period.</li> <li>An increase in woody snags over the two year period.</li> </ul> |

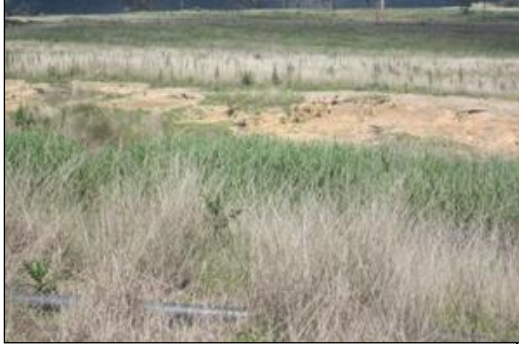
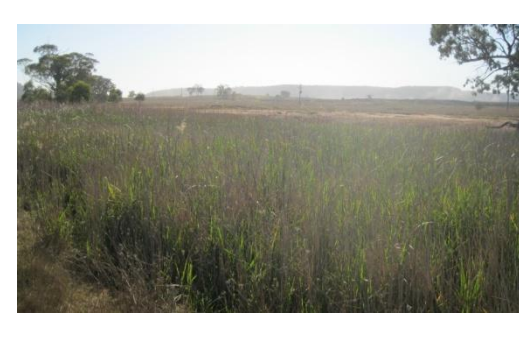
| 26 | | | | <ul style="list-style-type: none"> <li>• Area has remained stable with good groundcover between 2011 and 2013.</li> </ul> |

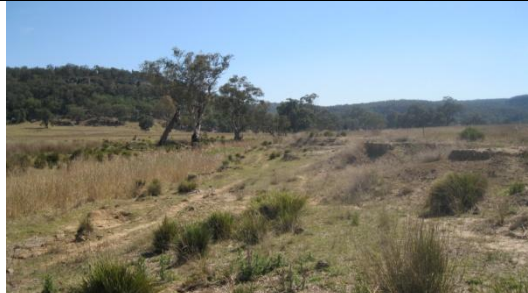
| 37 | | | | <ul style="list-style-type: none"> <li>• A reduction in 'green' groundcover within the creek bed, on the bank faces and within riparian areas between 2011-12.</li> <li>• Increase in soil exposure and sheet erosion of the right bank in 2012, which has stabilised in 2013.</li> <li>• Reduction of the active channel width in 2013.</li> </ul> |

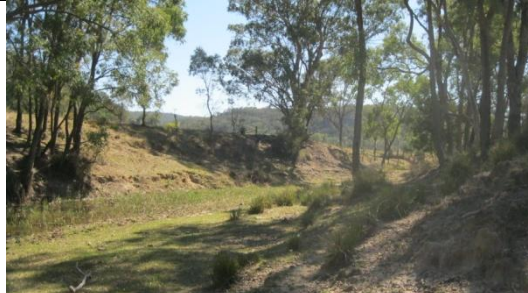
| 38 | | | | <ul style="list-style-type: none"> <li>• A reduction in 'green' groundcover within the creek bed, on the bank faces and within riparian areas between 2011-12.</li> <li>• Increase in soil exposure and sheet erosion of the right bank in 2012, which has regenerated with an increase in groundcover in 2013.</li> <li>• An increase in erosion of the left bank, with evidence of sheet erosion noted on the lower banks in 2013.</li> </ul> |

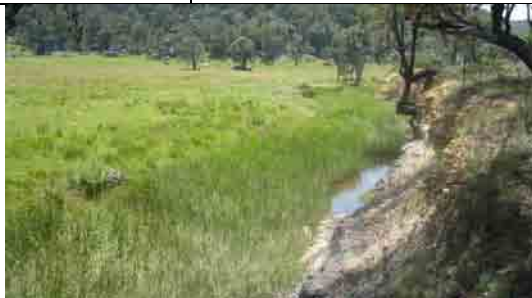
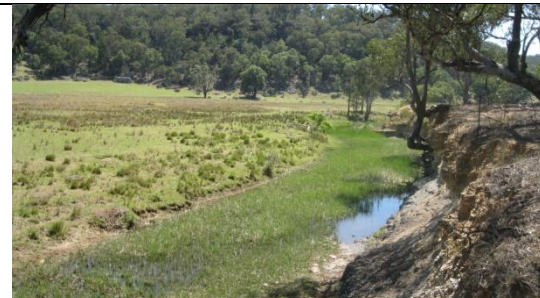
| 42 | | | | <ul style="list-style-type: none"> <li>• A reduction in 'green' groundcover within the creek bed, on the bank faces and within riparian areas between 2011-12. Site remains similar in 2013.</li> <li>• Increase in soil exposure, erosion and regrowth of the right bank, as noted by an increase in bank steepness and rootlet exposure in 2013.</li> <li>• An increase in undercutting of the left bank in 2013.</li> <li>• Channel width has remained similar.</li> </ul> |

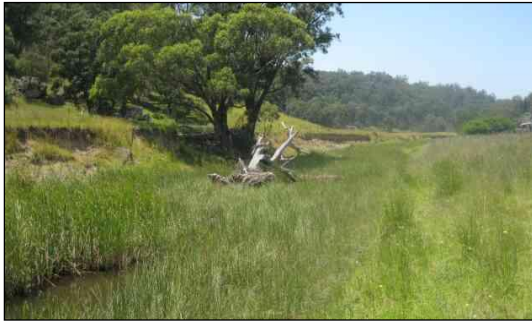
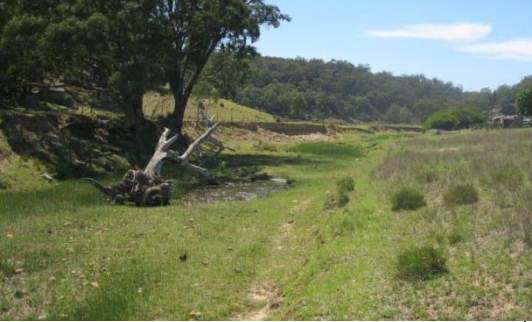
| 43 | | | | <ul style="list-style-type: none"> <li>• A reduction in 'green' groundcover within the creek bed, on the bank faces and within riparian areas between 2011-13.</li> <li>• Increase soil exposure of the left creek bank faces during 2012, however this has stabilised in 2013.</li> <li>• A reduction in the active channel width during 2011-2013.</li> </ul> |

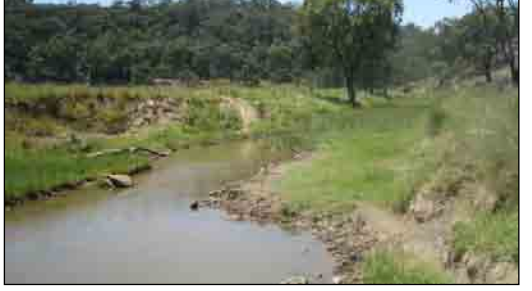
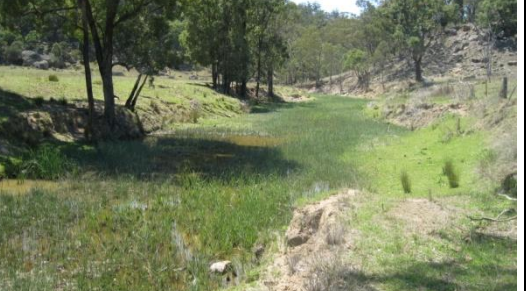
| 44 | | | | <ul style="list-style-type: none"> <li>• Photo is slightly downstream of previous location.</li> <li>• A reduction in 'green' groundcover on the creek bank faces and within riparian areas between 2011-12.</li> <li>• An increase in bank undercutting in 2012 in comparison to 2011, however this has stabilised in 2013.</li> <li>• An increase in instream vegetation growth in 2013.</li> </ul> |
