## **APPENDIX 3C – SURFACE WATER MONITORING**

# Wilpinjong & Cumbo Creek Stability Assessment, 2015

Wilpinjong Coal Mine

Mar-16  
(Our Reference: 23823\_E01\_Final)

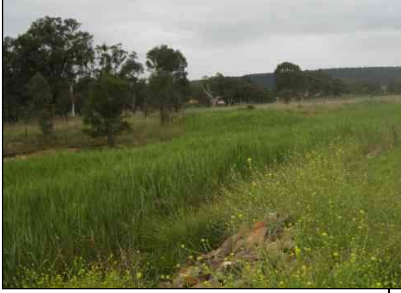
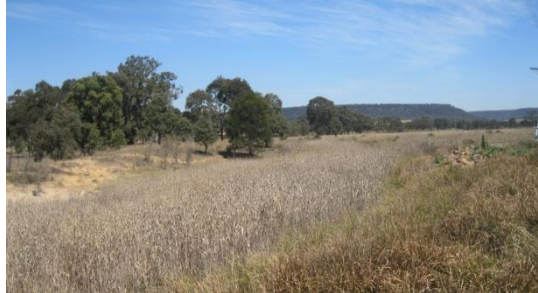
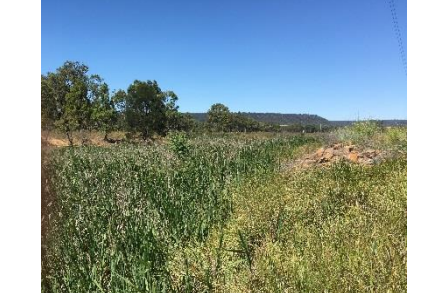
<ul style="list-style-type: none"> <li>▪ Increase in healthy instream flora from 2014;</li> <li>▪ Increased bank groundcover growth – both banks – scotch thistles noted;</li> <li>▪ Increased bleaching of exposed soils on the right bank face;</li> <li>▪ Left bank remains stable;</li> <li>▪ Reduction of the active channel;</li> <li>▪ Little to no riparian zone.</li> </ul>

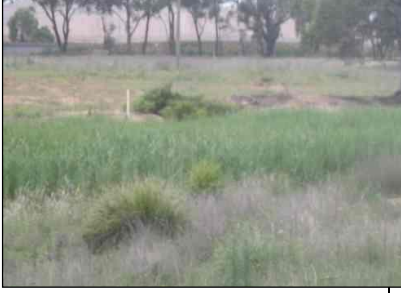
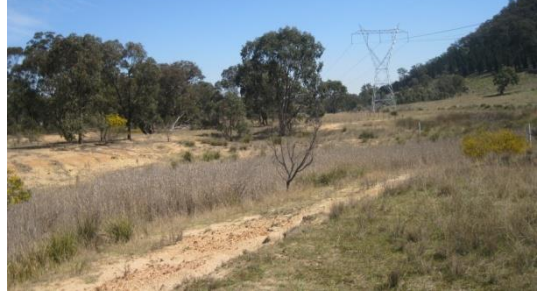
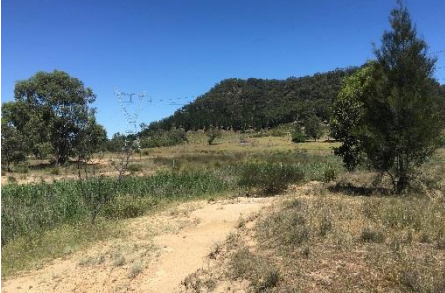
<ul style="list-style-type: none"> <li>▪ Increase in healthy instream flora;</li> <li>▪ Increased bleaching of exposed soils on the bank faces;</li> <li>▪ An increase in sheet erosion;</li> <li>▪ Active channel – remains stable;</li> <li>▪ Little to no riparian zone.</li> </ul>
24

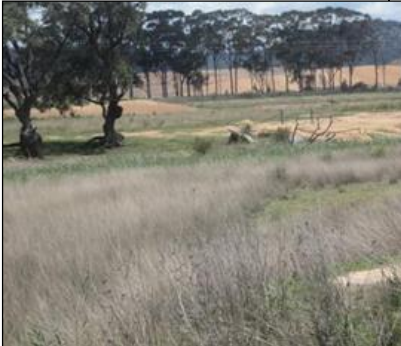
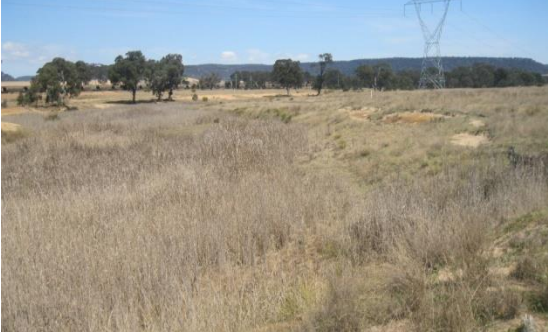
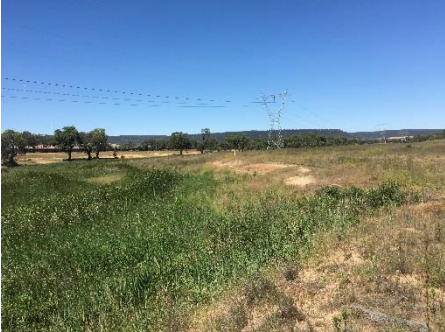
<ul style="list-style-type: none"> <li>▪ Increase in growth of flora species in stream from 2014;</li> <li>▪ An increase in sheet erosion of the exposed bank faces – scold remains active;</li> <li>▪ Active channel remains stable;</li> <li>▪ Little to no riparian zone;</li> <li>▪ Evidence of wombats and rabbits;</li> <li>▪ Blackberry noted around the site</li> </ul>
27

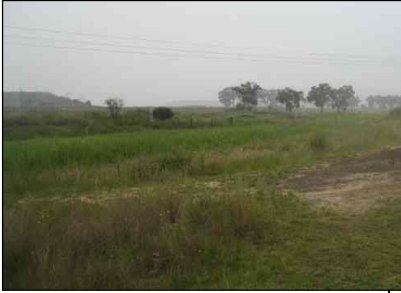
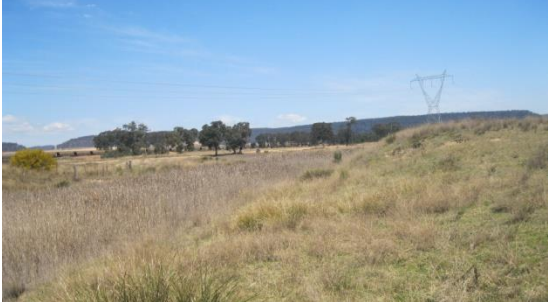
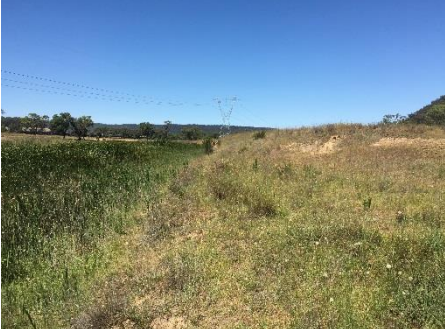
<ul style="list-style-type: none"> <li>▪ Increase in growth of flora species in stream from 2014;</li> <li>▪ Left bank increase in soil exposure and soil bleaching;</li> <li>▪ Active channel remains stable;</li> <li>▪ Little to no riparian zone;</li> <li>▪ Evidence of wombats and rabbits;</li> <li>▪ Blackberry noted around the site Reduction in healthy instream flora;</li> <li>▪ Site remains similar.</li> </ul>

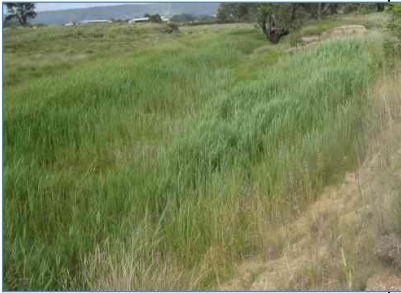
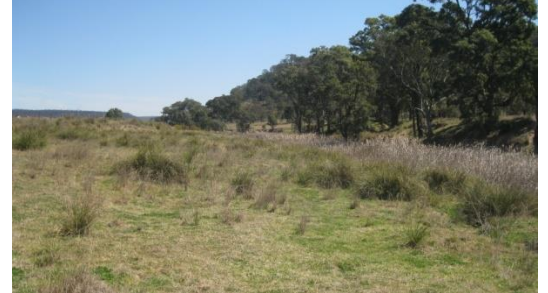
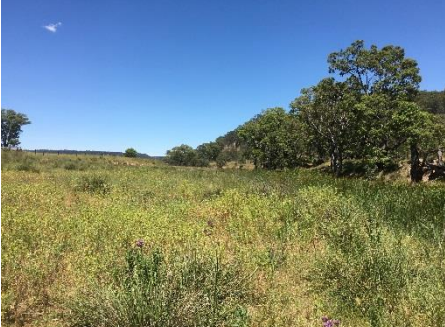
<ul style="list-style-type: none"> <li>▪ Increase in growth of flora species in stream from 2014;</li> <li>▪ Increased stability of the right bank;</li> <li>▪ Site remains similar.</li> </ul>

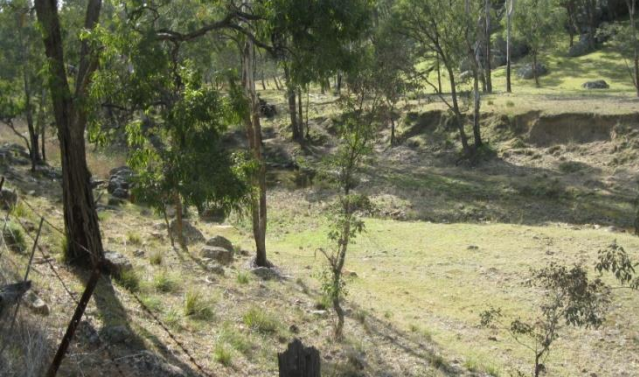
<ul style="list-style-type: none"> <li>▪ Reduction in the active channel width;</li> <li>▪ Increased undercutting and gullyng of the left bank face, as a result of reduced coverage;</li> <li>▪ Soil exposure remains stable instream and on the right bank face.</li> <li>▪ Riparian zone naturally regenerating.</li> </ul>
49

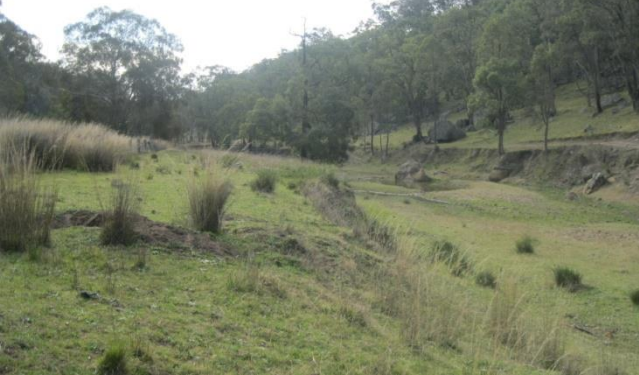
<ul style="list-style-type: none"> <li>▪ A reduction in the active channel width;</li> <li>▪ There has been an increase in groundcover within the creek bed, resulting in a reduction of soil and bed exposure;</li> <li>▪ There is an increase in groundcoverage on both bank faces, as a result of natural regeneration;</li> <li>▪ Site continues to regenerate.</li> </ul>

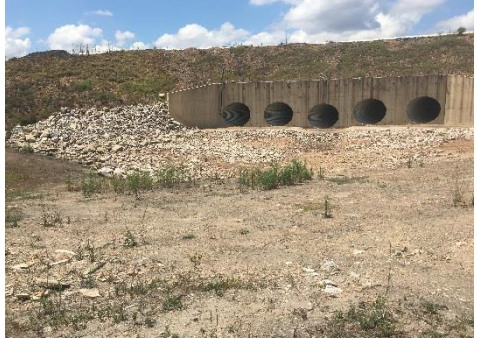
<ul style="list-style-type: none"> <li>Area exposed due to construction activities – lack of bed coverage and bank coverage in 2015</li> </ul>
8

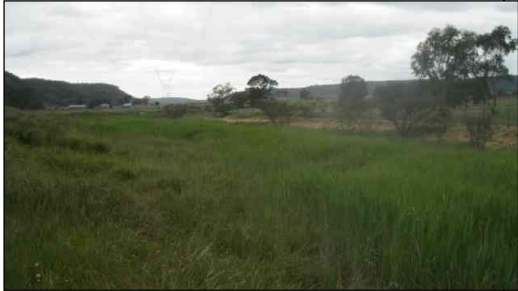
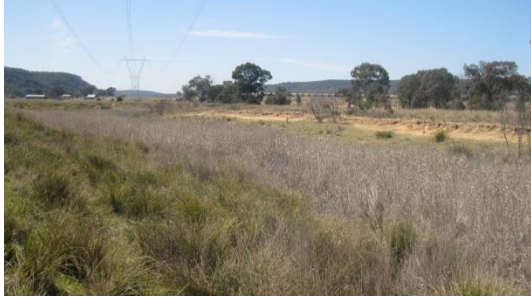
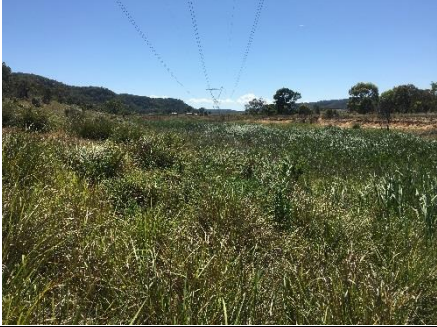
<ul style="list-style-type: none"> <li>Increase in healthy instream flora from 2014;</li> <li>Increased bank groundcover growth – both banks – scotch thistles noted;</li> <li>Increased bleaching of exposed soils on the right bank face;</li> <li>Left bank remains stable;</li> <li>Reduction of the active channel;</li> <li>Little to no riparian zone.</li> </ul>
23

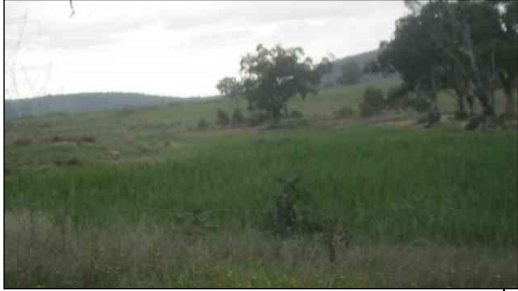
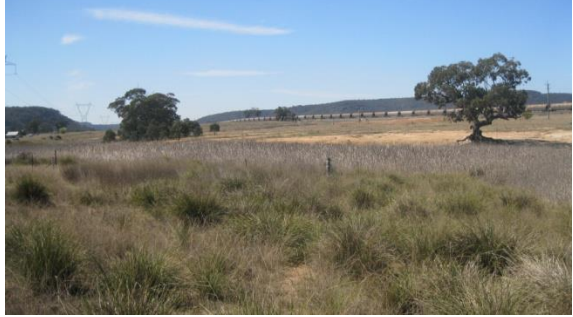
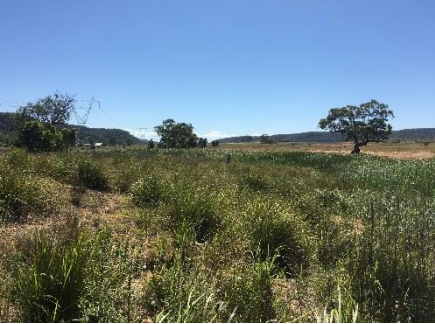
<ul style="list-style-type: none"> <li>Increase in healthy instream flora;</li> <li>Increased bleaching of exposed soils on the bank faces;</li> <li>Active channel – remains stable;</li> <li>Little to no riparian zone.</li> </ul>

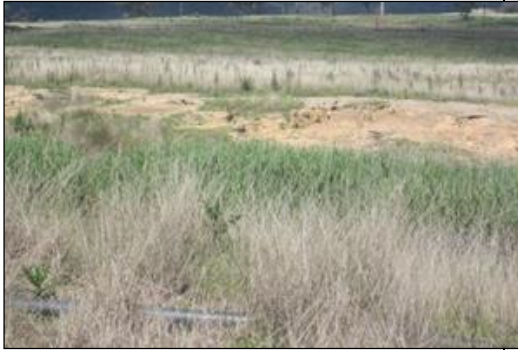
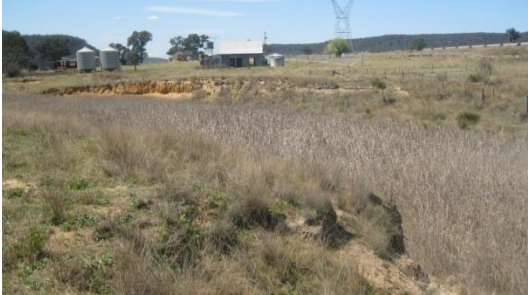
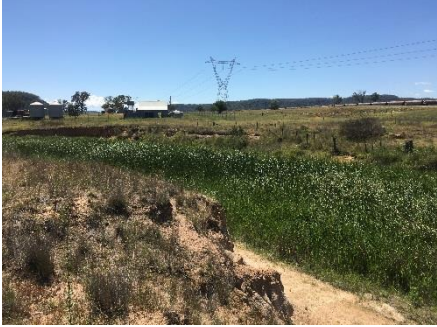
<ul style="list-style-type: none"> <li>▪ Increase in growth of flora species in stream from 2014;</li> <li>▪ An increase in sheet erosion of the exposed bank faces – scold remains active;</li> <li>▪ Active channel remains stable;</li> <li>▪ Little to no riparian zone;</li> <li>▪ Evidence of wombats and rabbits;</li> <li>▪ Blackberry noted around the site</li> </ul>
27

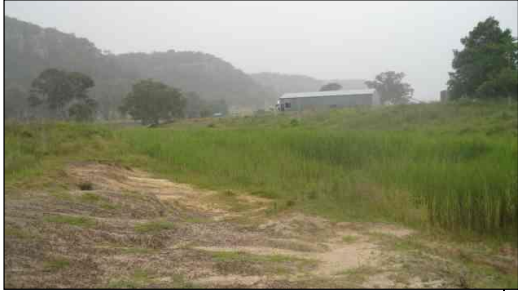
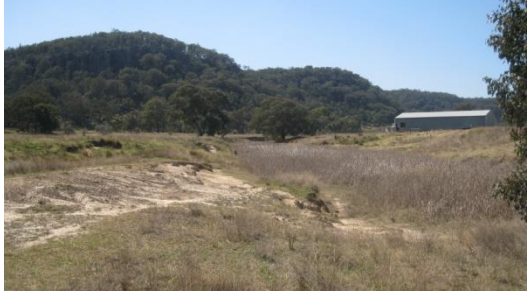
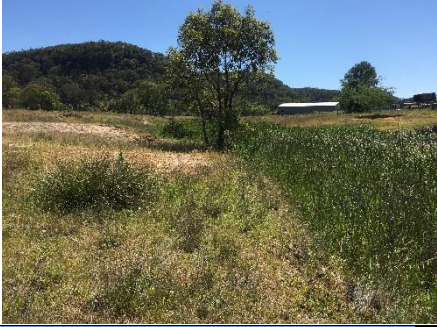
<ul style="list-style-type: none"> <li>▪ Increase in growth of flora species in stream from 2014;</li> <li>▪ Left bank reduction in soil exposure;</li> <li>▪ Active channel remains stable;</li> <li>▪ Little to no riparian zone;</li> <li>▪ Evidence of wombats and rabbits;</li> <li>▪ Blackberry noted around the site</li> <li>▪ Reduction in healthy instream flora;</li> <li>▪ Site remains similar</li> </ul>

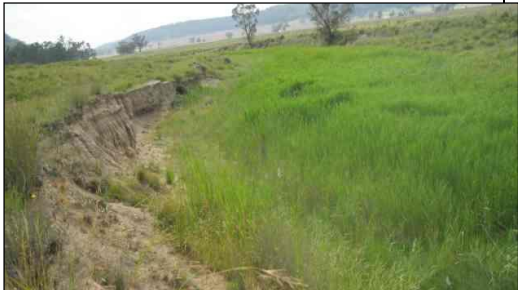
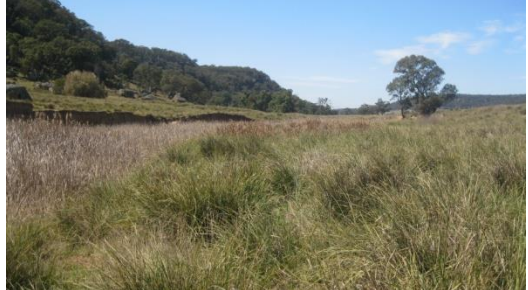
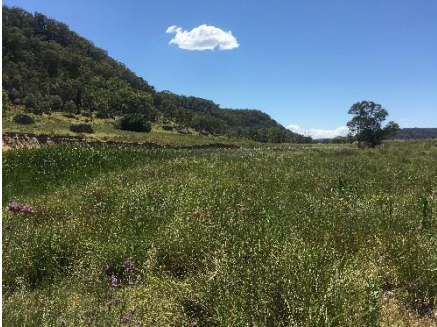
<ul style="list-style-type: none"> <li>▪ Increase in growth of flora species in stream from 2014;</li> <li>▪ Increased stability of the right bank;</li> <li>▪ Site remains similar.</li> </ul>
30

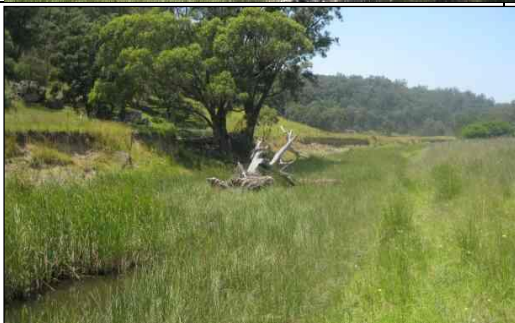
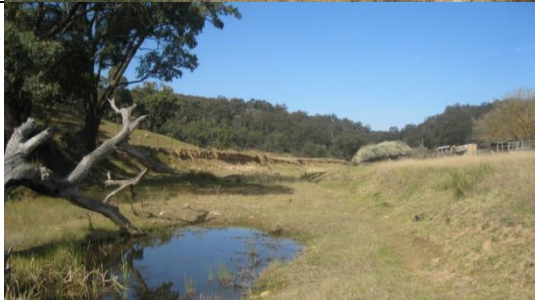
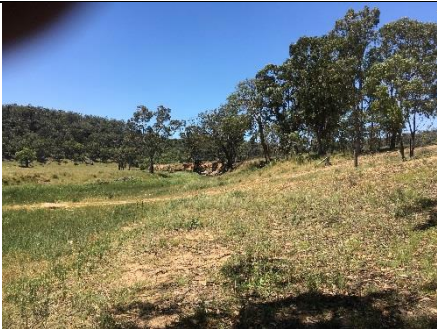
<ul style="list-style-type: none"> <li>Instream flora in the creek bed remains similar;</li> <li>Knick point noted in the creek bed;</li> <li>Increased exposure of the right bank resulting in sheet erosion and some soil exposure;</li> <li>Minor woody vegetation coverage in the riparian zone;</li> <li>Active channel width remains stable.</li> </ul>
44

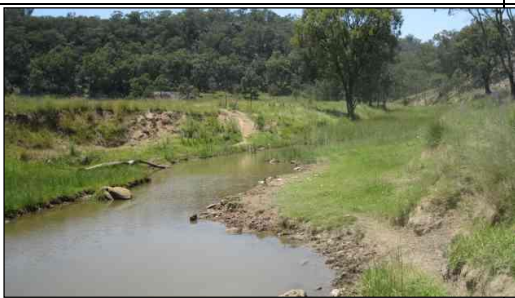
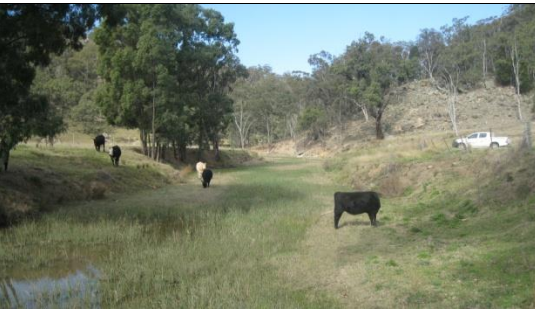
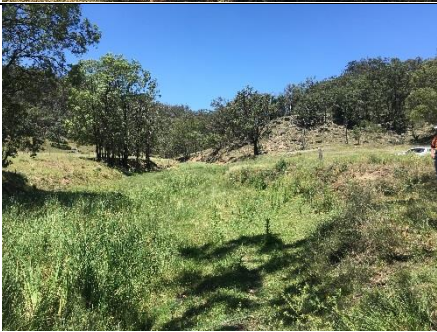
<ul style="list-style-type: none"> <li>Increase in growth of flora species in the creek bank since 2014;</li> <li>Banks remain stable, however there is an increase in soil exposure and potential sheet erosion of the right bank</li> <li>Increased bank stability as a result of an increase in vegetation coverage on both banks;</li> <li>Little to no woody riparian zone in the area.</li> </ul>
