Aboriginal Heritage

METROPOLITAN COAL - ENVIRONMENTAL MONITORING SUMMARY

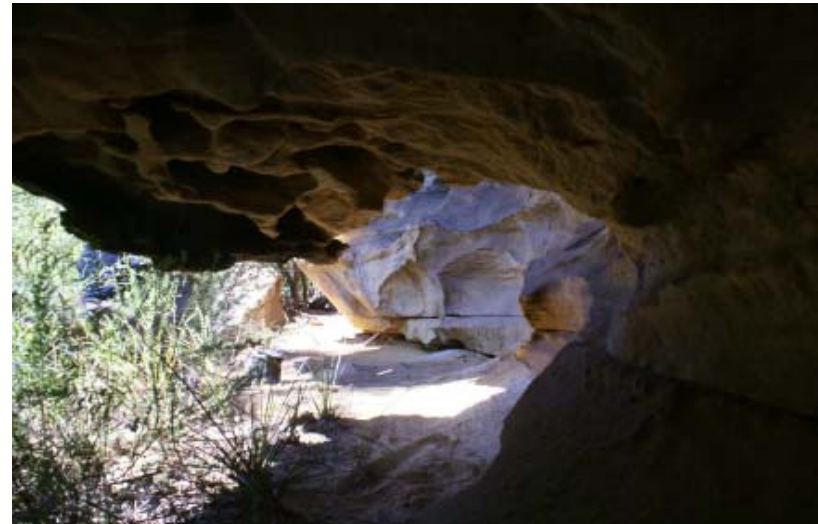
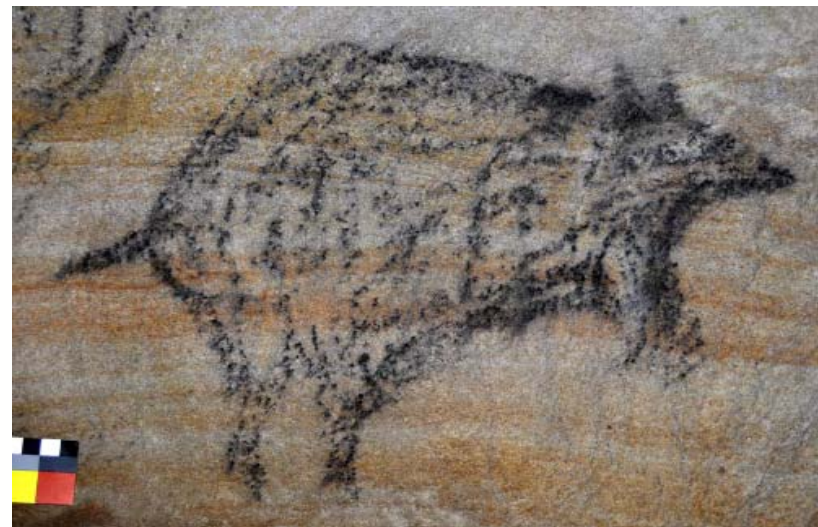
- At site FRC 15 (an overhang with artefacts and deposit), the vertical crack previously noted on the back wall during Round 1 monitoring was observed to have increased in width and shifted laterally during Round 2 monitoring. Vertical cracking had also increased along the margins of this crack.

- At site FRC 284 (an overhang with artefacts and deposit), displacement of a small section of exfoliated shelter surface associated with a fractured corner of the shelter was observed during the Round 2 monitoring. This impact was consistent with the types and scale of impact (cracking, displacement and slumping/falling of exfoliated pieces) noted during Round 1 monitoring.

- At site FRC 281 (an overhang with art, artefacts and deposit), the impacts recorded during Round 1 monitoring (multiple cracks ranging from large, medium and small recorded in the shelter wall either running through or next to the motifs) were observed at the site during Round 2. There had, however, been no change in the shelter condition since Round 1 monitoring, suggesting the site had stabilised.
