Rehabilitation

Rehabilitation Strategy – Surface Facilities Area

METROPOLITAN COAL - ENVIRONMENTAL MONITORING SUMMARY

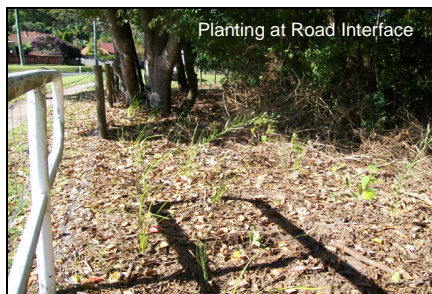
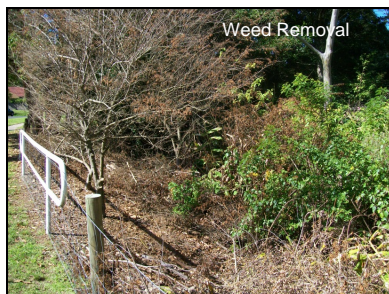
Rehabilitation activities during the reporting period have included active planting of native vegetation, primarily around the boundary of the site and weed control measures. In 2012, native planting (approximately 180 native plantings) and weed control measures were carried out in the area adjacent to Parkes Street on the northern and western boundaries, and along Colliery Road on the southern/western boundary of the site. In 2013, approximately 7,200 native plants were planted, targeting areas with low regeneration of native species. The plantings were concentrated along Parkes Street and along Helensburgh Gully.

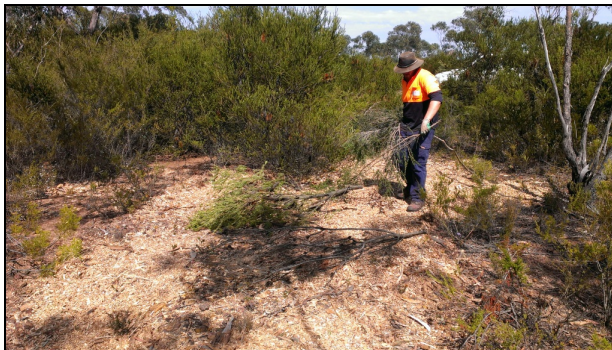
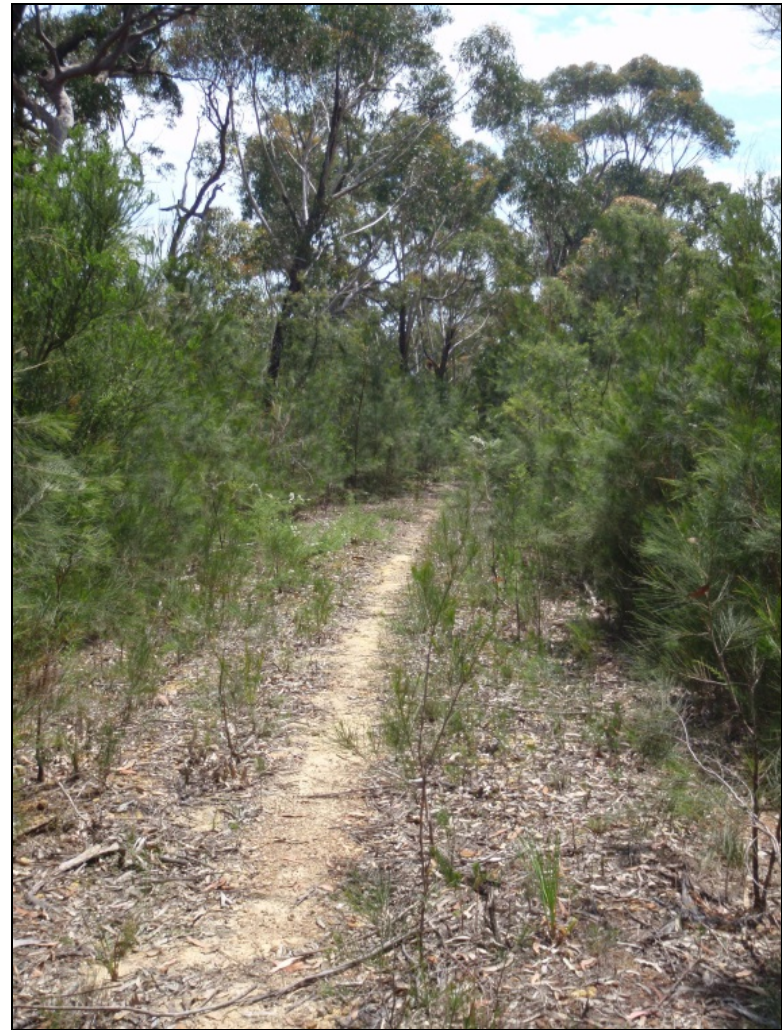
The rehabilitation site on Fire Road 9H is a former ironstone quarry. Rehabilitation activities during the reporting period have focused on re-introducing organic matter and seeds into the site and creating conditions that are conducive to natural regeneration along Fire Road 9H. This involved distributing native mulch and brush matting over the site.

A disused track to the former Darkes Forest Mine, which has been closed since 1991, has also been subject to rehabilitation activities. The track provides a vector for deer access, dispersal of weed species and unauthorised access (e.g. dirt bikes) to the catchment. Rehabilitation activities during the reporting period have focused on weed control. Weed management activities have been undertaken monthly, and more frequently in spring when weeds were actively growing. In the next reporting period, weed control measures will continue to be implemented as well as methods to encourage the regeneration of native species within the site.
