METROPOLITAN COAL

METROPOLITAN COAL
2010 ANNUAL REVIEW

Project No. MET-08-08/8.1
Document No. 00371542

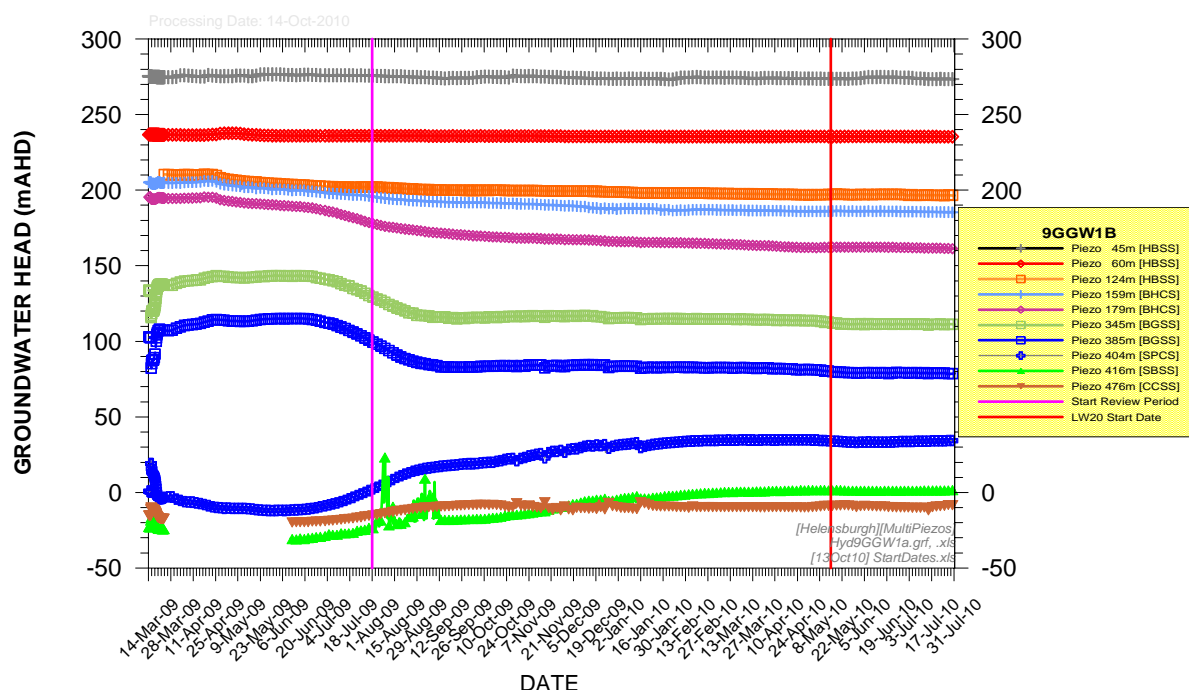
Chart 14 Time Variations in Potentiometric Heads at Site 9GGW1B

The time-series record for site 9GGW1B is shown on Chart 14. Site 9GGW1B shows strong depressurisation below the Bulgo Sandstone, with heads about -20 m Australian Height Datum (AHD) in the Scarborough Sandstone and the Coal Cliff Sandstone. The heads in this hole are stable and are yet to show any effect from Longwall 20 mining.

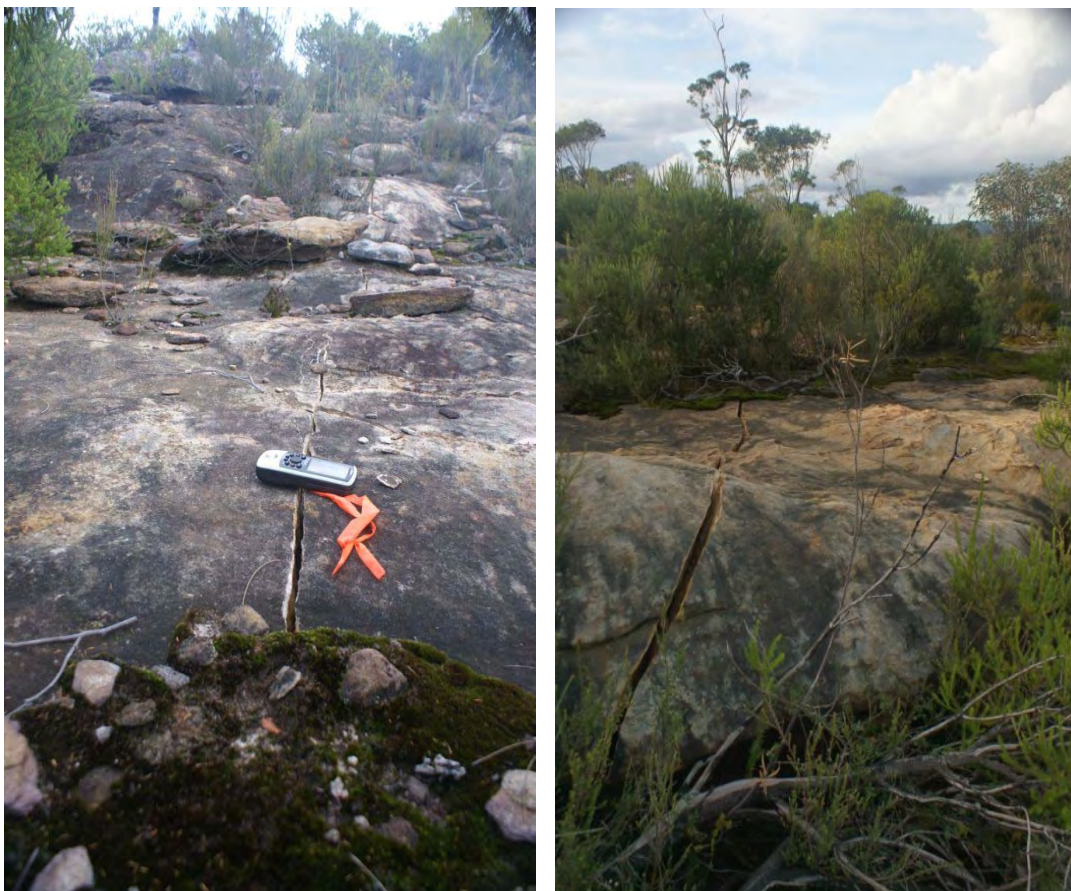
Plates 1 and 2: Surface Tension Crack above Longwall 18

A surface tension crack has however recently been recorded above Longwall 18 (Plates 1 and 2). The tension crack is located sub-parallel to the gate roads, directly above mining and at a distance of approximately 50 m from the goaf edge. The tension crack extends semi-continuously over a length of approximately 200 m. The width of the tension crack is typically less than 10 mm, with a maximum width of 40 mm.
