METROPOLITAN COAL

2011 ANNUAL REVIEW

Project No. MET-08-08/8.1
Document No. 00416578

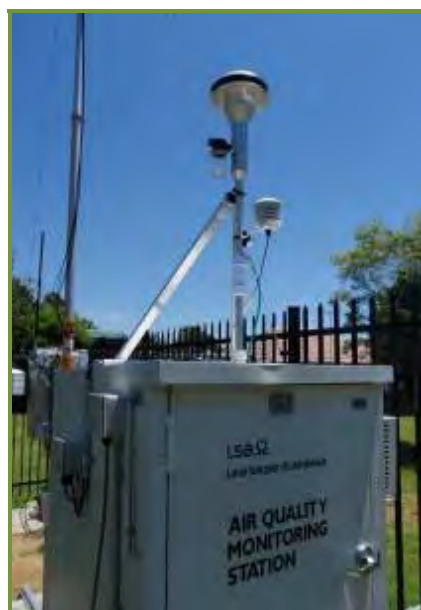
Plate 4 Metropolitan Coal TEOM

- ten dust deposition gauges to monitor monthly dust fall out;
- one High Volume Air Sampler (HVAS) to measure 24 hour average particulate matter less than 10 microns (μm) (PM_{10}) concentrations on a 6-day cycle;
- one Tapered Element Oscillating Microbalance (TEOM) monitor to measure PM_{10} in real-time (installed in December 2010) (Plate 4); and
- one Automatic Weather Station.

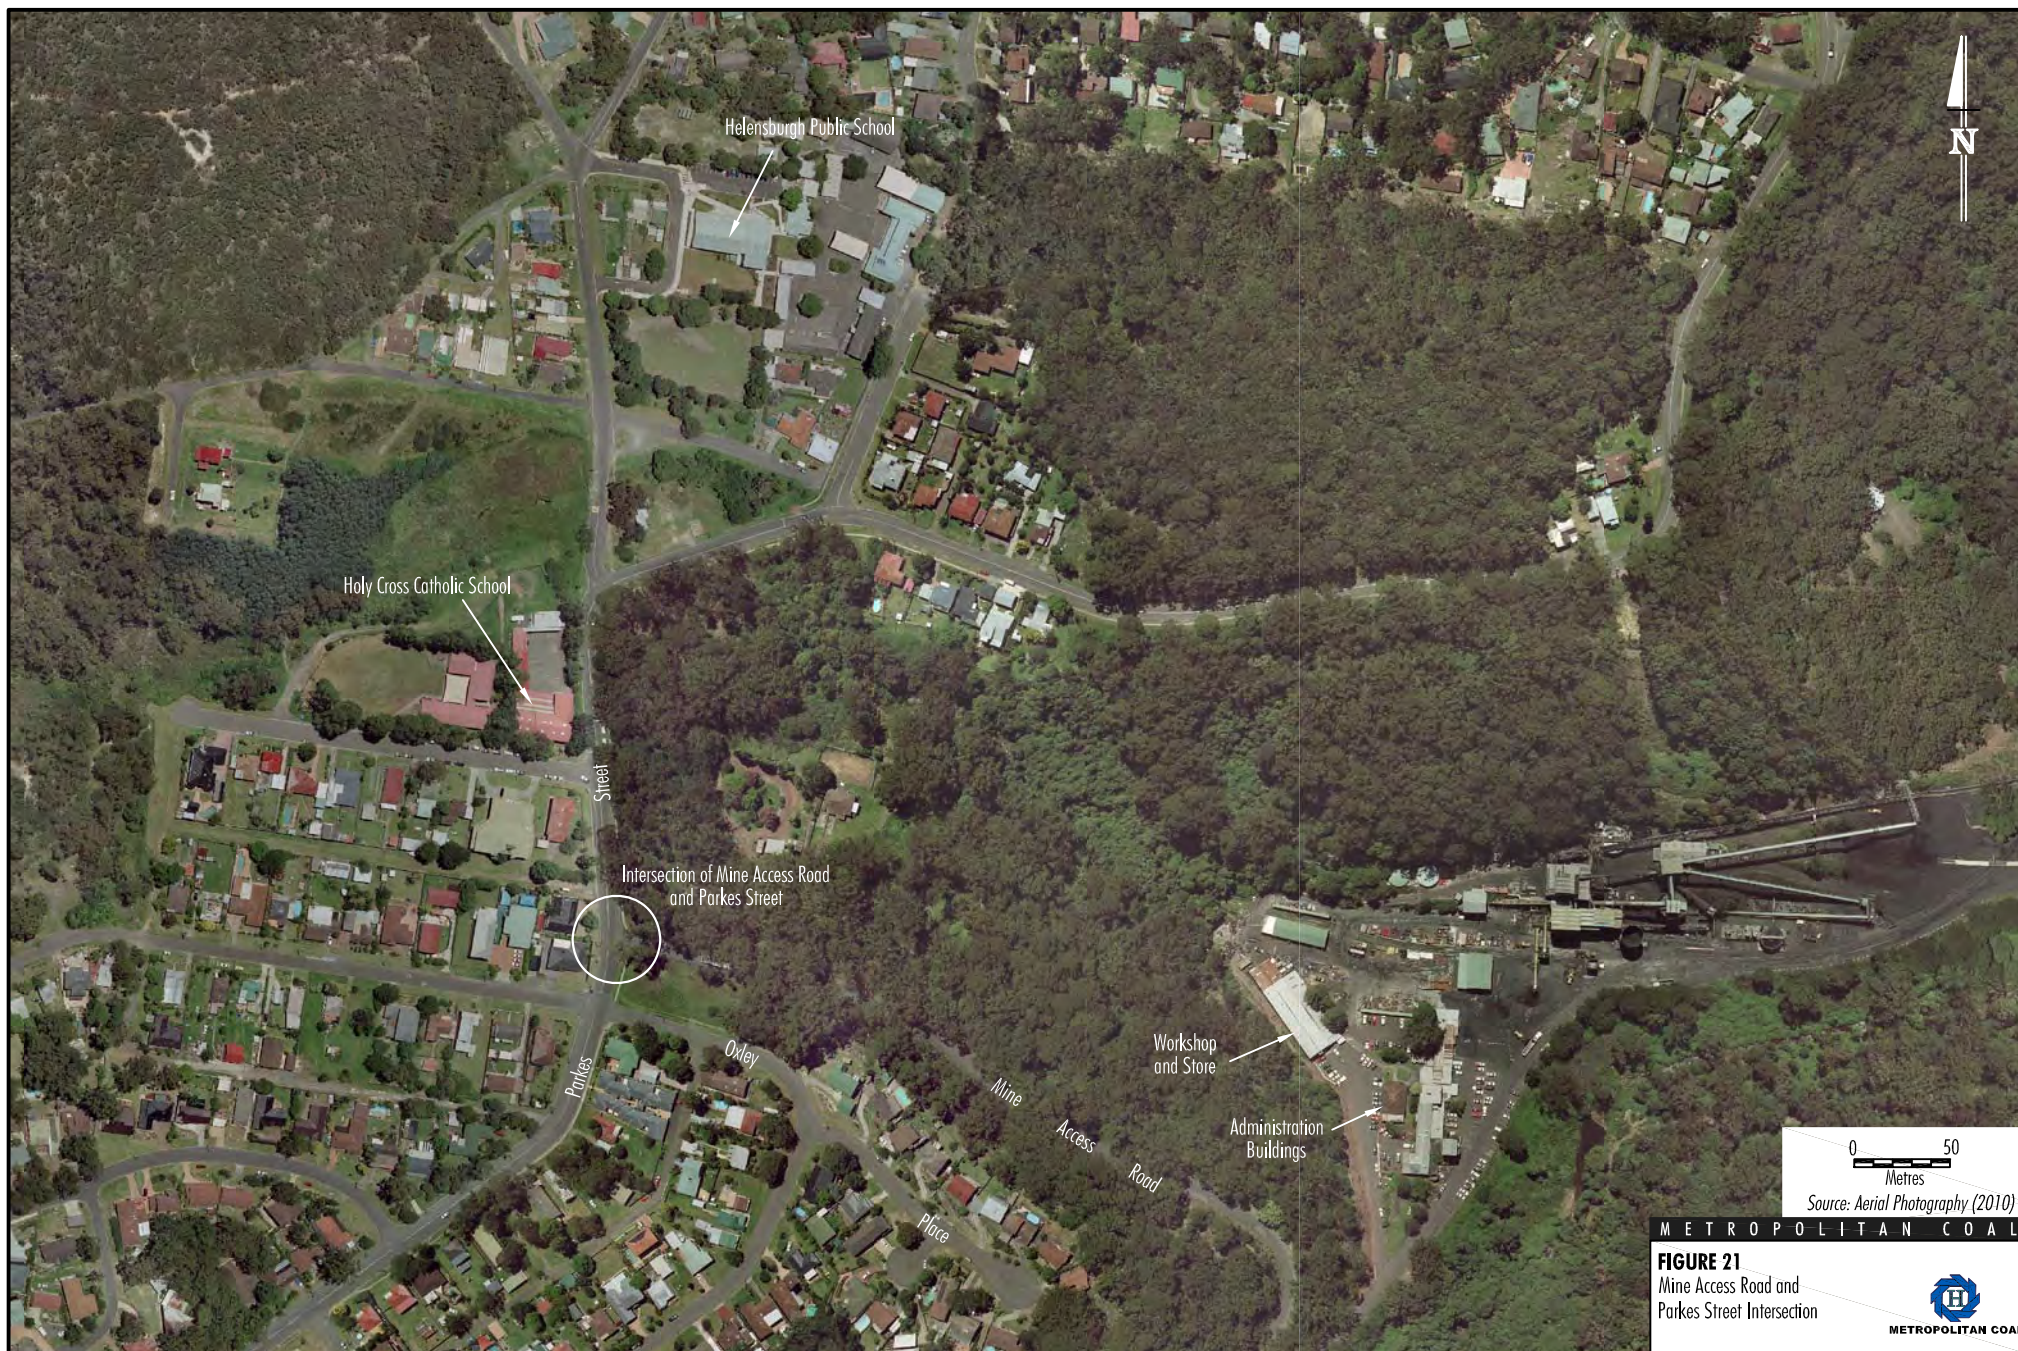
The Road Safety Audit of the Mine Access Road and Parkes Street intersection (Figure 21) has been undertaken and submitted to the WCC for review. The Road Safety Audit Report has been completed in accordance with *Austroads Road Safety Audit Guidelines, 2002* and *RTA Accident Reduction Guide Part 2 – Road Safety Audits, 2005*.

As described above Metropolitan Coal conducted a Road Safety Audit of the Mine Access Road and Parkes Street intersection (Figure 21) in consultation with the RTA and WCC. Metropolitan Coal will implement the recommendations of the Road and safety Audit and conduct intersection improvements once was approved by WCC Traffic Committee and the RTA.
