## METROPOLITAN COAL PROJECT ENVIRONMENTAL ASSESSMENT

**METROPOLITAN COAL PROJECT  
NON-ABORIGINAL HERITAGE ASSESSMENT**

**A REPORT FOR HELENSBURGH COAL PTY LTD.**

**AUGUST 2008**

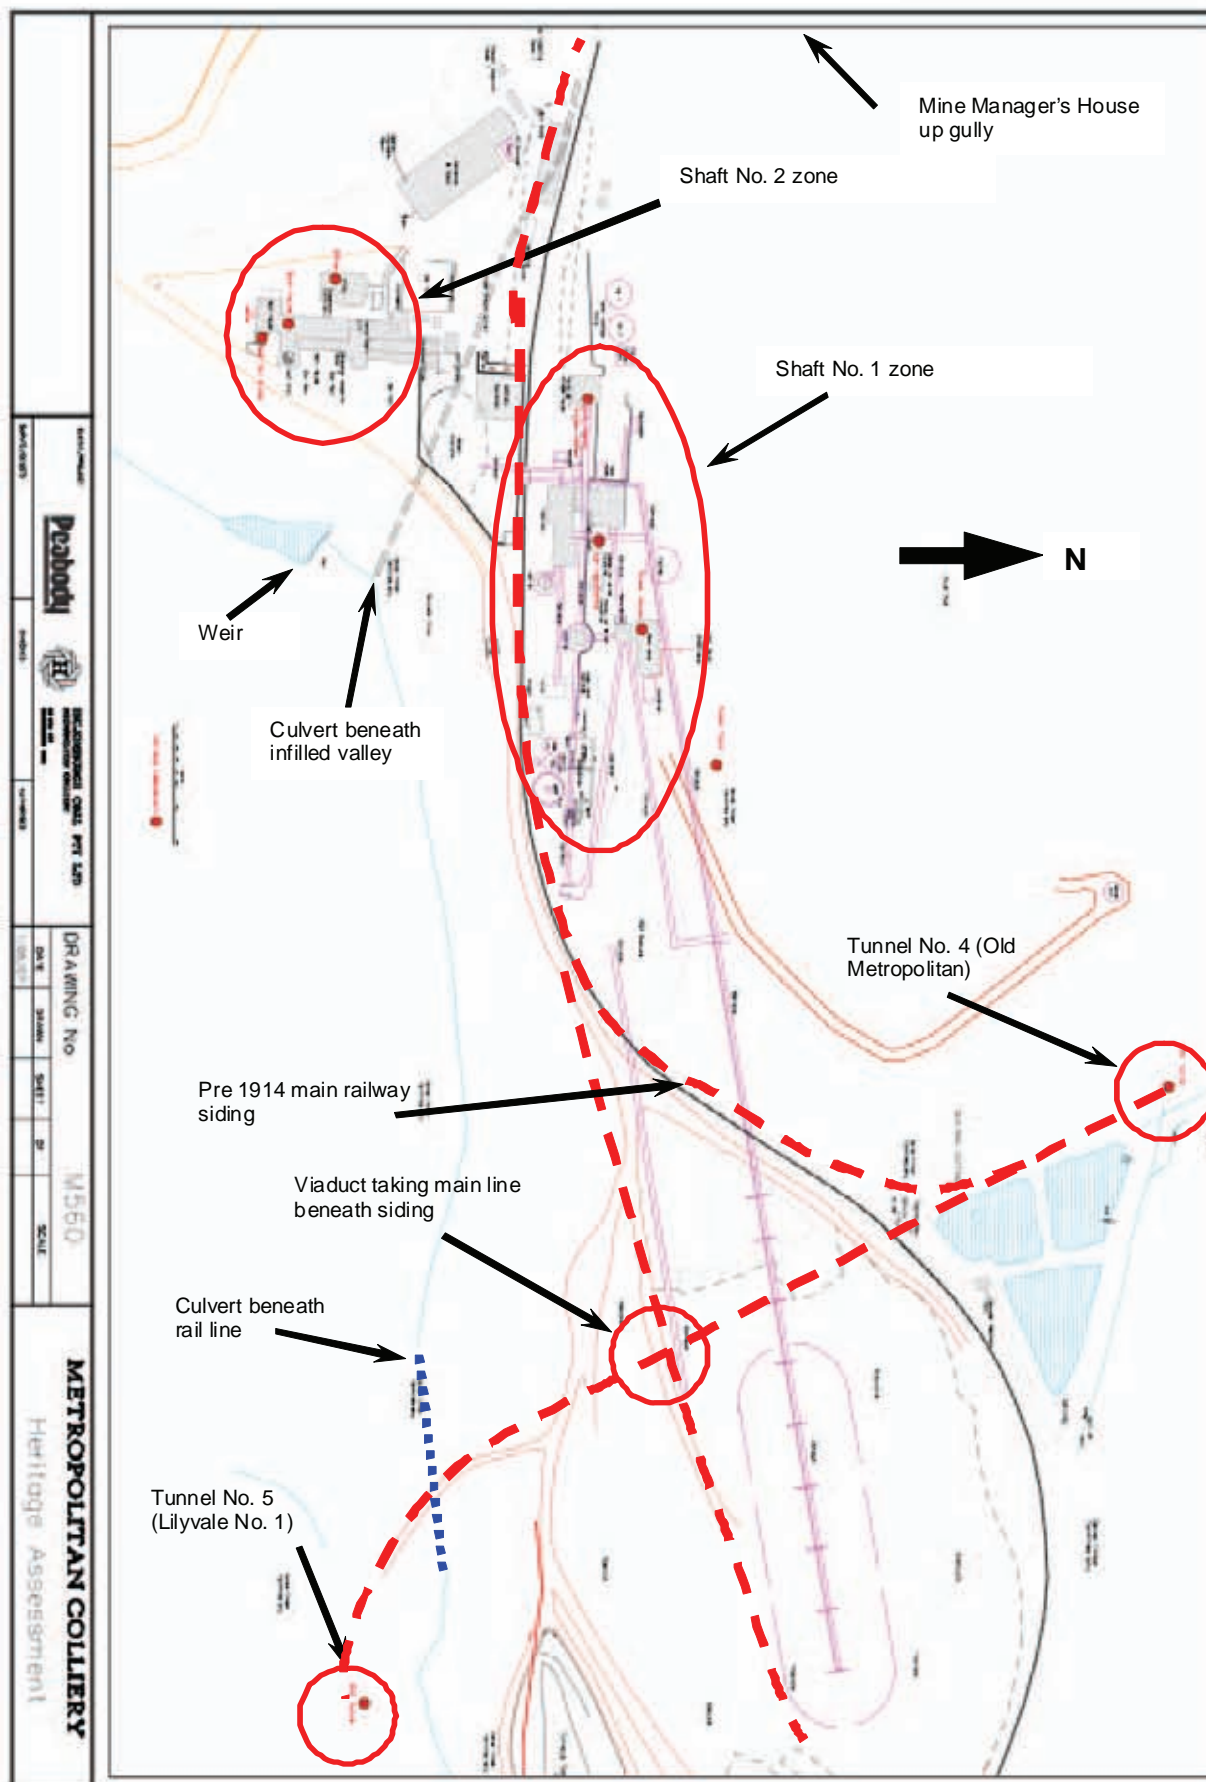
Plan 1— Showing Heritage Areas and Original Rail Lines

Plan 1 shows the location of heritage elements of the Metropolitan Colliery site. Appendix 2 contains photographs of each of the heritage items identified.

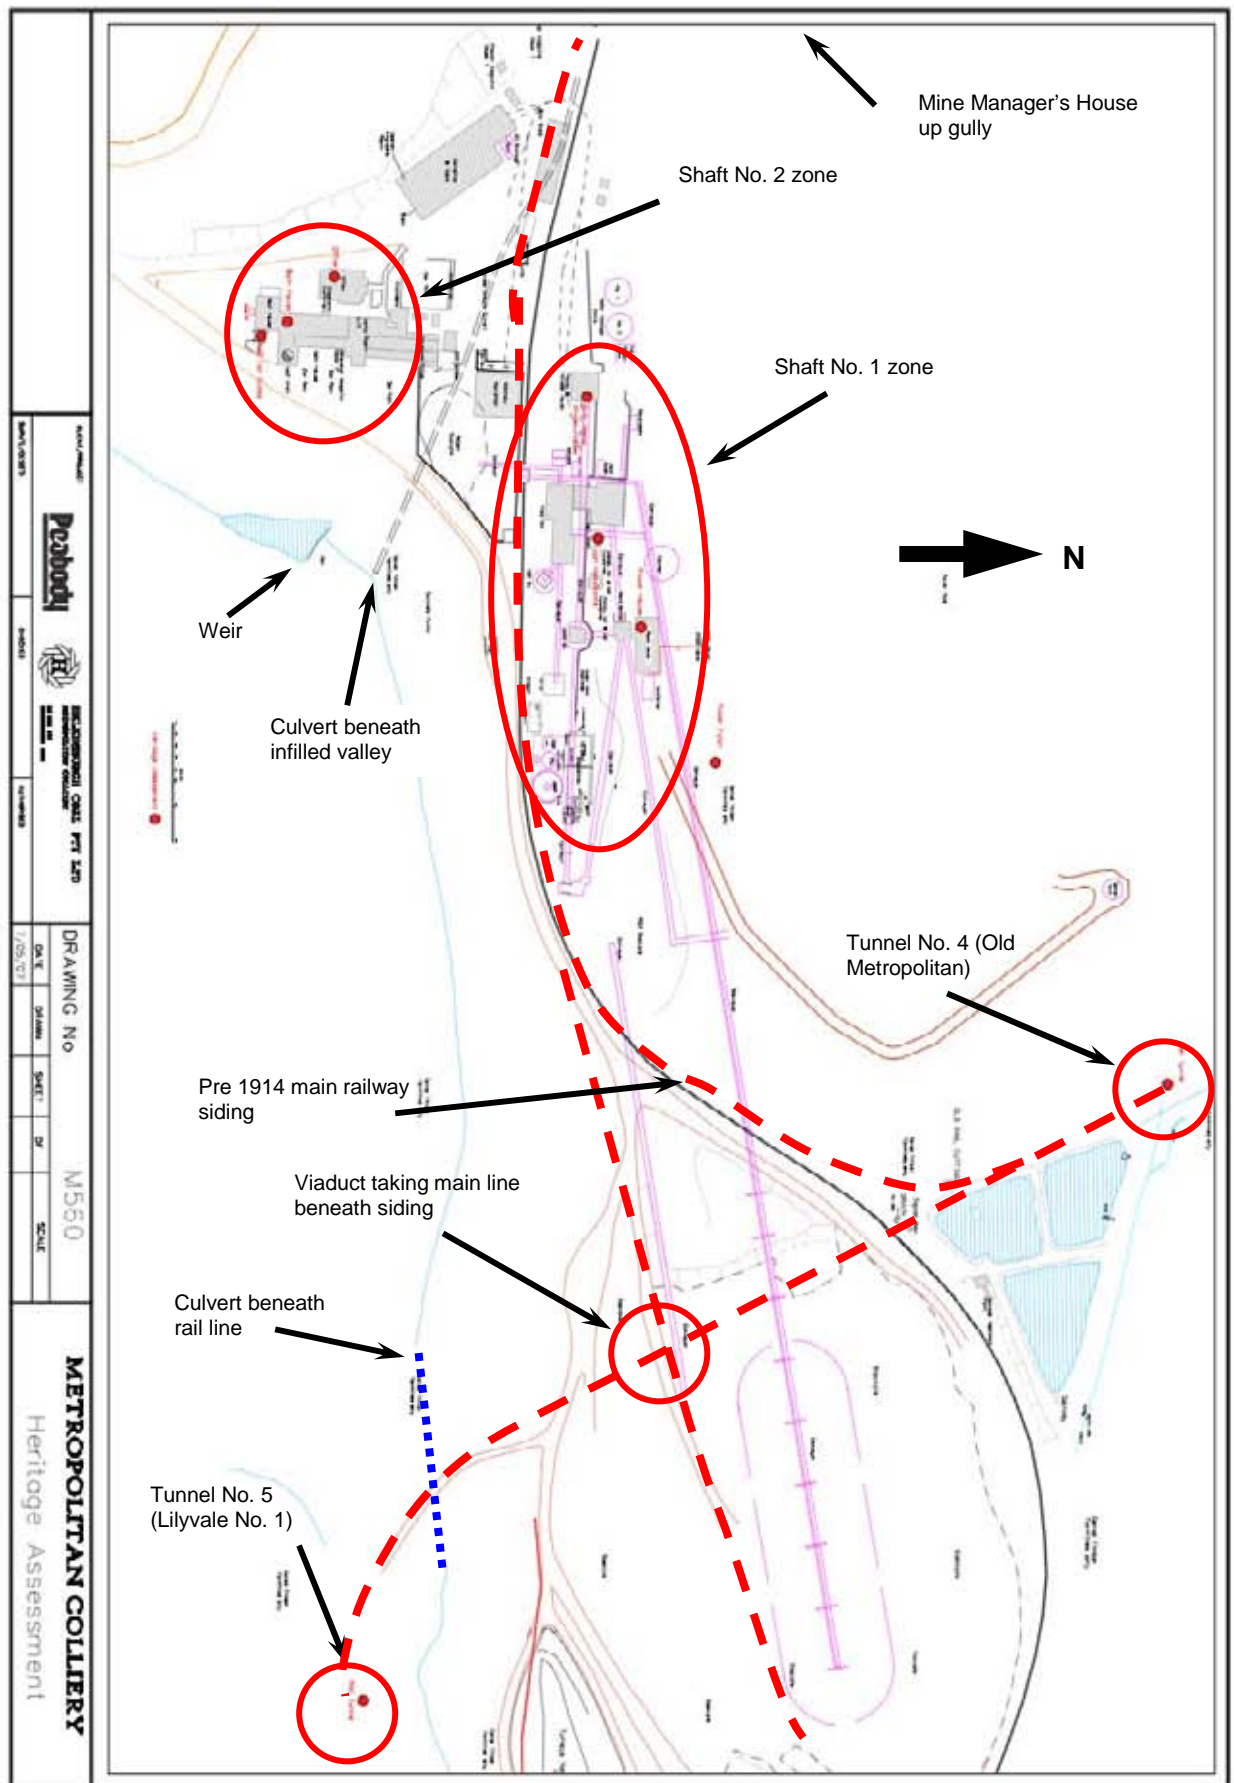
Plan 1—Showing Heritage Areas and Original Rail Lines

Plan 1 shows the main zones of heritage significance, and the original route of the pre-1914 rail line and sidings.

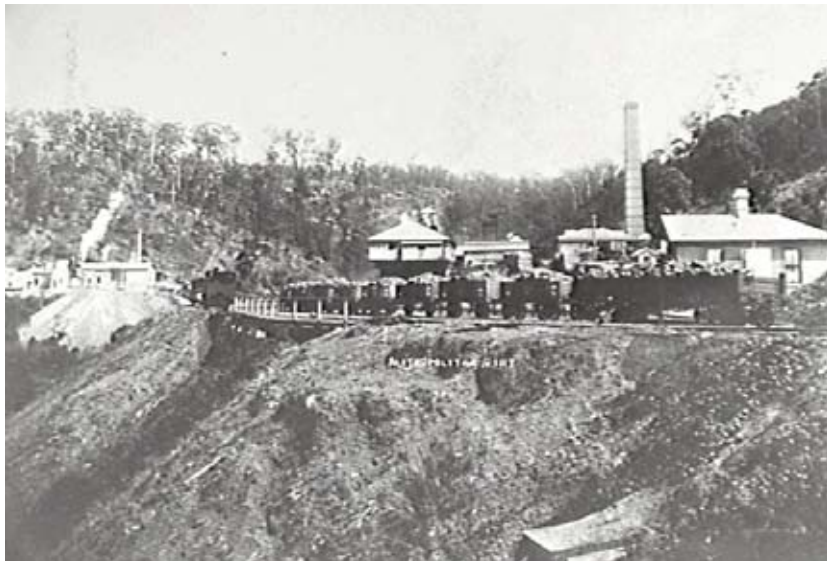
Figure 1. Shaft No. 1 to right, shaft No. 2 to left. Loading gantry centre. C. 1915.

The series of photographs show the range of buildings adjacent to the shaft, including the loading gantry. All of these buildings, with the possible exception of the current powerhouse in later photos, appear to have been demolished for later developments. A brick building with five gable-ends and ventilated roof west of the shaft (Figs. 2-5) would appear to be workshops. The Headframe is shown in most images, with a brick winder house and chimney to its north. A building to the west of the complex may be the original powerhouse (pre-1910), which may have been replaced by the current powerhouse about 1915 (see below). The original coal loading facility is shown in Figs.1-4. Figure 6 shows a new set of buildings in the coal loading area, and the new powerhouse.

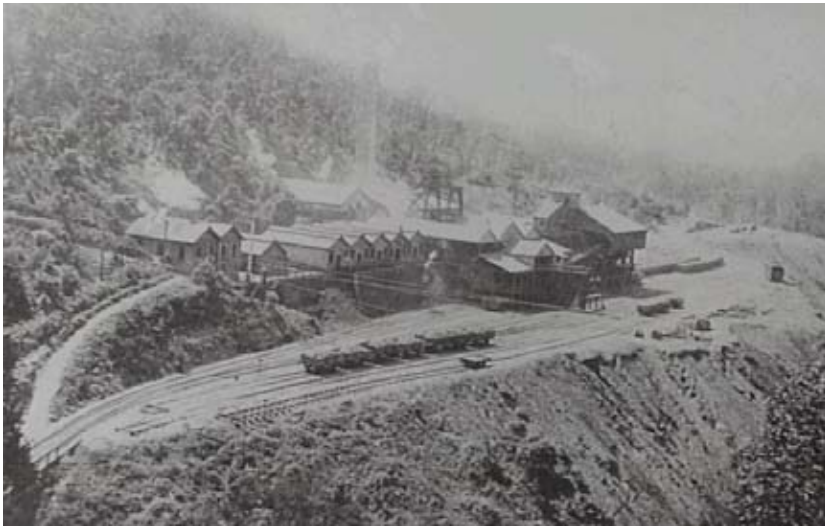
Figure 2. Shaft No. 1 complex from south-west, Original powerhouse to left, Shaft No. 1 centre, coal loader to right. Undated

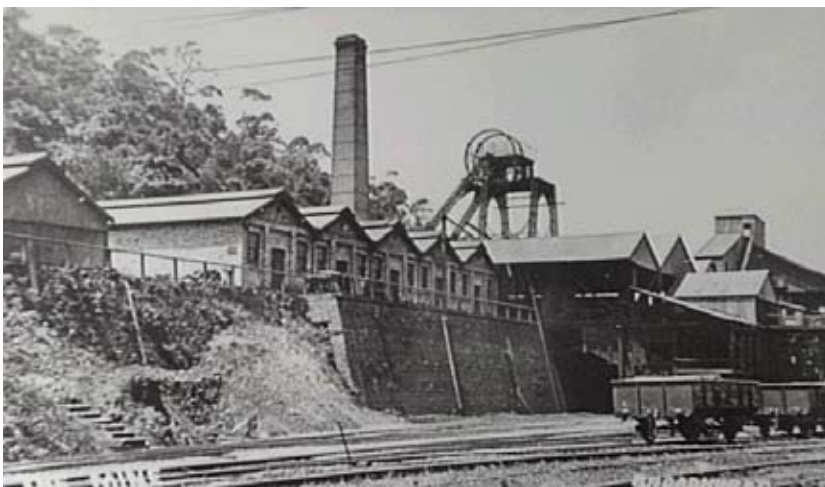
Figure 3. Shaft No. 1 complex from south-west, Shaft No. 1 centre, coal loader to right. Undated

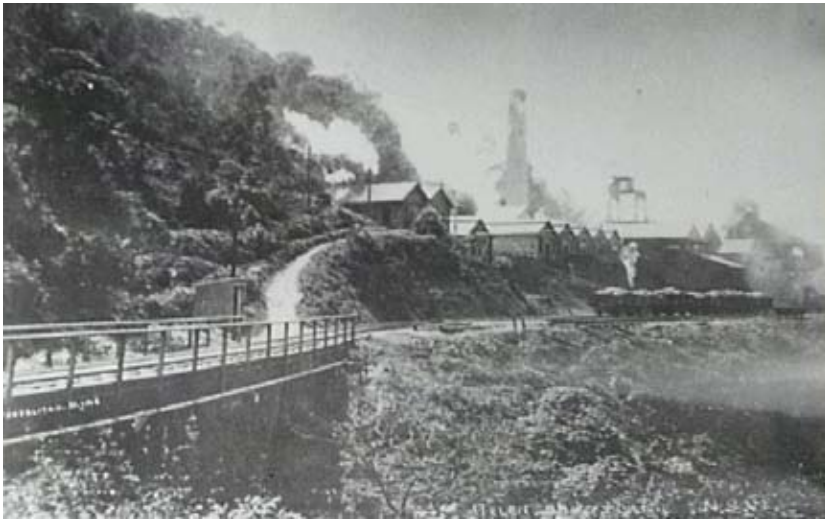
Figure 5. Shaft No. 1 complex from west, Shaft No. 1 and chimney to right, rail bridge over now-filled in valley to left. Undated.

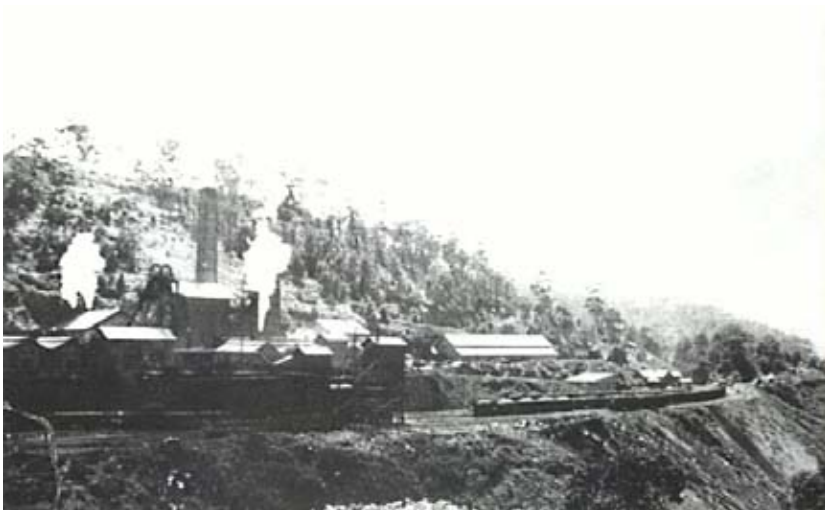
Figure 6. Shaft No. 1 complex showing a next-generation of buildings at the coal loader. Shaft No. 1 and chimney to left with new building in front of chimney, current powerhouse centre background with long building to its right. Undated.

The surviving powerhouse is a brick two-storey structure. Power generation equipment has been removed, the building now housing a switch room and a workshop. An overhead 3000 kg gantry crane is intact, and an old screening trommel is located adjacent to building. Three transformers are located to the east (two of them old). The construction date of this building is not yet clearly established. The original powerhouse may be a building shown to the west of the Shaft No. 1 complex in Figs. 2 & 5. Power generation was upgraded about 1915, and again in about 1927 and 1933, and again in the mid 1950s. The current building is shown in Fig. 6, and Figs. 8 & 12, which appear to be taken about 1955.

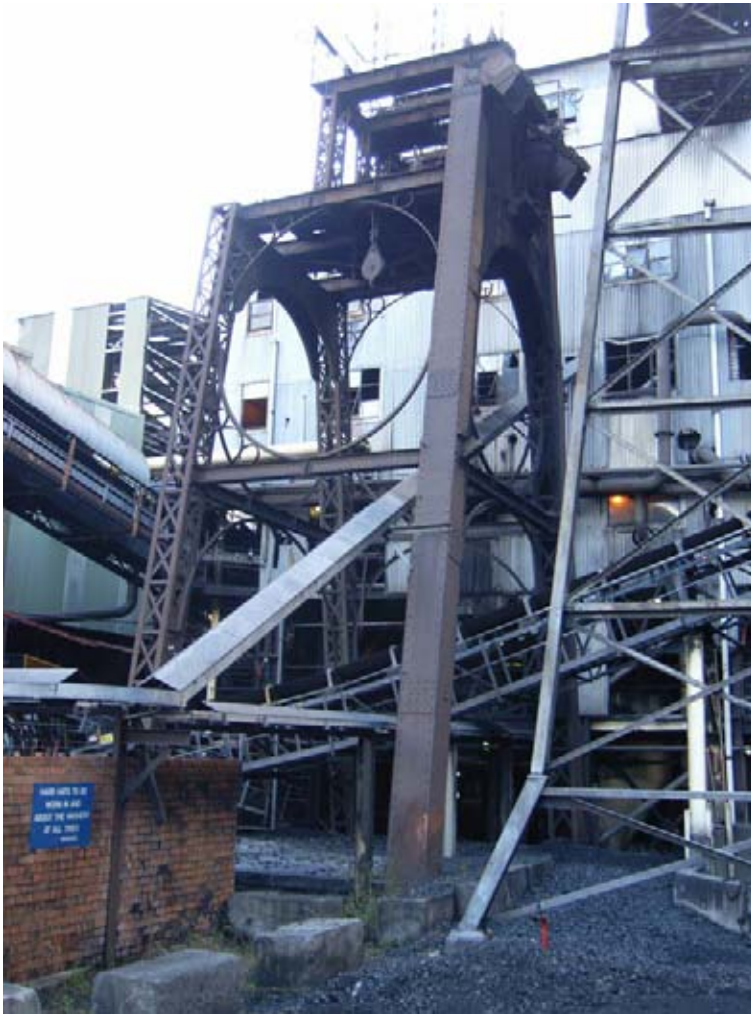
Figure 7. Shaft No. 1 headframe. The stumps of the cut-off brace legs can be seen to the right and the top section. Washery behind. 2007.

The No. 1 headframe appears in early photographs of the colliery, and is assumed to have dated from the earliest mining phase in the 1880s. It is a large steel headframe with circular bracing panels and decorative wrought iron hand rails. The bracing legs have been cut off, and the winding engine house site is now occupied by bins. The shaft itself is no longer in use and is gridded for safety, being replaced for access by the drift tunnel in 1954.

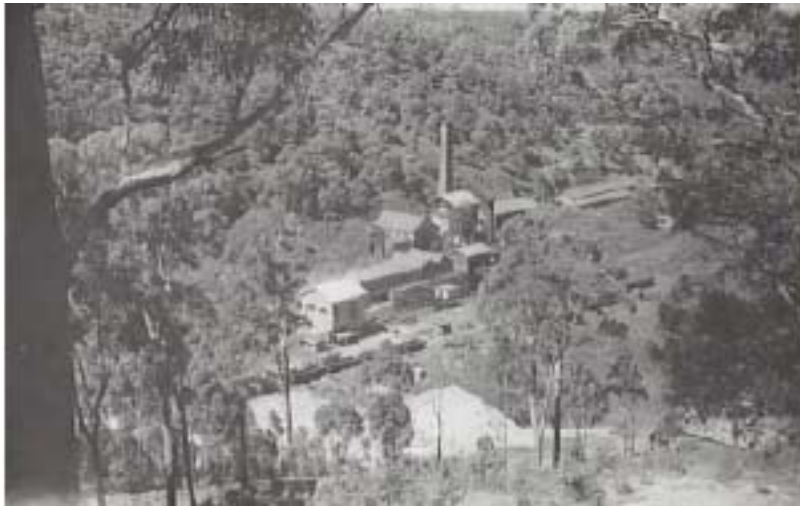
Figure 8. Shaft No. 1 zone from southwest, 1955. Shows the new drift portal winding engine house (with large windows in side), No. 1 headframe, and powerhouse to its right. The winder house to the left rear of the shaft, the chimney and other buildings have been demolished.

The Drift, portal and winder were built in 1954, replacing the No. 1 shaft. The drift is currently 1,164 m long, angled at 1:3. The Ward Leonard type winding engine supplied by BTH (British Thomson-Houston Co. Ltd, Rugby) and its cab are still in operation, driven by a 310 bhp electric motor. The winder is housed in a brick building, presumably also built in 1954. British Thomson-Houston (BTH) was a British engineering and heavy industrial company, formed in 1894 and based at Rugby, Warwickshire, England. They were known primarily for their electrical systems and steam turbines.

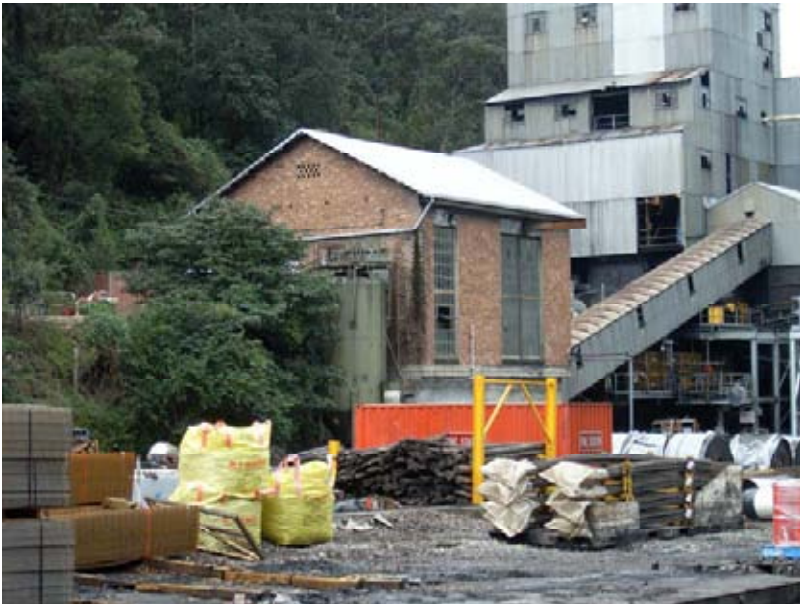
Figure 9. Drift portal winding engine house. 2007.

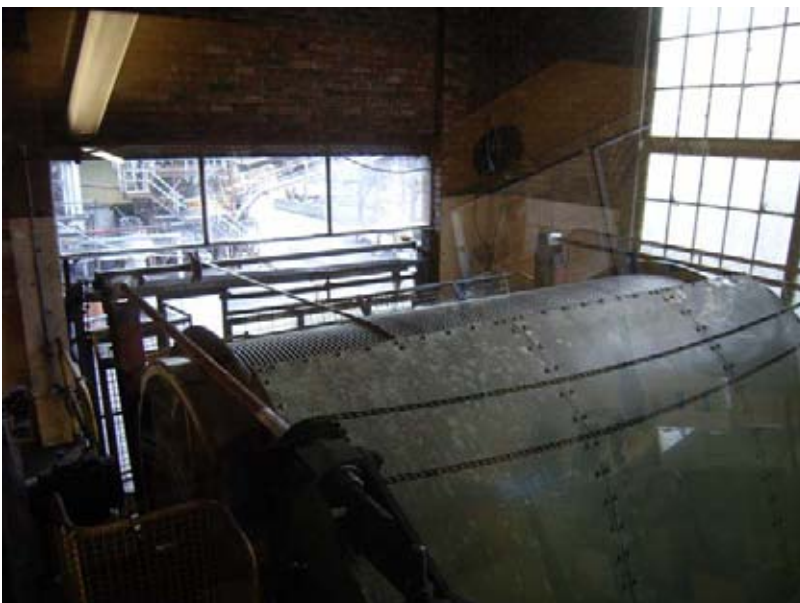
Figure 10. Drift portal BTH winding engine. 2007.

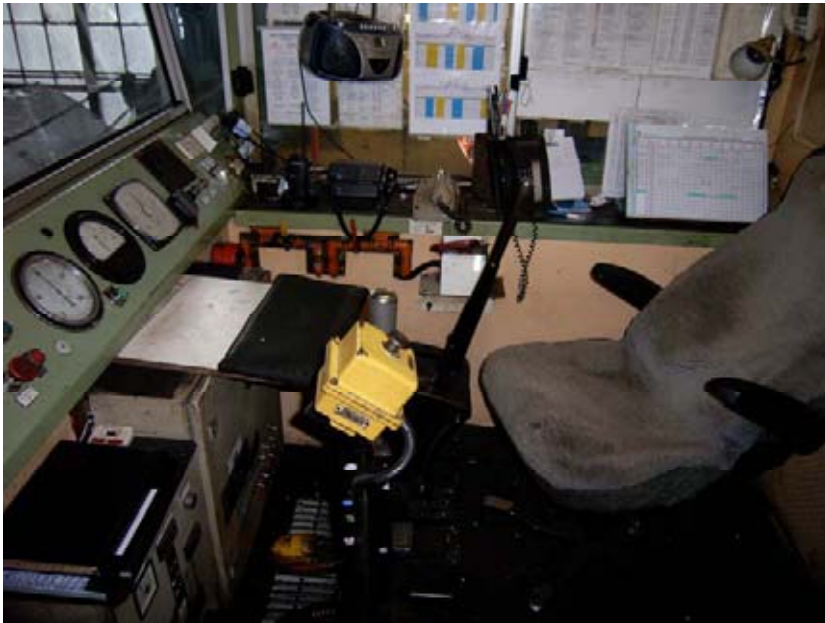
Figure 11. Drift portal BTH winding engine cab. 2007.

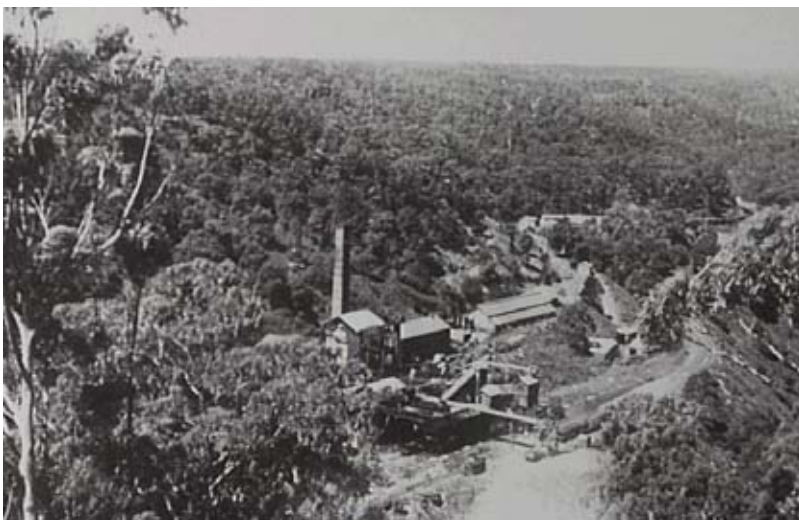
Figure 12. Shaft No. 1 zone from southwest, c.1955. Shows the powerhouse to the right of the headframe. The chimney and all other buildings in this view have been demolished.

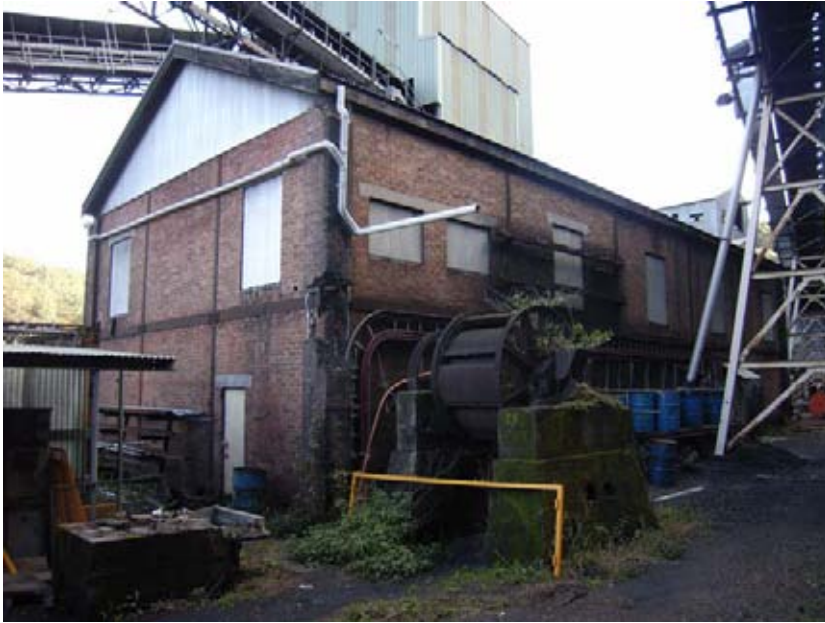
Figure 13. Powerhouse with trommel in front.

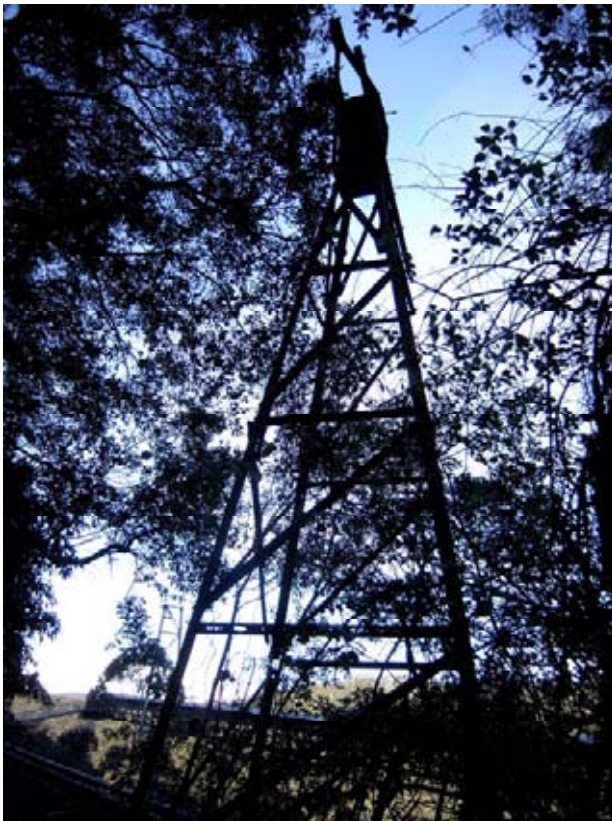
Figure 14. Power Pylon upslope of Powerhouse, possible dating to the 1915 supply of power to Helensburgh village.

A power pylon is located up slope of the power station, built of angle-iron lattice sections with three cross-trees of angle-iron. It appears to be part of the early mine infrastructure, possibly related to the supply of power from the mine to the Helensburgh township from 1915. The pylon is severely corroded and in danger of collapse.

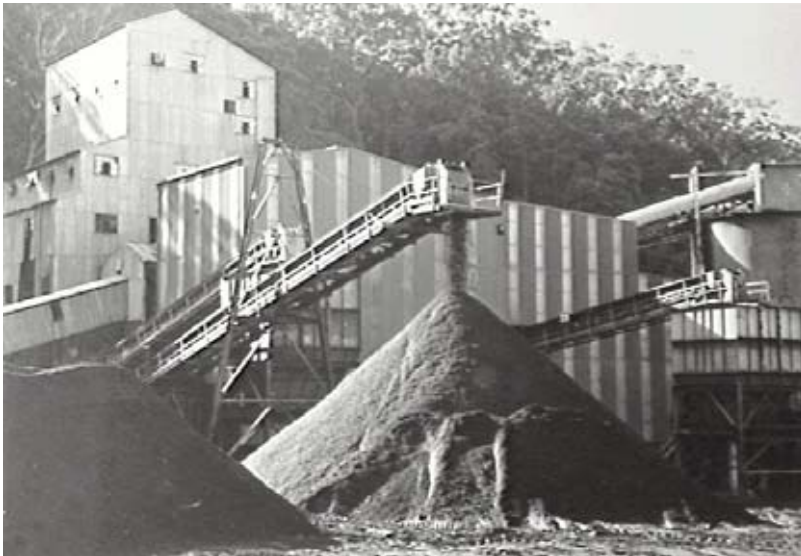
Figure 15. Washery in 1994.

Construction of the washery and coal storage began in 1959, and it has elements from successive developments and alterations. The construction of the washery necessitated the demolition of nearly all of the pre-1959 coal handling structures along the embankment near Shaft No. 1 seen in earlier photographs.

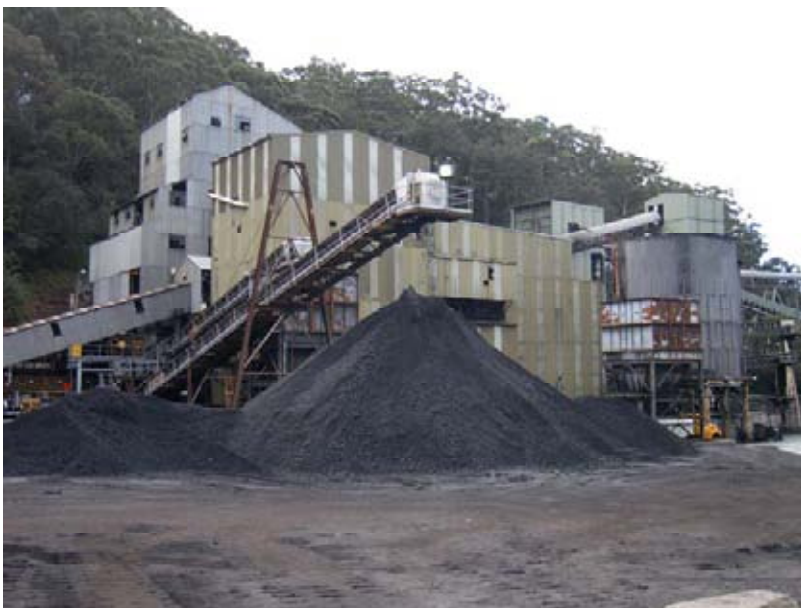
Figure 16. Washery in 2007. Central building has been raised a storey, and one conveyor removed.

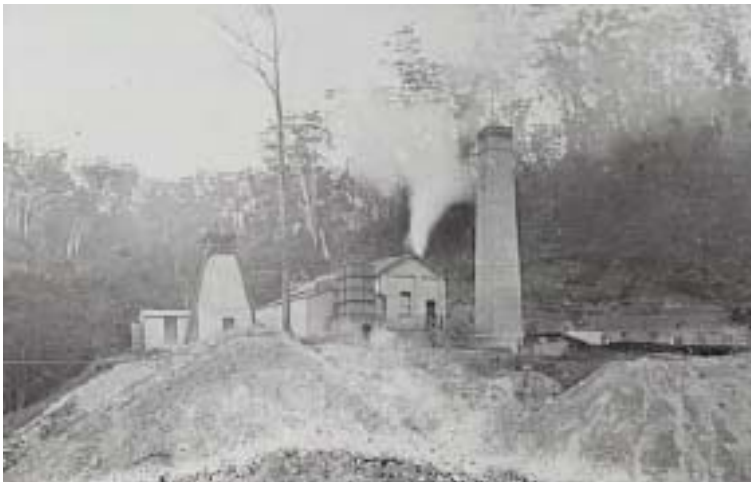
Figure 17. Shaft No. 2 Ventilation shaft and engine house. Shaft to left. Undated.

The photographs show the evolution of the No. 2 shaft complex in its early years. The complex was originally separated from the main No. 1 shaft and coal handling area (zone 1) by a deep valley (see Fig. 20), which was subsequently filled in, the present culvert shown on Plan 1 indicating its course. The bathhouse extension and office buildings were eventually constructed in front of the shaft and fan house on reclaimed land.

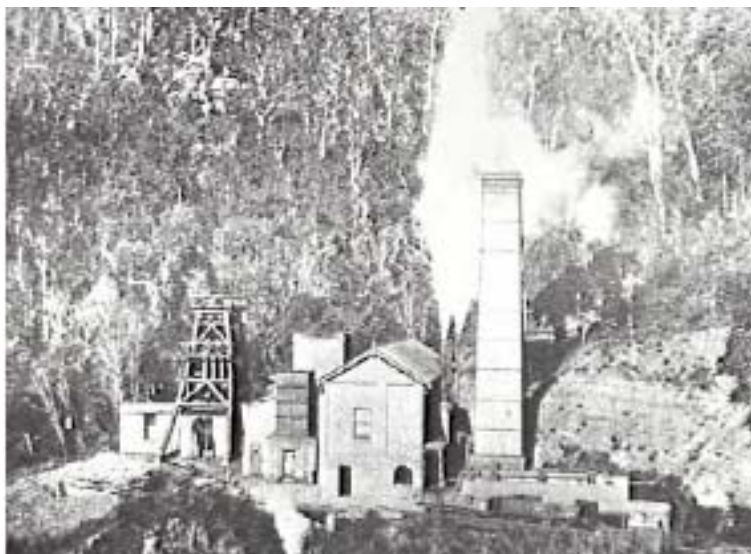
Figure 18. Shaft No. 2 Ventilation shaft and engine house. 1907. Shaft headframe has been replaced. The engine house later became the bathhouse.

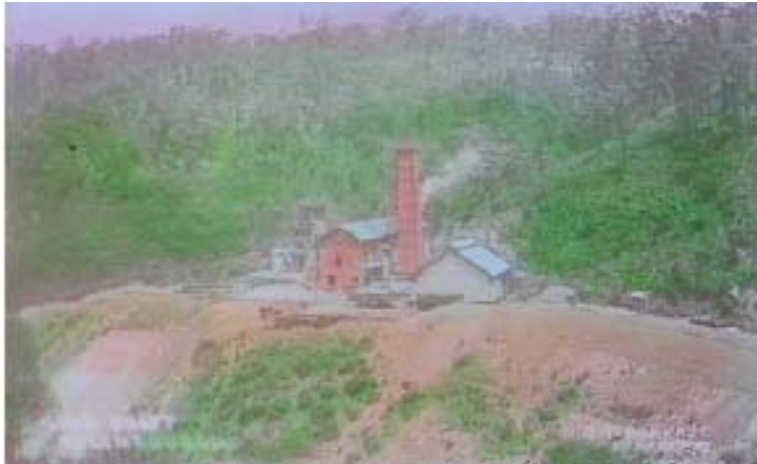
Figure 19. Shaft No. 2 Ventilation shaft and engine house. Undated. New shed beside chimney.

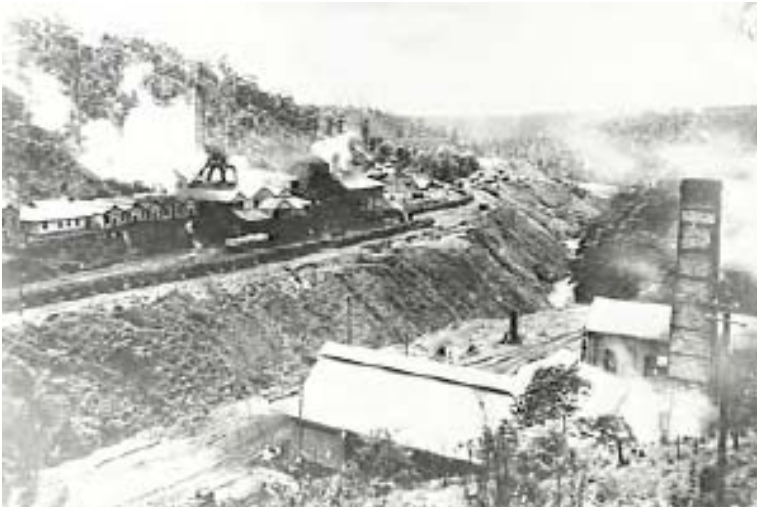
Figure 20. Shaft No. 2 Ventilation shaft and engine house, looking across the deep valley to the main No. 1 shaft area. Undated (but post 1915). The valley is now filled in.

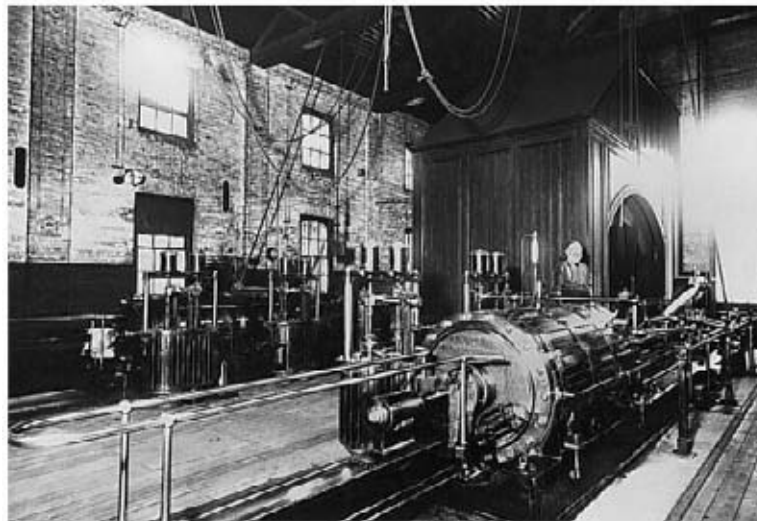
Figure 21. engines and fan housing in original fan house. The building was later converted into the bathhouse. Photo 1906.

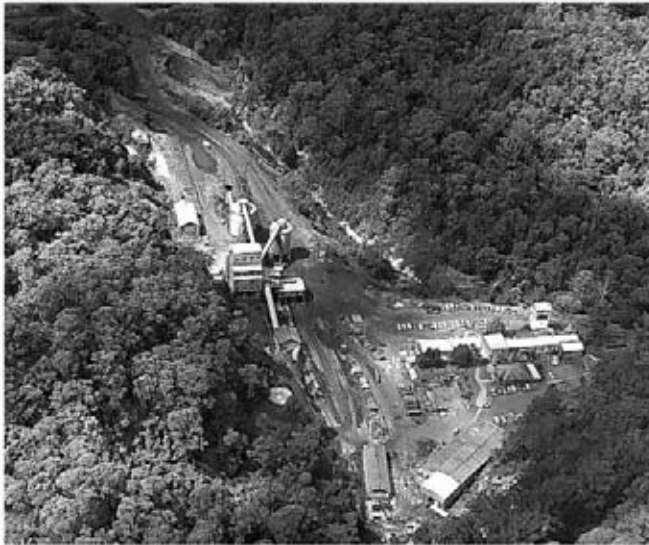
Figure 22. Aerial photo of the colliery, dated after 1954. It shows the covered bathhouse, reduction pond at extreme right, drift winder house, and the new rail engine house and workshop at bottom of frame.

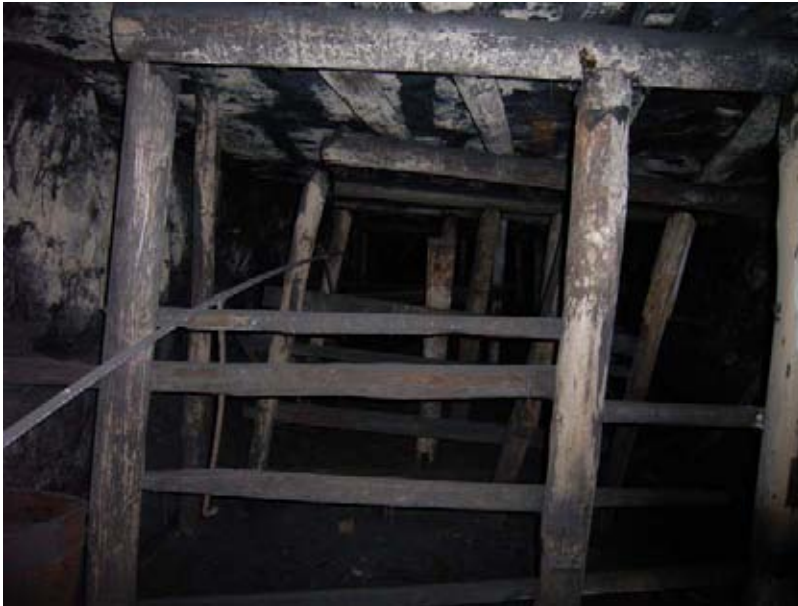
Figure 23. Pit horse stalls. Rails separate stalls, access being from the tramway right, out of frame.

The stabling at the Metropolitan Colliery appears to have been quite similar to that in many British mines, where a common form was to have the stalls down one side of a wide corridor, sometimes with the walls and roof of bare rock or coal, though in Britain often the walls would be of brick. Each stall would have a food box and water container. In Britain the roadway behind the stalls might be fitted with rails (as at Metropolitan) to ease the supply of food and to carry away the soiled bedding. The bedding was rarely straw because of the risk of fire. In some cases peat was used but the most common material was sawdust that was comfortable for the pony.

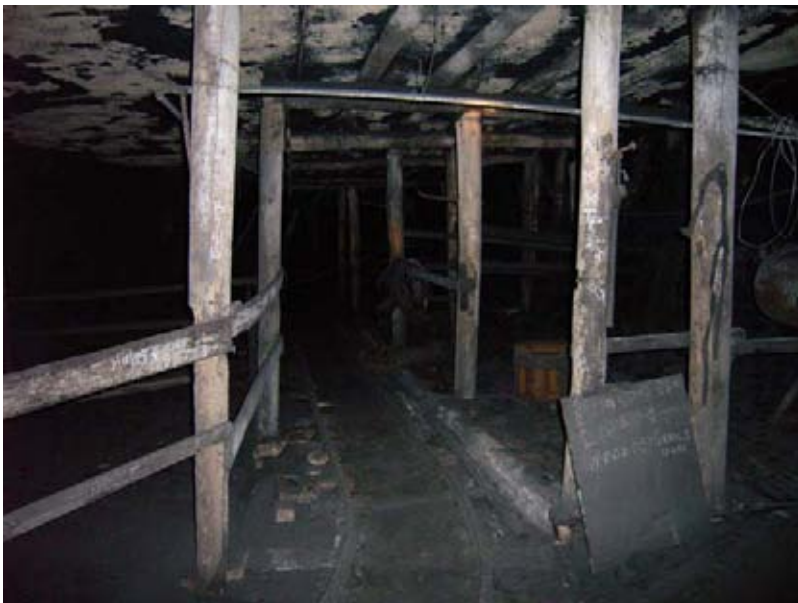
Figure 24 . Pit horse stalls, showing .the brick floor of the stalls. Rails used to demarcate stalls, and tramway which in most drives runs on one side of the stalls. The blackboard shows safety inspection dates and comments.

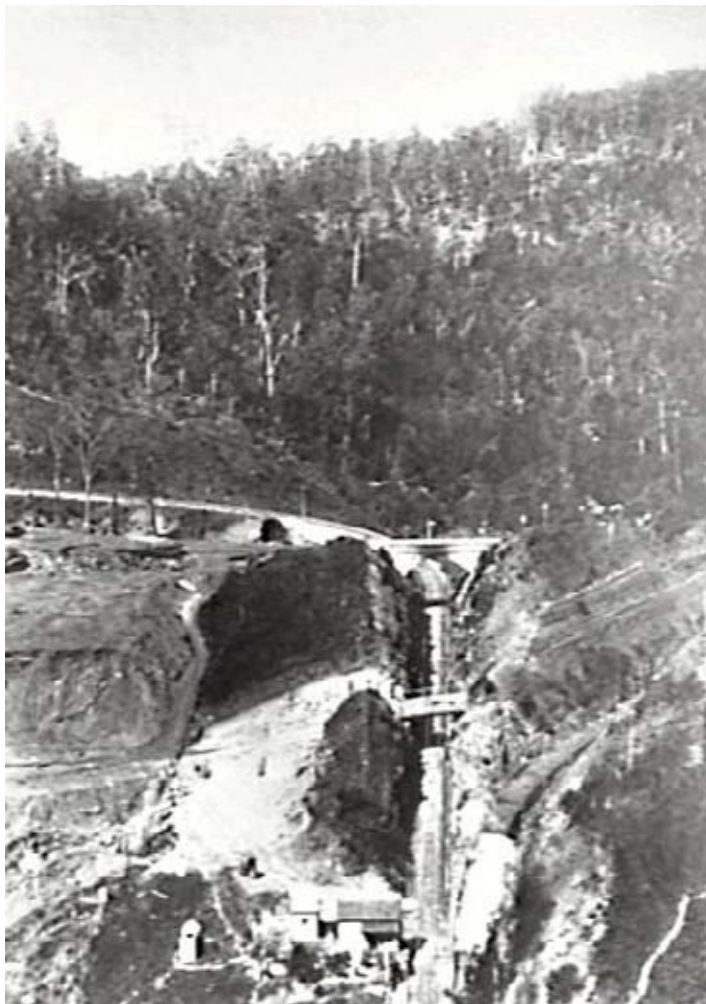
Figure 25. View of the main Illawarra line looking south from above the old Metropolitan Tunnel. The Metropolitan Colliery siding swing to the right at the bottom edge of the photo, and has a coal train on it. The brick arch viaduct is centre, with a temporary dray bridge closer to the camera. The tunnel No. 5 is out of frame to the left. The hut controlling the siding is left of the line at the bottom of the frame (see Fig 23). This area is now settlement ponds for the mine. Photo c.1915.

Between the two tunnels the main line ran beneath the colliery siding, the main line being crossed by way of a brick arch bridge (see Fig. 25). This bridge has subsequently been partially buried in the coal stockpile, but can still be seen (Fig. 26). The colliery siding left the main line just after it left the old Metropolitan Tunnel, and cut through what is now the rail and road line north of the 'island'. The junction was supervised from a track-side house (see Fig. 27).

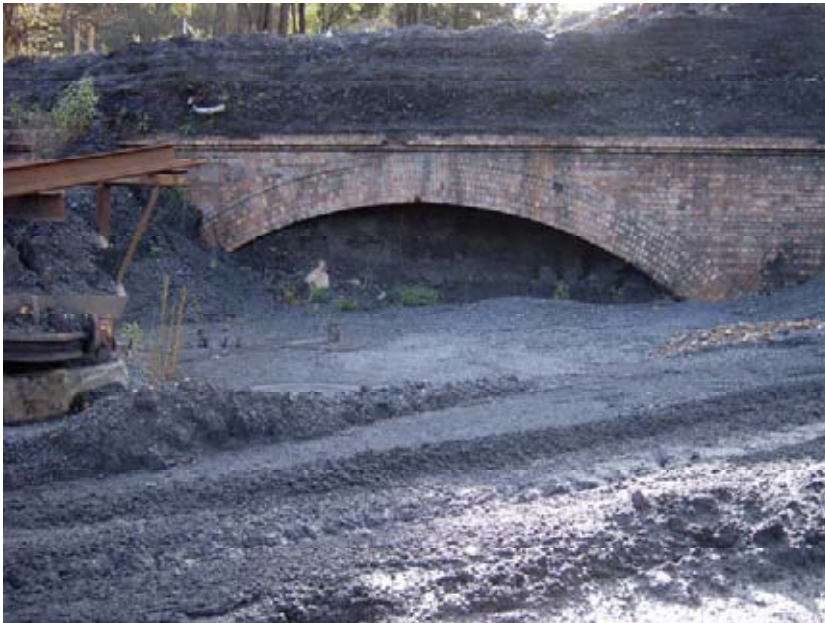
Figure 26. The viaduct that carried the colliery siding over the main line. The parapet has been removed, and the bridge buried in coal stockpile material.

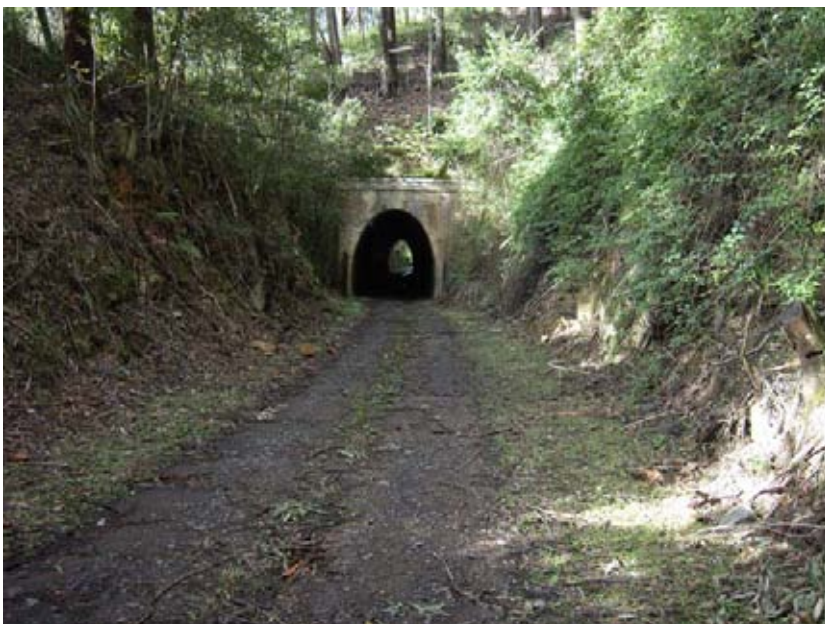
Figure 28. Rail tunnel No. 5 (aka Lilyvale No. 1), in the northern section of the Metropolitan lease area, showing single-track width and ovoid brick form.

Tunnel No 5 (Lilyvale No. 1) is located on the southern side of the lease area, and is still open and in good condition (see Plan 1 above).

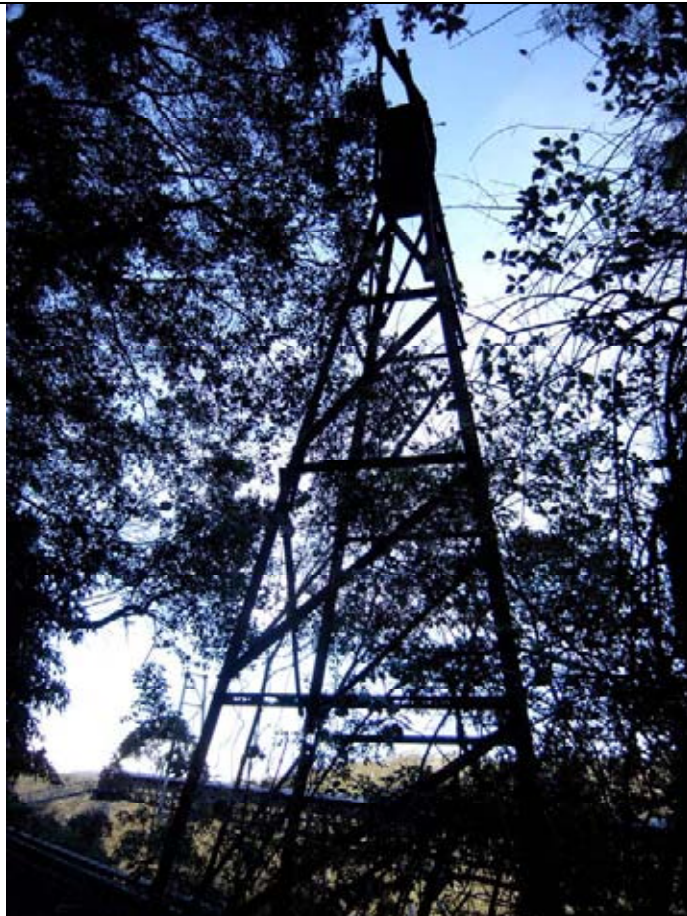
Metropolitan Colliery—  
Power Pylon

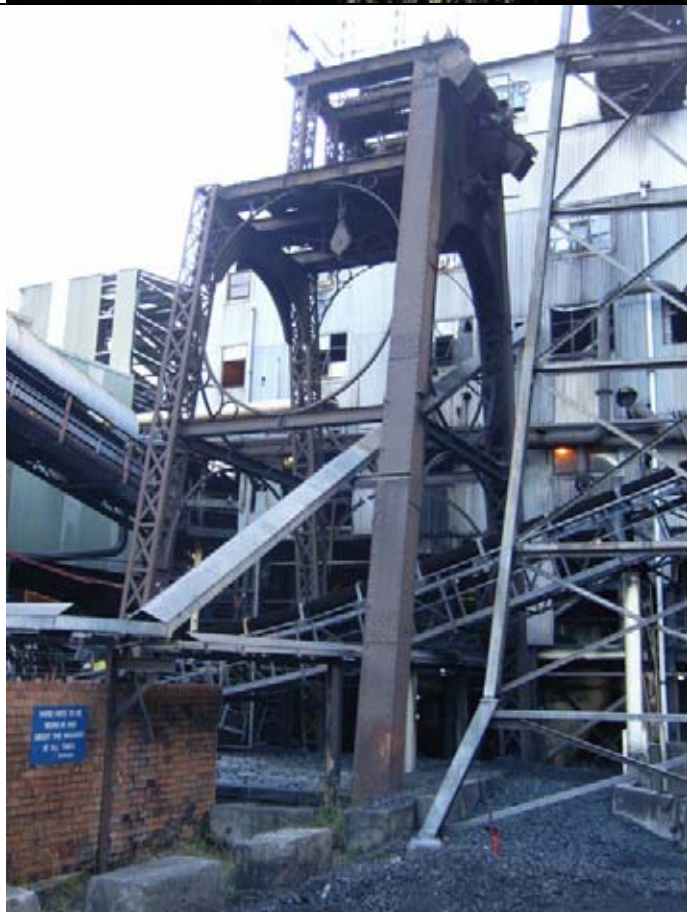
Metropolitan Colliery—  
Shaft No 1 head frame

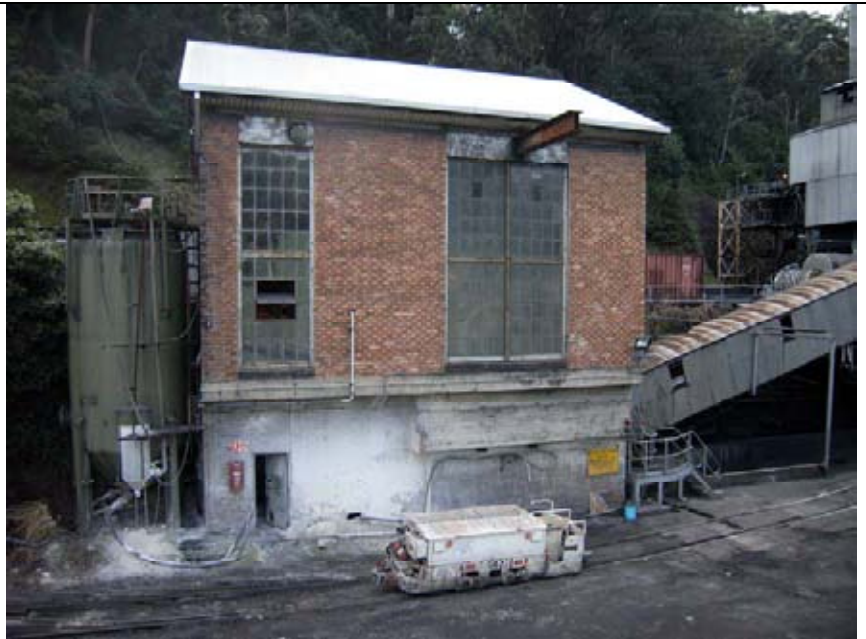
Metropolitan Colliery—  
Tunnel opening, portal  
and winder house

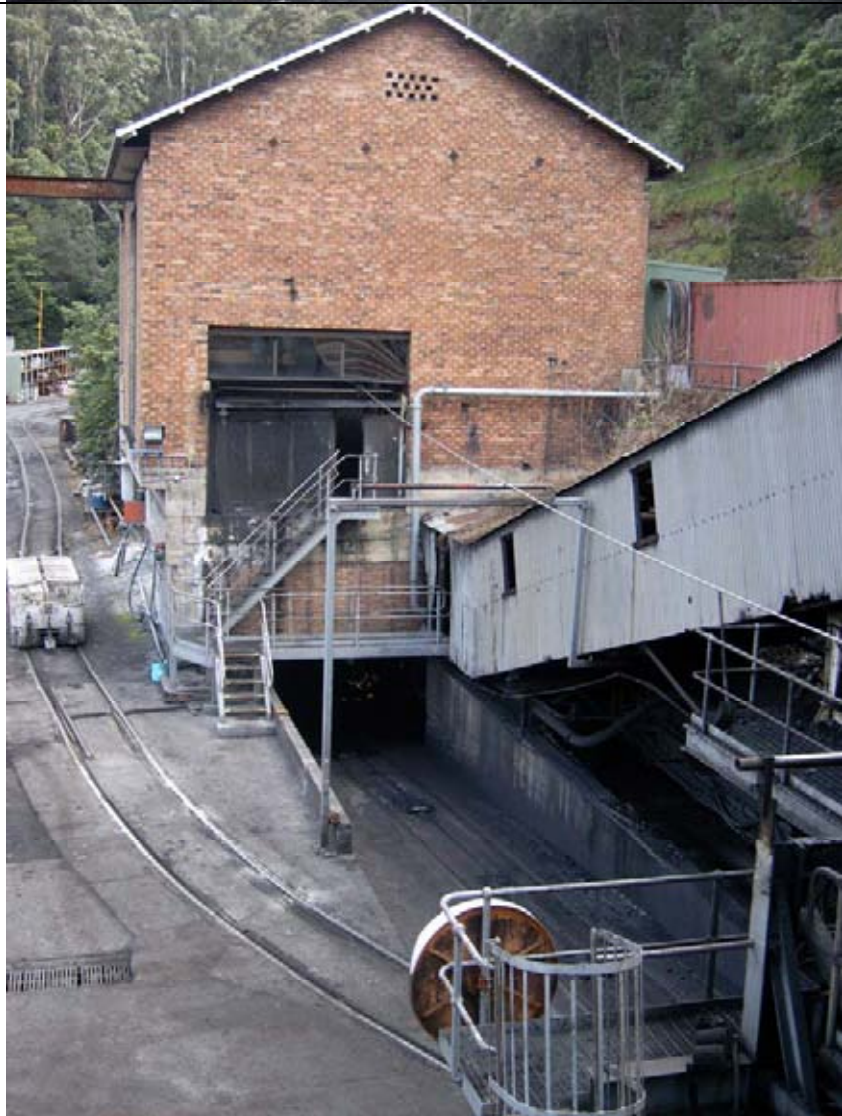
Metropolitan Colliery—  
Portal beneath winder  
house. Haulage cable  
crosses mid-screen,  
then runs around a  
pulley out of frame to  
right and returns to  
descend through the  
portal at floor-level.  
The conveyor belt to  
right raises coal from  
the mine.

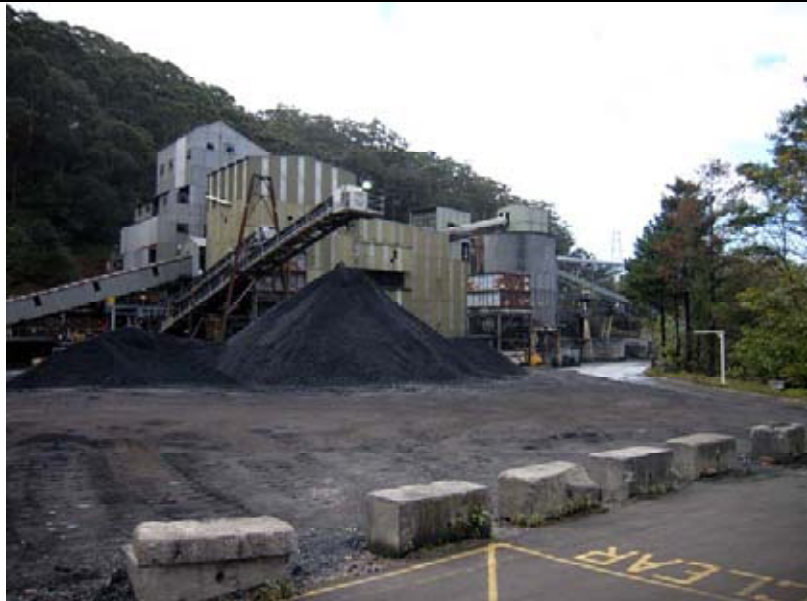
Metropolitan Colliery—  
Coal Storage and  
Washery

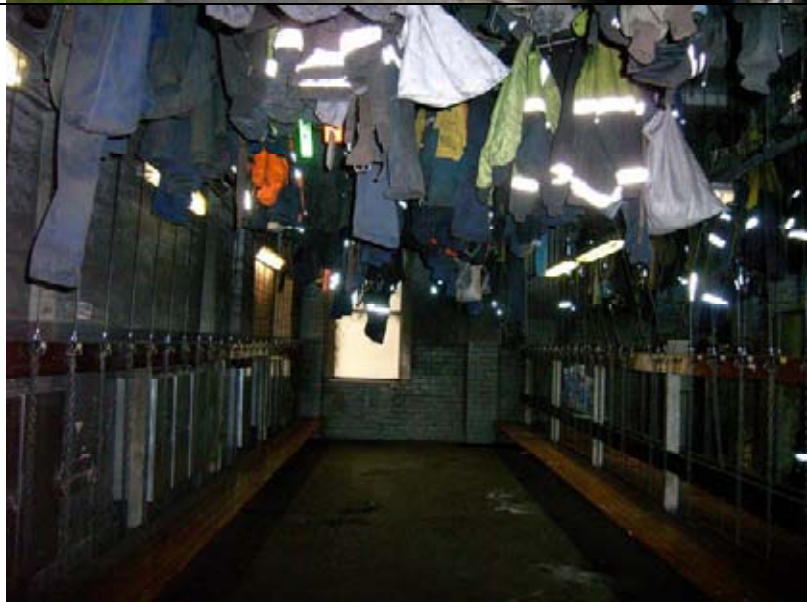
Metropolitan Colliery—  
Bathhouse interior, with  
miner's clothing raised  
by pulleys.
