## METROPOLITAN COAL PROJECT ENVIRONMENTAL ASSESSMENT

**METROPOLITAN COAL PROJECT  
NON-ABORIGINAL HERITAGE ASSESSMENT**

**A REPORT FOR HELENSBURGH COAL PTY LTD.**

**AUGUST 2008**

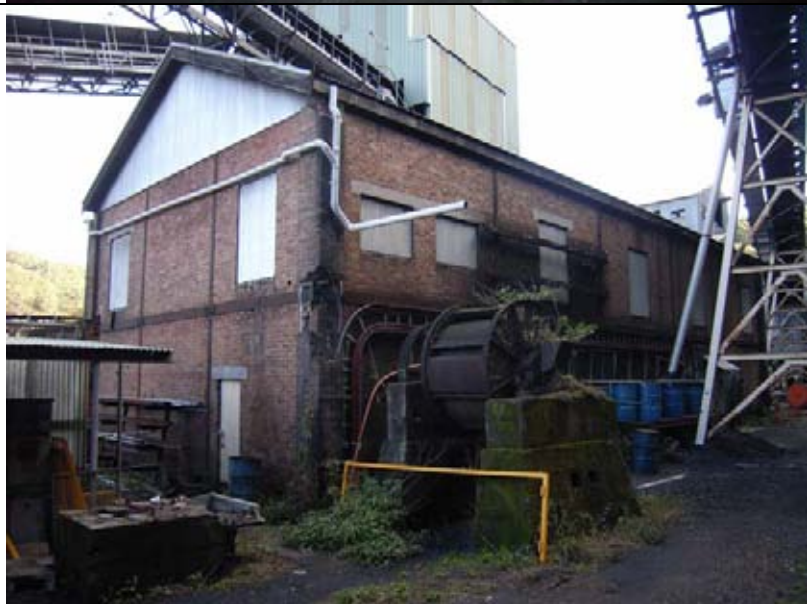
Metropolitan Colliery—  
Powerhouse

The surviving powerhouse is a brick two-storey structure. Power generation equipment has been removed, the building now housing a switch room and a workshop. An overhead 3000 kg gantry crane is intact, and an old screening trommel is located adjacent to building. Three transformers are located to the east (two of them old). The construction date of this building is not yet clearly established. The original powerhouse may be a building shown to the west of the Shaft No. 1 complex in Figs. 2 & 5. Power generation was upgraded about 1915, and again in about 1927 and 1933, and again in the mid 1950s. The current building is shown in Fig. 6, and Figs. 8 & 12, which appear to be taken about 1955.
