WAMBO COAL PTY LTD

NORTH WAMBO UNDERGROUND MINE

EXTRACTION PLAN
LONGWALLS 8 TO 10A

HERITAGE MANAGEMENT PLAN
LONGWALLS 8 - 10A

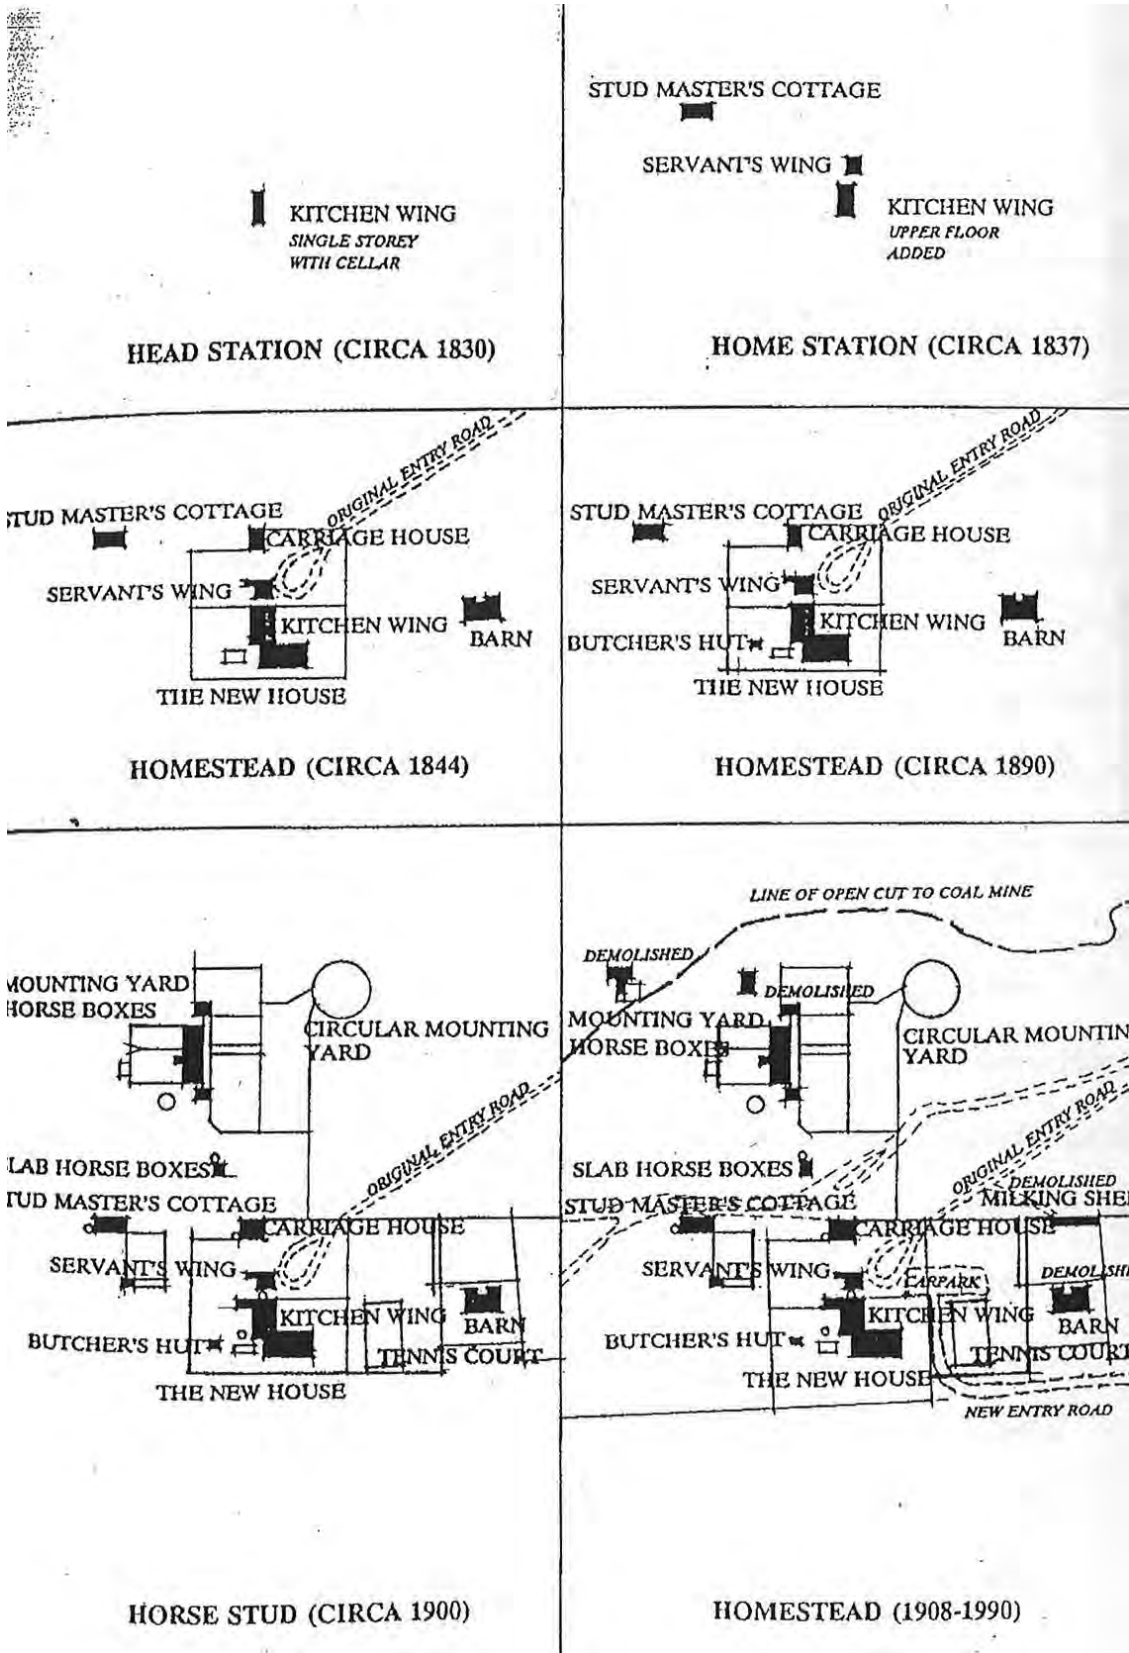
Figure 2.2 Plans illustrating the development of the Wambo Estate from 1830 until 1990. These sketch plans prepared by B Collins show the expansion of the homestead particularly in the period 1830–1844, with later demolition also indicated. (Source: Collins CMP 1994)

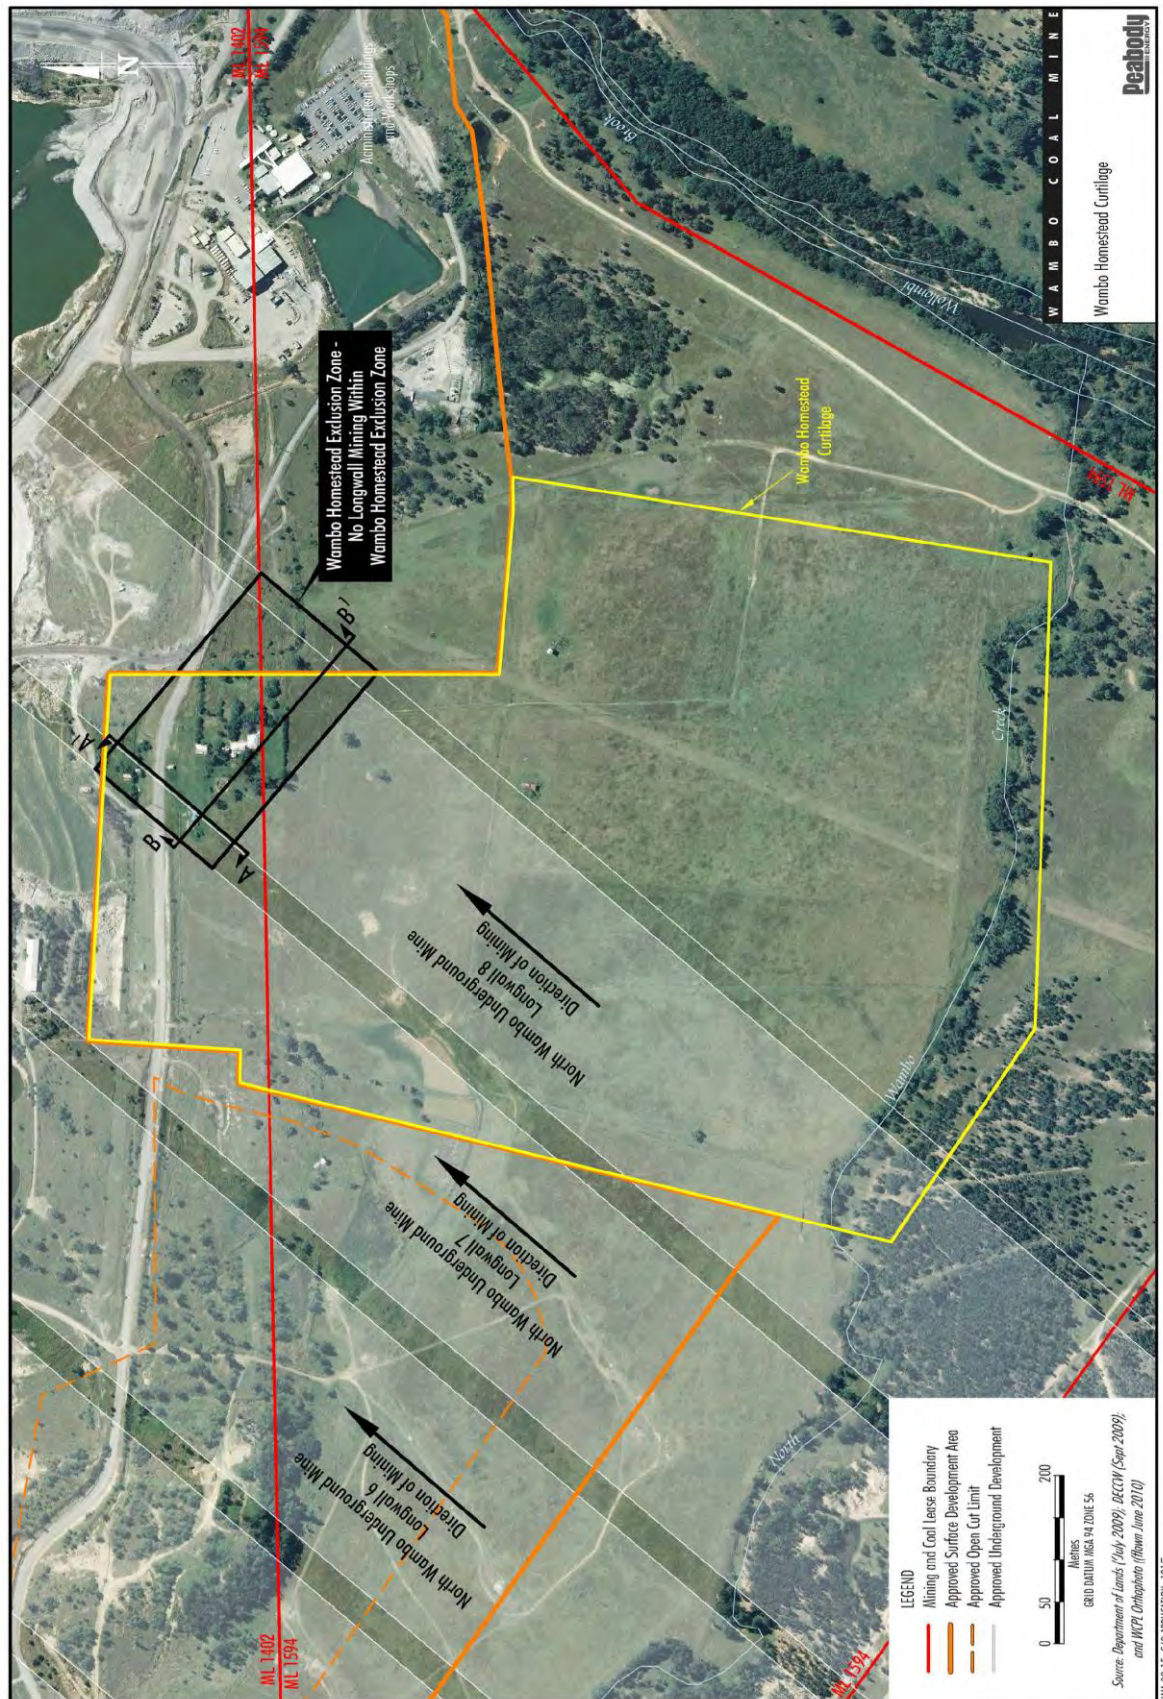
Figure 3.1 Lease and mining boundaries in relation to Wambo Homestead SHR Curtilage. (Source: Wambo Coal Pty Ltd)

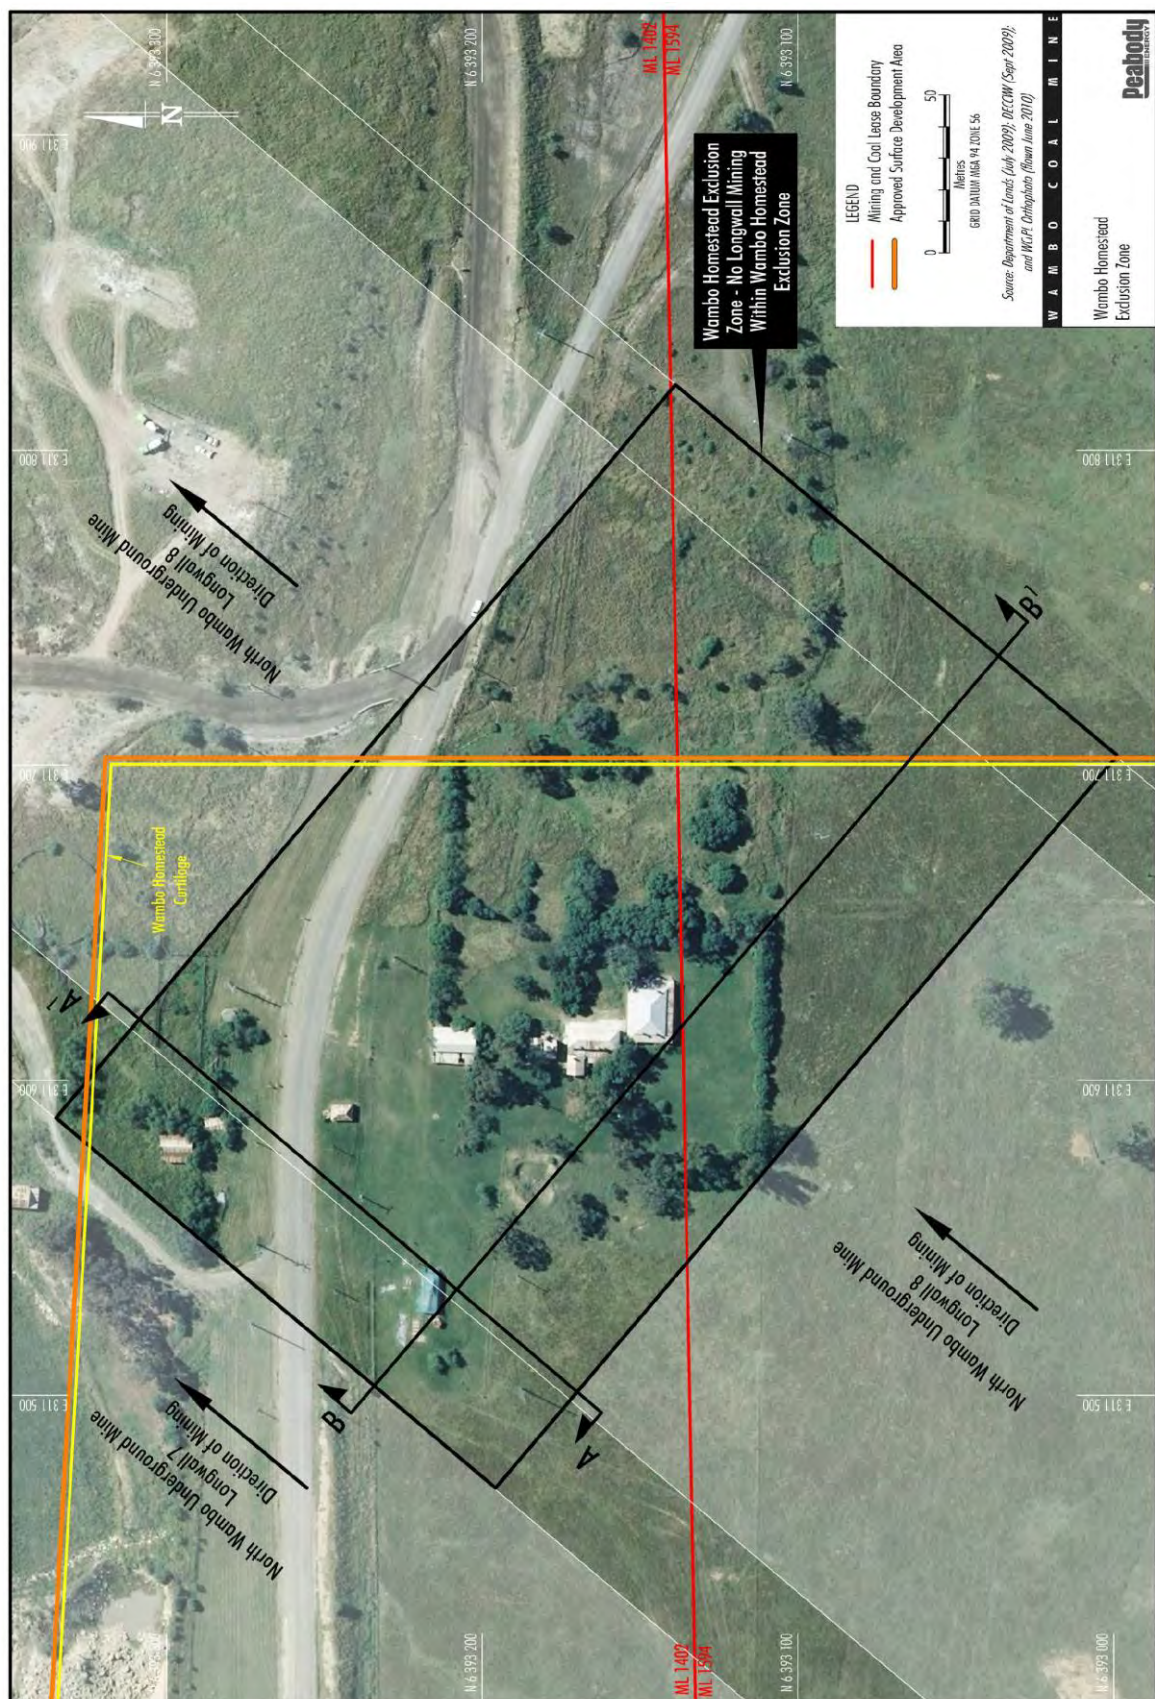
Figure 5.2 Proposed mining LW7 and LW8 in relation to WHC.

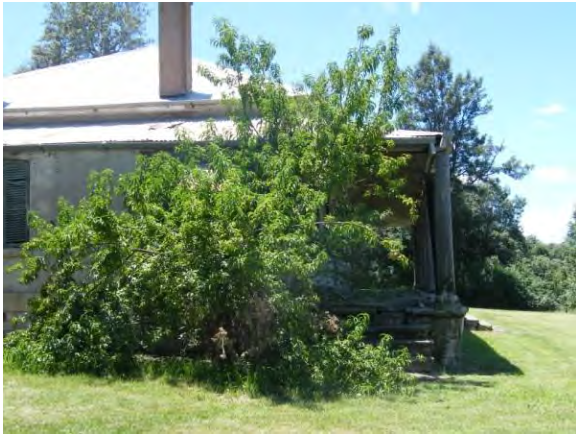
Figure 2 Southwest corner showing invasive tree suckers **before** removal and works to roof and verandah drainage.

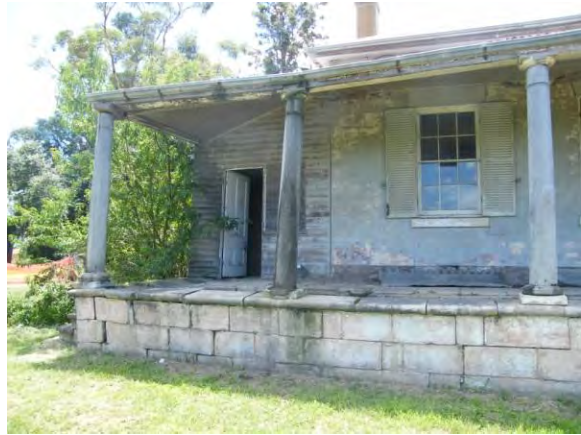
Figure 3 West end of front verandah **before** works showing deterioration in timber columns and settlement of retaining wall and edge beam with attached eaves gutter.

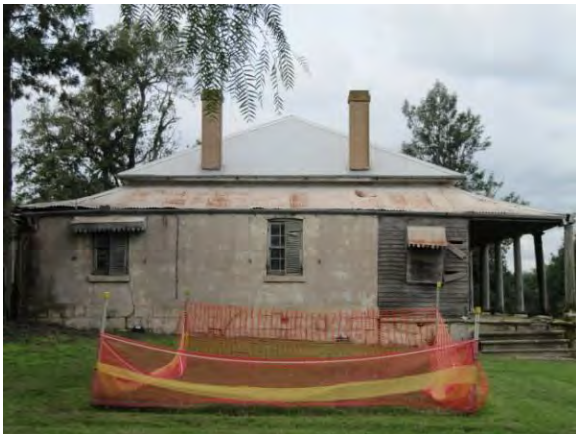
Figure 4 South elevation **after** of intrusive vegetation showing the newly exposed original galvanised steel hood over the verandah infill-room window.

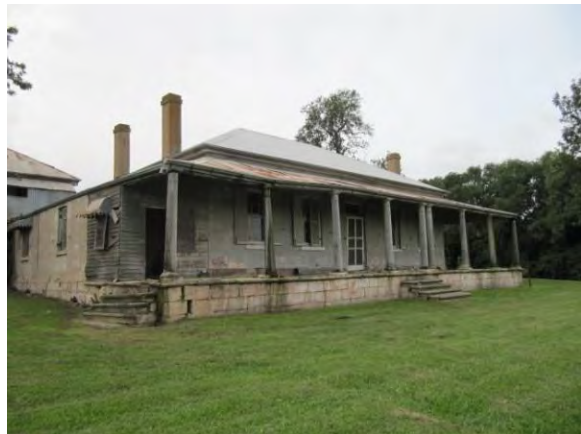
Figure 5 Southwest corner of front elevation **after** removal of intrusive vegetation but **before** works to verandah.

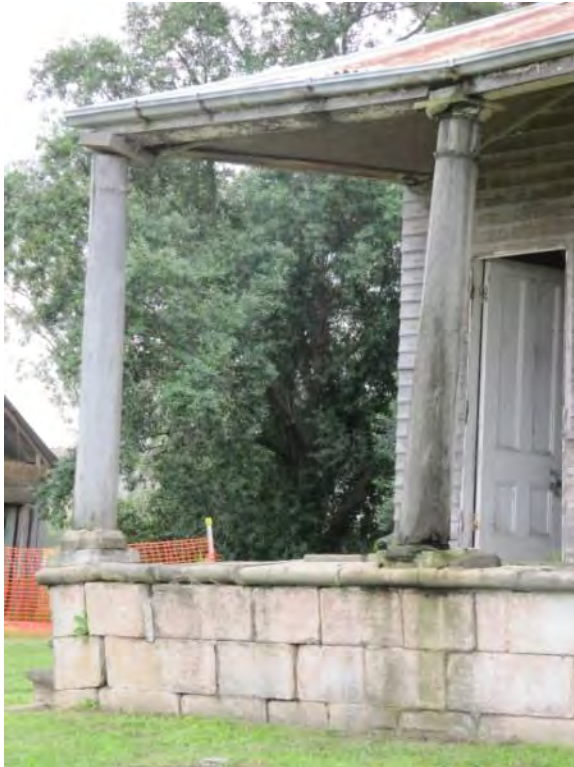
Figure 6 Detail of west end of front verandah **before** works showing deterioration in timber columns and settlement of retaining wall and edge beam with attached eaves gutter.

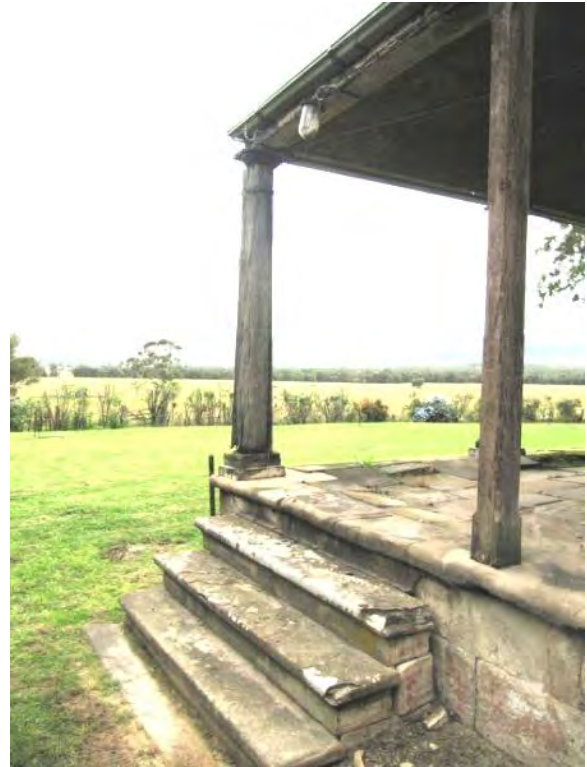
Figure 7 Detail of east end of front verandah **before** works showing deterioration in southeast corner columns and early replacement (stop-chamfered) column.

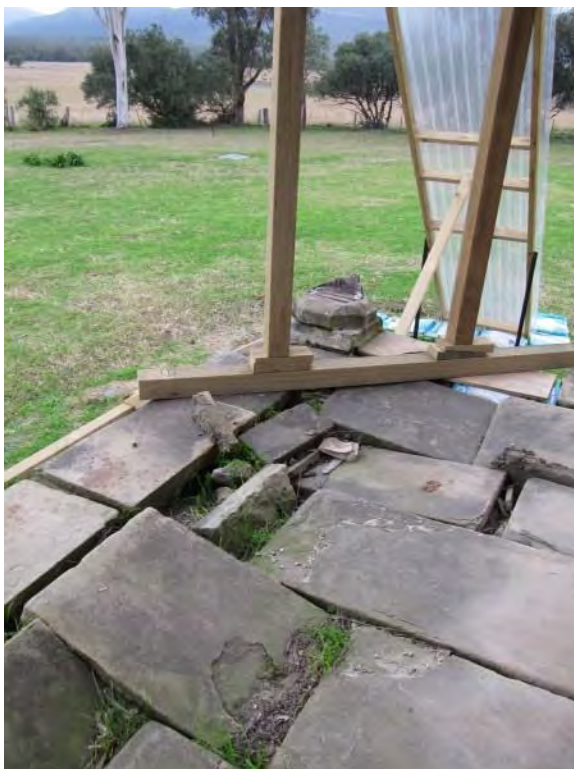
Figure 8 West end of front verandah **after** removal of unsound corner column showing new timber props to support roof framing and timber-framed 'water chute' with acrylic sheeting to collect and disperse roof water onto ground away from base of building.

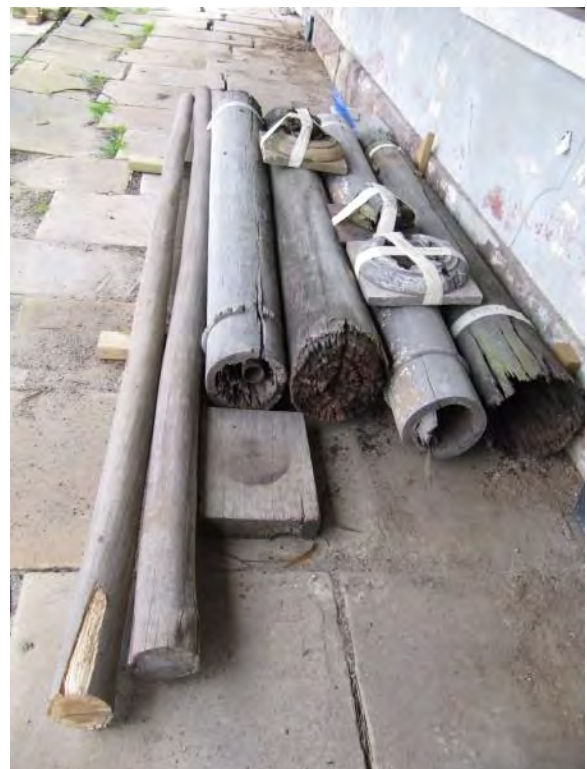
Figure 9 Original/early timber columns, bases and framing **after** removal—because of deteriorated physical/structural condition—for storage inside New House.

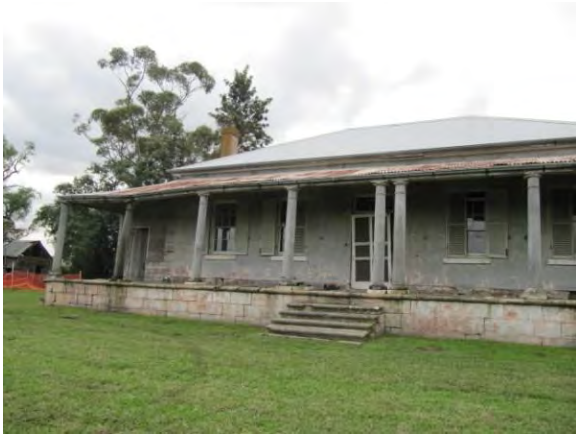
Figure 10 South elevation with verandah **before** works.

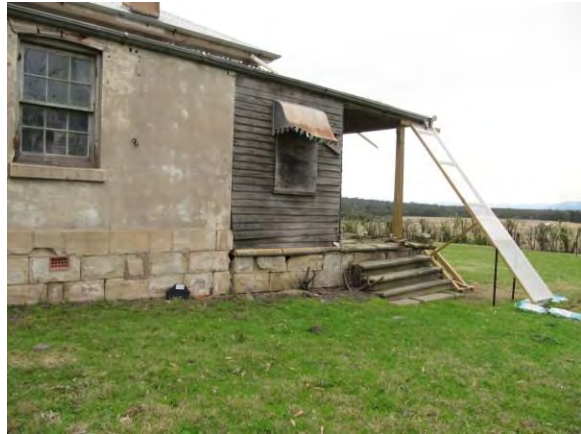
Figure 11 South end of west elevation **after** works to brace front verandah framing and front wall and rectify roof water drainage.

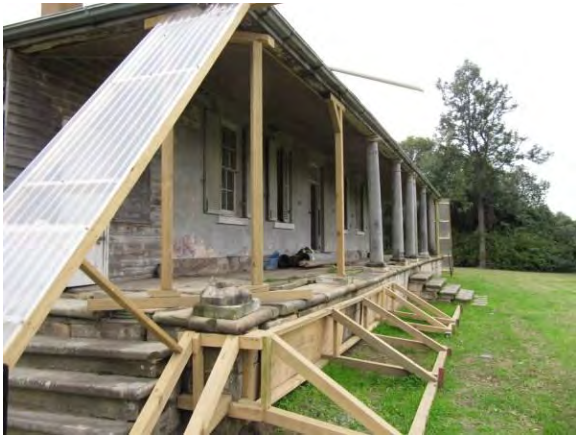
Figure 12 South elevation **after** works including bracing of verandah support wall to halt settlement and rotation; removal of deteriorated columns and replacement with new timber props; resecuring and realignment of gutter and construction of new timber-framed 'water chute' with acrylic sheeting to collect and disperse roof water onto ground away from base of building.

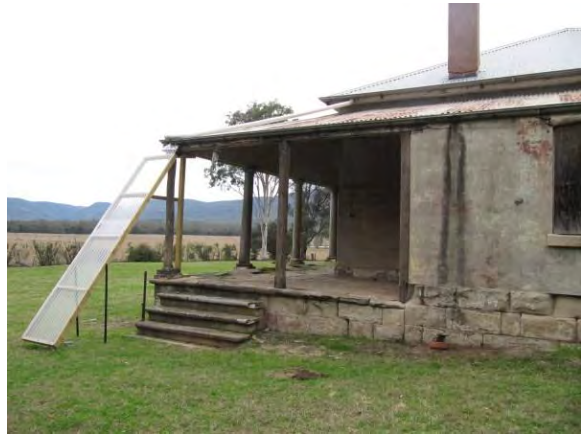
Figure 13 South end of east elevation **after** works including new timber bracing to supplement retained existing corner column; resecuring and realignment of gutter and construction of new timber-framed 'water chute' with acrylic sheeting to collect and disperse roof water onto ground away from base of building.

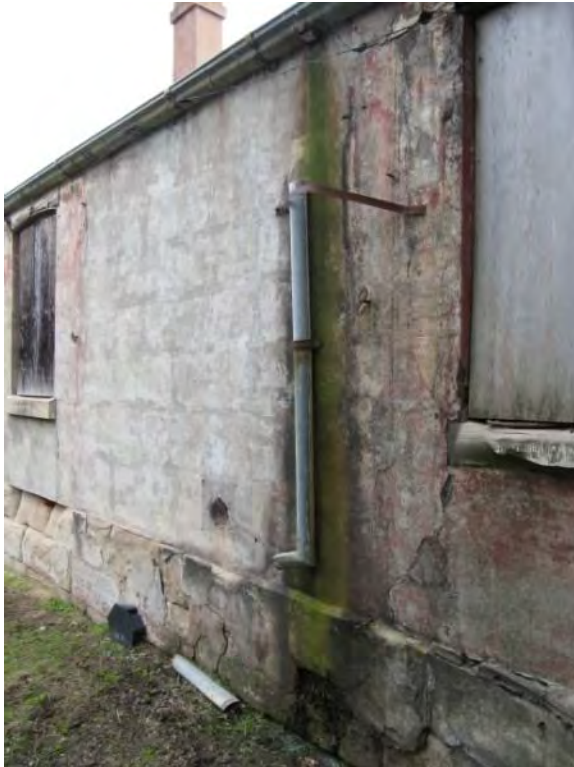
Figure 14 North end of east elevation **before** works to upgrade drainage with new 'water-chute' as shown below.

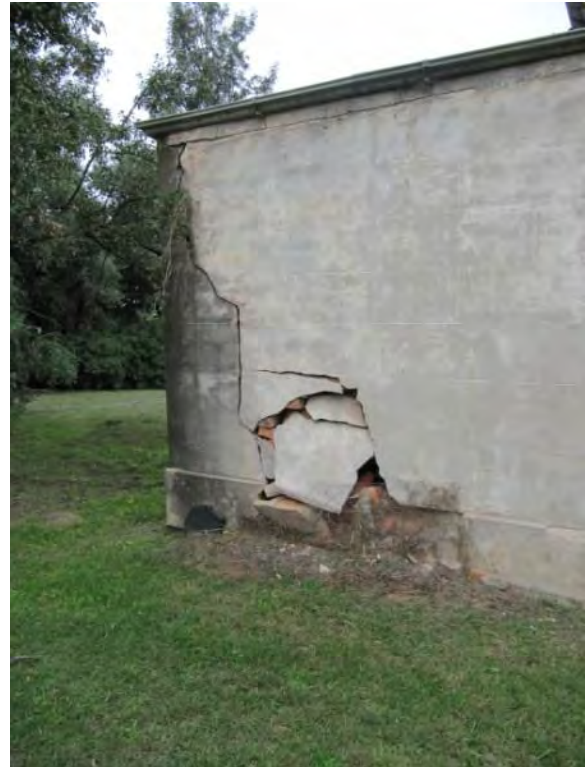
Figure 15 East end of north elevation **before** works showing settlement due to salt-damp deterioration of basement walls.

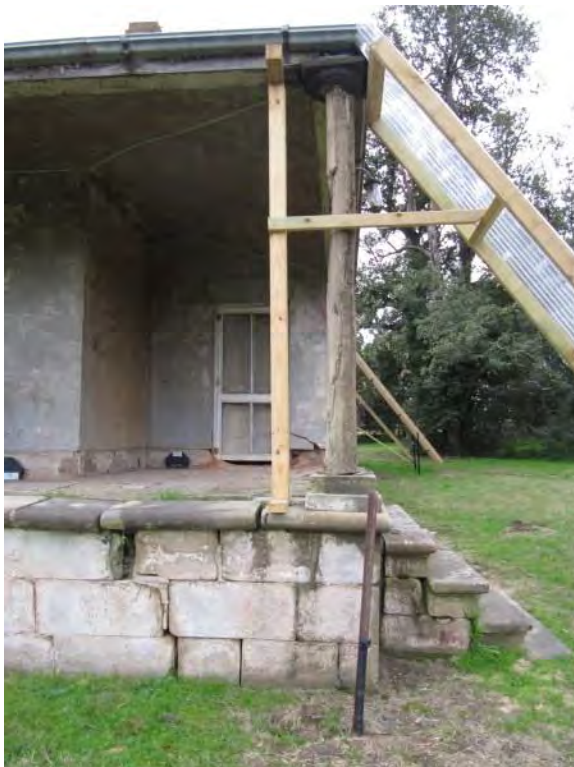
Figure 16 Southeast corner **after** works to upgrade roof drainage showing two new timber-framed 'water chutes' to disperse roof water onto ground away from base of building at south and north ends of east elevation.

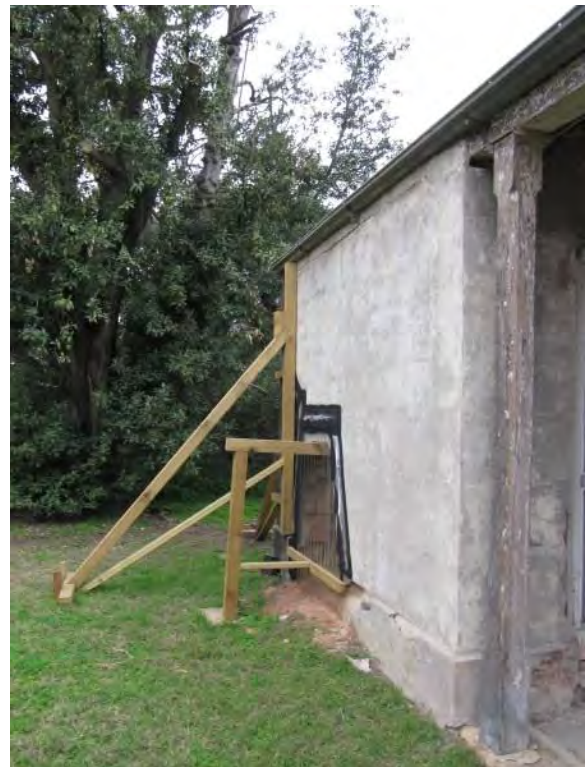
Figure 17 East end of north elevation **after** works to prop and brace collapsing masonry wall on inside and outside faces of building.

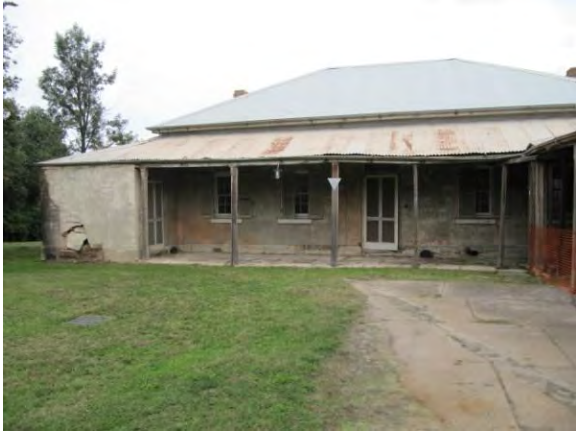
Figure 18 Northeast courtyard showing north elevation of New House and junction to Kitchen Wing at west end **before** works to prop wall and framing and upgrade drainage.

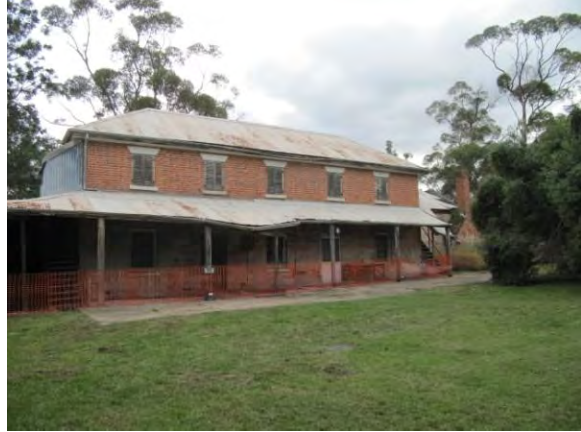
Figure 19 East elevation of Kitchen Wing to northeast courtyard **before** works to roof, verandah framing and drainage.

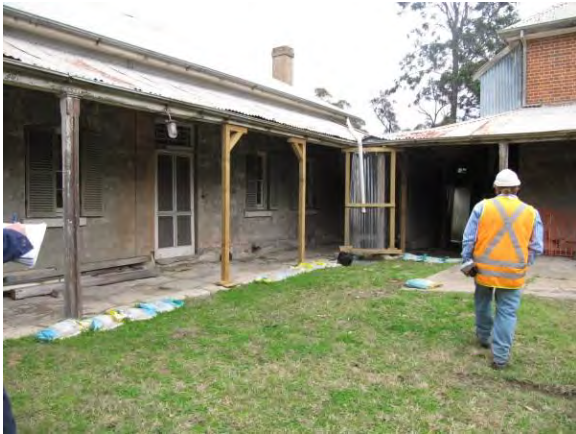
Figure 20 Southwest corner of northeast courtyard **after** works to prop edge beam and realign verandah gutter on New House. Also shows new timber-framed 'water chute' at junction with Kitchen Wing to disperse roof water away from verandah framing into existing drainage system.

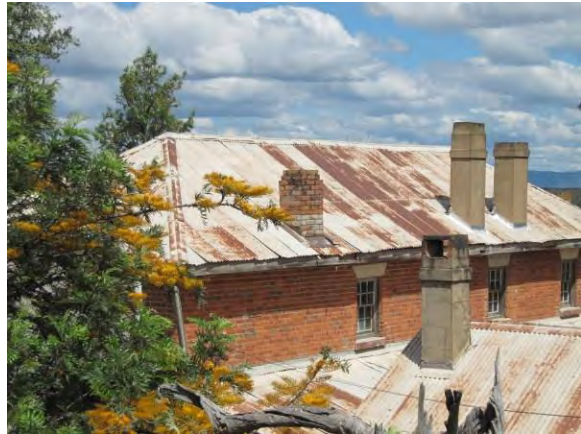
Figure 21 West elevation of Kitchen Wing **before** works to roofs and gutters and removal of invasive *Grevillia robusta* (Silky Oak) tree suckers.

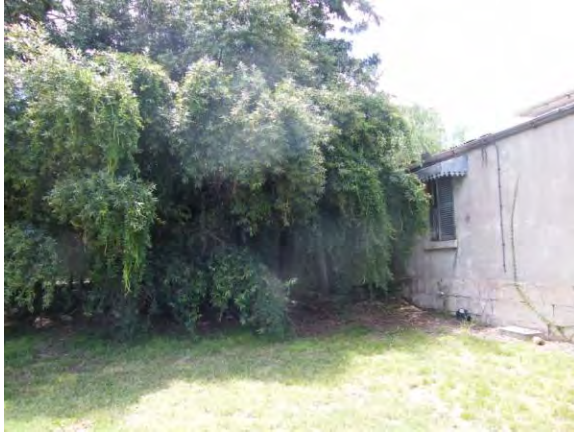
Figure 22 Southwest corner of Kitchen Wing at junction with west wall of New House **before** works showing invasive plant growth including African Olive and Silky Oak (self-sown and suckers).

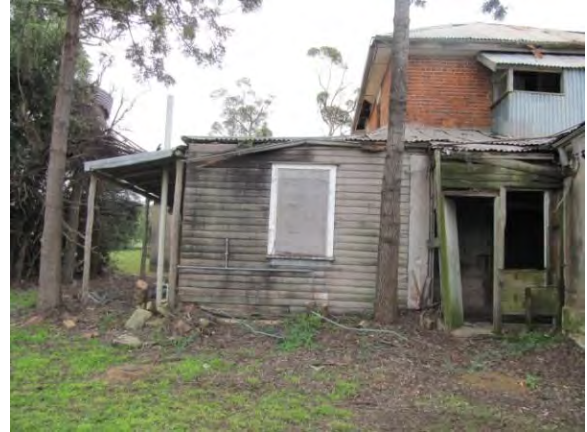
Figure 23 South elevation of Kitchen Wing at junction with northwest corner of New House **after** removal of invasive plant growth including African Olive and Silky Oak.

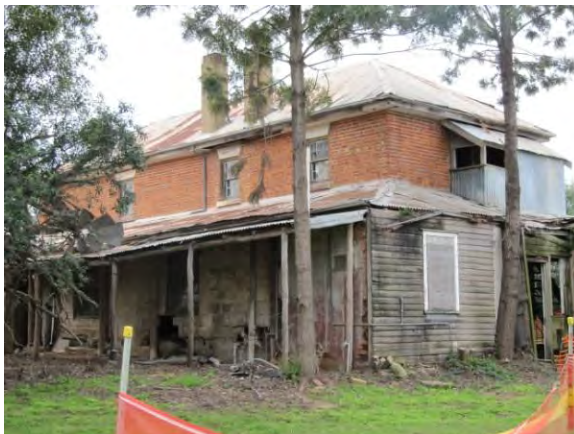
Figure 24 West elevation of Kitchen Wing from southwest **after** initial clearing of invasive plant growth showing formerly hidden components and fabric.

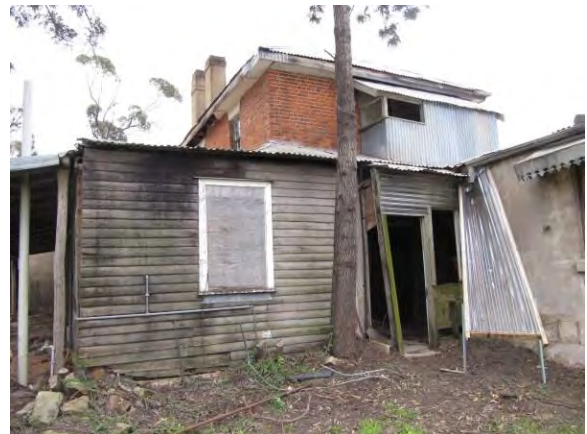
Figure 25 Southwest corner of Kitchen Wing at junction with west wall of New House **after** works to improve roof drainage, including checking over and resecuring/repairing roofing, removal of deteriorated sections of gutter, re-securing and/or replacing existing gutters, installation of new spouts/outlets and construction of new timber-framed 'water chute' with acrylic sheeting to collect and disperse roof water onto ground away from base of buildings.

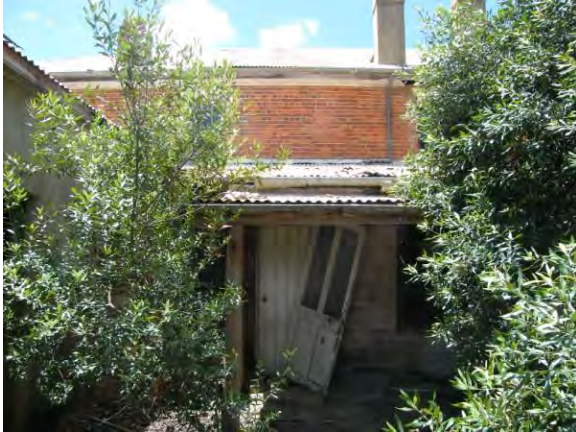
Figure 26 North end of west elevation of Kitchen Wing at junction with attached Laundry facing west courtyard **before** works showing invasive plant growth including African Olive and Silky Oak (self-sown and suckers).

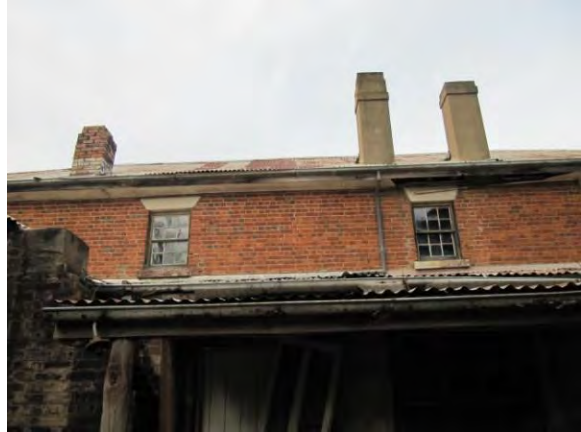
Figure 27 North end of west elevation of Kitchen Wing at junction with attached Laundry facing west courtyard **after** removal of invasive plant growth but **before** repairs to roof drainage showing newly exposed areas roofs, guttering and verandah framing

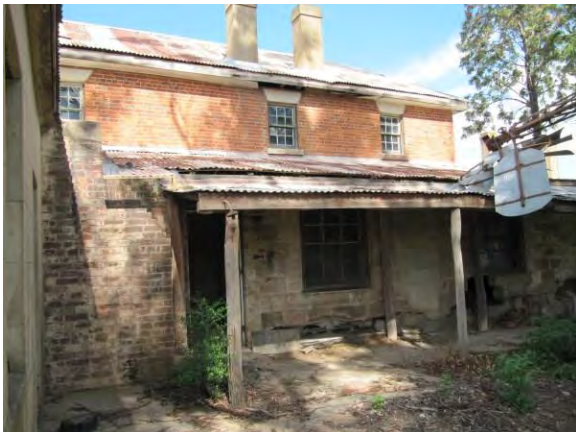
Figure 28 North end of west elevation of Kitchen Wing at junction with attached Laundry facing west courtyard **after** repairs to roofs and drainage including checking over and repair/refixing of roof sheeting (main roof and verandah) and flashings, removal of deteriorated gutters and downpipes and installation of 'water-chutes' with new flashings to collect and disperse roof water from valleys and wall junctions.

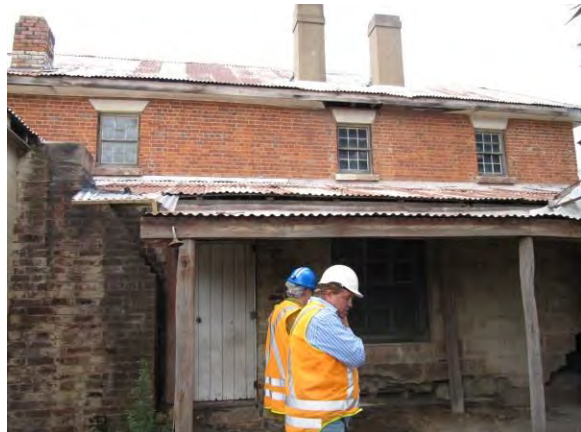
Figure 29 Further detail of north end of west elevation of Kitchen Wing facing west courtyard **after** repairs to roofs and drainage. Also shows verandah after clearing up works and realignment of verandah posts/edge beam.

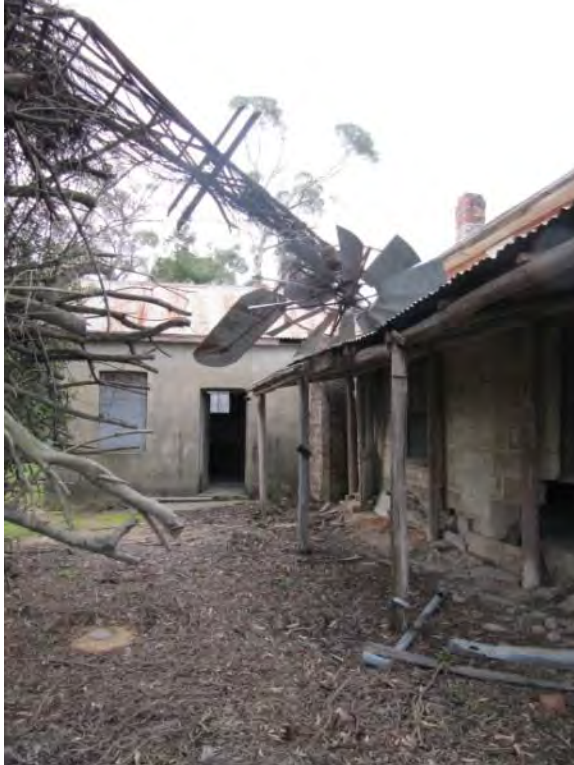
Figure 30 West courtyard **after** removal of invasive plant growth showing collapsed windmill supported on verandah roof exposed by this work, but **before** repairs to roof drainage showing newly exposed areas roofs, guttering and verandah framing

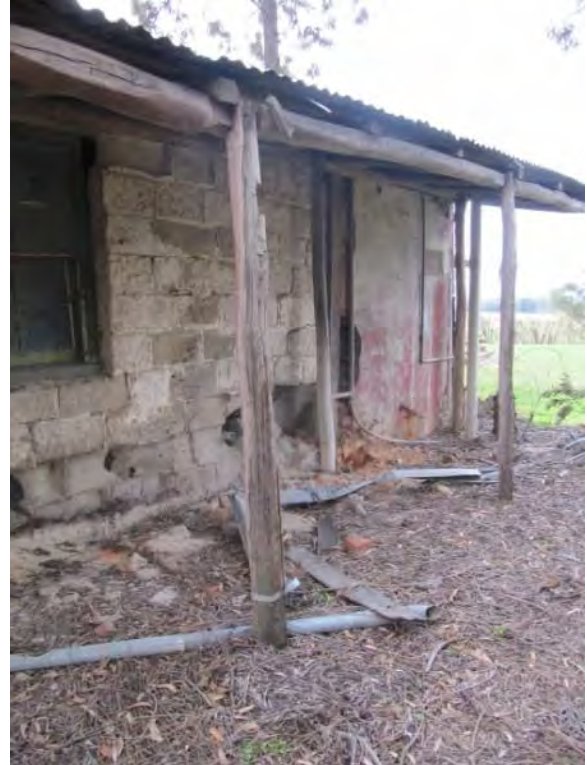
Figure 31 South end of west elevation of Kitchen Wing (from west courtyard) **after** removal of invasive plant growth but **before** repairs/propping to framing and upgrading of roof drainage showing newly exposed areas and components.

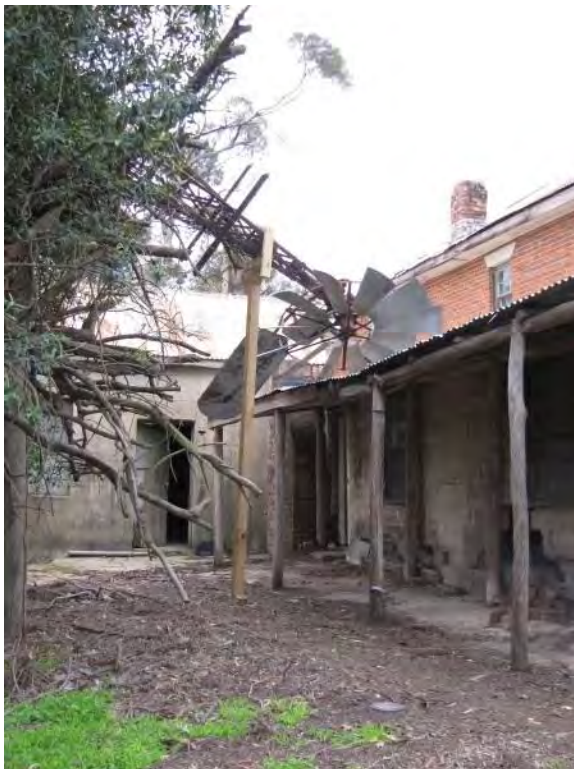
Figure 32 West courtyard **after** new props installed to support windmill off verandah roof, clearing out and realignment/propping of framing and upgrading of roof drainage.

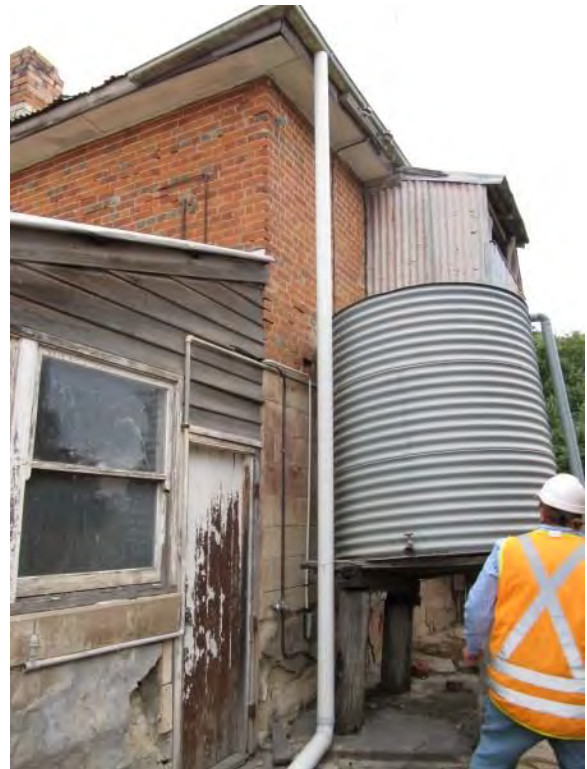
Figure 33 East corner of north elevation of Kitchen Wing showing new gutter and downpipe installed as part of drainage upgrading. Main roof left gutter-less to drain to verandah below.

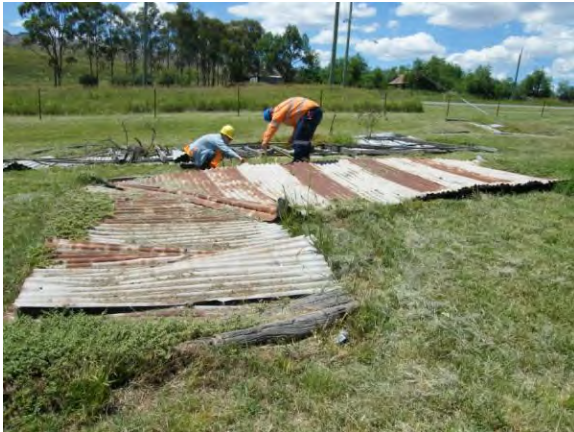
Figure 34 Initial inspection of surviving fabric from former roof **before** sorting, analysis and storage – showing hip connection from main roof sheeting.

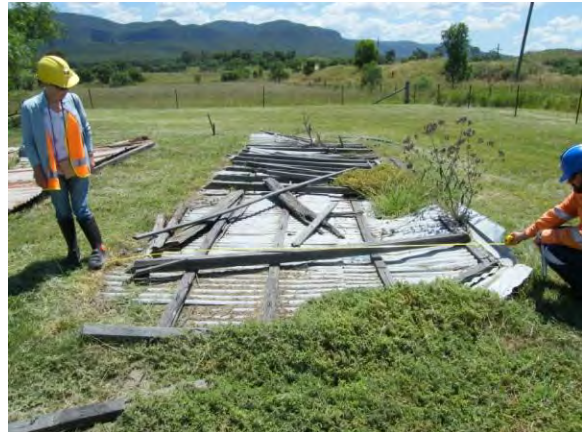
Figure 35 Initial inspection of surviving fabric from former roof **before** sorting, analysis and storage.

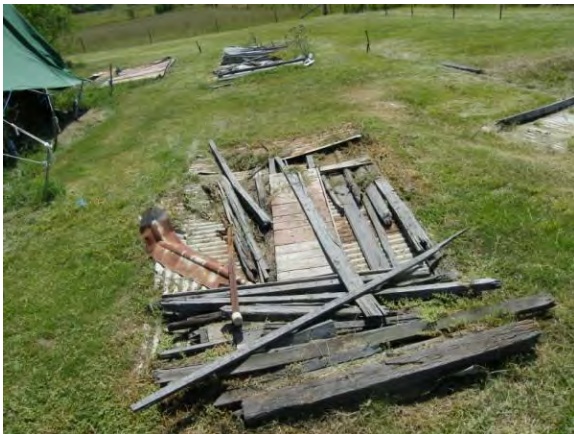
Figure 36 Initial sorting and stockpile of roof framing and sheeting **before** later analysis and storage.

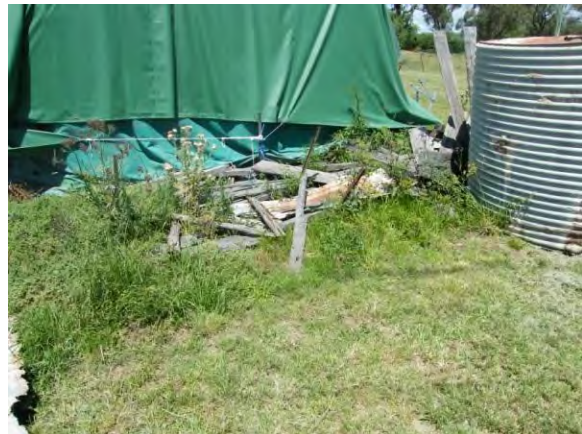
Figure 37 Surviving components/fabric from former roof, verandah, (etc) at west end of Cottage (adjacent to tank stand) **before** sorting, analysis and storage.

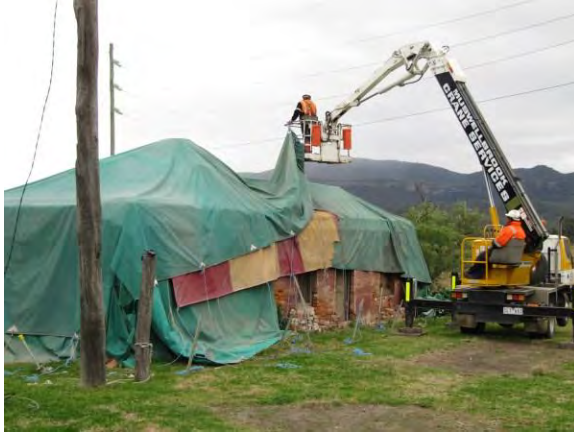
Figure 38 Removal of weatherproof tarpaulin over roof to allow inspection of masonry, remaining roof/ceiling components and interiors of building **before** inspection/ analysis and storage of surviving roof and verandah fabric inside building.

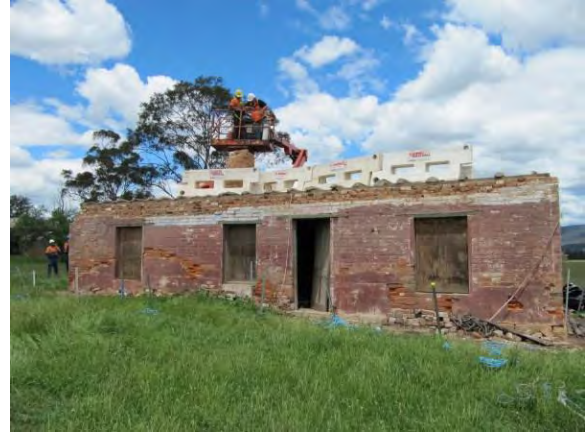
Figure 39 North elevation after initial removal/clear up of stockpiled materials and removal of tarpaulin to allow inspection of walls, roof/ceiling components and interiors.

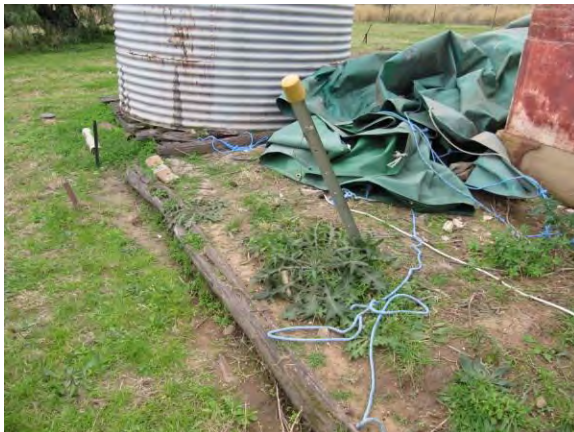
Figure 40 West end of south elevation (adjacent to tank stand) **after** initial clearing and removal of stockpiled building components showing location/evidence/fabric of previous verandah along this elevation.

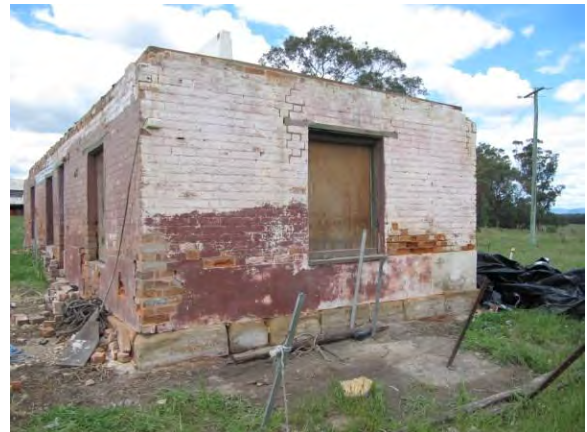
Figure 41 East end of Cottage – following temporary removal of tarpaulin cover – **after** clear-up/removal of components/fabric from former roof and verandah for sorting and storage.

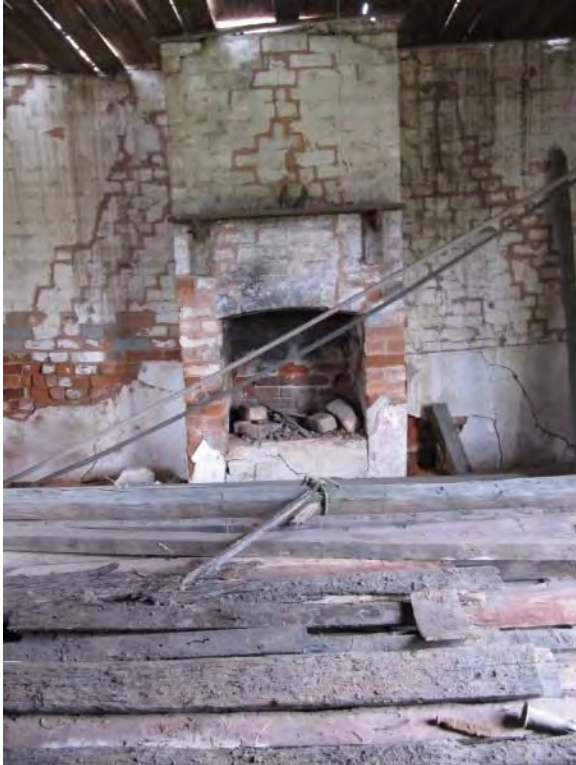
Figure 42 Interior of cottage used for interim storage of major timber framing components from former roof and verandah – including posts, beams, plates, etc – **after** inspection and sorting.

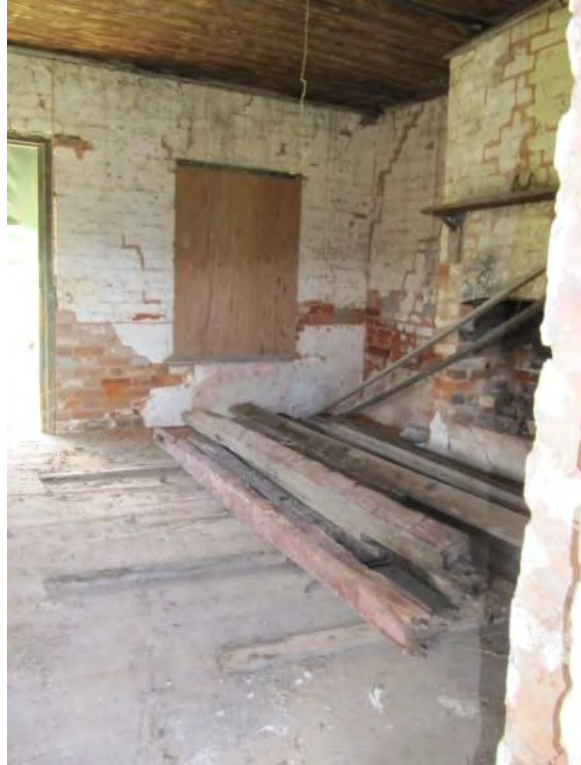
Figure 43 Same interior space as 42 during removal of stored fabric to nearby container showing examples of retrieved and stored timber framing (posts, beams, etc).

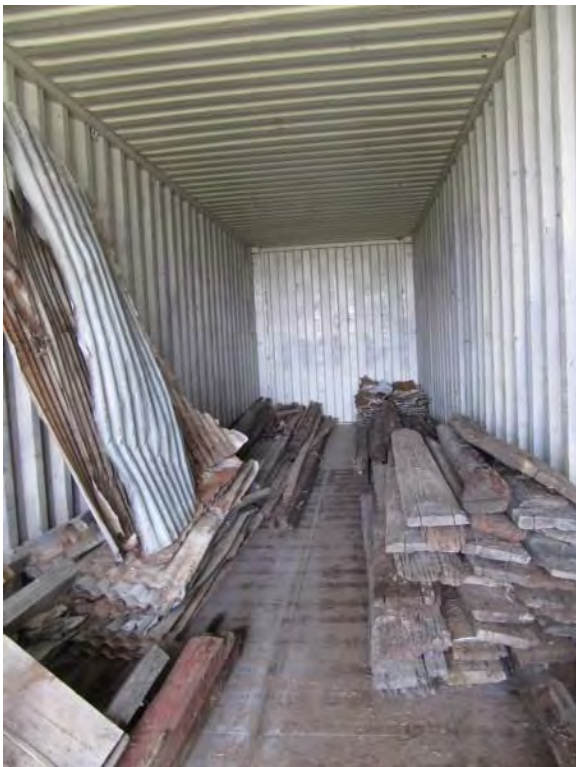
Figure 44 Interior of container used for storage of retrieved building components and fabric from roof and verandah **after** analysis and sorting.

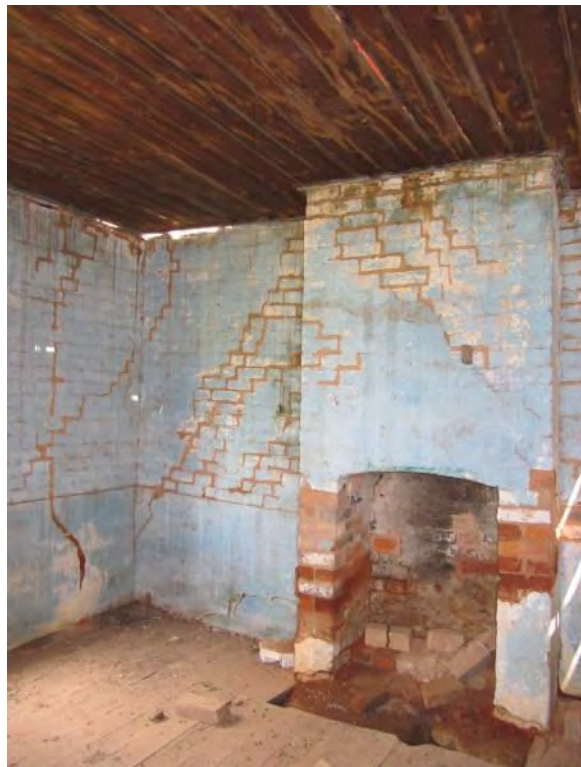
Figure 45 Cleared interior of second room inspected **after** access allowed by removal of tarpaulin and relocation of stored fabric to nearby container.

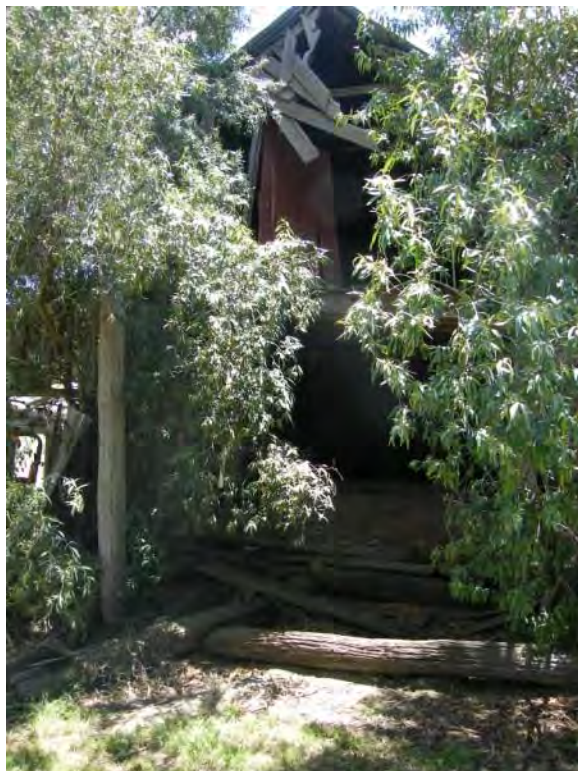
Figure 46 South elevation of Stables **before** works showing invasive plant growth including African Olive and Silky Oak.
