WAMBO COAL PTY LTD

NORTH WAMBO UNDERGROUND MINE

EXTRACTION PLAN
LONGWALLS 8 TO 10A

HERITAGE MANAGEMENT PLAN
LONGWALLS 8 - 10A

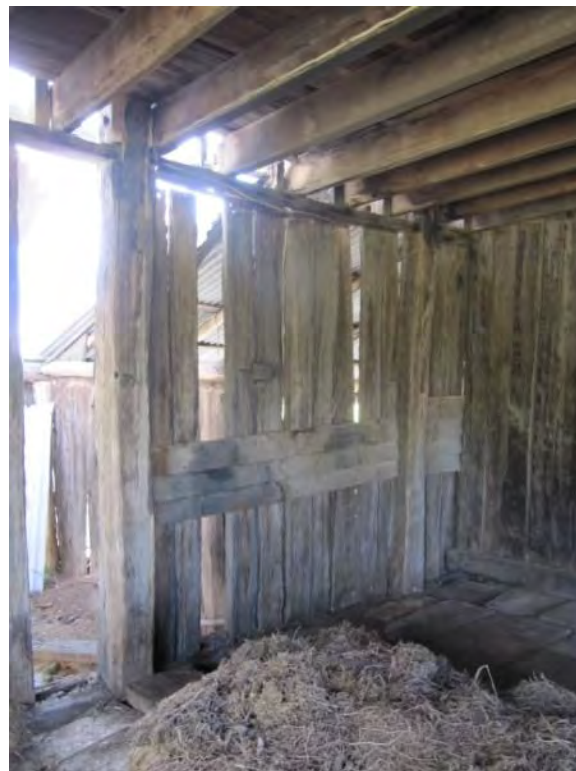
Figure 47 Interior of Stables/Coach House **during** internal clean up (removing stored hay) to allow inspection and stabilisation.

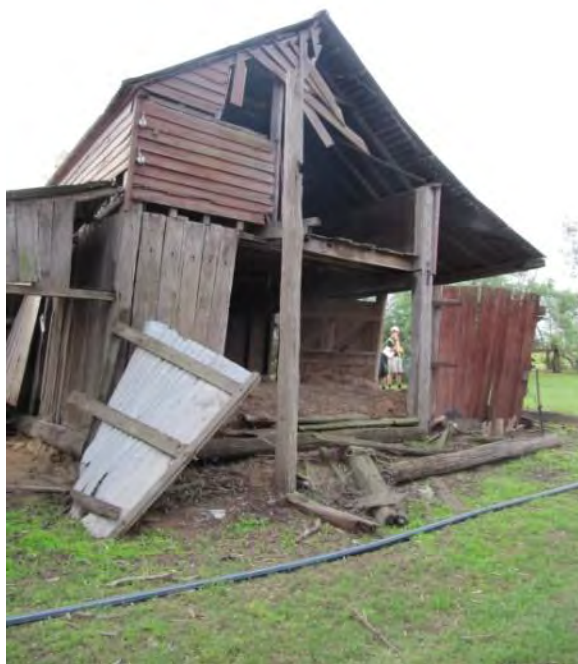
Figure 48 South elevation **after** removal of invasive plantings showing extent/condition of fabric **before** stabilisation works.

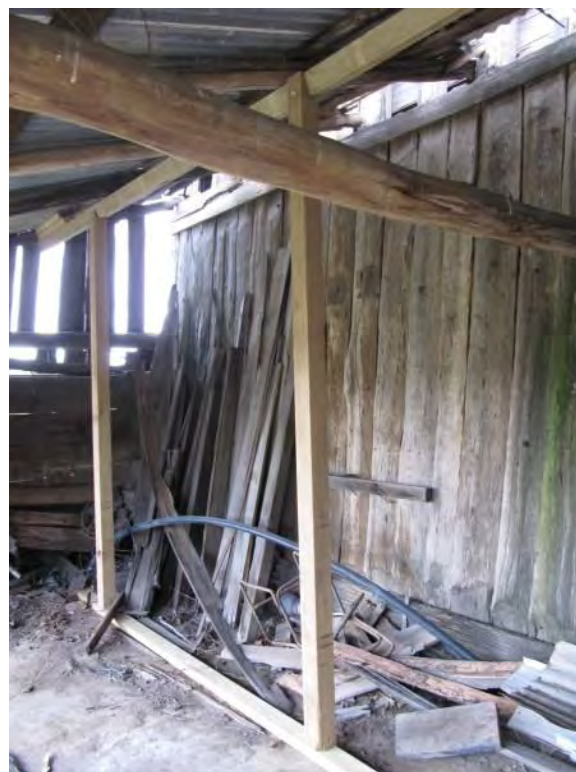
Figure 49 Interior **after** clean up and installation of new timber props to support roof framing showing stockpiled retrieved fabric.

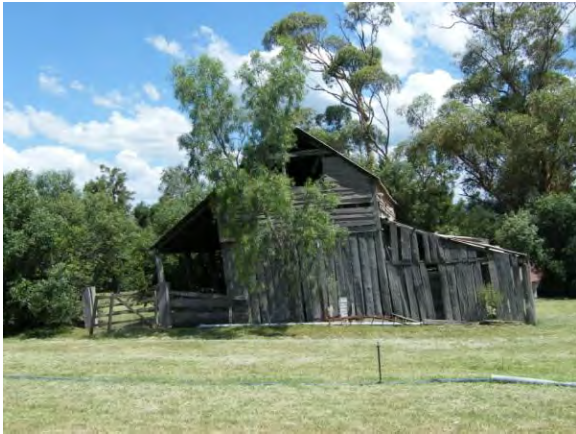
Figure 50 North elevation of Stables/Coach House **before** removal of invasive tree growth (lifting framing), propping and straightening and protection of openings/exposed fabric.

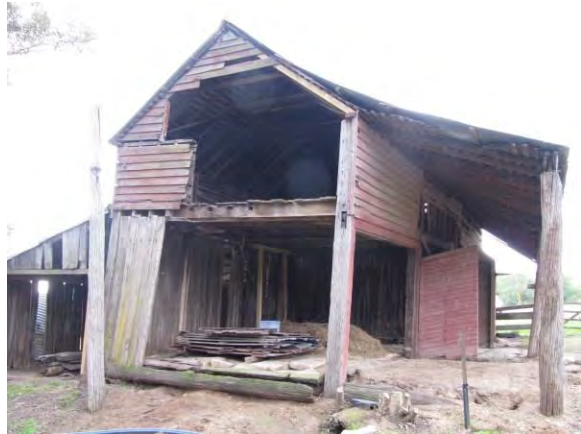
Figure 51 South elevation of Stables/Coach House **after** clearing out and sorting of components but **before** propping and repairs.

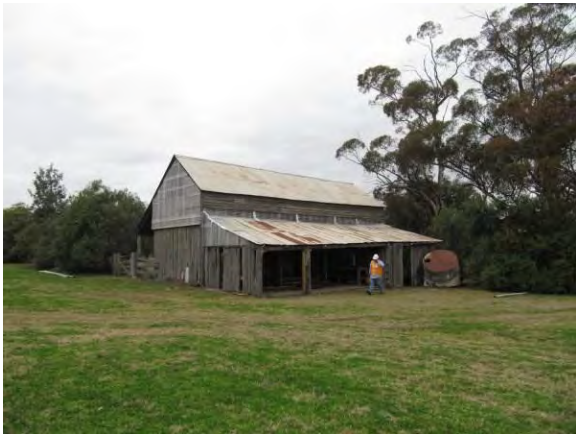
Figure 52 North and west elevations of Stables/Coach House **after** clearing, stabilisation/propping works and installation of new acrylic sheeted water-proofing to provide ventilated weather protection of openings and fabric exposed to weather.

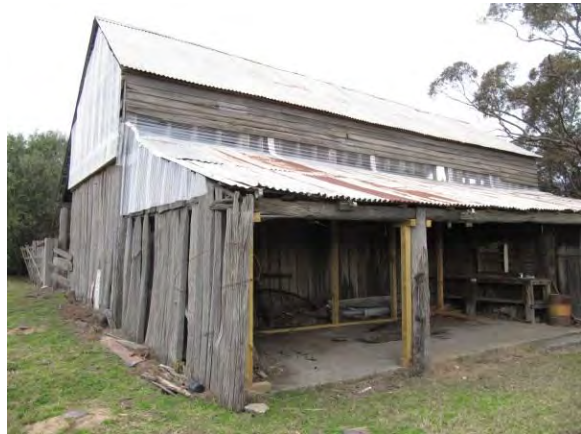
Figure 53 Northwest corner of Stables/Coach House **after** clearing out, stabilisation/propping works and installation of new acrylic sheeted water-proofing to provide ventilated weather protection of openings and fabric exposed to weather showing detailing of works carried out.

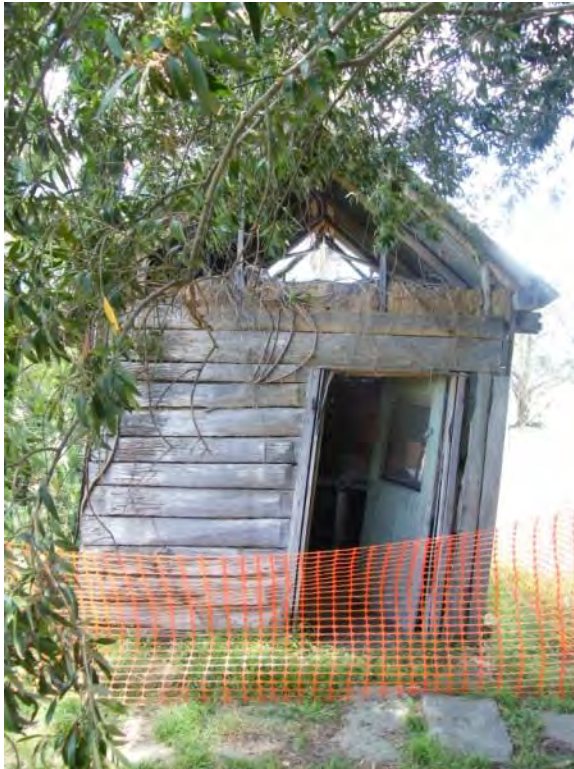
Figure 54 East elevation **before** works.

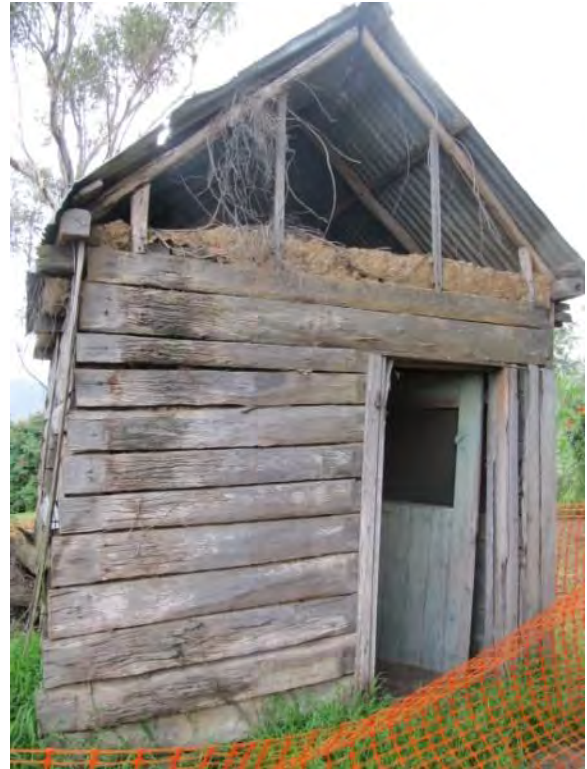
Figure 55 Detail of east elevation **before** works showing old vine growth in roof space (above parging) and timber framing.

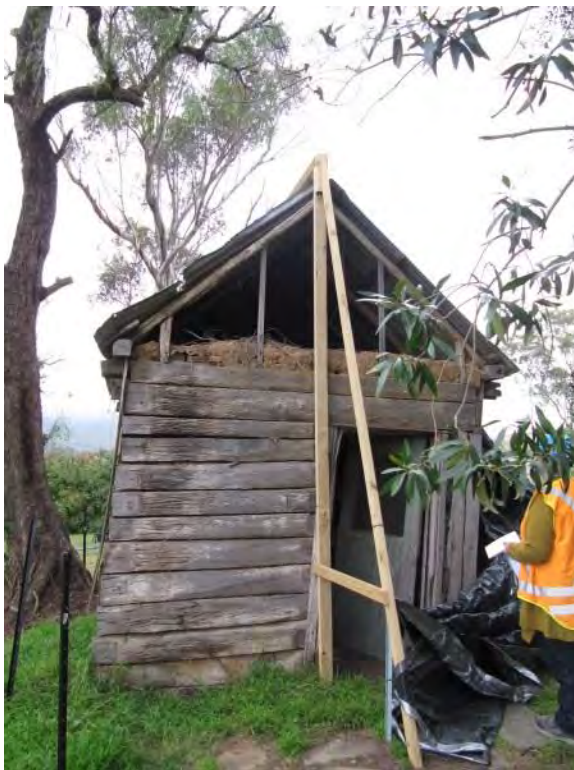
Figure 56 East elevation **after** removal of invasive plant growth and structural propping to support temporary roof covering.

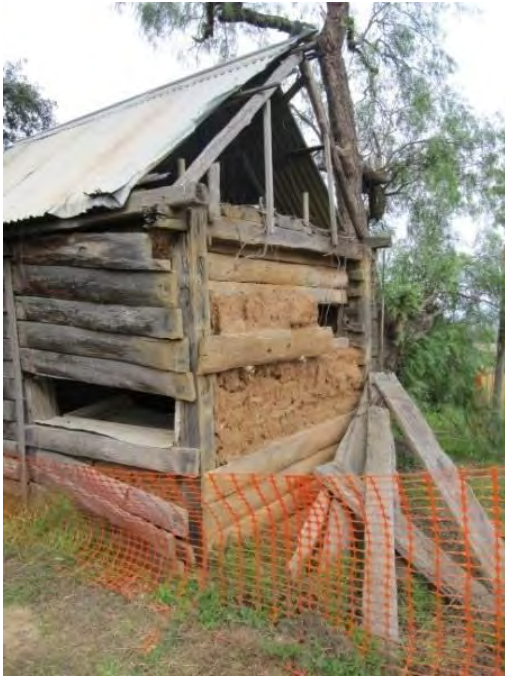
Figure 57 South elevation **after** clearing and stabilisation works, including resecuring loose/fallen slabs and associated joinery.

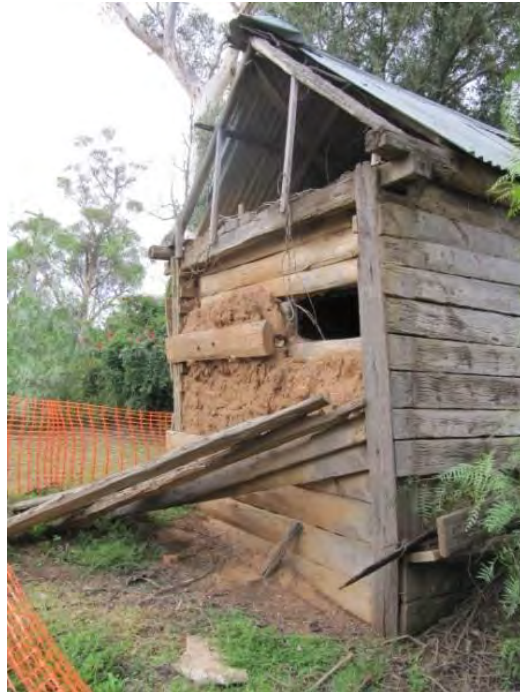
Figure 59 Detail of west elevation **before** works showing fallen wall slabs and mud-clay parging insulation behind.

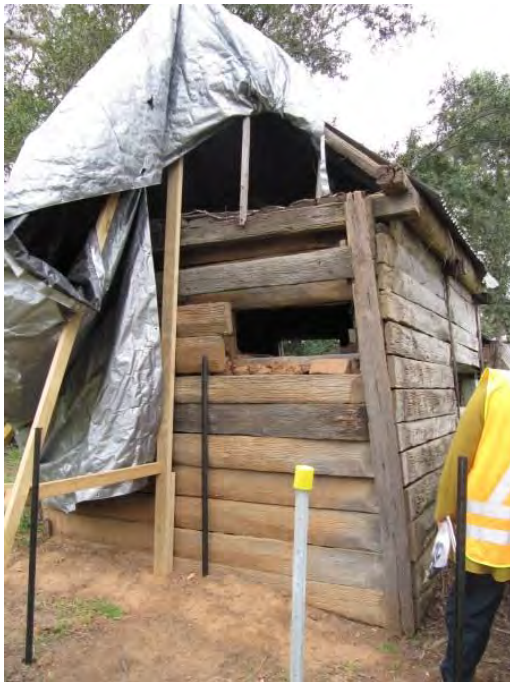
Figure 56 West elevation **after** removal of plant growth, restoration (ie reinstatement) of original timber slabs and parging and new timber props to support temporary roof covering.

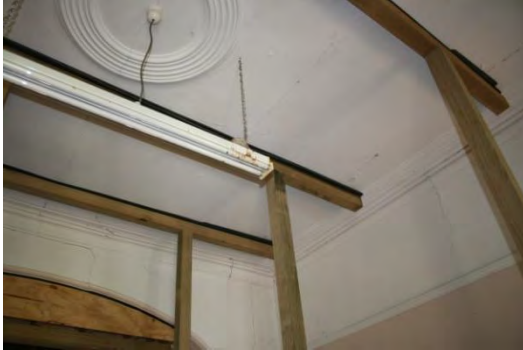
Figure 2 Interior of Drawing Room showing retention and propping of original lath and plaster ceiling and ceiling rose.

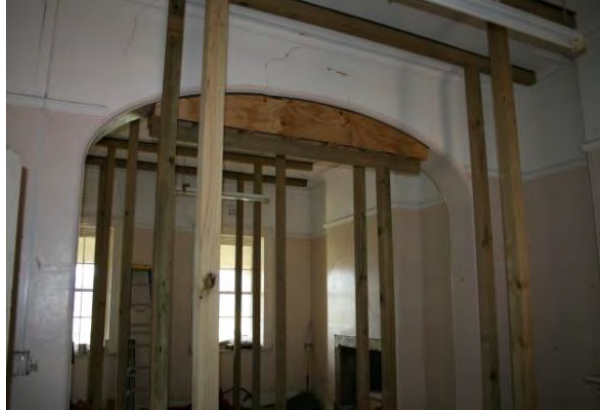
Figure 3 View of propping through whole of Drawing Room interior showing supporting formwork under central archway (looking south).

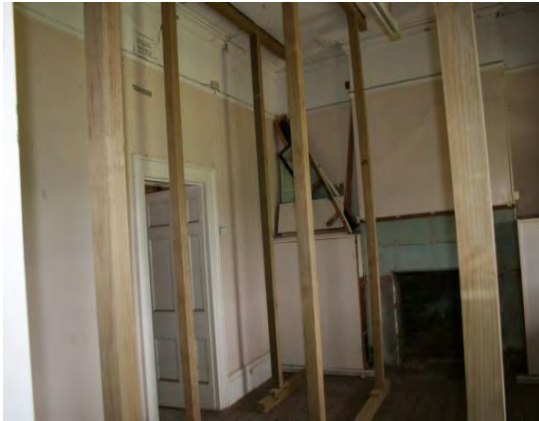
Figure 4 Interior propping of southeast front room looking east to fireplace and original door in north wall.

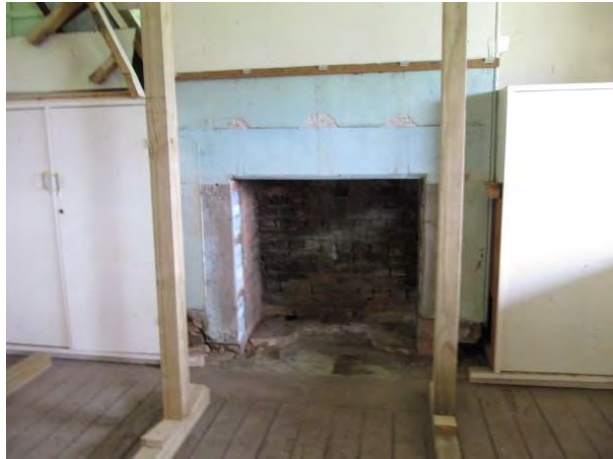
Figure 5 Exposed fireplace opening in east wall of southeast front room following opening up and cleaning of room.

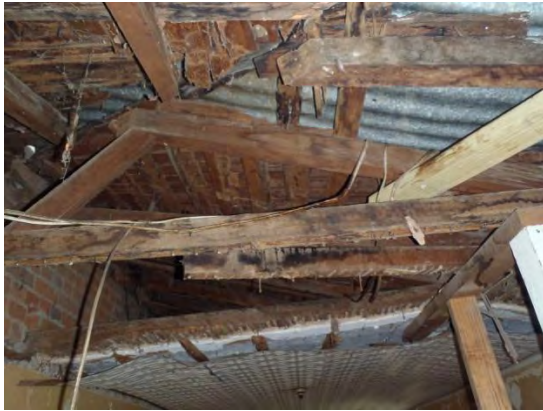
Figure 6 Interior of roof and ceiling framing above rear (north) room showing retained components and fabric (including two ceiling linings) and modern, supplementary bracing (posts and ceiling ties).

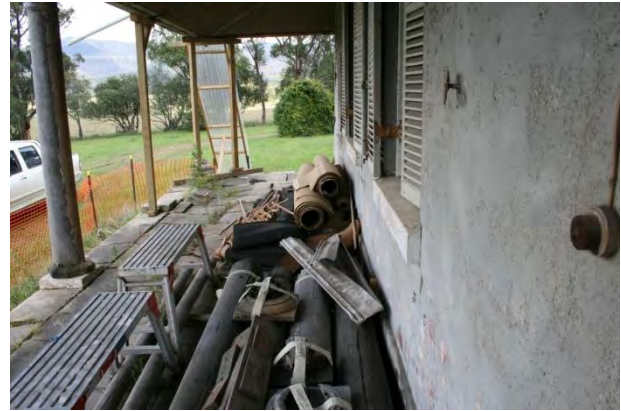
Figure 7 Temporary stock-pile of retrieved components and fabric on front (south) verandah prior during propping works. Components were returned to building for secure, weather-proof storage after completion of internal works.

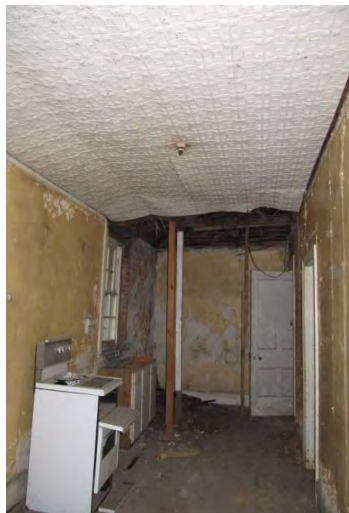
Figure 8 View towards east end of north (rear) room after clearing out and propping of roof and ceiling structure.

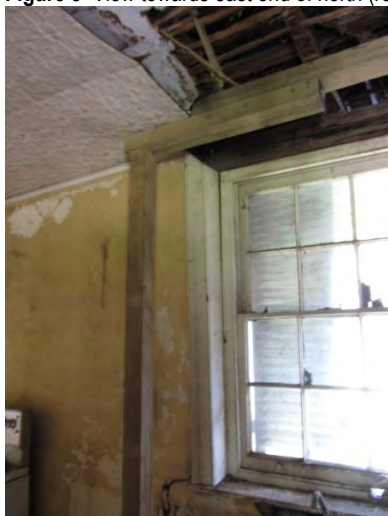
Figure 9 Detail of propped ceiling and roof structure above original window at east end of north (rear) elevation showing retained

evidence of original plaster and pressed metal ceiling linings.

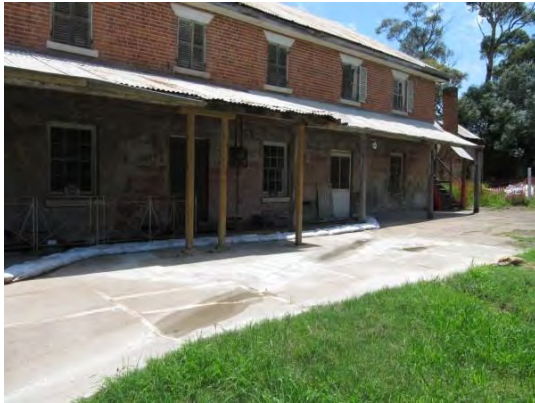
Figure 10 East elevation to northeast courtyard **after** works showing propped verandah framing, repairs to cracked cement paving and sand-bag barrier to prevent water entry to cellar.

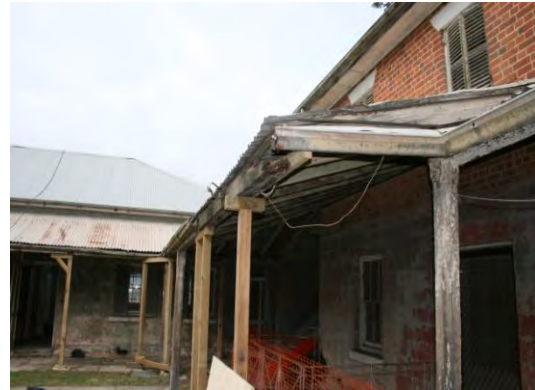
Figure 11 View south along verandah to Kitchen wing **after** propping showing retained building components and fabric.

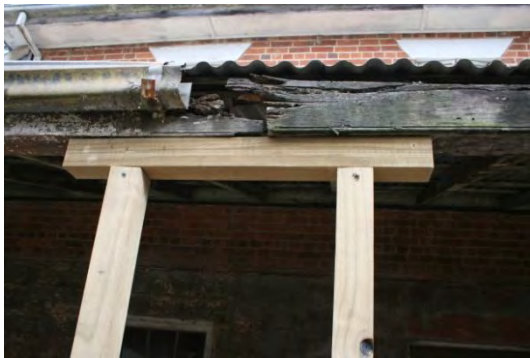
Figure 12 Detail of new propping to east verandah supporting and retaining historical fabric in situ.

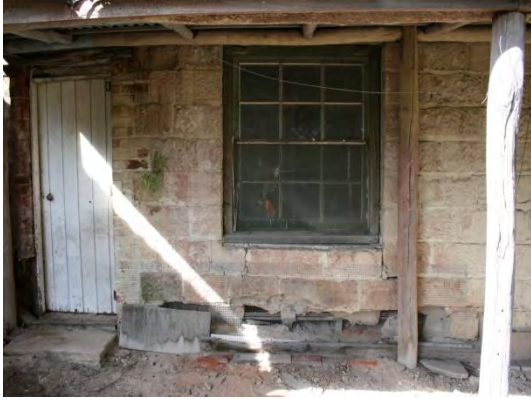
Figure 14 Eroded masonry wall fabric on west elevation of Kitchen Wing due to salt-damp attack **before** repairs.

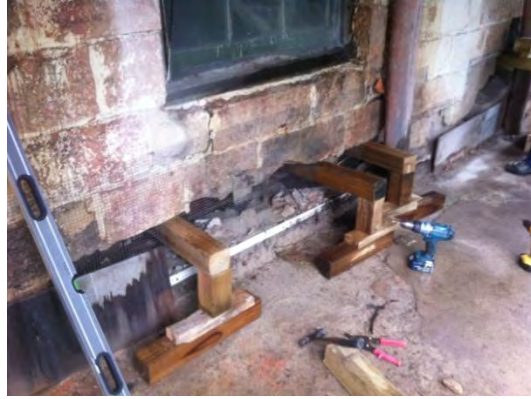
Figure 15 New propping to masonry wall on west elevation of Kitchen Wing to secure structural elements in place.

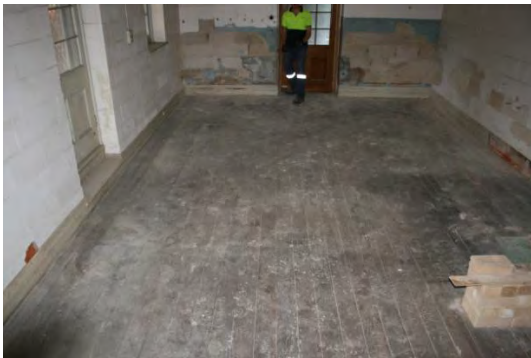
Figure 16 Interior of main ground floor room (south end of Kitchen Wing) **after** removal of modern carpet, veneer dado linings (over salt affected masonry) and associated debris.

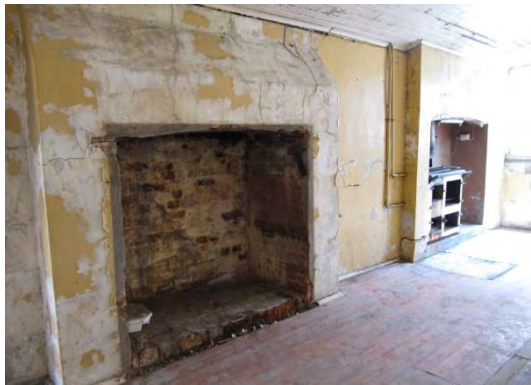
Figure 17 Detail of early and later fireplaces to former Kitchen on west side of Kitchen Wing **after** clean up and securing of fabric.

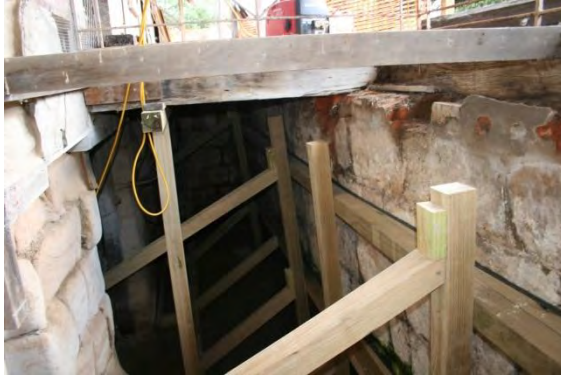
Figure 18 Propping of east retaining wall to Area leading down to cellar/basement below Kitchen Wing after cleaning out and completion of stabilisation works.

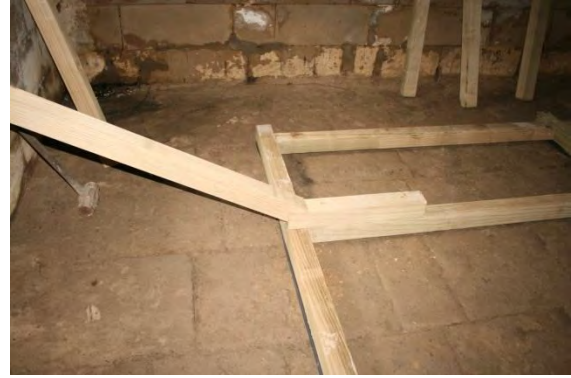
Figure 19 Interior of cellar/basement after cleaning up showing exposed flag stone flooring and new timber props to walls and ceiling.

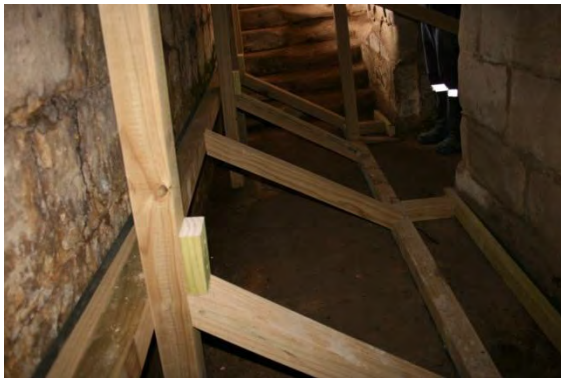
Figure 20 View of newly propped walls to cellar/basement Area looking south towards stone steps (up to courtyard) and entry to cellar on west (right) side **after** completion of works.

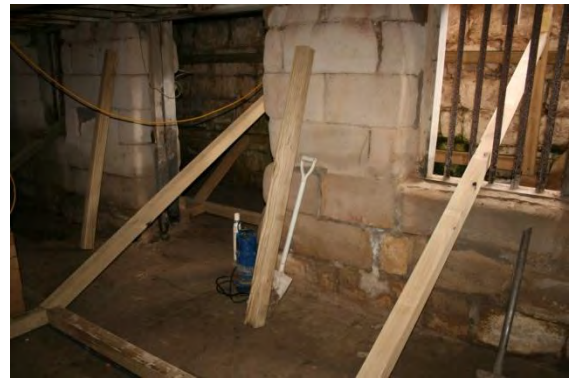
Figure 21 Interior of cellar/basement looking towards east wall with doorway and windows opening into Area. New timber props to Area wall are braced thorough window bars.

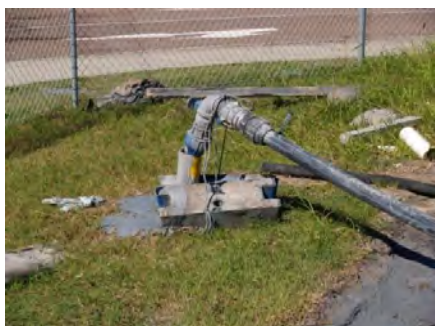
Plate 1: Borehole entrance into underground mining void

- Boreholes would be drilled from the surface into the Homestead Underground Mine voids.
- Boreholes would be cased and capped for the duration of the project to reduce potential water inflow to the Homestead Underground Mine voids.
- The seal and backfill material would be mixed and prepared at the surface.
- To ensure containment of the backfill a sealer material would be pumped into the Homestead Underground Mine voids through the boreholes.
- After the mine is sealed a backfill mixture would be injected via the boreholes into the Homestead Underground Mine voids (Plate 1).
- The backfill mixture would disperse within the Homestead Underground Mine voids to a designated level (Plates 2 and 3).
- On completion the boreholes would be surveyed and assessed to ensure the relevant Homestead Underground Mine voids are adequately filled and stabilised.

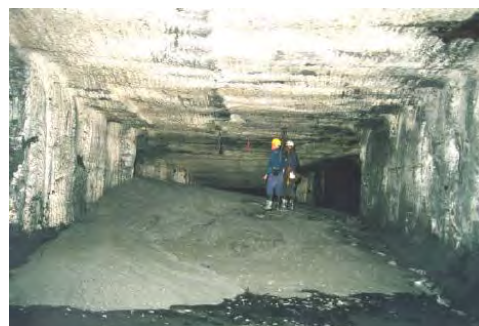
Plate 2: Inside mining void during filling operations

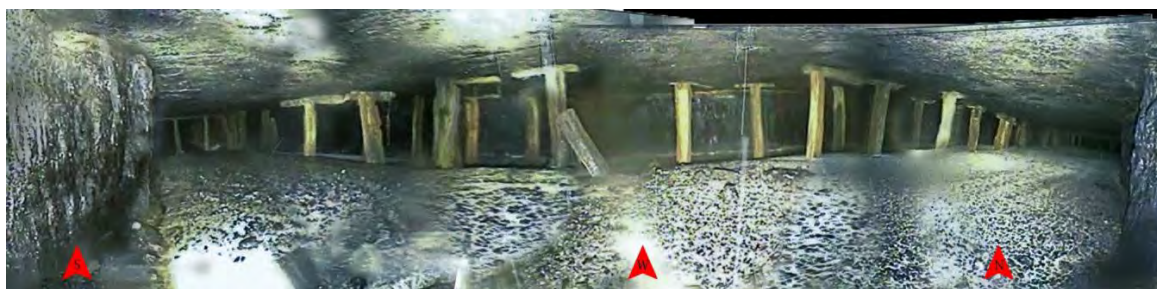
Plate 3: Mining void during filling operations
