WILPINJONG COAL PROJECT

WILPINJONG COAL PROJECT NON-ABORIGINAL HERITAGE IMPACT ASSESSMENT

Dr Michael Pearson

Heritage Management Consultants Pty Ltd

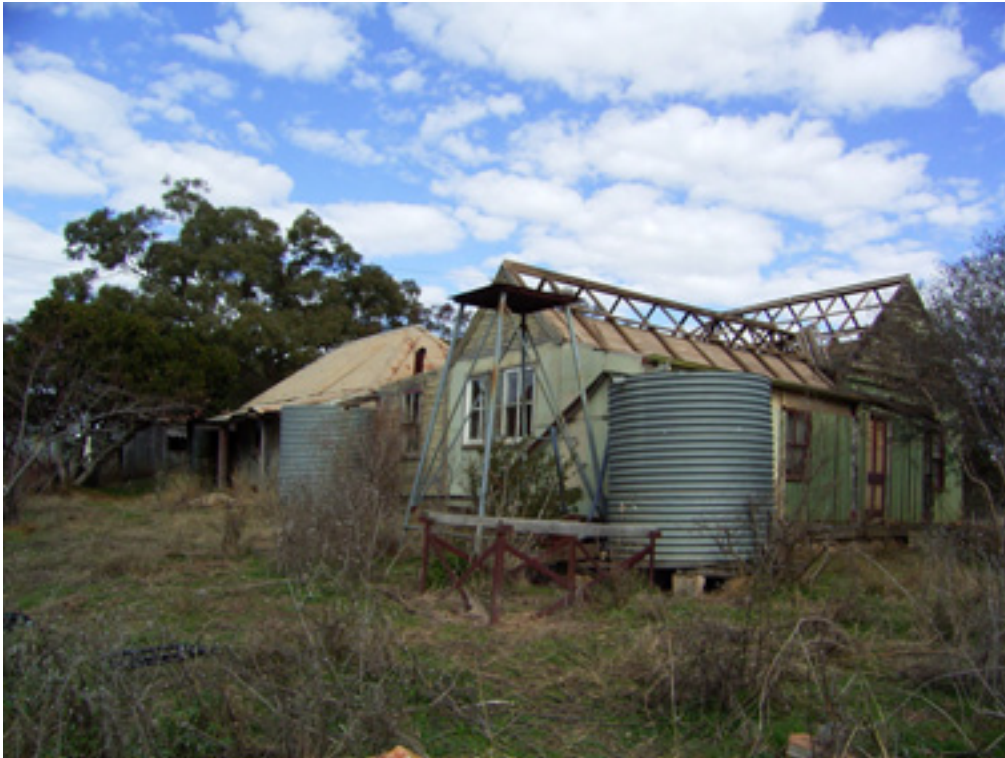
Plate GA-1: Hillside View 1

The middle building is the original two-room slab cottage (Plate GA-2). This abuts the infilled 'L' of the northern building at an angle of about 4°-5°, the resulting gap being infilled with makeshift walls and roofing. The slab walls sit on timber plates, retained in place by nailed timber battens.

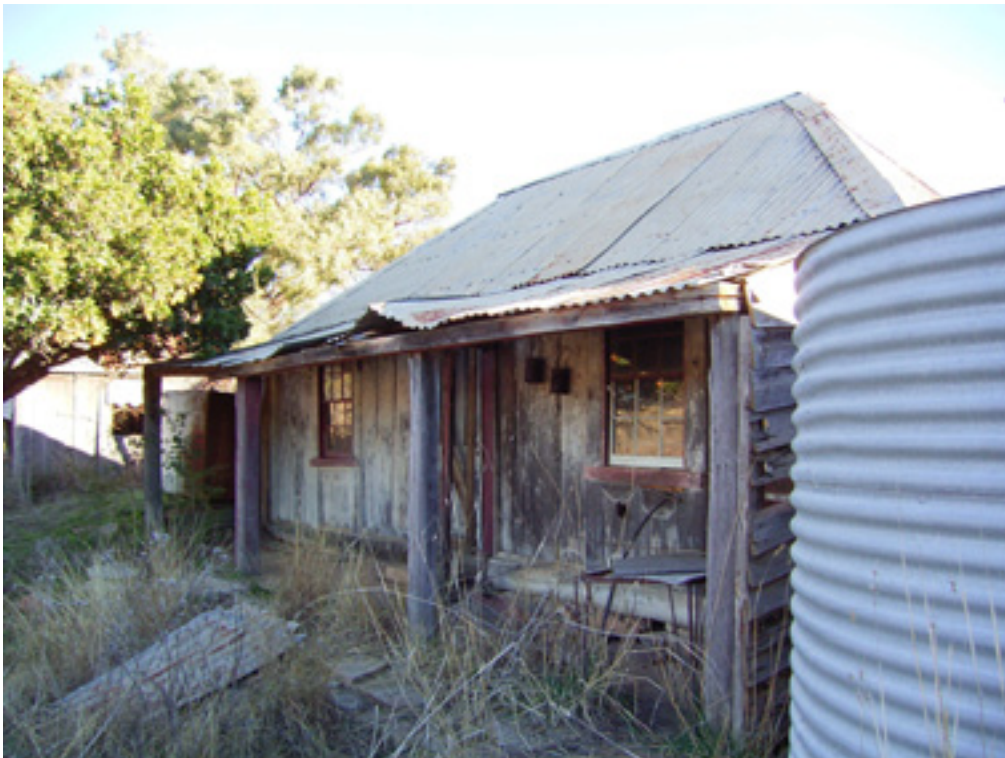
Plate GA-2: Hillside Slab Cottage

The wall plates rest on stone foundation walls that have been constructed to deal with the sloping block. The slabs are cut from the outside of the log, with rounded exterior faces. The internal wall and ceiling lining is white-ant eaten, and covered with fibro sheet. The southern wall has fallen out, and the floor covering the cellar beneath the southern room has rotted and is covered with plywood sheet. The stone-walled cellar extends the full dimensions of the southern room (3 x 4m), and is 2m deep, and is clear and accessible (Plate GA-3). The corrugated iron roof on a round timber frame is intact. A flagged and partly-cemented verandah extends along the eastern side, and the verandah along the western side has been enclosed and extended to join the northern building. A ship-tank water tanks sits south of the building, and a cylindrical corrugated iron tank to the north.

The *Hillside* cottage group is in poor condition, with the roof on one building removed, several collapsed walls, rotten flooring, and white-ant eaten wall and roof members and cladding. The wool shed is in good condition, the slab shed in fair condition, and the corrugated iron shed in poor condition.

The *Hillside* cottage group is located on the edge of proposed Pit 4, while the woolshed group is located further within the pit area. The poor condition of the cottage group is such that conservation would be difficult technically and is not justifiable economically. The likely impact of the closely adjacent pit (eg. through blasting vibration) would also be a risk to any buildings if they were to be conserved in this location. There is no immediate requirement to demolish the group, but if demolition does occur, there is a potential for the re-use of the timber slabs, which might be offered to local owners to the Council and Mudgee Museum for conservation work elsewhere.

The *Hillside* cottage group has been recorded photographically and documented to the Heritage Office standard applying to places of local significance as a precaution before further deterioration occurs.

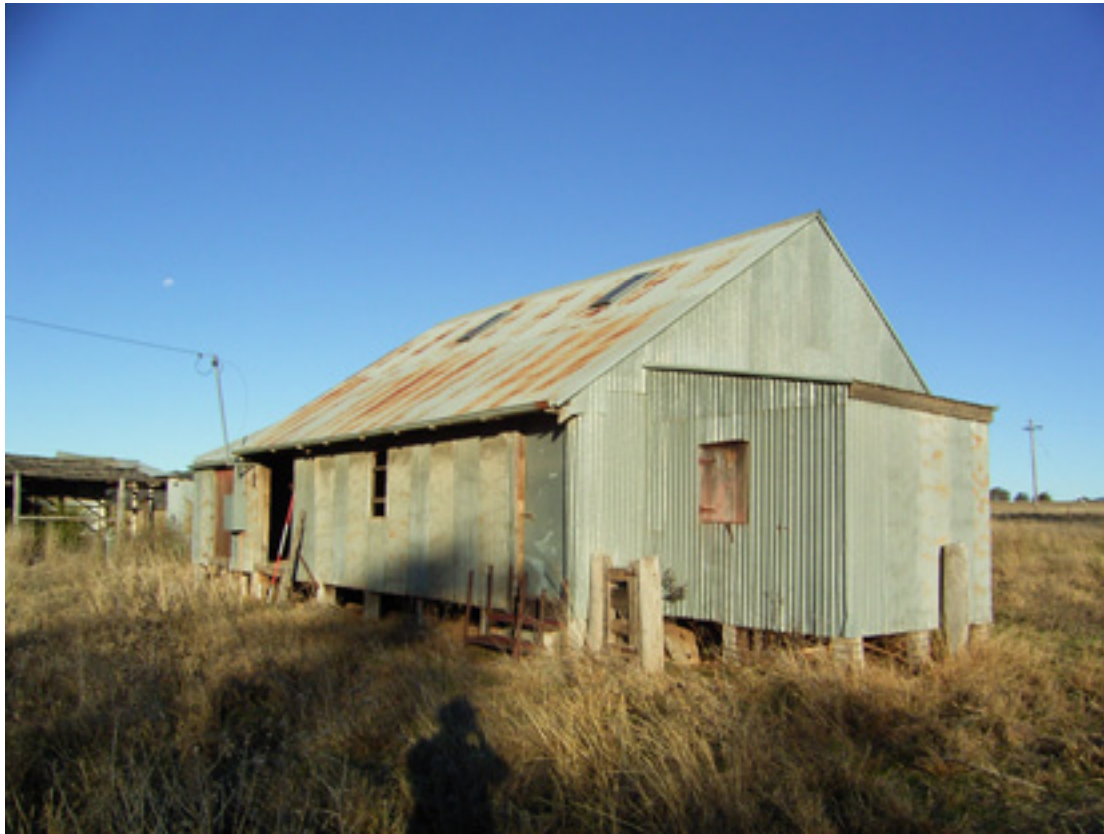
Plate GA-4: Hillside Woolshed

The woolshed group consists of a corrugated galvanised iron 'L'-shaped 2-stand woolshed, a slab shed raised on timber stumps, and a corrugated iron shed and skillion in semi-collapsing condition (Plate GA-4).

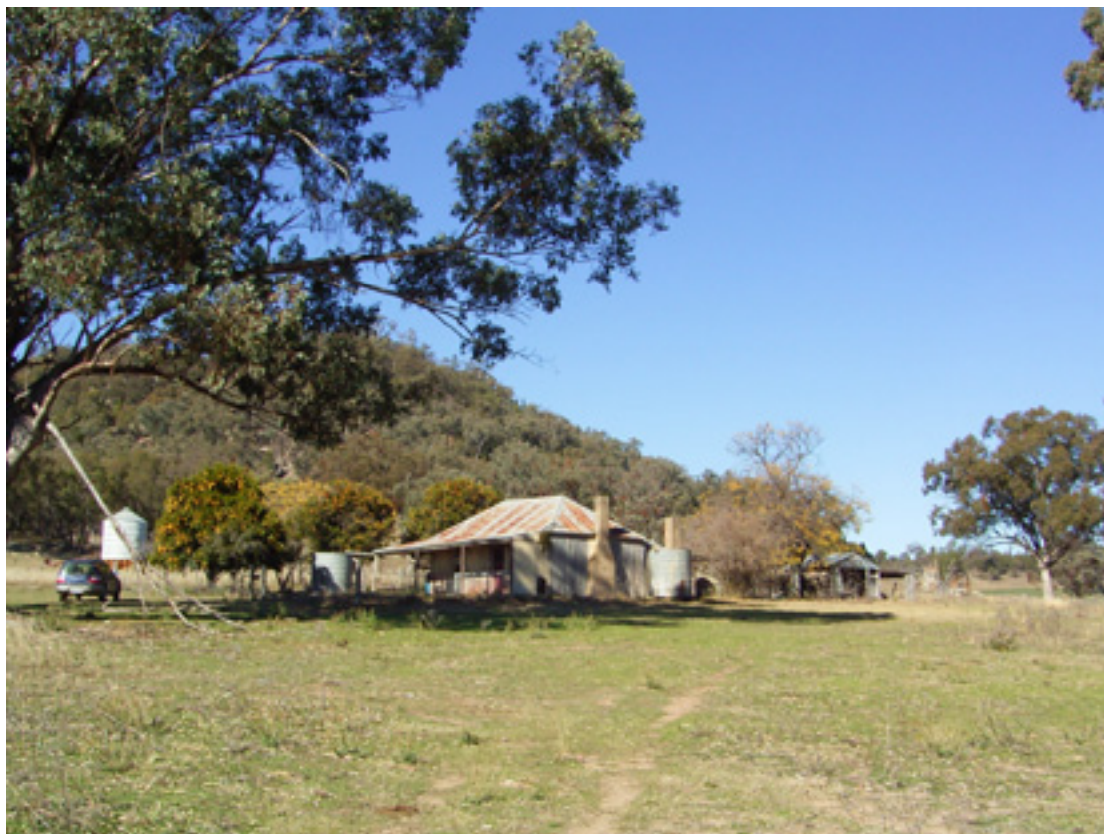
Plate GA-5: Warrawong

The slab cottage is believed to have been built at the junction of Cumbo Creek and Wilpinjong Creek, on the Marskell's *Cumbo Creek* block (on Portion 3, Parish Cumbo), and moved by John and Catherine Marskell to the *Warrawong* block in 1912, when the *Cumbo Creek* cottage was built. This suggests Marskell controlled the *Warrawong* block by that date. The Marskell family remained in residence at Warrawong until 1968, the last occupants being Ted Marskell, and then his widow. Jack and Lyn Robinson bought this block in 1972, and have used it as a weekender since¹⁴ (Plate GA-5).

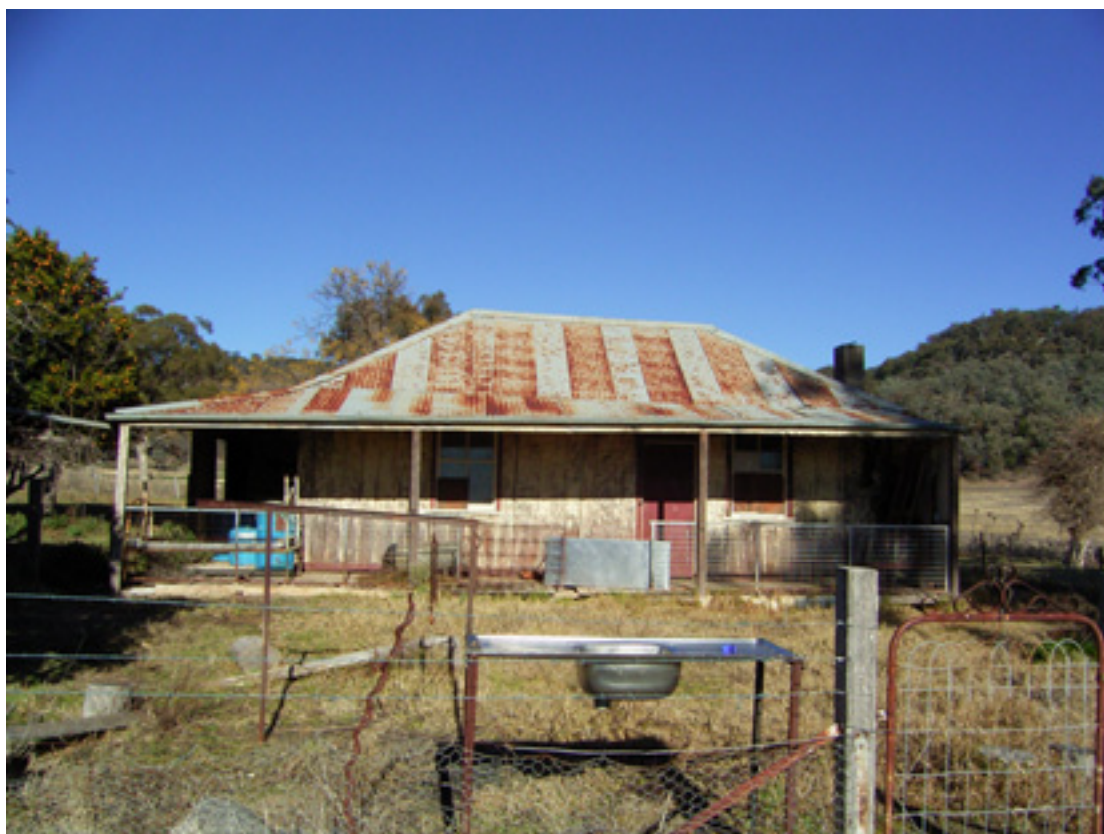
Plate GA-6: Warrawong

The Warrawong cottage is a three-room slab cottage with a slab skillion bath/laundry extension (Plate GA-6 and Plans GA-3 and GA-4). The vertical slabs are up to 400mm wide, skew-nailed to squared-timber bottom and top plates without battens, clearly indicating the relocation of the structure. The squared corner posts are 230mm square. Internal walls and ceilings are fibro clad (presumably relacing white-ant eaten timber cladding), and the floor is timber boards. The roof is corrugated galvanised iron. A skillion-roofed verandah is located on the northern and eastern sides, the eastern side enclosed with fibro sheeting. A rear (southern) verandah has a concrete slab floor.

The Warrawong cottage is in fair to good condition, apart from extensive wombat burrows undermining the rear walls and verandah. The sheds and yards are in poor condition.

Warrawong is located within the southern limits of the proposed footprint of Pit 2, and is therefore likely to be destroyed. However, as development of this section of Pit 2 may be later in the mine life, there is no urgency in action concerning the cottage. It is recommended that demolition should not be undertaken until a firm and committed plan and timeframe for mining is fixed, in case any changes in-pit footprint allows the building to remain. If demolition is undertaken, the slabs should be offered to the Robinson family and the Mudgee historical society for use in the conservation of other buildings.

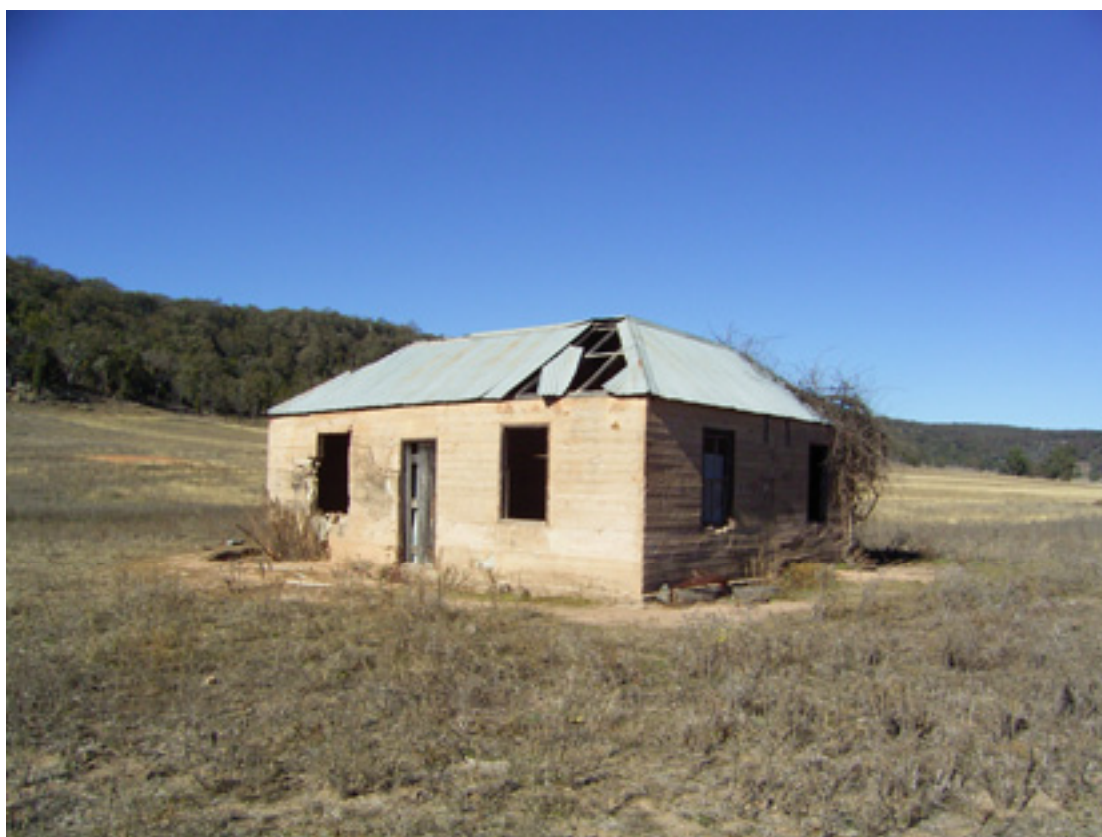
Plate GA-8: Atchesons Cottage

The three-roomed cottage has formwork concrete walls with a collapsed timber skillion kitchen at the rear (Plate GA-8 and Plan GA-5). The cottage has a corrugated galvanised iron roof on a pole frame, and has been stripped of all lining materials and window timbering. Beer bottles dating to 1949-1965 are scattered near the cottage walls. A dead vine over the south-west corner of the building suggests at least some earlier garden plantings, though the building now sits in a cleared paddock.

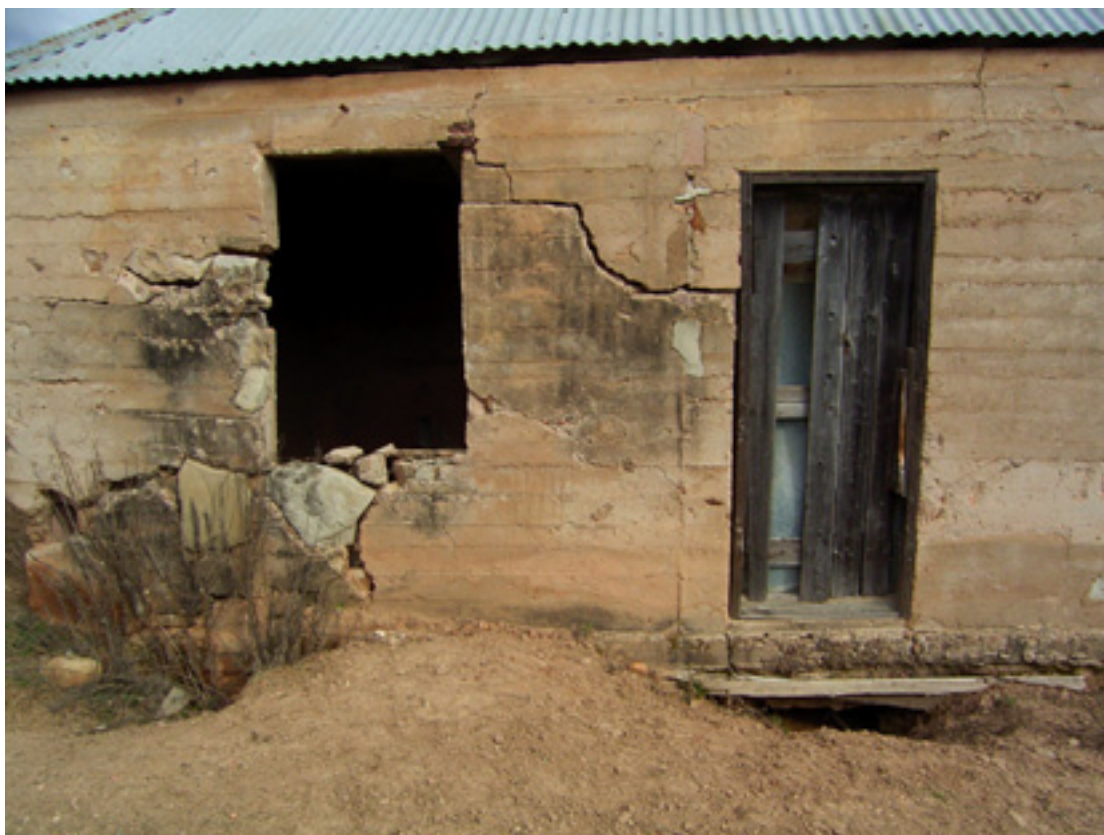
Plate GA-9: Achesons Cottage

The cottage is in poor condition. The concrete walls are undermined by wombat burrows at the north-eastern corner, and the corner has subsided causing major cracking on the northern and eastern walls (Plate GA-9). Roofing iron is coming off, and all interior lining has been removed.

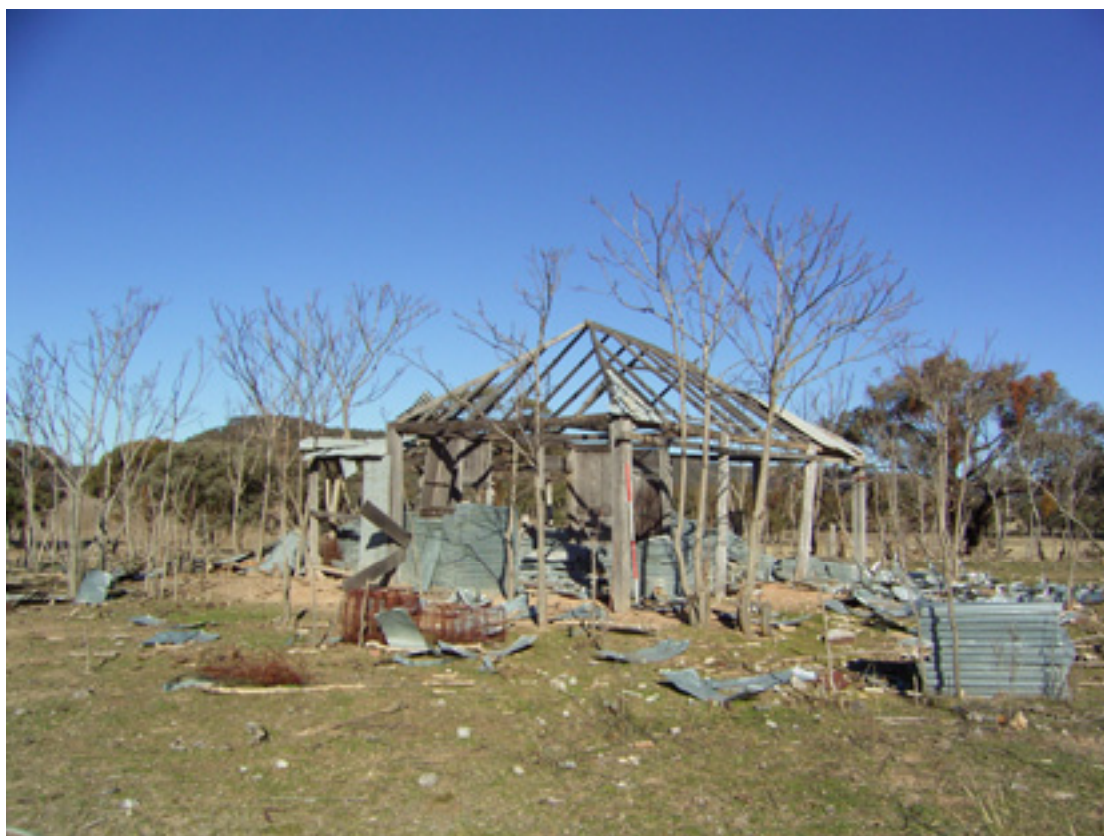
Plate GA-10: Loy’s Cottage

The collapsing ruin of a vertical slab cottage on portion 13 is a two or three-roomed cottage, with a frame of squared timber with vertical slab walls and a verandah on the eastern side (Plate GA-10 and Plan GA-6). Only one small section of an internal slab wall remains standing.

The cottage is in very poor condition, on the verge of total collapse (Plate GA-10). It is beyond conservation as a building. The group of former building sites is however, an interesting archaeological site.

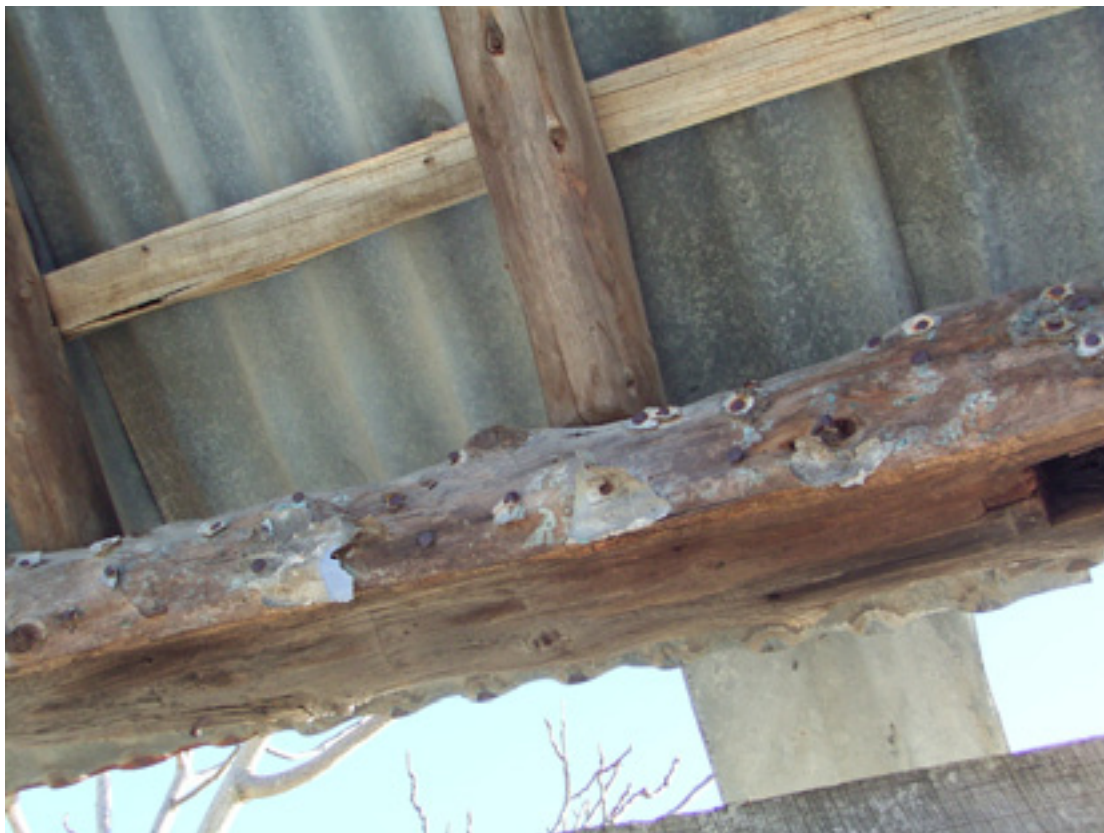
Plate GA-11: Loy's Cottage Ceiling Cloth

The Corrugated iron roof has almost all blown off, and the timber floor has largely failed. Remnants of nails and cloth along the edge of the top-plate indicate that a ceiling cloth was used in the rooms (Plate GA-11), and the remaining original verandah posts have chamfered profile, indicating a domestic use of the building. Joinery of the remaining window frames utilises tusked mortice and tenon joints. The cottage has subsequently been converted to a small shearing shed, with sections of the wall being converted to gates and chutes. More recently it has been used as a geological core store, with a jumble of core trays and cores across the floors.

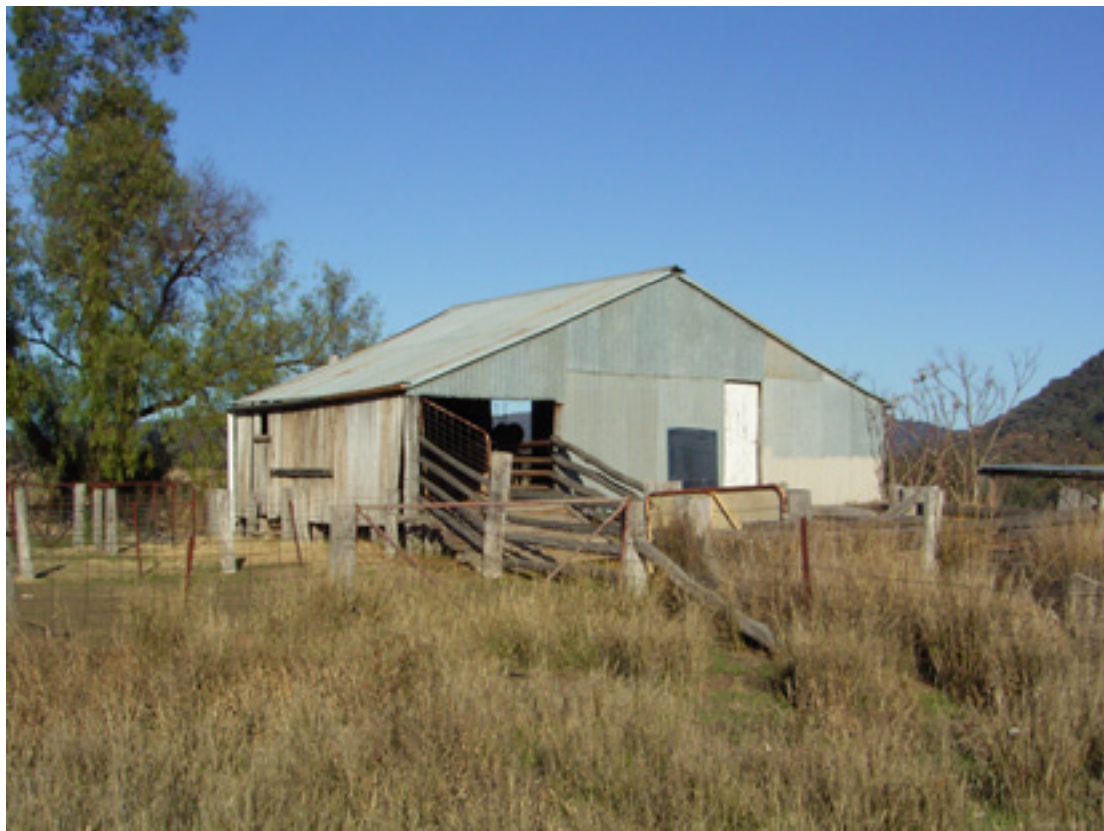
Plate GA-12: Pine Park Woolshed

William Lennox purchased Portion 151, parish Cumbo, in 1889, the block being forfeited to the Bank of NSW by 1932. A cottage was built on the block at some stage, being nothing but a ruined site by the 1980s. The two-stand woolshed (Plate GA-12) , believed to date to the 1930s, is said to have been used as ‘depot’ shed by a number of local small-holders who did not have their own shearing sheds.¹⁹

The woolshed is in fair condition. The yards are in poor condition.

The *Pine Park* woolshed is not directly impacted by pit development. However, if the *Pine Park* property is to be vacated, as is believed to be the case, the shed is likely to deteriorate without any active use, and even if moth-balled will be separated from its traditional landuse.

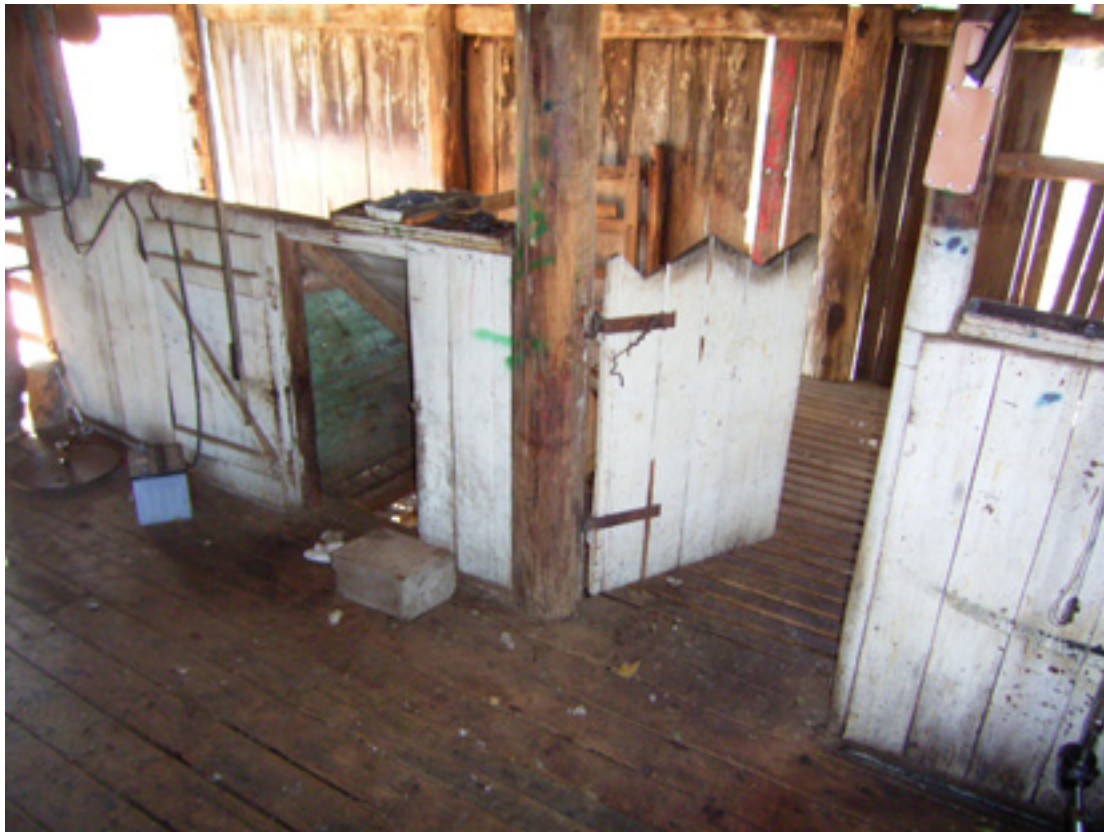
Plate GA-13: Pine Park Woolshed – Internal Detail

The sheep chutes at each of the two shearing stands is a timber framed and clad angled box penetrating the floor of the centre of the shed (Plate GA-13), ejecting the shorn sheep beneath the raised sheep pens and out into the yards. The pens area within the shed is limited, most of the space of the shed being taken up by the sorting table, board, wool press and wool bins. The engine for the shearing machinery is located outside the shed, driving a line shaft supported by an external post. A concrete sheep dip runs south from the shed, sheep being able to be directed into the dip straight from the shed or the adjacent yards.

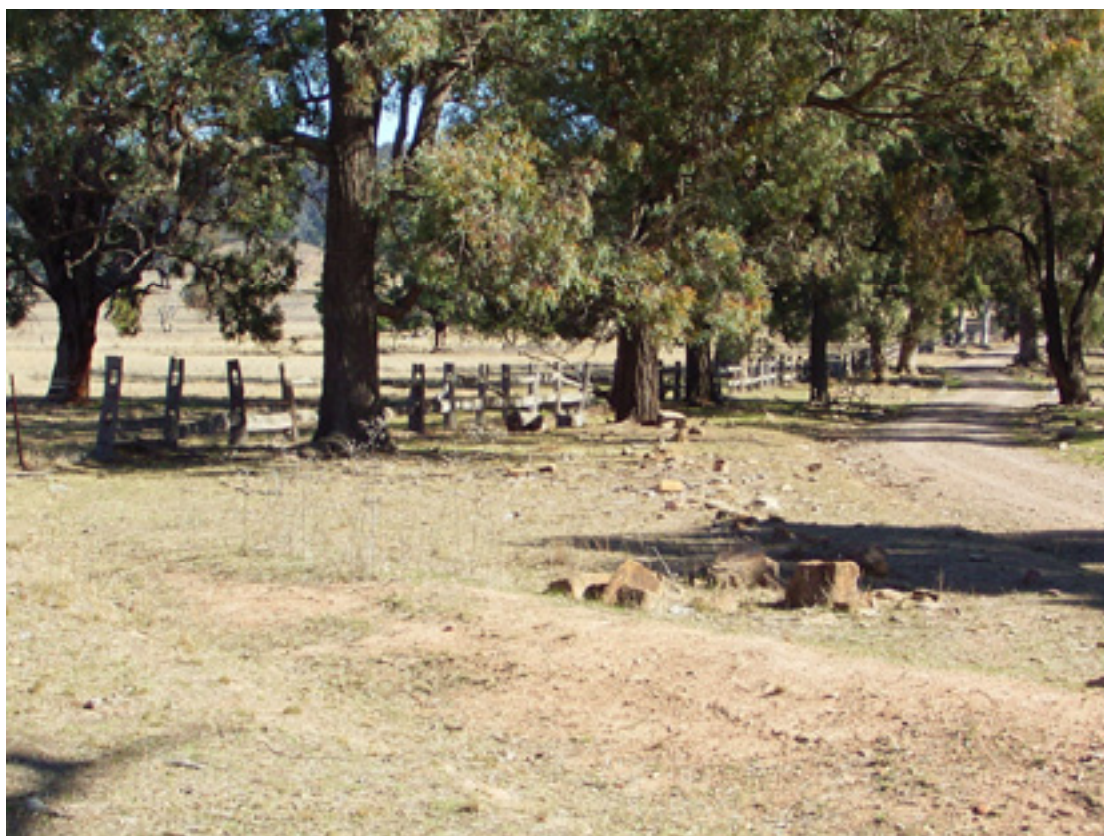
Plate GA-14: Post and Rail Fence

The line between these portions was a public roadway, the fence marking the southern side of the road reserve (Plate GA-14). However, the exact date of its construction is not known.

The fence is located in the area of the ROM Pad, tailings dam, rail loop and mine facilities area, and would be destroyed by the Project. The fence is so deteriorated as to be beyond conservation, and its timbers are of no value for re-use. The fence has been recorded photographically and documented to the Heritage Office standard applying to places of local significance.

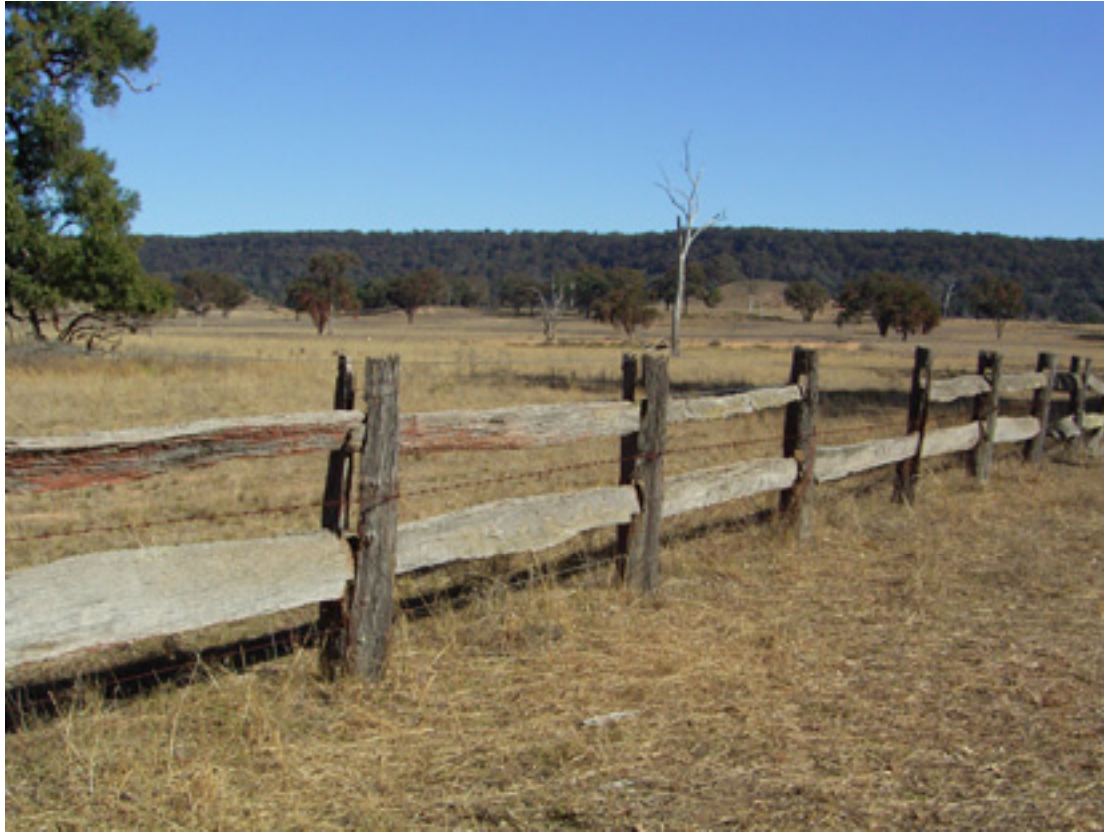
Plate GA-15: Post and Rail Fence - Detail

The fence has timber posts morticed to take two rails (Plate GA-15). Wire has been run along the posts to try to extend the fence's life and make it stock proof. As the fence runs along a public road reserve, a line of trees parallels the fence, adding to the rural landscape aesthetic of the fence.

The fence is in poor condition. Many of the posts are split, and many rails are missing, fallen or sagging. The easternmost 370 m is in the best condition (Plate GA-15), while the remainder has very low integrity, with many sections missing.

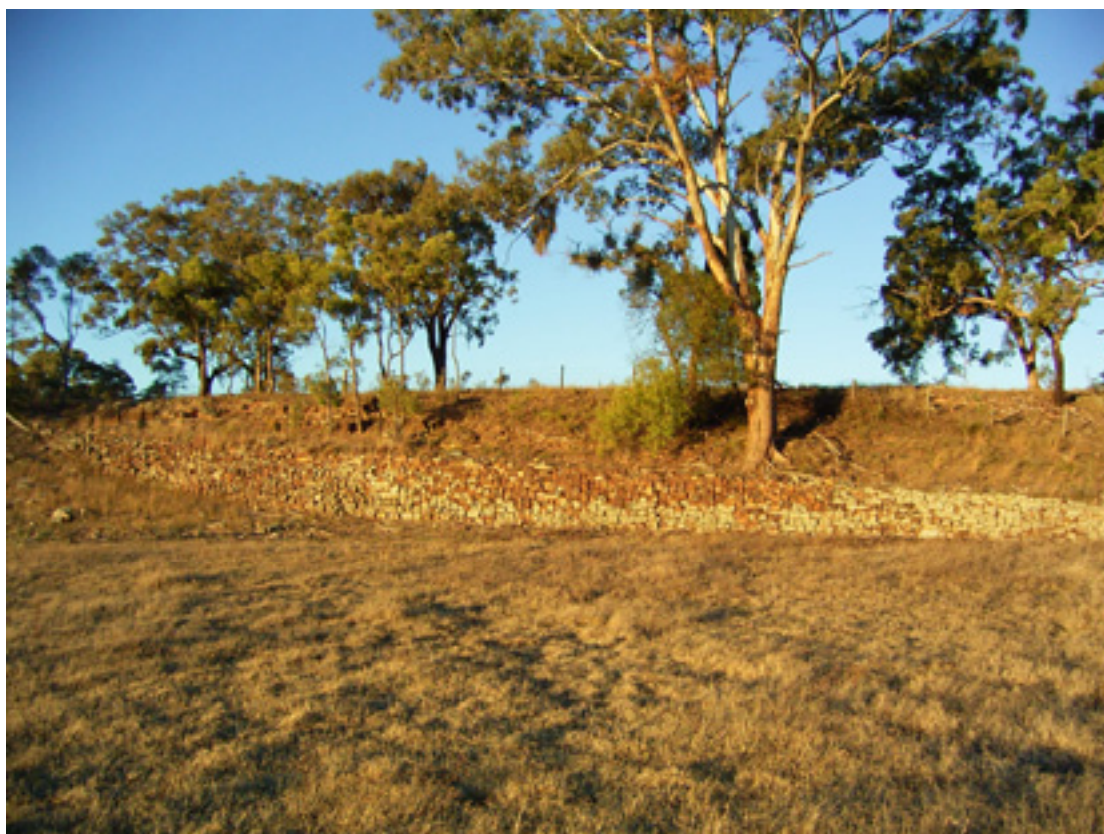
Plate GA-16: Stone Embankment

The stone road embankment on Wilpinjong Road in portion 26, Parish Cumbo (Plate GA-16), has not been dated. The roadway existed by the time of the first parish map in 1884, and had become a gazetted public road by the parish map of 1908.²¹ It was built before the memory of anybody interviewed for this report, so was in place by at least the 1930s, and probably much earlier, perhaps being late 19th century in date.

The stone embankment is in good condition, with some bulging and other signs of movement at the northern end.

The stone embankment is on the alignment of the proposed Mine Access Road. Major road improvements or heavy traffic would very likely lead to the destruction or destabilisation of the embankment. It is recommended that the alignment of the Mine Access road be reconsidered to see if the stone embankment can be avoided. As the stone embankment is close to where the proposed new road meets the existing Wilpinjong Road alignment, it may be possible to slightly angle the new road from the Wollar Road, and join the Wilpinjong Road alignment north of the stone embankment.

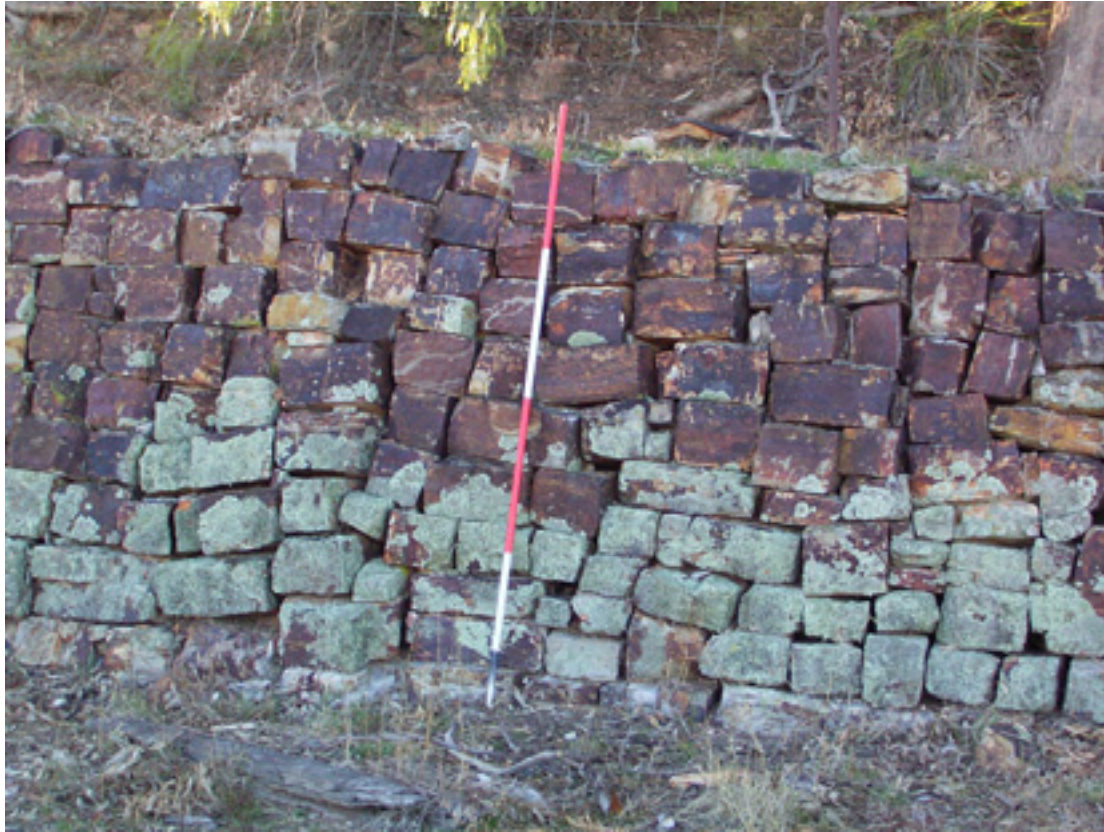
Plate GA-17: Stone Embankment - Detail

The stone road embankment is the down-slope retaining wall of the road as it climbs out of a tributary of Cumbo Creek, up a steep natural bank. The rock has been cut from the up-slope cutting, and the natural cleavage lines of the rock has provided squared stones that have been laid in un-coursed random rubble form to create an embankment 43 m long and 2.5 m high at its highest point. The natural regularity of the stone results in a perception that the stonework is laid better than it actually is. The stone is not coursed, and there are vertical joint lines that are inherently unstable (Plate GA-17). It is not the work of a professional stone mason or even a skilled rural stone worker. Yet it has survived and is an impressive sight.
