# WILPINJONG COAL MINE

## ANNUAL ENVIRONMENTAL MANAGEMENT REPORT

February 2012

**Annual Environmental Management Report**  
1 January 2011 - 31 December 2011

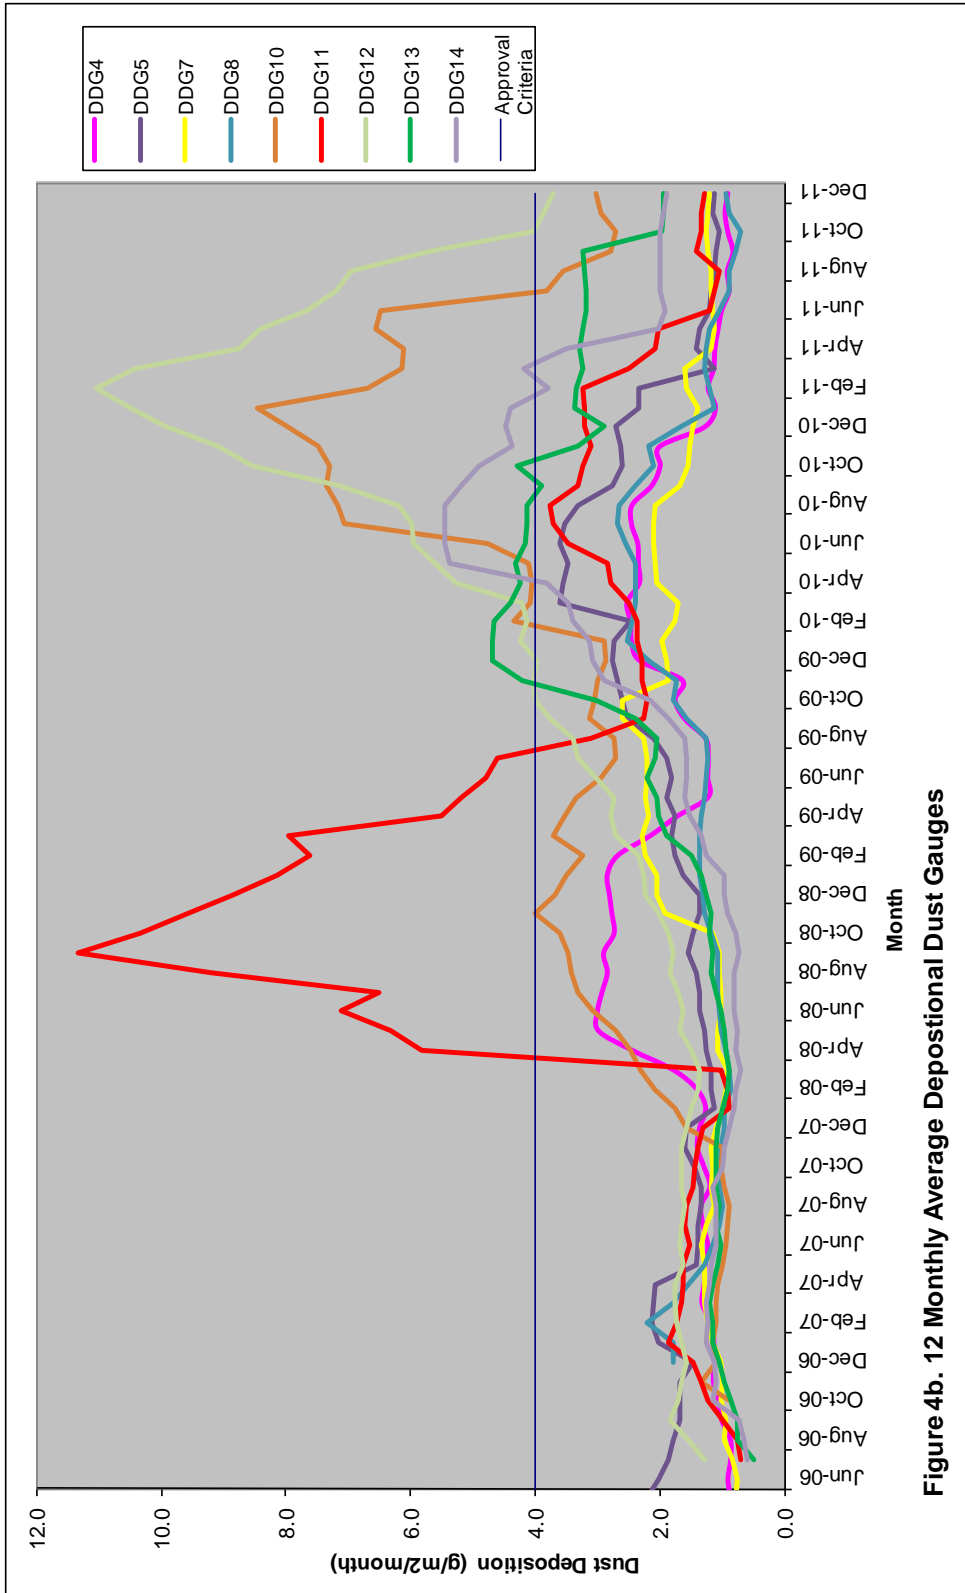
Figure 4b. 12 Monthly Average Depositional Dust Gauges

Figure 4b shows the 12 monthly average for each DDG since June 2006.

It was noted during the reporting period that average dust levels at DG10, DG12 and DG14 were trending above the criteria for annual maximum total deposited dust levels. Upon identification of this trend, the air quality monitoring protocol was implemented. The investigation involved consideration of previous monitoring results in conjunction with prevailing and preceding conditions relevant to the location of DG10, DG12 and DG14. The investigations concluded the following:

- DG10 – High dust concentrations were monitored in January (6.3 g/m<sup>2</sup>/mth), May (5.4 g/m<sup>2</sup>/mth) and June (7.9 g/m<sup>2</sup>/mth). This was caused by cattle grazing in the paddock surrounding the dust gauge. Once the cattle were removed from the paddock monitored dust concentrations returned to normalised levels.

- DG14 – A dust concentration of 6.8 and 5.2 g/m<sup>2</sup>/month was recorded in March and May respectively. These values are considered spurious as it is not supported by the levels recorded by surrounding depositional dust gauges i.e.: DG13 which monitored levels of 1.5 & 1.3 g/m<sup>2</sup>/month in March and May respectively. If these values were replaced by the average monthly concentration value, the annual average would have been 2.9 g/m<sup>2</sup>/month.

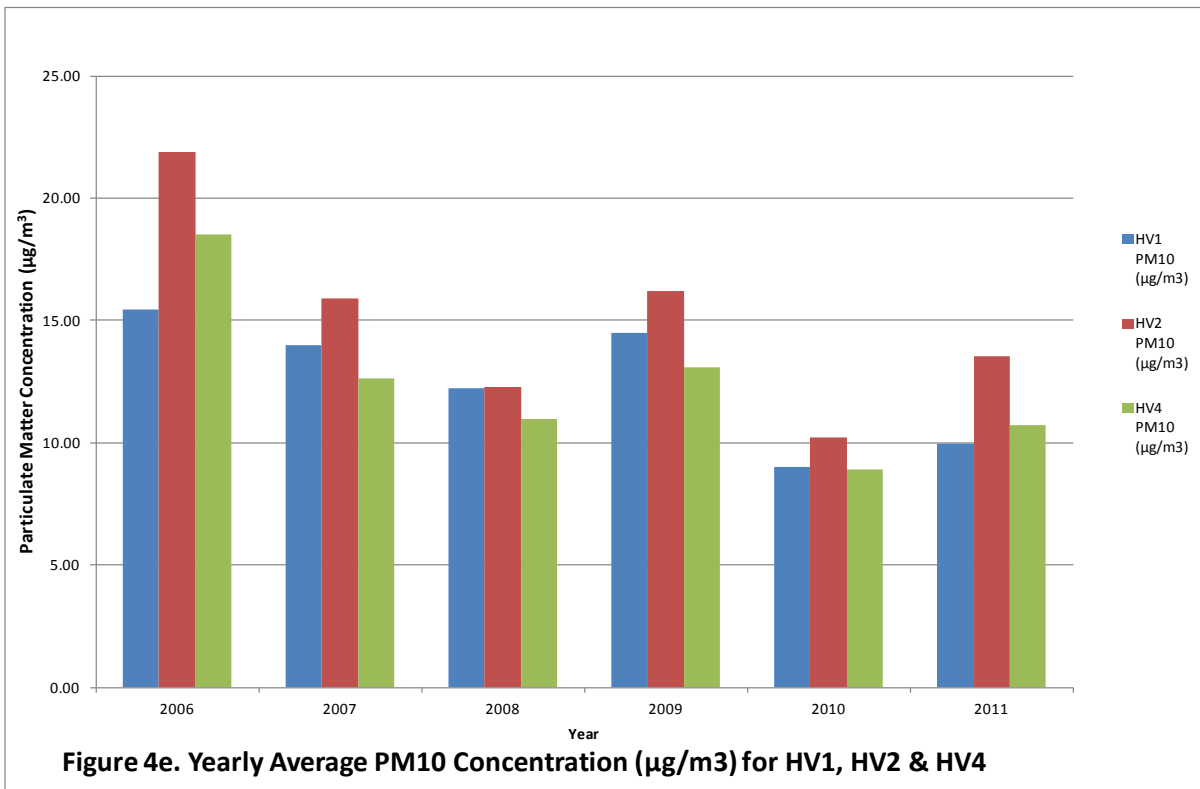
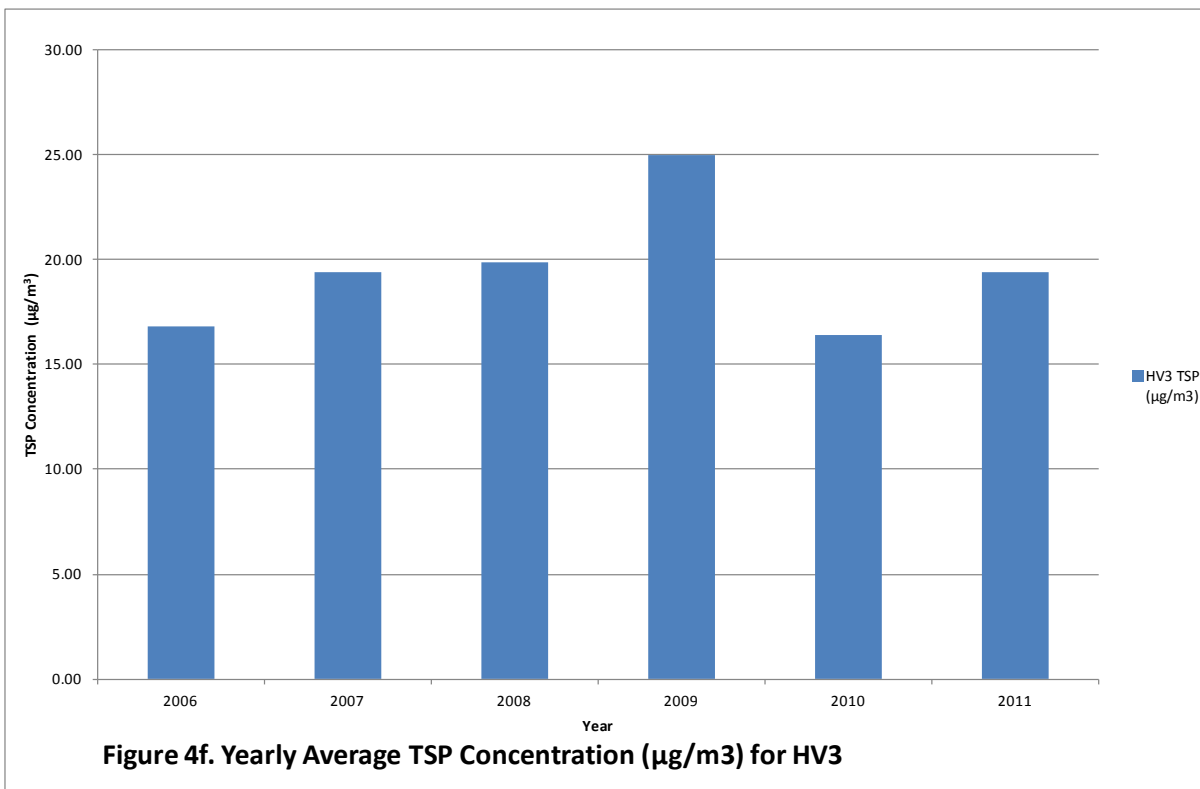
Figure 4f shows the annual average TSP concentration for HV3 since its commissioning in 2006.

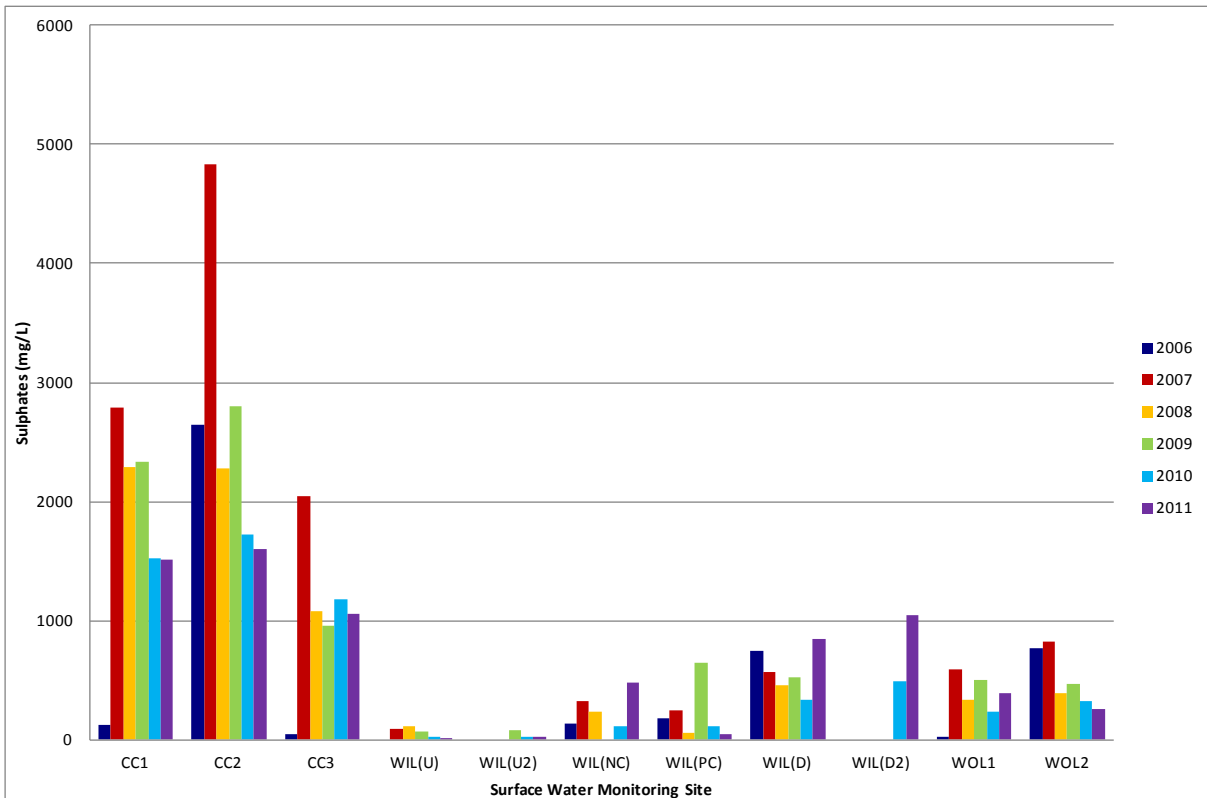
Figure 5d. Yearly Average Sulphates for each surface monitoring site

Surface water quality monitoring data collected during the reporting period for EC and turbidity indicated that results were within baseline ranges. SO<sub>4</sub> results also within baseline ranges in Wilpinjong Creek. Cumbo Creek SO<sub>4</sub> recorded levels were outside the Baseline range; this is the fifth year in which this has occurred. These readings are considered to be natural fluctuations as there has been no mining related impact on this creek system. Monitoring results from Surface Water monitoring sites CC1, WIL(U), WIL(U2) and WIL(PC) were generally within the relevant groundwater impact assessment criteria for pH (~0.5 above or below the baseline range).

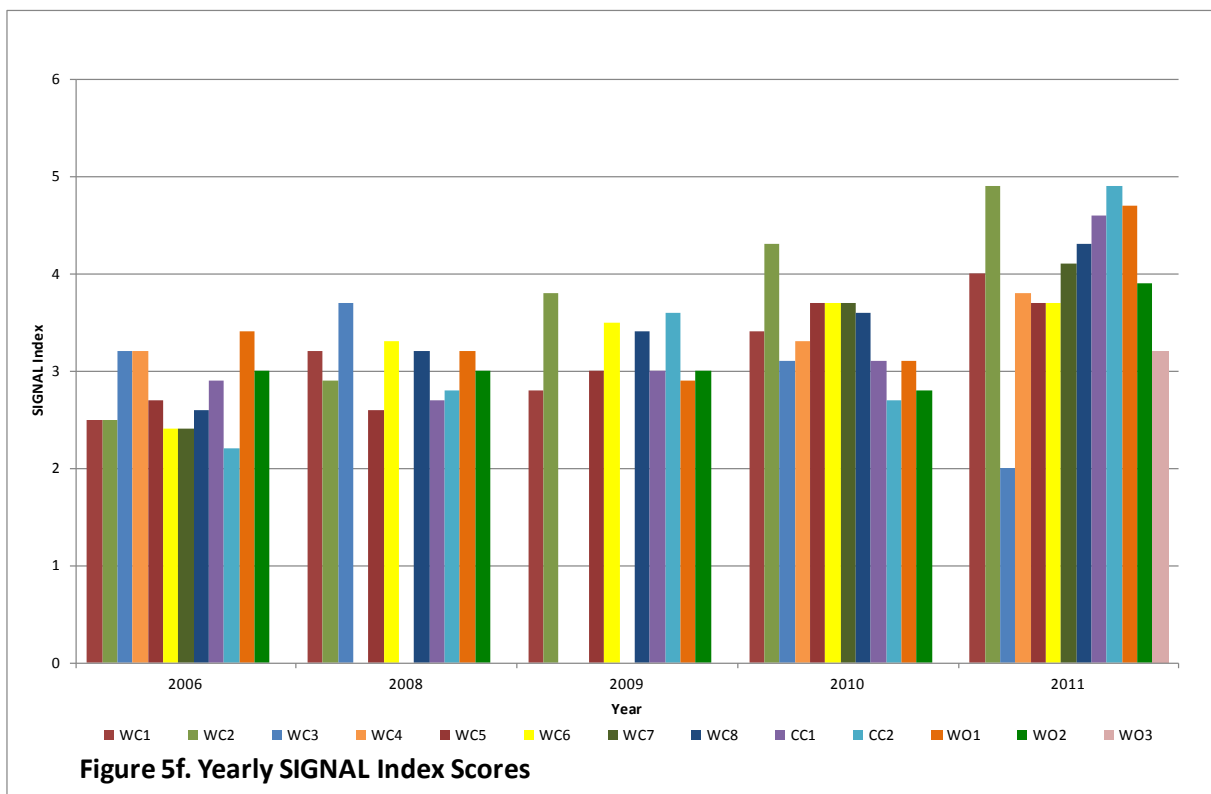
Wilpinjong Creek and Cumbo Creek are both classified as being “severely polluted” when using the SIGNAL index for macro invertebrate abundance (Figure 5f). Stream health is also considered to be “very poor”. SIGNAL index scores of <4 is severely polluted; 4-5 is moderately polluted; 5-6 is mildly polluted; and >6 is healthy.

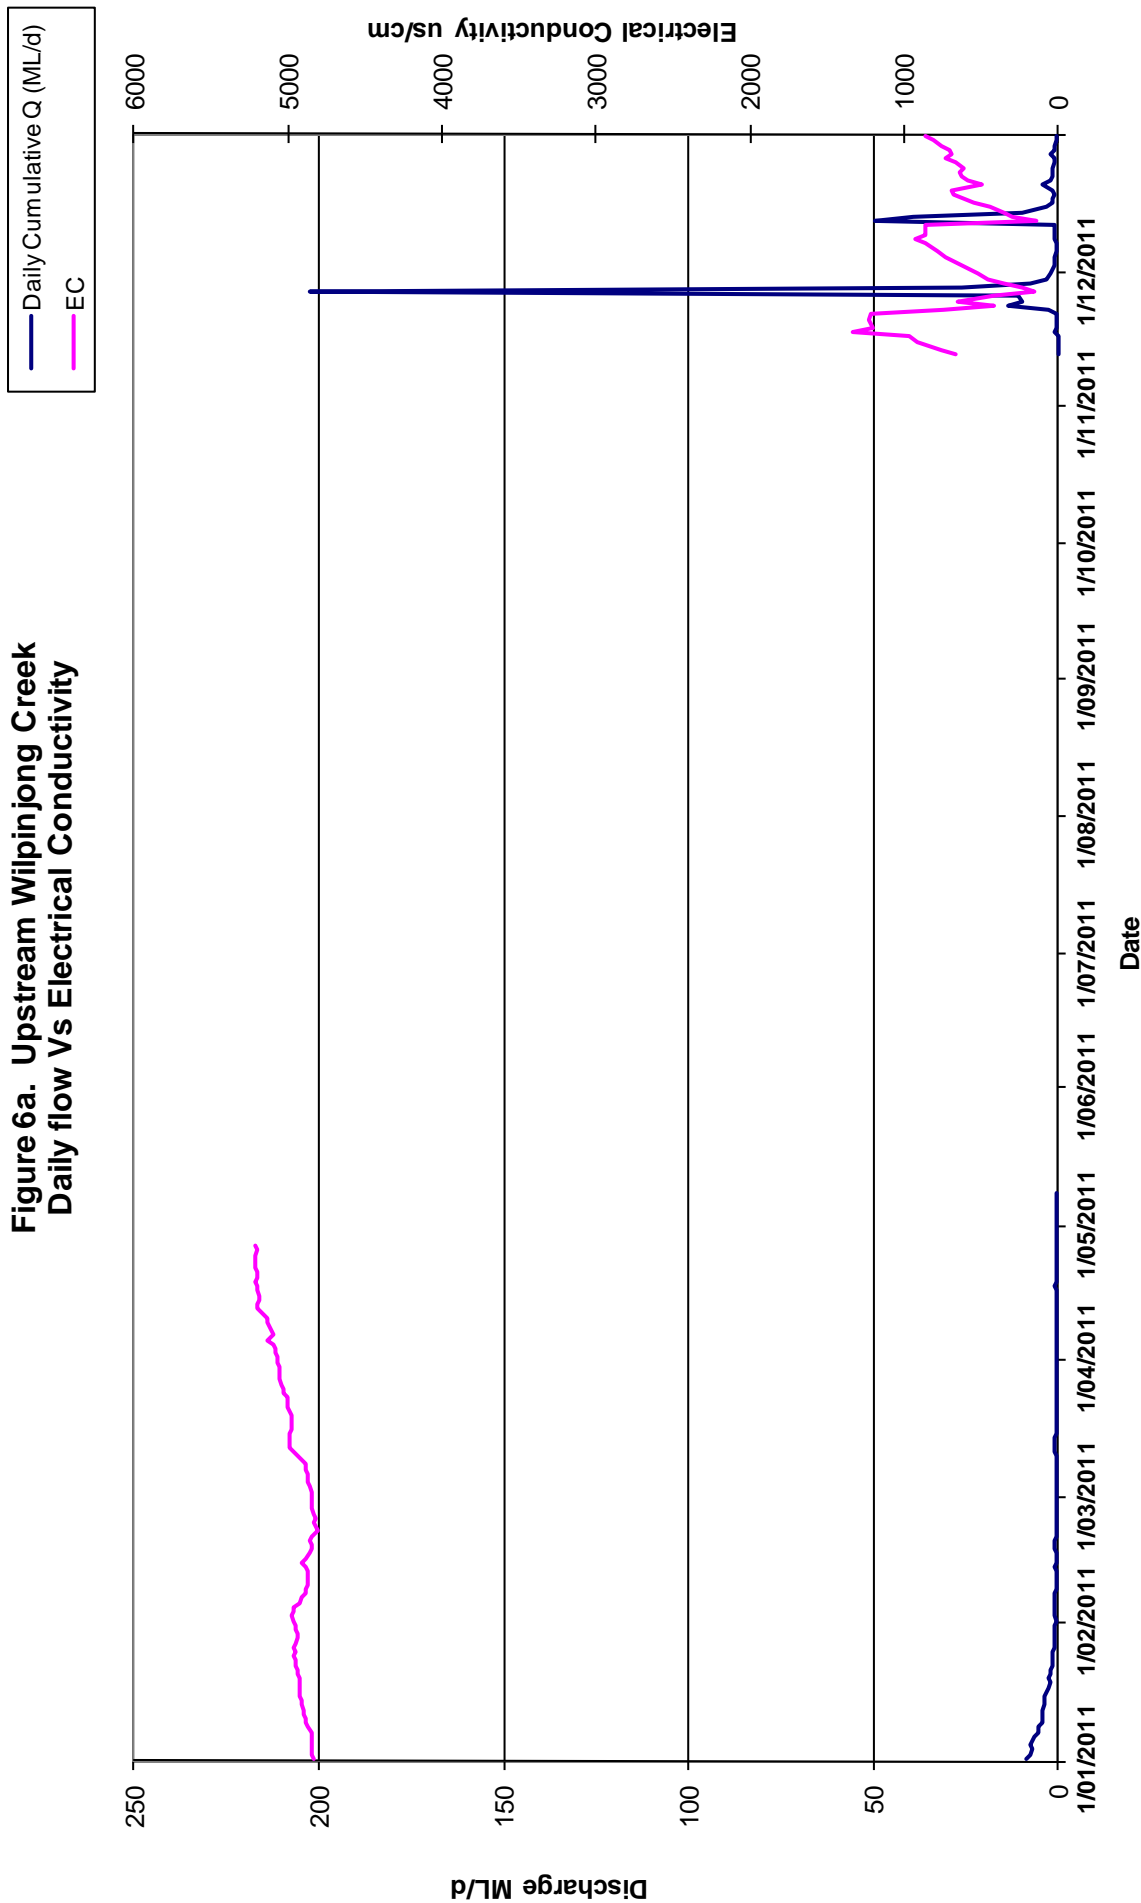
**Figure 6a. Upstream Wilpinjong Creek  
Daily flow Vs Electrical Conductivity**

The mine operated three gauging stations throughout the reporting period. The stations are located upstream and downstream of the mining lease on Wilpinjong Creek and on Cumbo Creek upstream of the confluence with Wilpinjong Creek (figure 5). The stations monitor flow and EC on 15 minutes intervals (Figures 6a, 6b and 6c). As indicated on Figures 6a, 6b and 6c, there were several gaps in the EC data at the Upstream and Downstream Wilpinjong stations and the Cumbo Creek station. Each gap in EC data can be attributed to monitoring equipment failure.

Data for the Upstream Wilpinjong Creek gauging station between May and November 2011 was unable to be collected due to failure of the station.

- Section 3.6.1 – Figures 6a, 6b and 6c indicate that there were several gaps in the EC data at the Upstream Wilpinjong station and the Cumbo Creek station (approximately 7 months of missing data). It is recommended that these stations are more regularly serviced and maintained to ensure continuous monitoring results throughout the reporting period. The AEMR should contain information on how these monitoring equipment failures will be avoided in future.
