APPENDIX I AGRICULTURAL RESOURCE ASSESSMENT

Agricultural Resource Assessment: “Wilpinjong Coal Mine Modification”, Wollar, NSW

Prepared for Wilpinjong Coal Pty Ltd

Dr. David McKenzie
McKenzie Soil Management Pty. Ltd.
Orange NSW

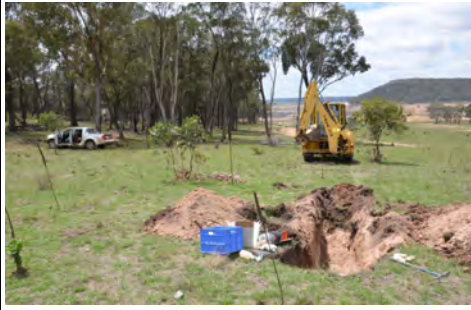
Soil pit*	Landform variations present in the vicinity of the pit	Zone represented by the pit	General photograph of soil pit location
A	Mix of approximately 70% cleared pasture and 30% timbered areas; mostly <10% slope.	Representative of the majority of this Modification open cut extension area.

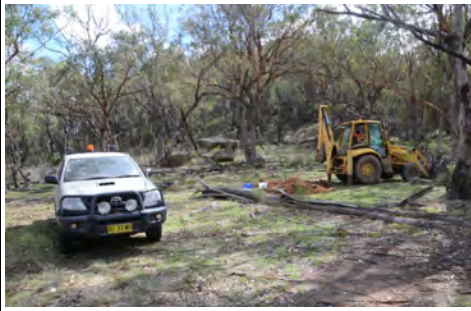
B	Mostly timbered with a large range of slope variation.	Approx. 6% slope; small area of pasture in between clumps of trees.

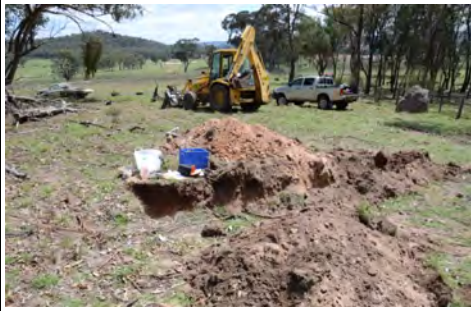
C	Cleared pasture country <10% slope, grading into steeper forested areas >10% slope.	Approx. 8% slope; small area of pasture in between clumps of trees.

Pit C is located on an upper mid-slope at the base of a ridgeline that extends north from the Munghorn Gap Nature Reserve and is similarly surrounded by steeply sloping lands to the south and the approved open cut of the Wilpinjong Coal Mine. Due to the proximity of the open cut of the Wilpinjong Coal Mine and slopes greater than 10% that form the majority of this minor extension area (Map 2), this also would not comprise 20 ha in area. A general location photograph provided in Table 2 illustrates the nature of the site and the landform.

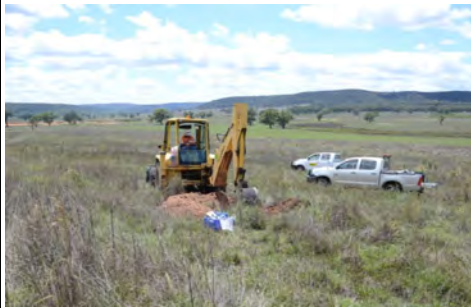
D	Mix of approximately 80% cleared pasture and 20% degraded timbered areas; major slope variations.	Approx. 9% slope; pasture with easterly aspect.

Pit D is located on an upper mid-slope to the east of a small elevated ridgeline that runs approximately north-south to the west of Cumbo Creek. The majority of the Modification open cut extension area in which this pit is located comprises greater than 10% slope (Map 2) (i.e. does not meet BSAL criteria), however, the pit is located in an area of approximately 9% slope (and, therefore, meets the BSAL criteria).

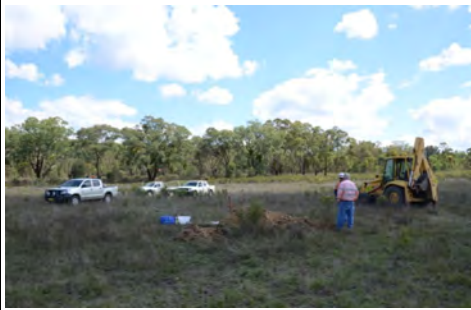
Soil pit	Landform variations present	Zone represented by the pit	General photograph of soil pit location
E	Mostly pasture <5% slope	Representative of the majority of this Modification open cut extension area

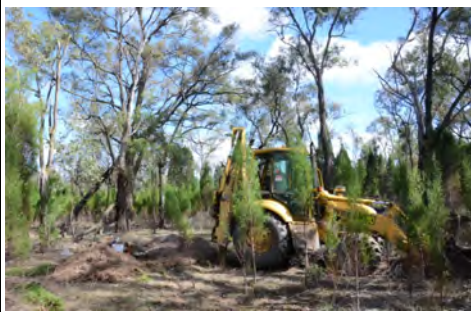
F	Timbered area, <5% slope	Representative of the majority of this Modification open cut extension area

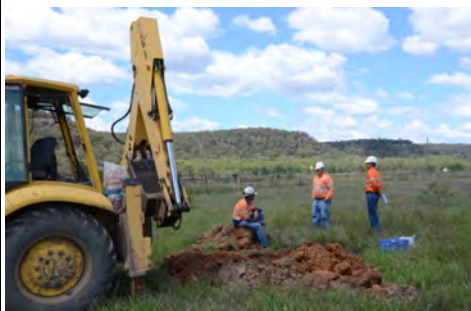
G	Lower slope (<5% slope) but with undulations	Slight rises

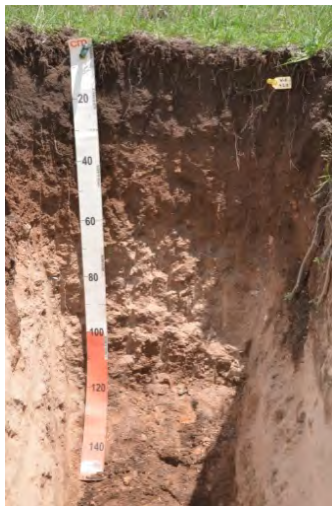
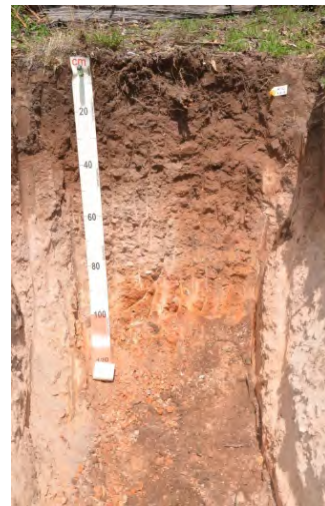
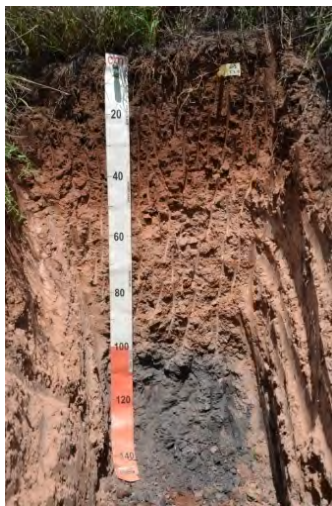
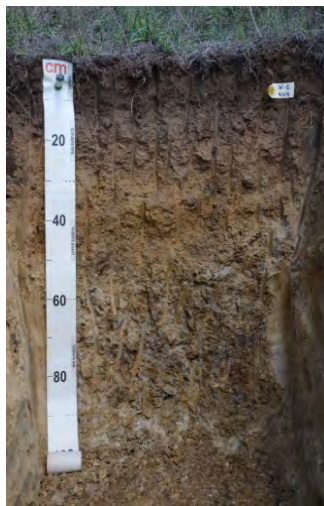
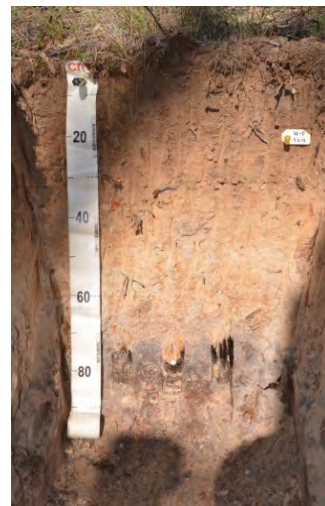
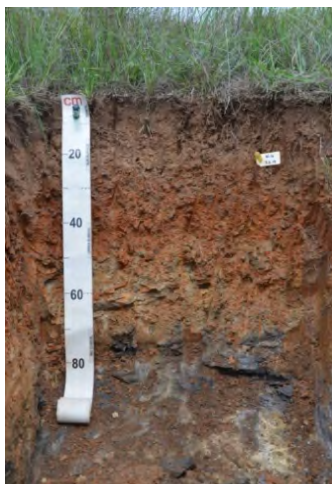
Figure 5. Photographs of Soil Types Identified during the Survey

Pit A: Brown Dermosol

Pit B: Red Kurosol

Pit C: Brown Kurosol

Pit D: Red Dermosol

Pit E: Brown Dermosol

Pit F: Brown Dermosol

Pit G: Red Kurosol

Photographs of the soils in the soil pit sites are presented in Figure 5.
