Aboriginal Heritage

METROPOLITAN COAL - ENVIRONMENTAL MONITORING SUMMARY

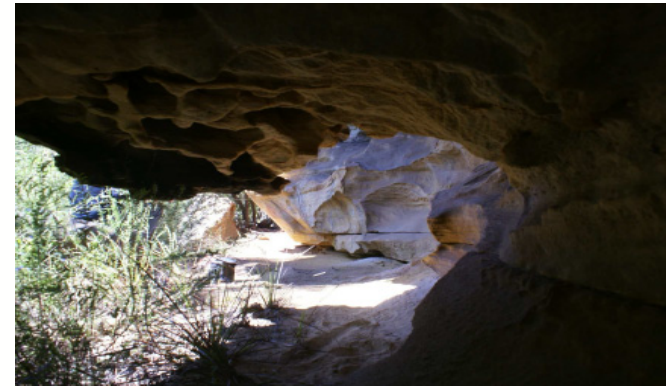
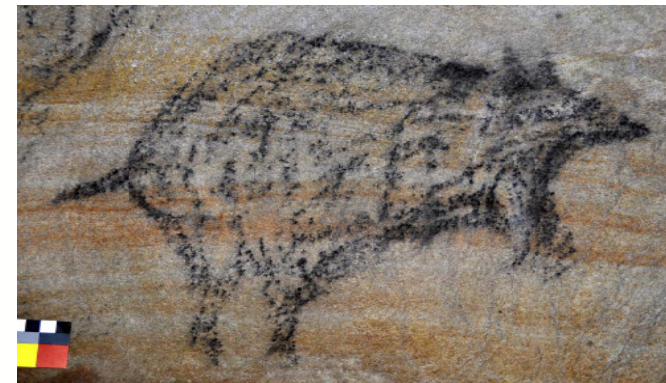
To date, five sites have been observed to have changes attributable to mine subsidence, namely sites FRC 15, FRC 284, FRC 281, FRC 283 and MET 1:

- At site FRC 15 (an overhang with artefacts and deposit), the vertical crack noted on the back wall during Round 1 monitoring was observed to have increased in width and shifted laterally during Round 2 monitoring. During the Round 3 survey, the previously identified fine cracking along the margins of the larger fissure were observed to have increased and at the southern end of the shelter there was an increased number of fine cracks.

- At site FRC 284 (an overhang with artefacts and deposit), displacement of a small section of exfoliated shelter surface associated with a fractured corner of the shelter was observed during the Round 2 monitoring. This change is consistent with the types and scale of subsidence effects (cracking, displacement and slumping/falling of exfoliated pieces) noted during Round 1 monitoring. No change in the shelter condition at site FRC 284 was identified during Round 3 monitoring, suggesting the site has stabilised.

- At site FRC 281 (an overhang with art, artefacts and deposit), the changes due to mine subsidence recorded during Round 1 monitoring (multiple cracks ranging from large, medium and small recorded in the shelter wall either running through or next to the motifs) were observed at the site during the Round 2 and Round 3 surveys. However, there had been no change in the shelter condition since Round 1 monitoring, suggesting the site has stabilised.

- Site FRC 283 (an overhang with art) was noted as having some increase in joint movement along the back wall bedding planes of the shelter in the Round 3 survey. As a result of natural processes, water seepage through the sandstone has formed a mineral accretion (silica) over the art panel.

- Site MET 1 (an overhang with art, artefacts and deposit) was also identified as having vertical cracking along the back wall of the shelter as well as some small cracking in the shelter in the Round 3 survey.
