## **APPENDIX 3C – SURFACE WATER MONITORING**

# Wilpinjong & Cumbo Creek Stability Assessment, 2015

Wilpinjong Coal Mine

Mar-16  
(Our Reference: 23823\_E01\_Final)

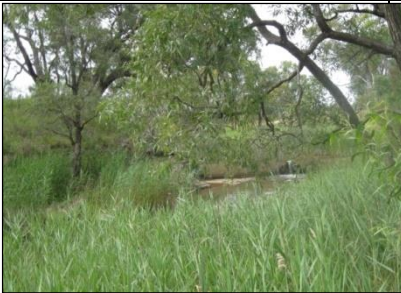
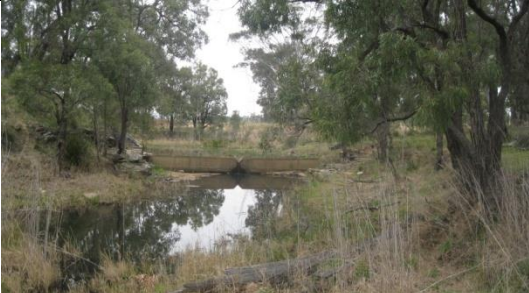
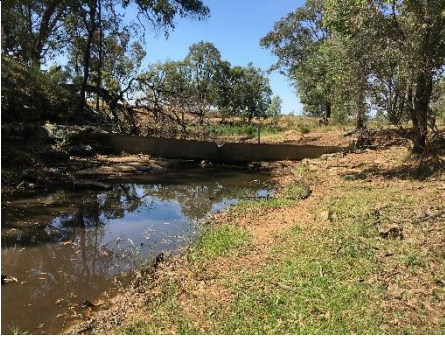
<ul style="list-style-type: none"> <li>Reduction in vegetative groundcover over the years;</li> <li>Reduction in instream flora</li> <li>Increased sediment deposition midstream, creating a bar feature;</li> </ul>
2

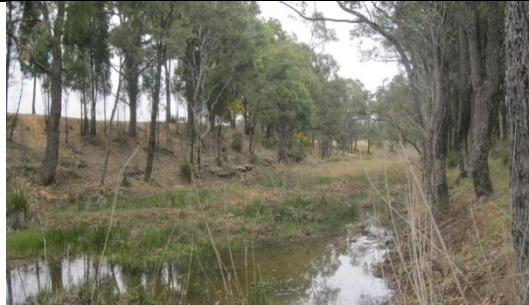
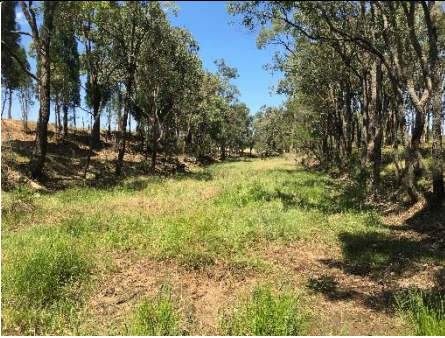
<ul style="list-style-type: none"> <li>Although there is a reduction of instream growth since 2011, instream flora (grasses) is maintained between 2014-2015;</li> <li>Increased sediment deposition between 2014-2015;</li> <li>Riparian vegetation maturing;</li> <li>Increased leaf litter on both banks – 2014-2015;</li> <li>Evidence of stock, wombats and pigs in and around the creek.</li> </ul>
3

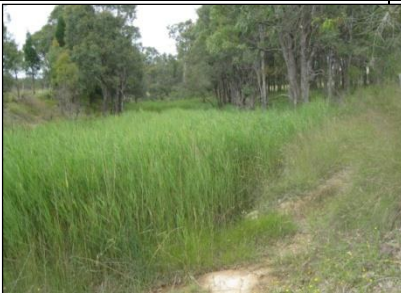
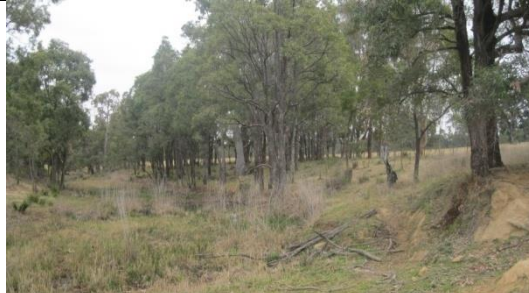
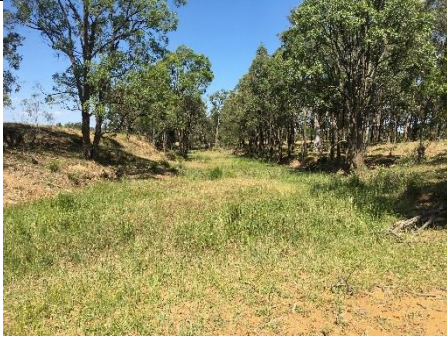
<ul style="list-style-type: none"> <li>Although there is a reduction of instream growth since 2011, instream flora (grasses) is maintained between 2014-2015;</li> <li>Increased sediment deposition between 2014-2015;</li> <li>Riparian vegetation maturing;</li> <li>Increased leaf litter on both banks – 2014-2015;</li> <li>Evidence of stock, wombats and pigs in and around the creek.</li> </ul>

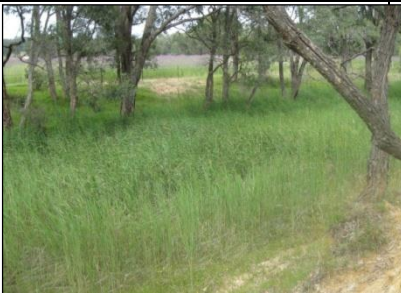
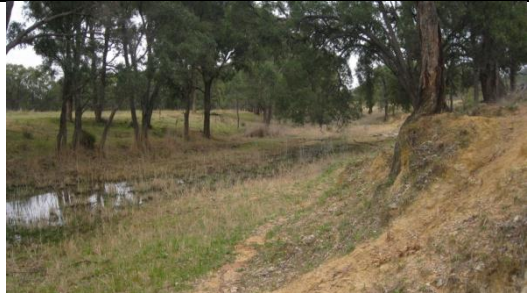
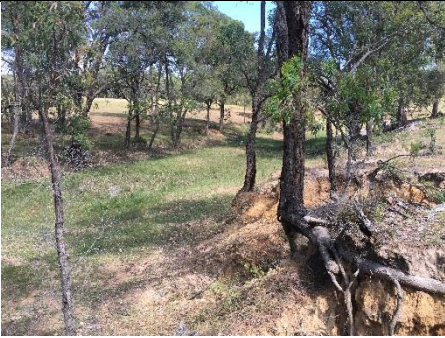
4

<ul style="list-style-type: none"> <li>Increased erosion and exposure of the left bank;</li> <li>Stabilisation of instream flora – reduction from 2011;</li> <li>Continued sediment deposition instream,;</li> <li>Riparian Areas improving in growth, no evidence of stock.</li> </ul>

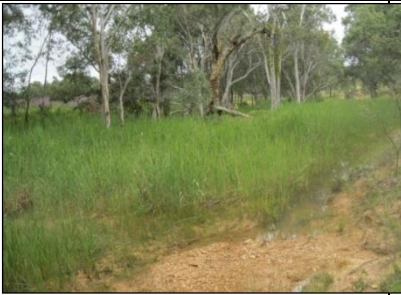
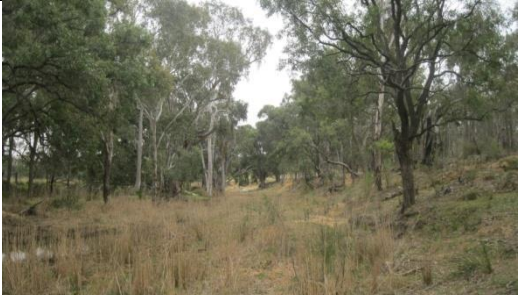
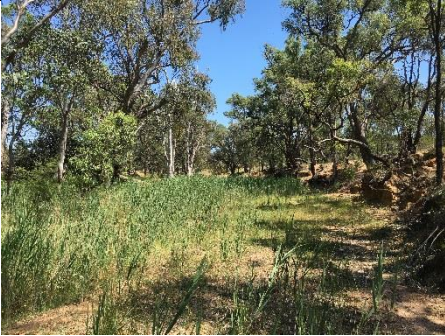
<ul style="list-style-type: none"> <li>Increased growth of grass species in the creek bed in 2015;</li> <li>Increased exposure of the left bank;</li> <li>An increase in the active channel;</li> <li>Natural regeneration since 2011;</li> <li>No evidence of stock in 2015.</li> </ul>
6

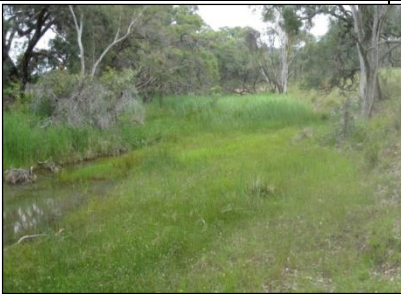
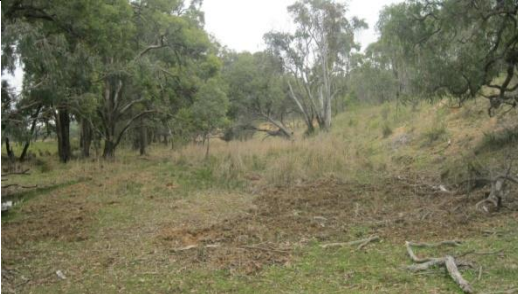
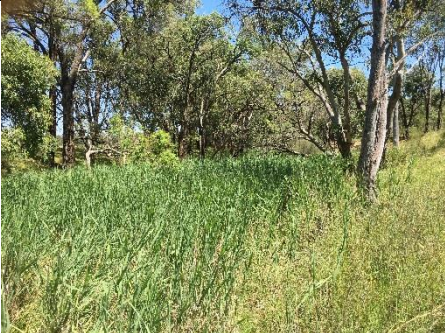
<ul style="list-style-type: none"> <li>Increased growth of grass species in the creek bed in 2015;</li> <li>Improved groundcover on both banks;</li> <li>An increase in the active channel;</li> <li>Natural regeneration since 2011;</li> <li>No evidence of stock in 2015.</li> </ul>
7

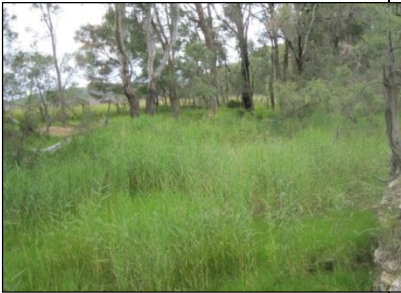
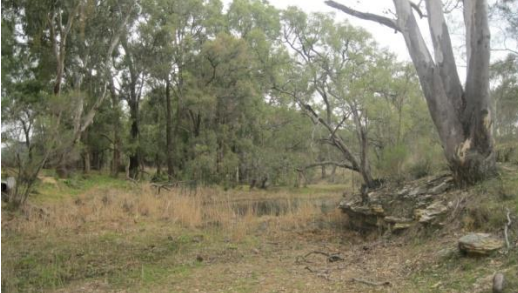
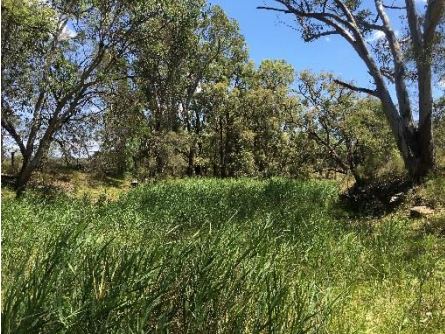
<ul style="list-style-type: none"> <li>Increased growth of grass species in the creek bed in 2015;</li> <li>Improved groundcover on both banks;</li> <li>An increase in the active channel;</li> <li>Stabilisation of the banks;</li> <li>Natural regeneration since 2011;</li> <li>No evidence of stock in 2015.</li> </ul>

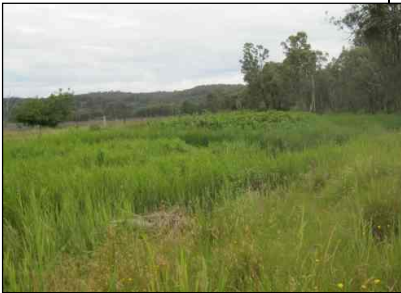
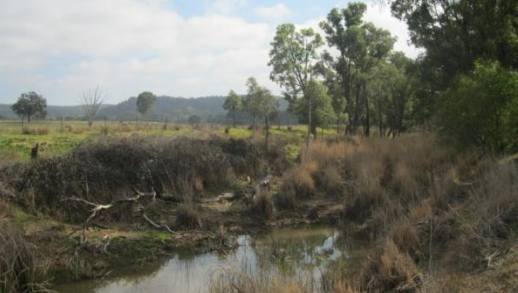
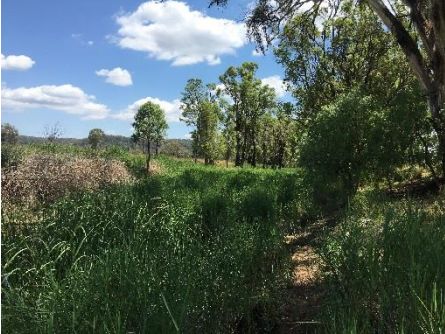
8

<ul style="list-style-type: none"> <li>Reduced exposure of the bank faces, increased grass coverage – 80% on both banks;</li> <li>No evidence of stock in the area;</li> <li>Blackberry sprayed</li> <li>Minimal riparian zone</li> </ul>
9

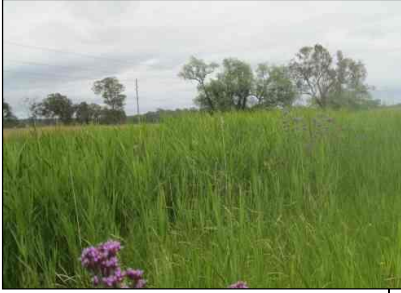
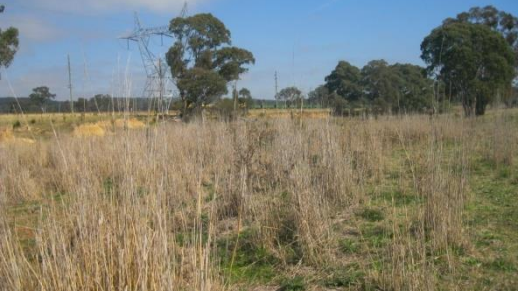
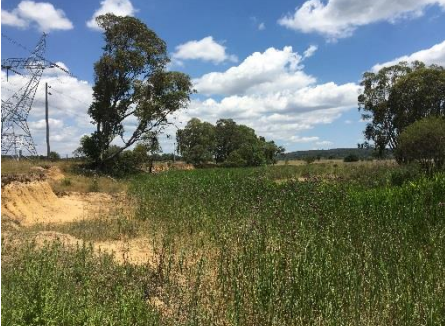
<ul style="list-style-type: none"> <li>Right bank suffering scolding and sheet erosion – ongoing over the years;</li> <li>Minimal riparian zone;</li> <li>Natural regeneration slow in this area.</li> <li>Increased bleaching of exposure soils of the bank faces;</li> </ul>

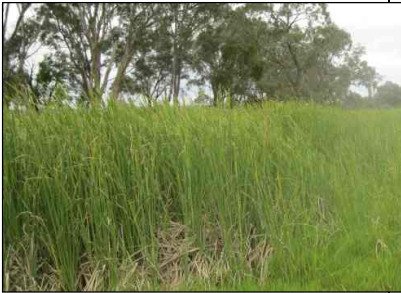
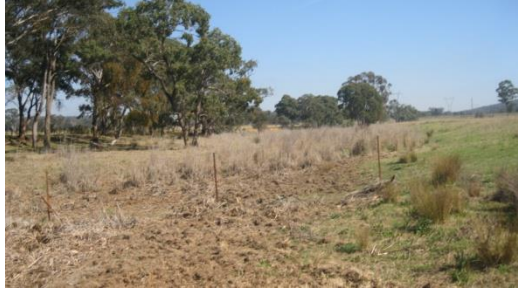
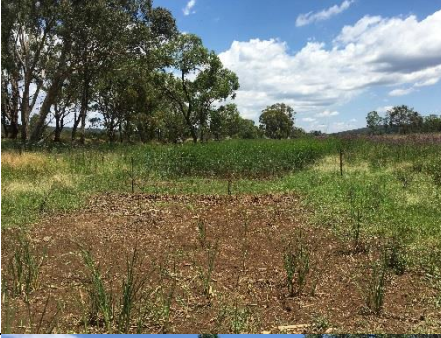
<ul style="list-style-type: none"> <li>Increased growth of grass species in the creek bed in 2015;</li> <li>Improved groundcover on both banks;</li> <li>Stabilisation of the banks;</li> <li>Continued Natural regeneration since 2011;</li> <li>Evidence of pigs in 2015</li> </ul>
11

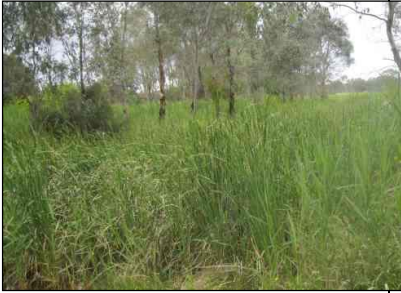
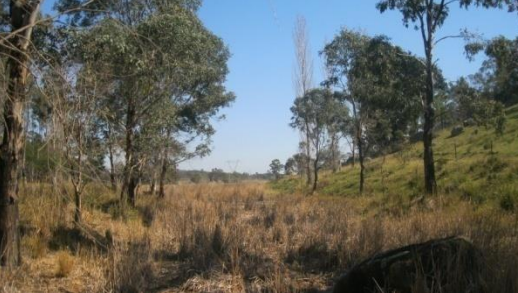
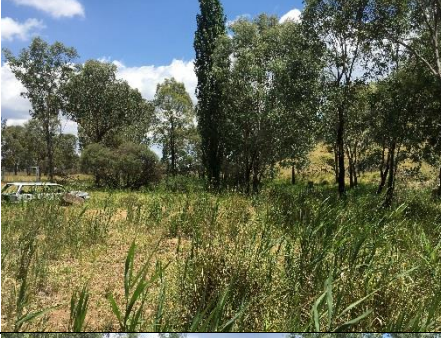
<ul style="list-style-type: none"> <li>Area has been fenced out allowing for natural regeneration to occur;</li> <li>Increased growth of flora species in the creek bed since 2014;</li> <li>Increased coverage of grass species on the creek banks;</li> <li>Riparian zone remains stable;</li> <li>Increased active channel width in 2015.</li> </ul>
12

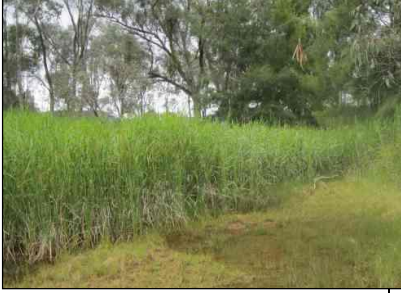
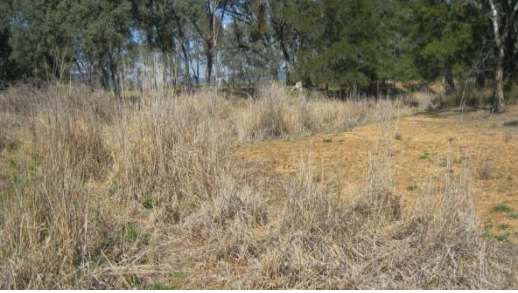
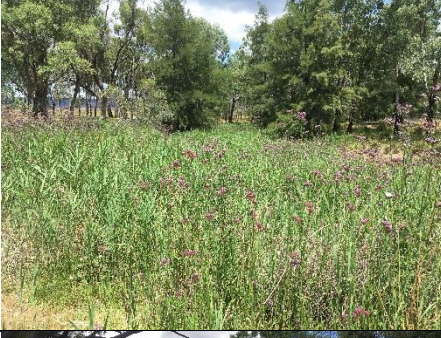
<ul style="list-style-type: none"> <li>Site remains relatively stable in 2015;</li> <li>Area has been fenced out allowing for natural regeneration to occur;</li> <li>Increased growth of flora species in the creek bed since 2014;</li> <li>Increased coverage of grass species on the creek banks;</li> <li>Increased active channel width in 2015;</li> <li>Evidence of wombats in the area in 2015.</li> </ul>

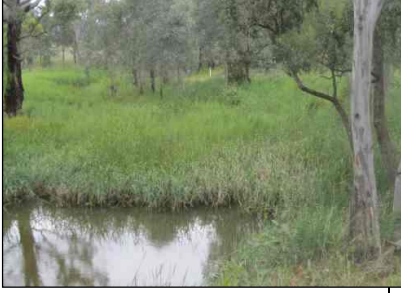
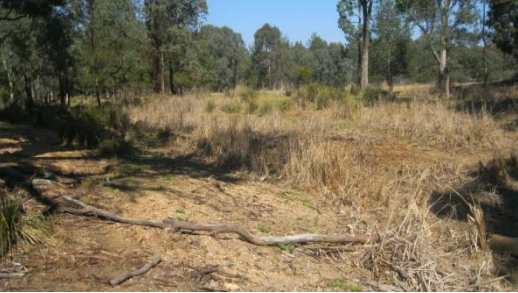
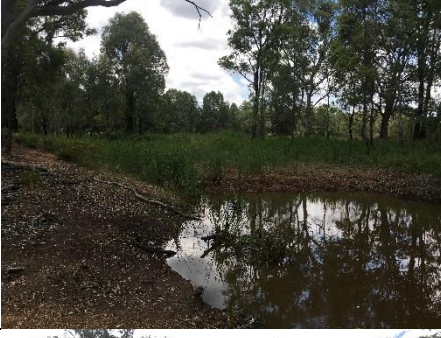
<ul style="list-style-type: none"> <li>Site remains relatively stable in 2015;</li> <li>Area has been fenced out allowing for natural regeneration to occur;</li> <li>Increased growth of flora species in the creek bed since 2014;</li> <li>Increased coverage of grass species on the creek banks;</li> <li>Increased pooling at site in 2015;</li> </ul>
14

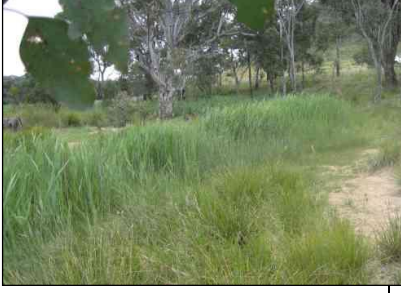
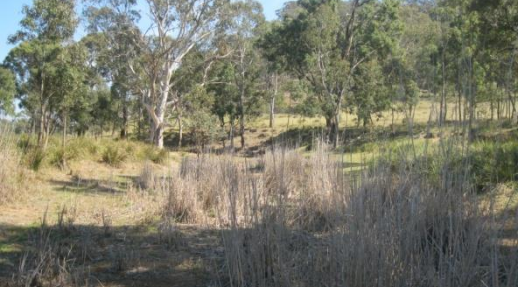
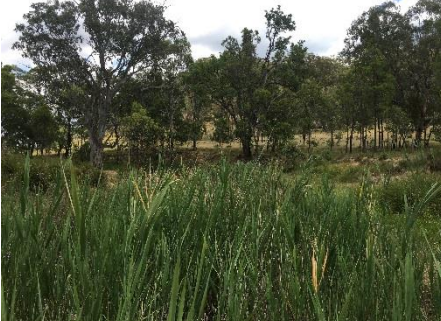
<ul style="list-style-type: none"> <li>Area has been fenced out allowing for natural regeneration to occur;</li> <li>Increased growth of flora species in the creek bed since 2014;</li> <li>Increased coverage of grass species on the creek banks;</li> <li>Increased active channel width in 2015;</li> <li>Evidence of wombats in the area in 2015</li> </ul>

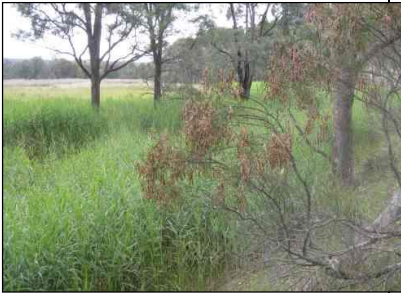
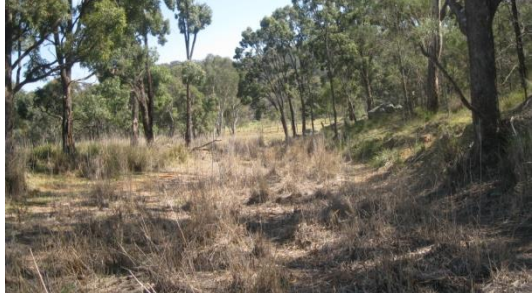
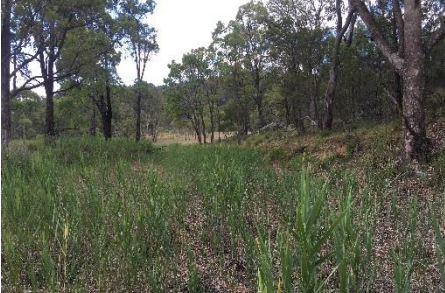
<ul style="list-style-type: none"> <li>Site remains relatively stable in 2015;</li> <li>Area has been fenced out allowing for natural regeneration to occur;</li> <li>Increased growth of flora species in the creek bed since 2014;</li> <li>Increased coverage of grass species on the creek banks;</li> <li>Increased active channel width in 2015;</li> <li>Evidence of wombats in the area in 2015</li> </ul>
16

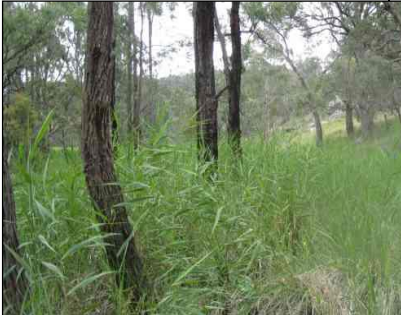
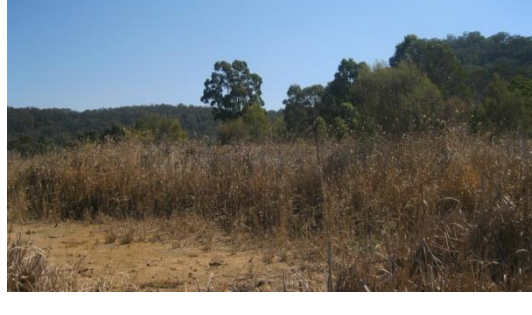
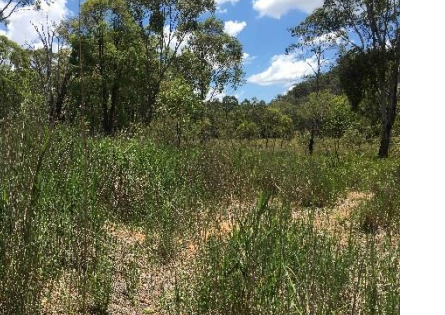
<ul style="list-style-type: none"> <li>Site moved due to lack of access in 2015;</li> <li>No evidence of stock in the location;</li> <li>Evidence of natural regeneration occurring at the site;</li> <li>Banks stable.</li> </ul>
17

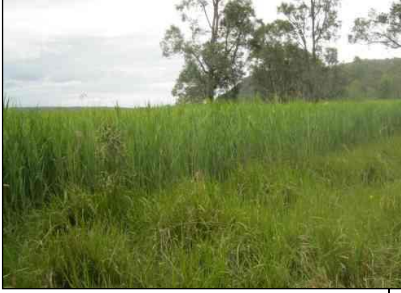
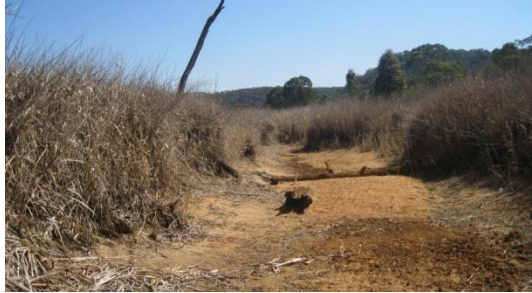
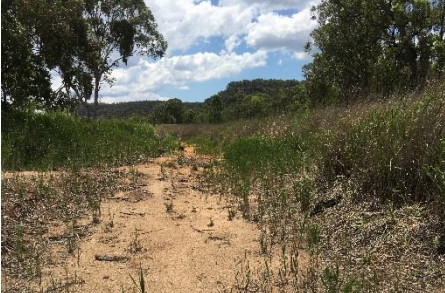
<ul style="list-style-type: none"> <li>Increased exposure of soils along access track and in the creek bed;</li> <li>Bank ground coverage 100%;</li> <li>Active sediment deposition zone;</li> <li>Little to no woody riparian zone.</li> </ul>

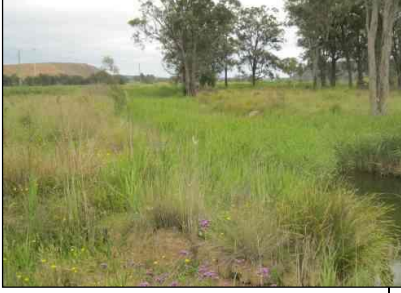
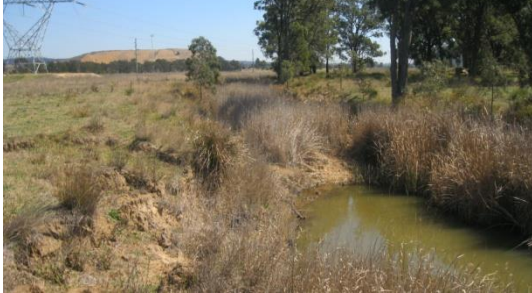
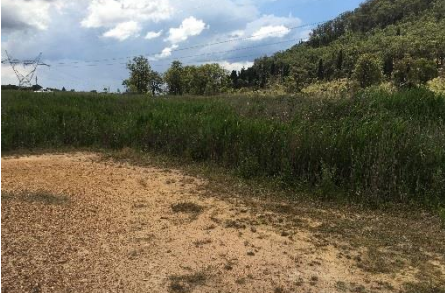
<ul style="list-style-type: none"> <li>Increased exposure of soils along access track and in the creek bed;</li> <li>Bank ground coverage 100%;</li> <li>Active sediment deposition zone;</li> <li>Little to no woody riparian zone.</li> </ul>
19

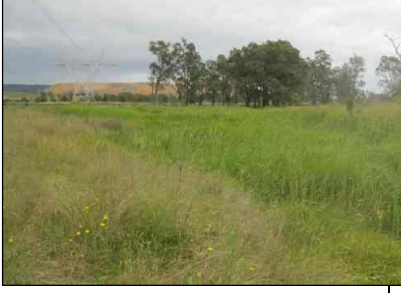
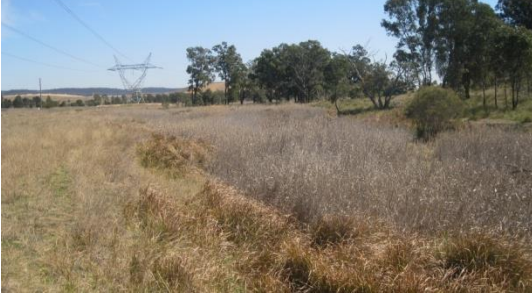
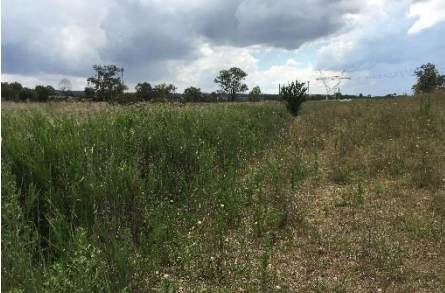
<ul style="list-style-type: none"> <li>Site remains relatively stable in 2015;</li> <li>Area has been fenced out allowing for natural regeneration to occur;</li> <li>Increased growth of flora species in the creek bed since 2014;</li> <li>Increased coverage of grass species on the creek banks;</li> </ul>

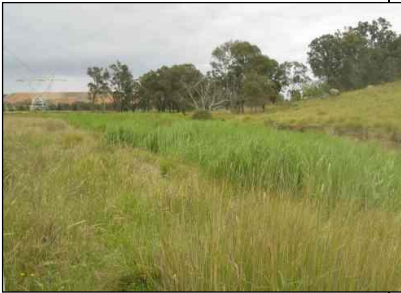
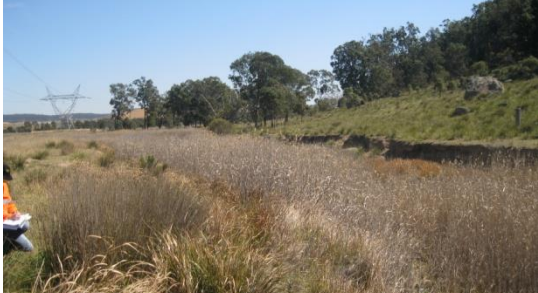
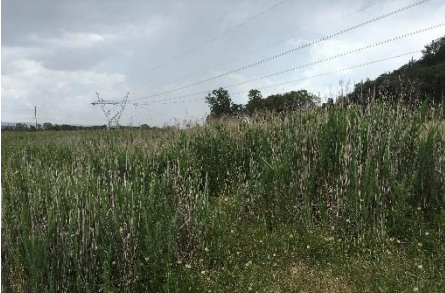
<ul style="list-style-type: none"> <li>▪ Increase in healthy instream flora;</li> <li>▪ Increased growth of flora species in the creek bed since 2014;</li> <li>▪ Increased coverage of grass species on the creek bank;</li> <li>▪ Increased bleaching of exposed soils on the left bank face – continued exposure and erosion;</li> <li>▪ Right bank remains stable;</li> <li>▪ Little to no riparian zone.</li> </ul>
21

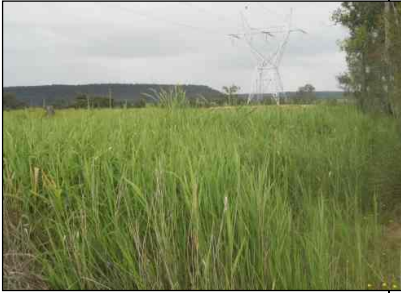
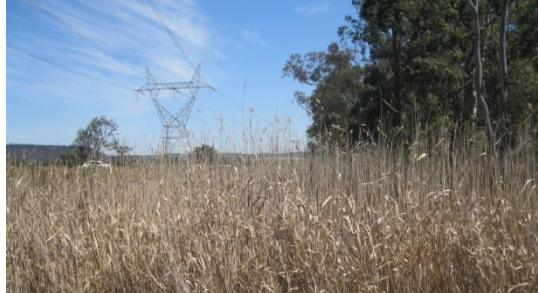
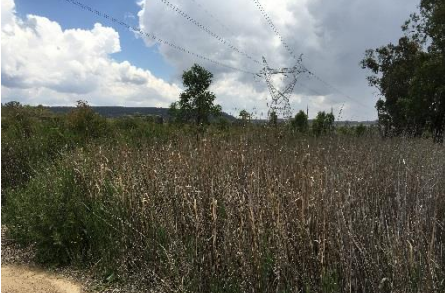
<ul style="list-style-type: none"> <li>▪ Site remains relatively similar in 2015;</li> <li>▪ Some increase in exposed soil on the right bank;</li> <li>▪ Little to no riparian zone.</li> </ul>
22

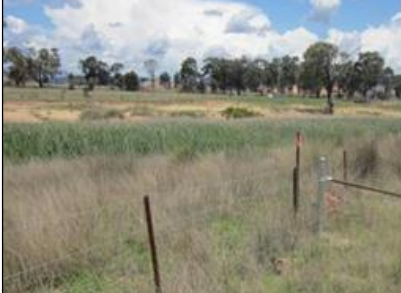
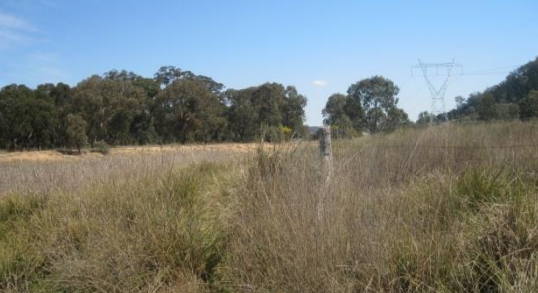
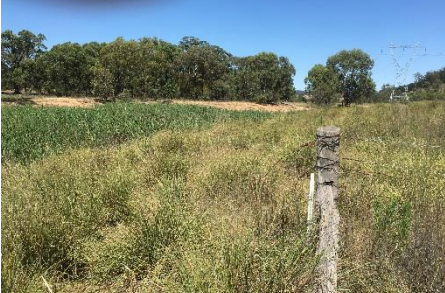
<ul style="list-style-type: none"> <li>▪ Increase in healthy instream flora;</li> <li>▪ Reduction in exposed soils on the right bank face – increased regeneration;</li> <li>▪ An increase in sheet erosion of the right bank;</li> <li>▪ Left bank remains stable;</li> <li>▪ Active channel remains stable;</li> <li>▪ Little to no riparian zone;</li> <li>▪ Evidence of wombats</li> </ul>

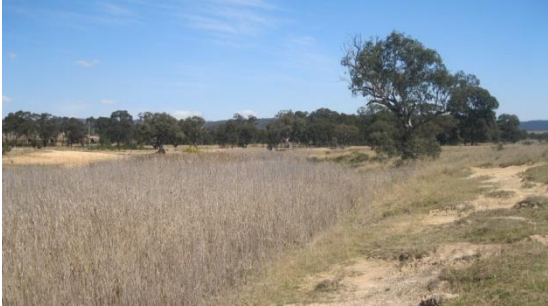
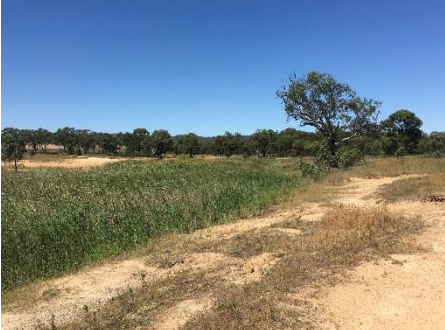
<ul style="list-style-type: none"> <li>▪ Increase in growth of flora species in stream from 2014;</li> <li>▪ An increase in sheet erosion of the exposed bank faces; ;</li> <li>▪ Active channel remains stable;</li> <li>▪ Little to no riparian zone;</li> <li>▪ Evidence of wombats.</li> </ul>
26

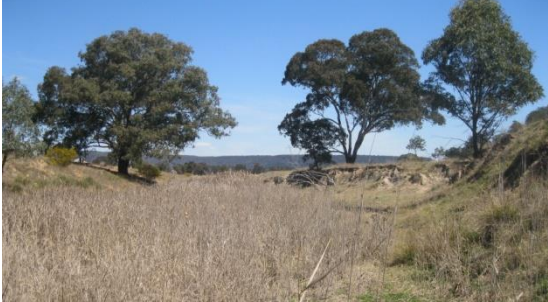
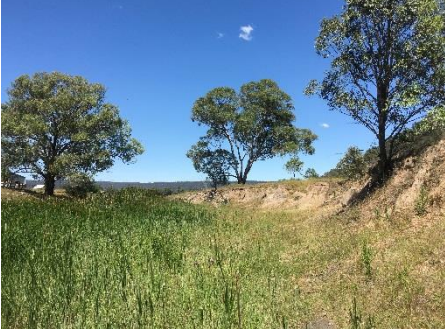
<ul style="list-style-type: none"> <li>▪ Increase in growth of flora species in stream from 2014;</li> <li>▪ An increase in sheet erosion of the exposed bank faces, especially the left bank;</li> <li>▪ Active channel remains stable;</li> <li>▪ Little to no riparian zone;</li> <li>▪ Evidence of wombats and rabbits;</li> <li>▪ Blackberry noted around the site</li> </ul>
29

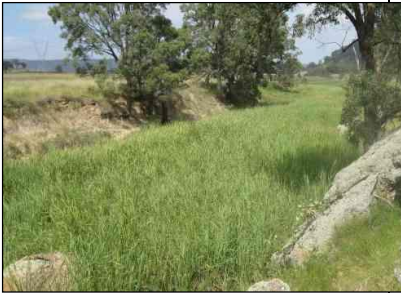
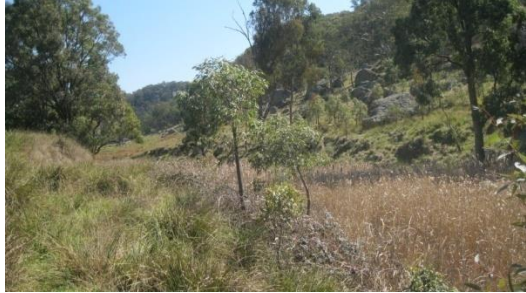
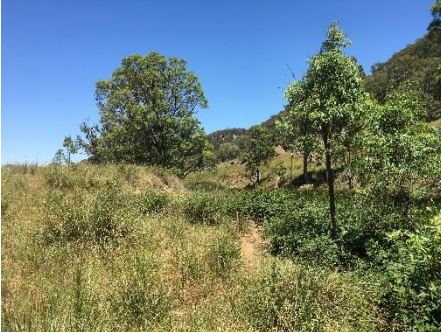
<ul style="list-style-type: none"> <li>Evidence of natural regeneration occurring;</li> <li>Good coverage of the creek bed and banks;</li> <li>Riparian zone limited to non-woody vegetation;</li> <li>Good general regeneration in the riparian areas as a result of destocking.</li> </ul>
31

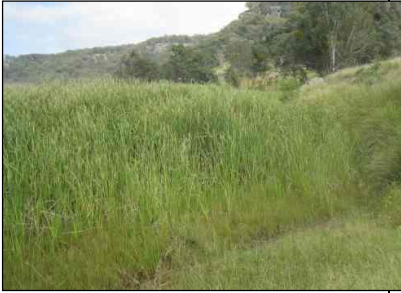
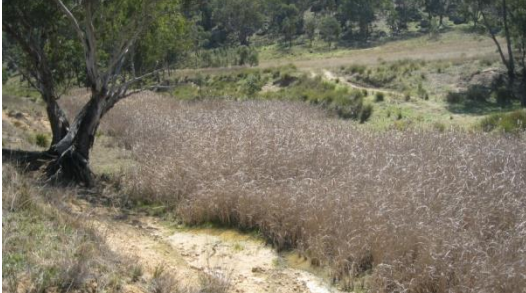
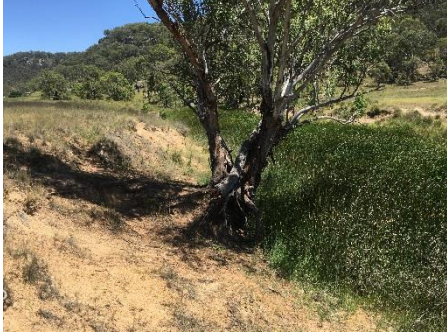
<ul style="list-style-type: none"> <li>Increase in growth of flora species in stream from 2014;</li> <li>An increase in sheet erosion of the exposed bank faces, especially the right bank;</li> <li>Active channel remains stable;</li> <li>Little to no riparian zone;</li> <li>Evidence of wombats and rabbits;</li> <li>Evidence of water ponding in the area in 2015;</li> <li>No evidence of salt crystallisation on the right bank in exposed areas in 2015.</li> </ul>
32

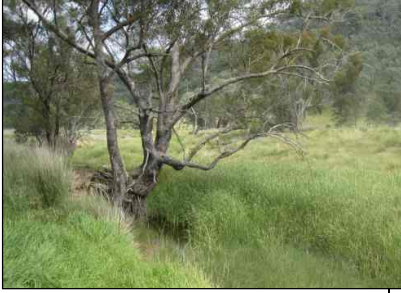
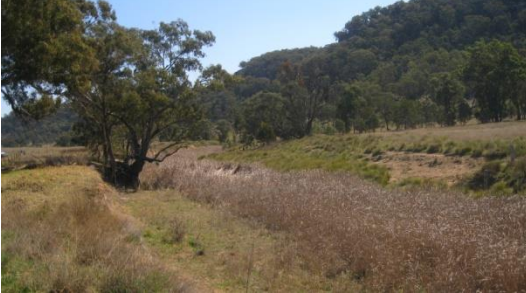
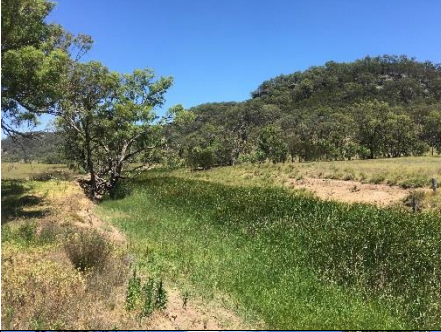
<ul style="list-style-type: none"> <li>Increase in growth of flora species in stream from 2014;</li> <li>An increase in sheet erosion of the exposed bank faces, Active channel remains stable;</li> <li>Little to no riparian zone;</li> <li>Evidence of water ponding in the area in 2015;</li> <li>Continued regression and erosion of the right bank;</li> </ul>

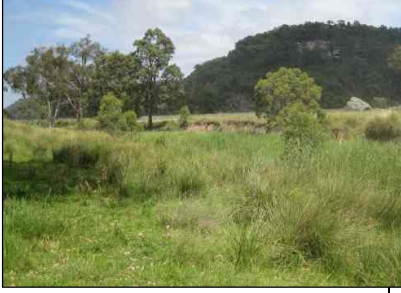
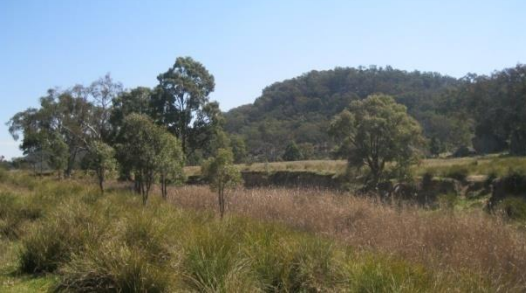
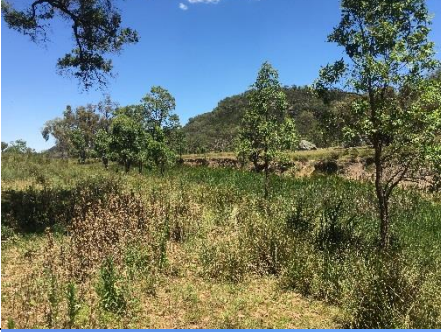
<ul style="list-style-type: none"> <li>Increase in growth of flora species in stream from 2014;</li> <li>Active channel remains stable;</li> <li>Little to no riparian zone;</li> <li>Evidence of wombats and rabbits;</li> <li>Continued regression and erosion of the left bank;</li> <li>Right bank remains similar.</li> </ul>
34

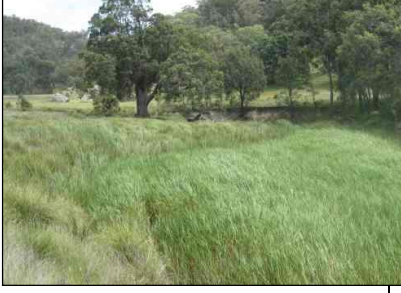
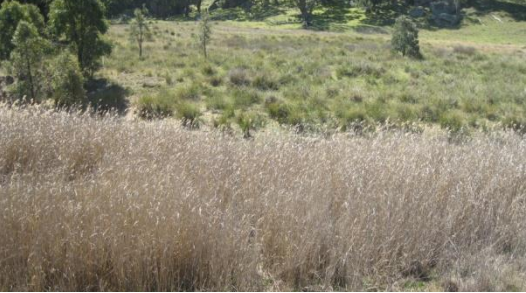
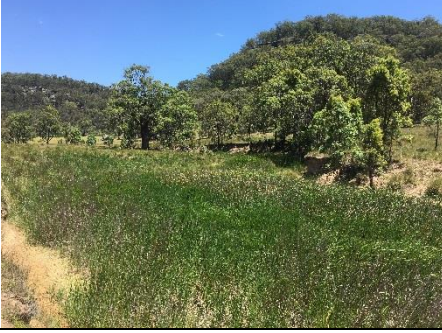
<ul style="list-style-type: none"> <li>Increase in growth of flora species in stream from 2014;</li> <li>Increase in exposure on the bank surfaces, resulting in sheet erosion;</li> <li>Site remains similar.</li> </ul>

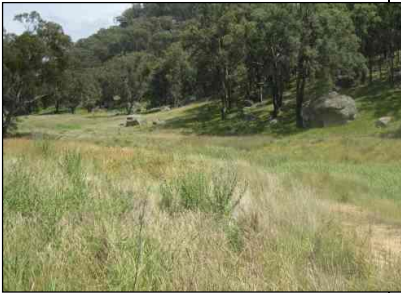
<ul style="list-style-type: none"> <li>▪ Increase in growth of flora species in stream from 2014;</li> <li>▪ An increase in sheet erosion of the exposed bank faces, especially the right bank;</li> <li>▪ Active channel remains stable;</li> <li>▪ Little to no riparian zone;</li> <li>▪ Evidence of wombats and rabbits;</li> </ul>
36

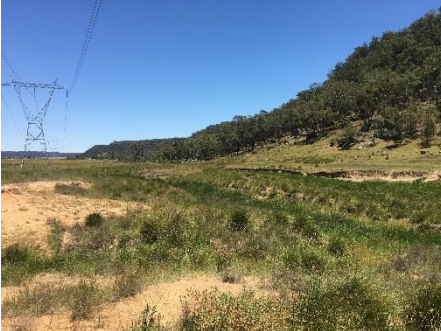
<ul style="list-style-type: none"> <li>▪ Instream flora remains similar in the creek bed;</li> <li>▪ An increase in sheet erosion of the exposed bank faces, especially the right bank;</li> <li>▪ Little to no riparian zone</li> </ul>
37

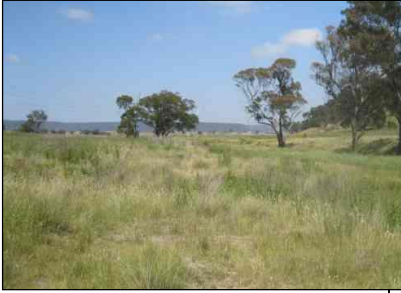
<ul style="list-style-type: none"> <li>▪ Instream flora remains similar;</li> <li>▪ Active channel width remains stable;</li> <li>▪ Continued regression and erosion of the right banks;</li> <li>▪ Continued exposure of surface soils on the right banks due to increased dryness during 2014;</li> <li>▪ Left bank remains well vegetated and stable;</li> <li>▪ Little to no riparian zone.</li> </ul>

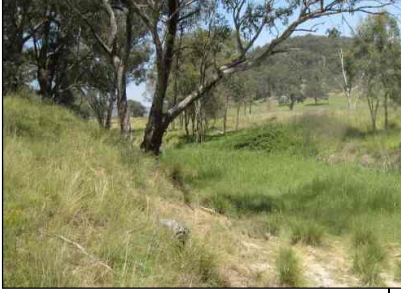
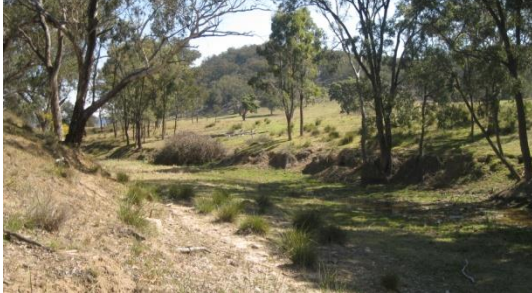
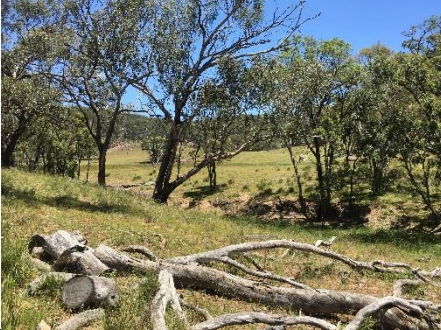
<ul style="list-style-type: none"> <li>▪ Natural regeneration of the site evident – increased ground coverage of the creek banks;</li> <li>▪ Instream flora remains similar;</li> <li>▪ Active channel width remains stable;</li> <li>▪ Reduction in exposure of surface soils on the right banks in 2015;</li> <li>▪ Increase in woody debris in 2015;</li> <li>▪ Riparian zone developing.</li> </ul>
39	No Access - Private property

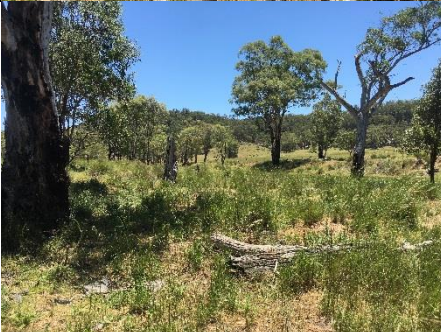
<ul style="list-style-type: none"> <li>▪ Natural regeneration of the site evident – increased ground coverage of the creek banks;</li> <li>▪ Instream flora remains similar;</li> <li>▪ Active channel width remains stable;</li> <li>▪ Increase in woody debris in 2015;</li> <li>▪ Some evidence of stock noted;</li> <li>▪ Riparian zone developing.</li> </ul>

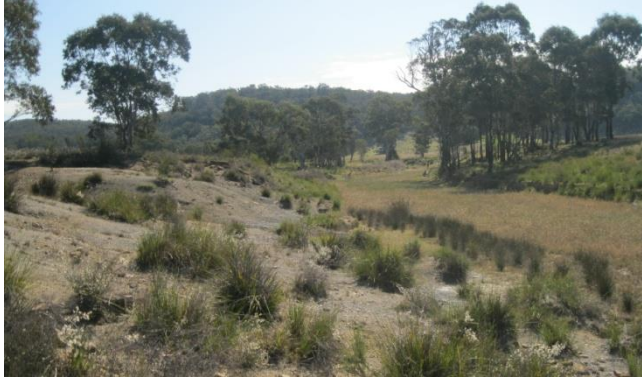
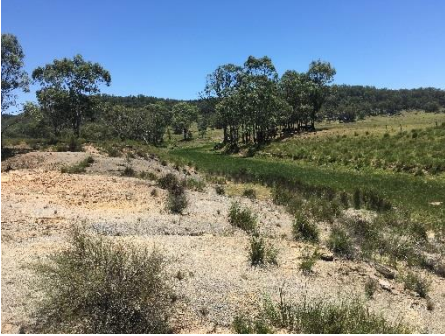
<ul style="list-style-type: none"> <li>▪ Increase in growth of flora species in stream from 2014;</li> <li>▪ An increase in sheet erosion of the exposed bank faces, especially the right bank;</li> <li>▪ Active channel remains stable;</li> <li>▪ Creek bed is well vegetated with little to no exposure of the creek bed;</li> <li>▪ Both banks suffering from soil exposure and sheet erosion;</li> <li>▪ Lack of riparian zone on both banks.</li> </ul>
41	No Access - Private property

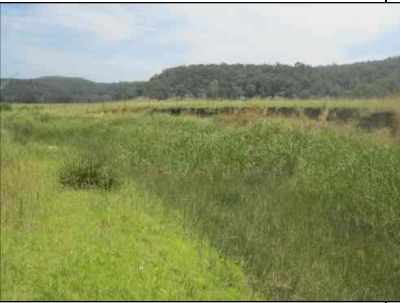
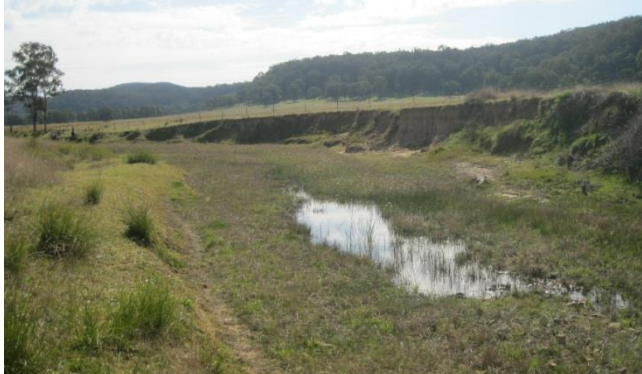
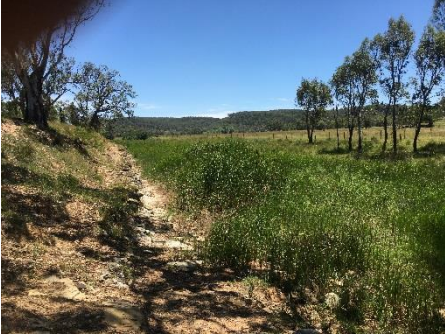
<ul style="list-style-type: none"> <li>▪ Instream flora in the creek bed remains similar;</li> <li>▪ Increased exposure of the right bank resulting in sheet erosion and soil exposure;</li> <li>▪ Minor woody vegetation coverage in the riparian zone;</li> <li>▪ Active channel width remains stable.</li> </ul>

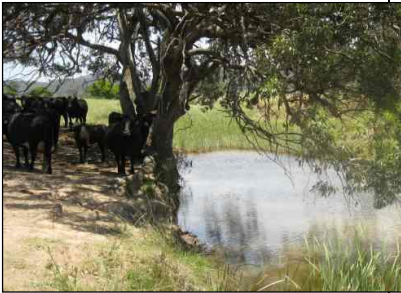
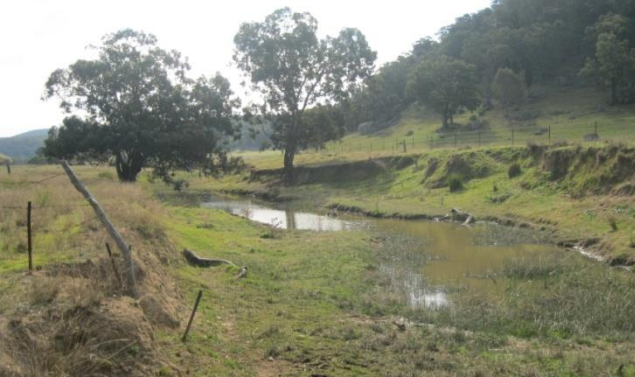
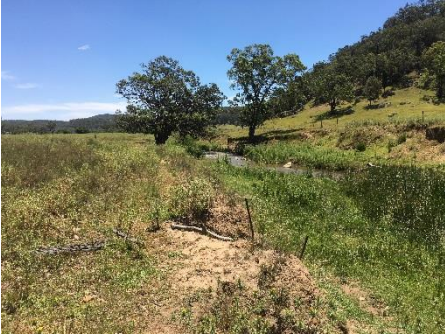
<ul style="list-style-type: none"> <li>Active channel remains stable;</li> <li>Banks remain stable, however there is an increase in soil exposure and potential sheet erosion of the right bank</li> <li>Increased bank stability as a result of an increase in vegetation coverage on both banks;</li> <li>Little to no woody riparian zone in the area.</li> </ul>
45

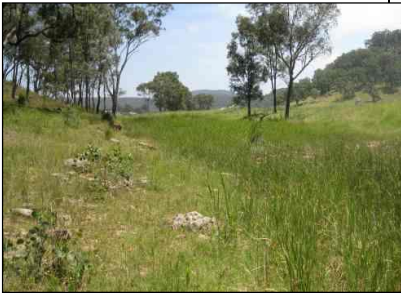
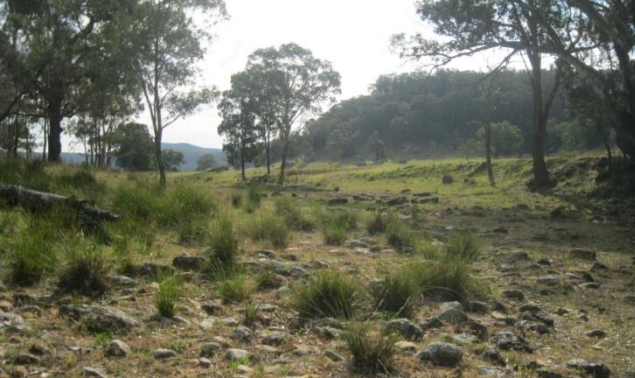
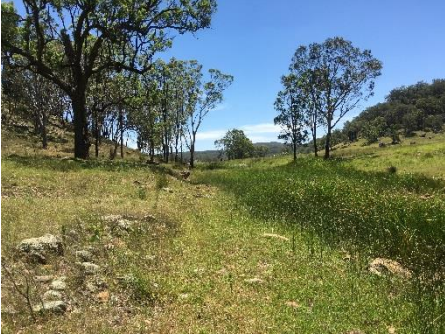
<ul style="list-style-type: none"> <li>Increase in instream flora growth in the creek bed;</li> <li>Bedrock material exposure appears to have reduced over the year;</li> <li>Creek bed width remains stable;</li> <li>Increased vegetation coverage and therefore a reduction in soil exposure on the left bank;</li> <li>Banks remains stable.</li> </ul>
46

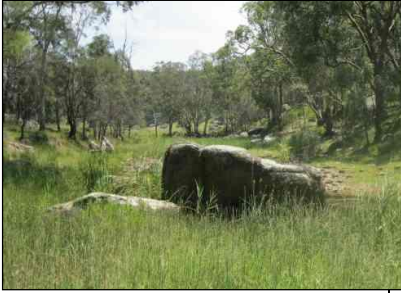
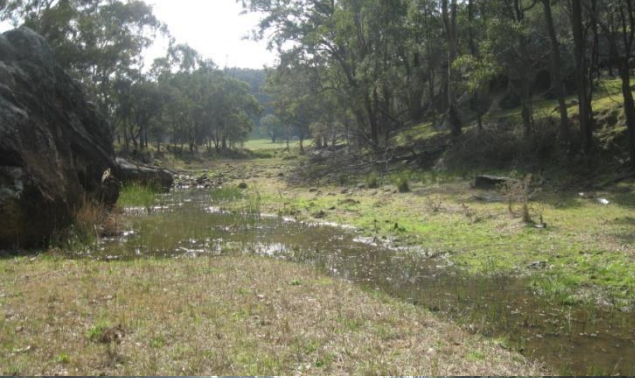
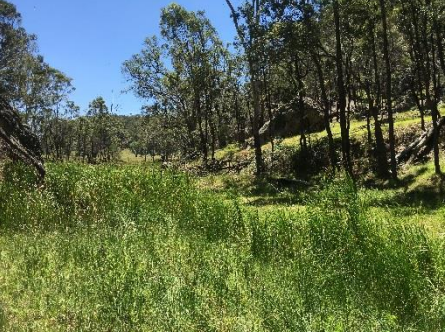
<ul style="list-style-type: none"> <li>Creek bed is well vegetated with little to no exposure of the creek bed;</li> <li>Both banks are well vegetated and stable;</li> <li>There is an increase in the active channel width;</li> <li>Some woody riparian zone – natural regeneration continuing. .</li> </ul>

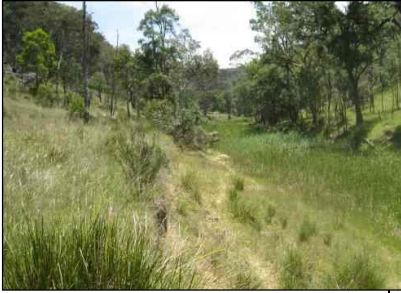
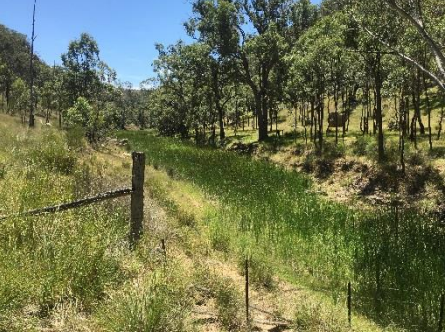
<ul style="list-style-type: none"> <li>An increase in the in stream flora coverage, resulting in a reduction in creek bed exposure;</li> <li>Both banks continue to regenerate as groundcover on the bank faces increases;</li> <li>Site continues to stabilise.</li> </ul>

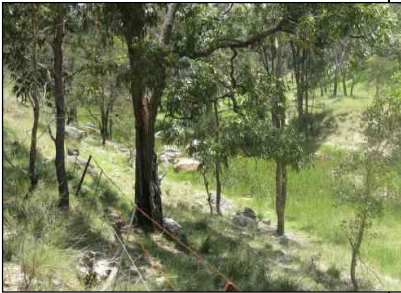
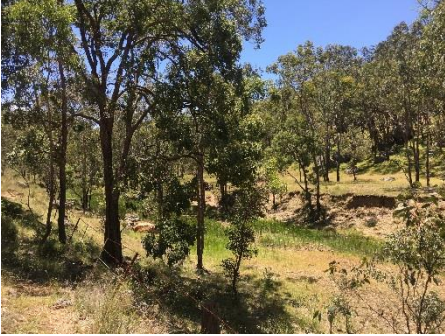
<ul style="list-style-type: none"> <li>▪ Reduction in the active channel width;</li> <li>▪ Increased undercutting and gullyng of the left bank face, as a result of reduced coverage;</li> <li>▪ Soil exposure remains stable instream and on the right bank face.</li> <li>▪ Riparian zone naturally regenerating.</li> </ul>
49

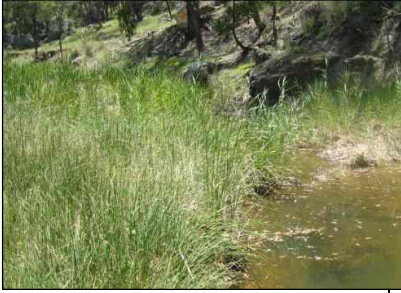
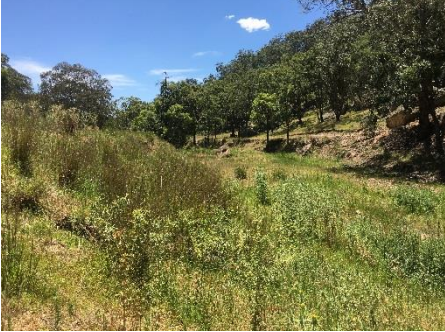
<ul style="list-style-type: none"> <li>▪ A reduction in the active channel width;</li> <li>▪ There has been an increase in groundcover within the creek bed, resulting in a reduction of soil and bed exposure;</li> <li>▪ There is an increase in groundcoverage on both bank faces, as a result of natural regeneration;</li> <li>▪ Site continues to regenerate.</li> </ul>

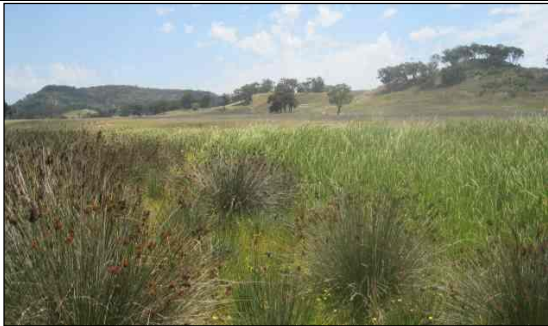
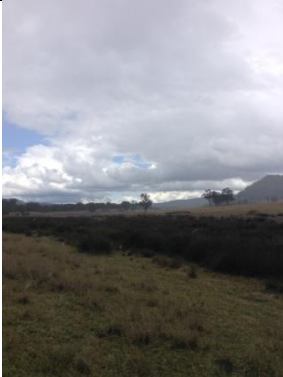
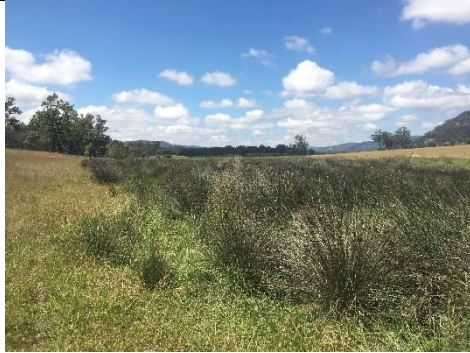
<ul style="list-style-type: none"> <li>Site remains well vegetated and stable;</li> <li>Lack of woody riparian zone.</li> </ul>
2

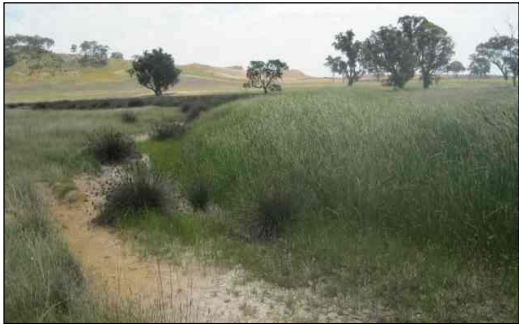
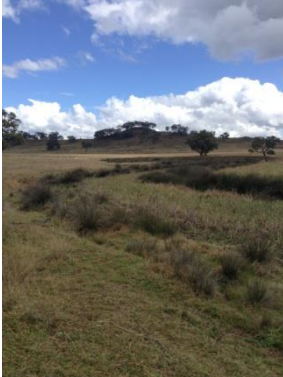
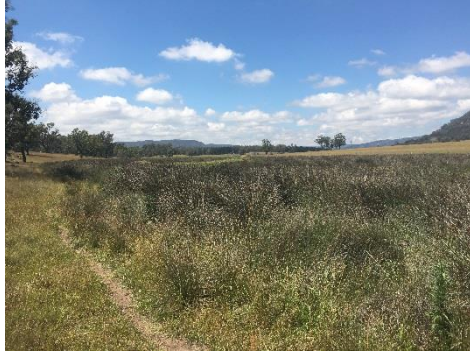
<ul style="list-style-type: none"> <li>Site remains well vegetated and stable;</li> <li>Lack of woody riparian zone.</li> </ul>
3

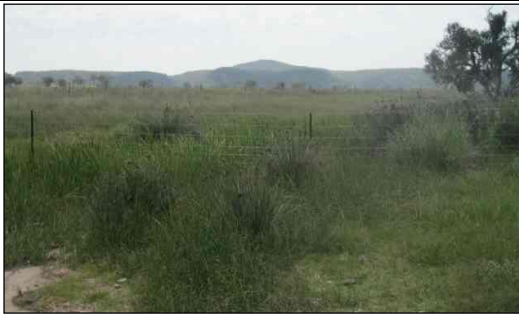
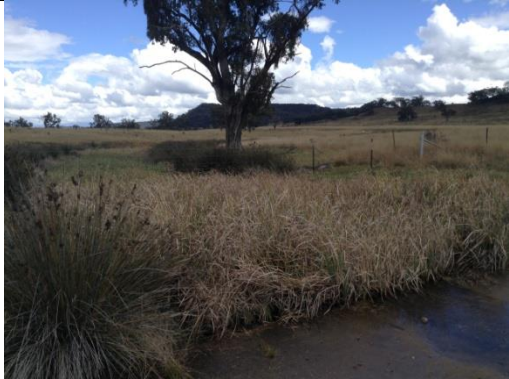
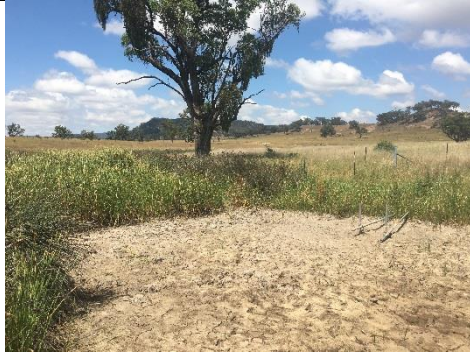
<ul style="list-style-type: none"> <li>Ponding site – lack of groundcover and growth due to inundation in the creek bed;</li> <li>Site banks remain well vegetated and stable.</li> </ul>
4

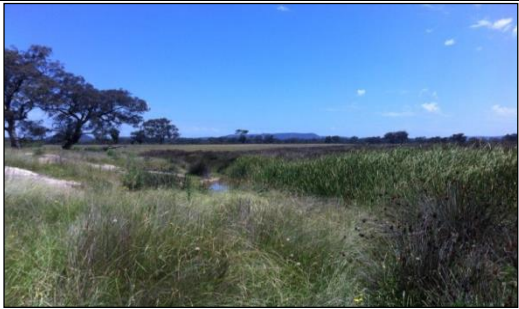
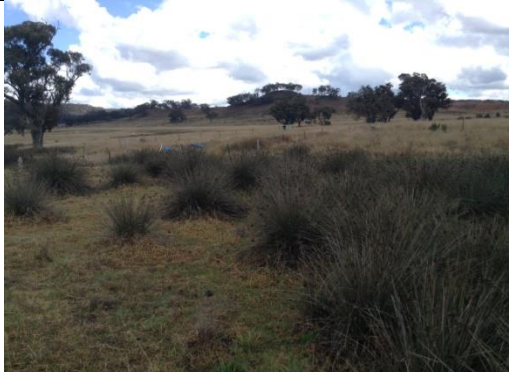
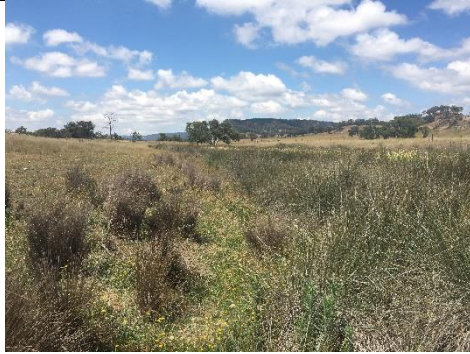
<ul style="list-style-type: none"> <li>Site remains well vegetated and stable;</li> <li>Lack of woody riparian zone.</li> </ul>

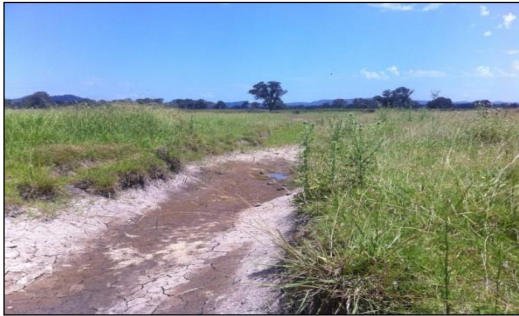
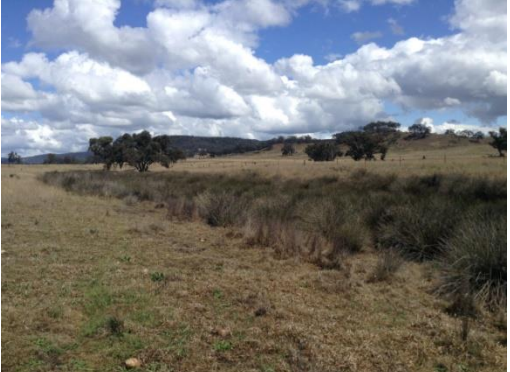
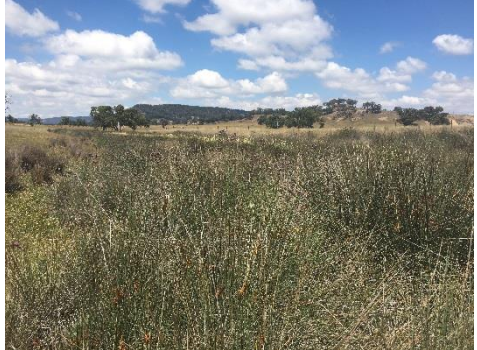
5

<ul style="list-style-type: none"> <li>Site remains well vegetated and stable;</li> <li>Lack of woody riparian zone.</li> </ul>
6
