## **APPENDIX 3C – SURFACE WATER MONITORING**

# Wilpinjong & Cumbo Creek Stability Assessment, 2015

Wilpinjong Coal Mine

Mar-16  
(Our Reference: 23823\_E01\_Final)

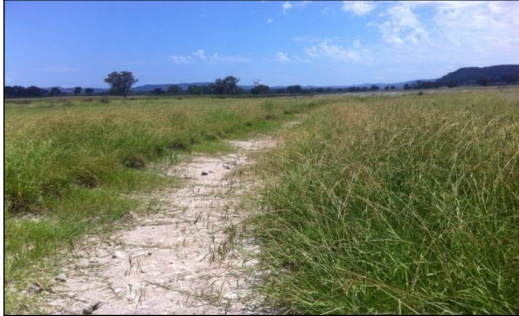
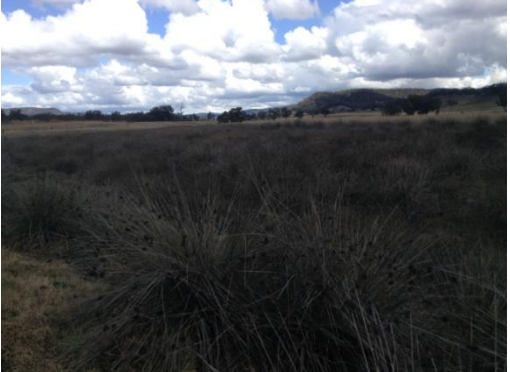
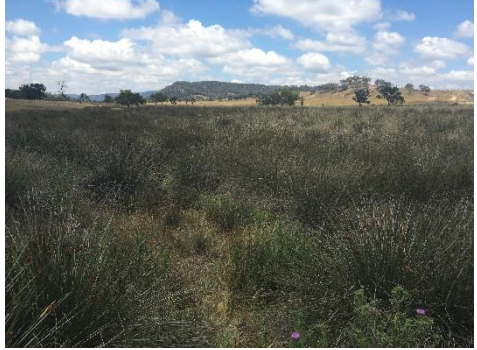
<ul style="list-style-type: none"> <li>Site remains well vegetated and stable;</li> <li>Lack of woody riparian zone.</li> </ul>
7

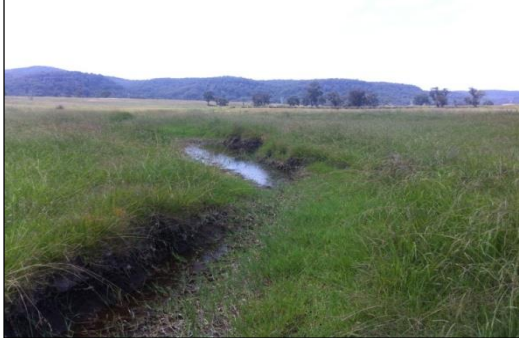
Missing due to construction

<ul style="list-style-type: none"> <li>Area exposed due to construction activities – lack of bed coverage and bank coverage in 2015</li> </ul>
8

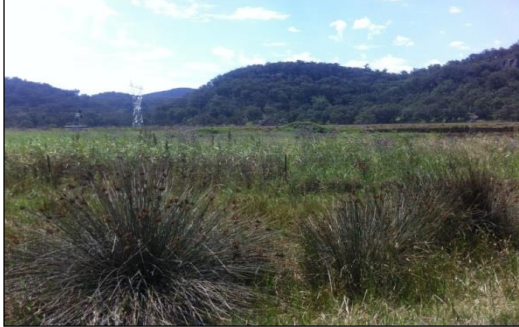
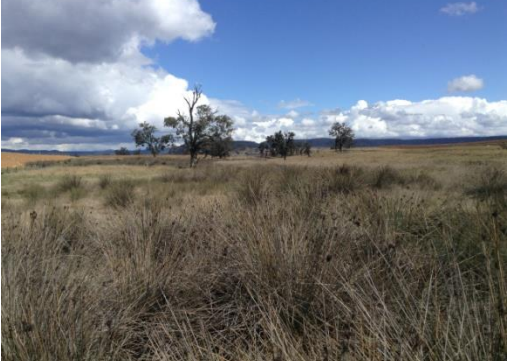
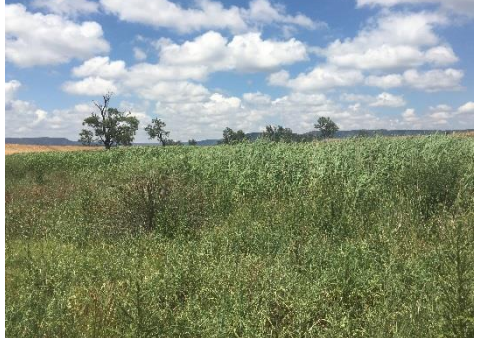
<ul style="list-style-type: none"> <li>Site remains well vegetated and stable;</li> <li>Lack of woody riparian zone.</li> </ul>

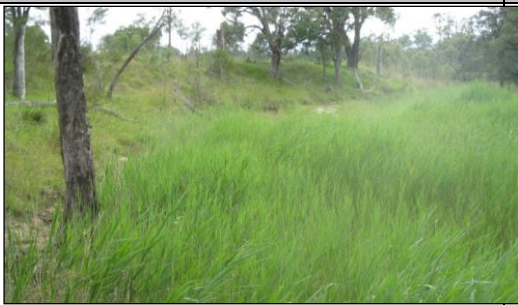
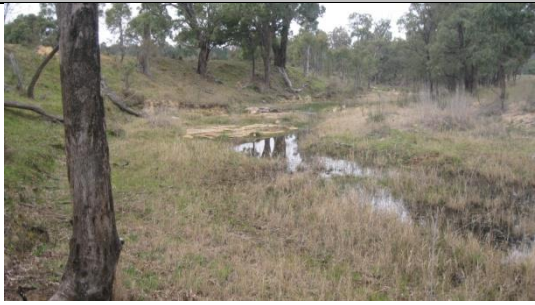
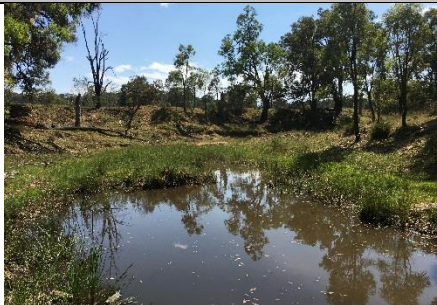
<ul style="list-style-type: none"> <li>▪ Increase pooling zone in 2015 to 2014;</li> <li>▪ Reduction in vegetative groundcover over the years;</li> <li>▪ Reduction in instream flora;</li> <li>▪ Increased sediment deposition midstream, creating a bar feature;</li> </ul>
2

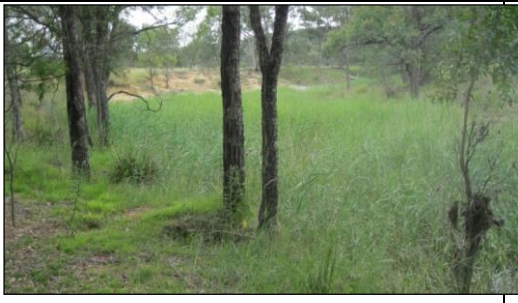
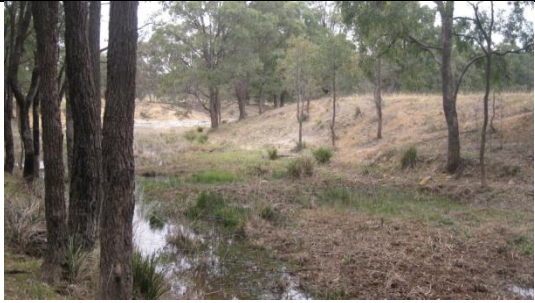
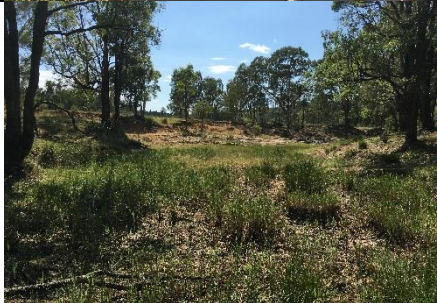
<ul style="list-style-type: none"> <li>▪ Continued growth of instream flora in 2015 from 2014. Reduction since 2011;</li> <li>▪ Increased sediment deposition between 2014-2015;</li> <li>▪ Riparian vegetation maturing;</li> <li>▪ Increased leaf litter on both banks – 2014-2015;</li> <li>▪ Evidence of stock, wombats and pigs in and around the creek.</li> </ul>
3

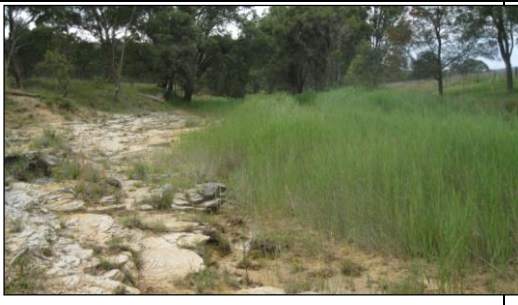
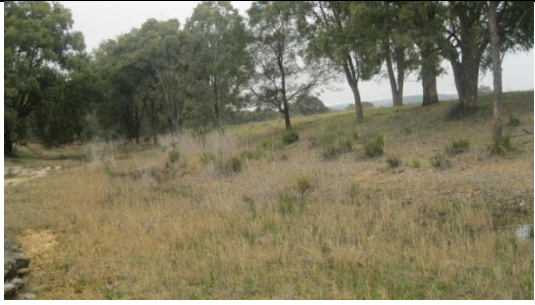
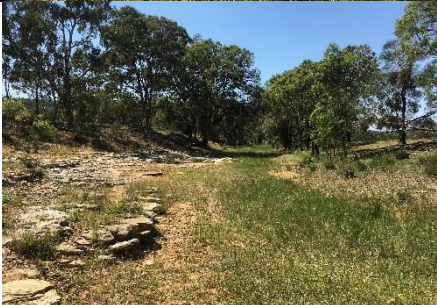
<ul style="list-style-type: none"> <li>▪ Although there is a reduction of instream growth since 2011, instream flora (grasses) is maintained between 2014-2015;</li> <li>▪ Increased sediment deposition between 2014-2015;</li> <li>▪ Riparian vegetation maturing;</li> <li>▪ Increased leaf litter on both banks – 2014-2015;</li> <li>▪ Increased exposure of bedrock on the right bank;</li> <li>▪ Evidence of stock, wombats and pigs in and around the creek.</li> </ul>

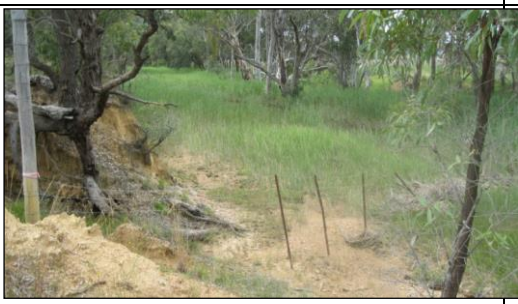
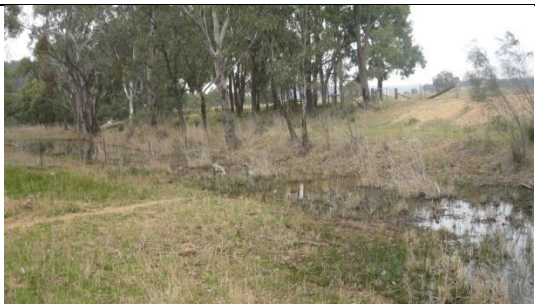
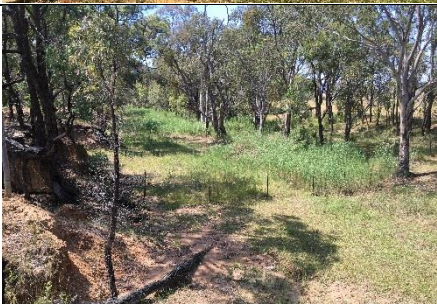
4

<ul style="list-style-type: none"> <li>▪ Increased erosion and exposure of the left bank;</li> <li>▪ Stabilisation of instream flora – reduction from 2011;</li> <li>▪ Continued sediment deposition instream,;</li> <li>▪ Riparian Areas improving in growth, no evidence of stock.</li> </ul>
5

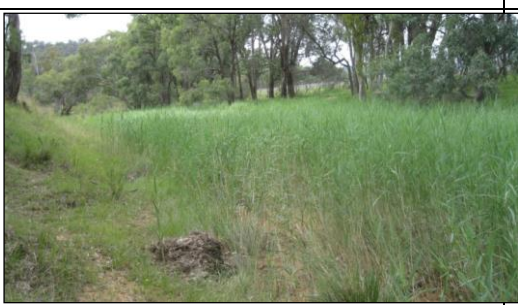
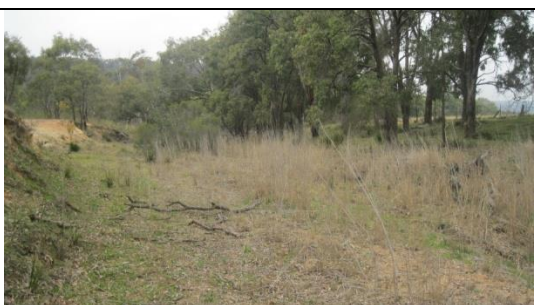
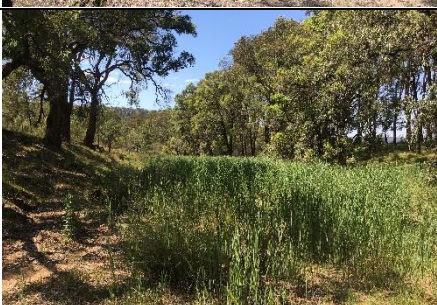
<ul style="list-style-type: none"> <li>▪ 2015 drier than the previous seasons;</li> <li>▪ Reduction in vegetative groundcover on the banks over the years;</li> <li>▪ Stabilisation instream flora in this location</li> <li>▪ Increased sediment deposition midstream, creating a bar feature;</li> </ul>

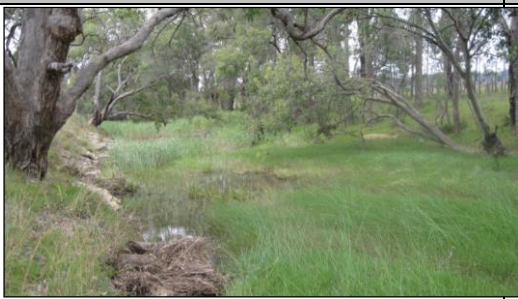
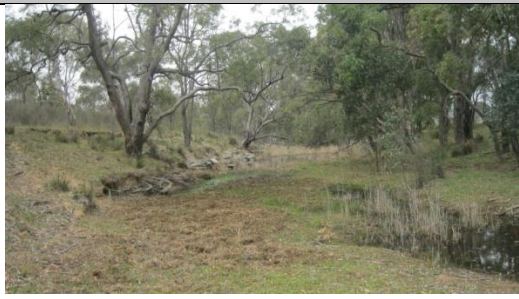
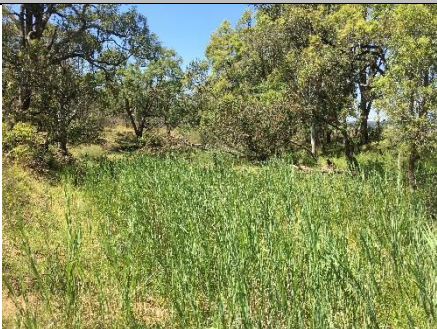
Sit e	Downstream December 2011	Downstream September 2014	Downstream December 2015	Main Comparisons
6

<ul style="list-style-type: none"> <li>Increased growth of grass species in the creek bed in 2015;</li> <li>An increase in the active channel;</li> <li>Natural regeneration since 2011;</li> <li>No evidence of stock in 2015.</li> </ul>
7

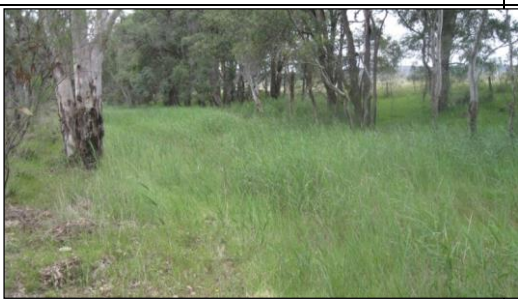
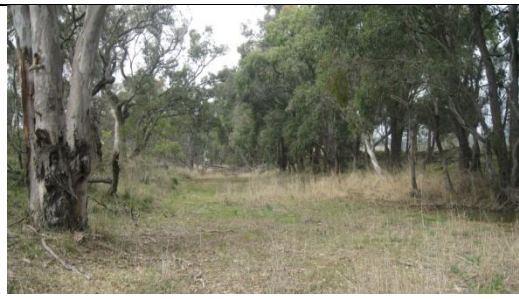
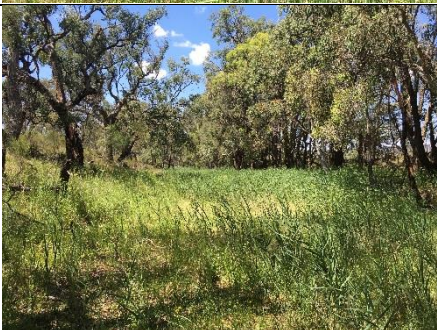
<ul style="list-style-type: none"> <li>Increased growth of grass species in the creek bed in 2015;</li> <li>Improved groundcover on both banks;</li> <li>An increase in the active channel;</li> <li>Natural regeneration since 2011;</li> <li>No evidence of stock in 2015.</li> </ul>
8

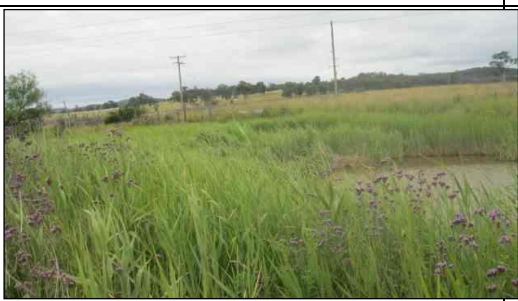
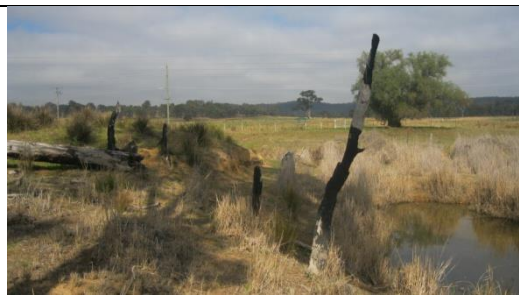
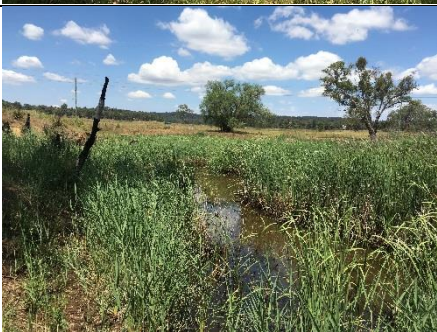
<ul style="list-style-type: none"> <li>Increased growth of flora species in the creek bed in 2015;</li> <li>Improved groundcover on both banks;</li> <li>An increase in the active channel;</li> <li>Stabilisation of the banks;</li> <li>Lack of riparian vegetation still apparent;</li> <li>No evidence of stock in 2015.</li> </ul>

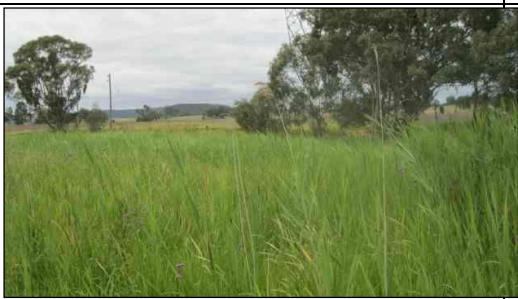
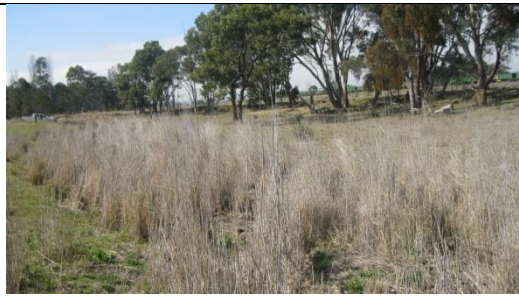
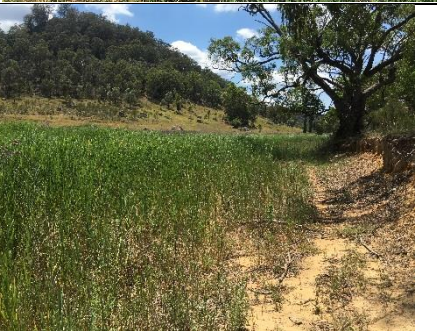
9

<ul style="list-style-type: none"> <li>Increased growth of flora species in the creek bed in 2015;</li> <li>Right bank suffering scolding and sheet erosion – ongoing over the years;</li> <li>Minimal riparian zone;</li> <li>Natural regeneration slow in this area.</li> <li>Increased bleaching of exposure soils of the bank faces;</li> </ul>
10

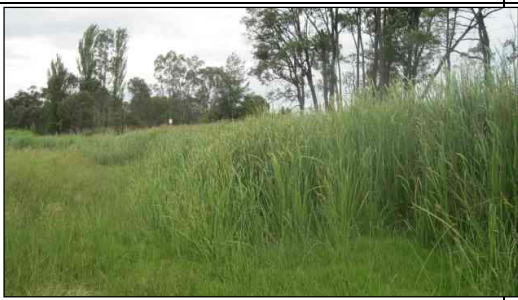
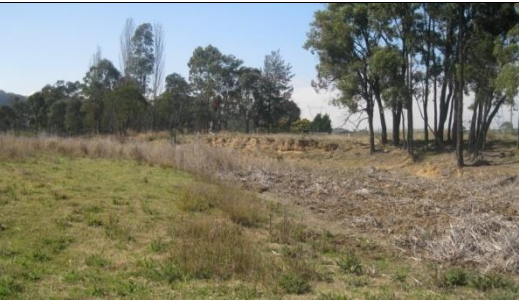
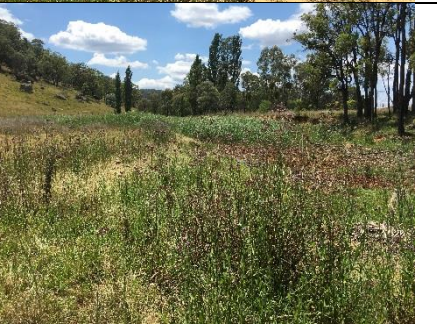
<ul style="list-style-type: none"> <li>Increased natural regeneration occurring;</li> <li>Increased growth of flora species in the creek bed since 2015;</li> <li>Improved bank stability in 2015;</li> <li>Evidence of pigs at site in 2015.</li> </ul>

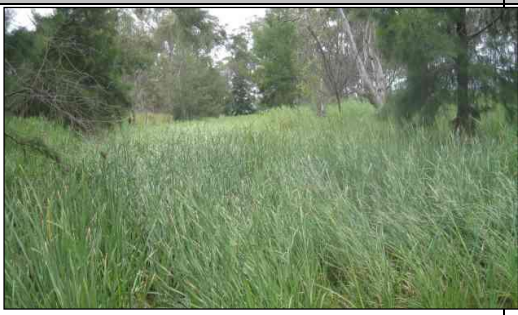
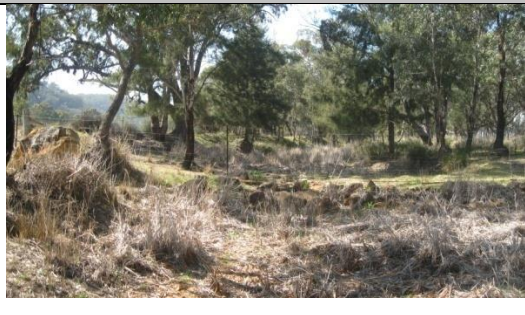
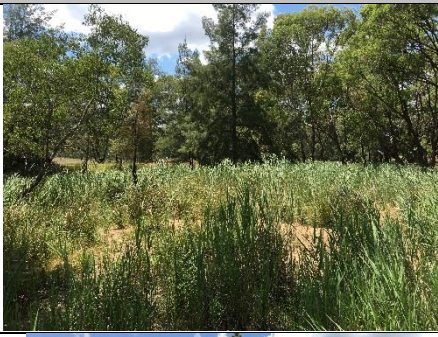
Sit e	Downstream December 2011	Downstream September 2014	Downstream December 2015	Main Comparisons
11

<ul style="list-style-type: none"> <li>Area has been fenced out allowing for natural regeneration to occur;</li> <li>Increased growth of flora species in the creek bed since 2014;</li> <li>Increased coverage of grass species on the creek banks;</li> <li>Riparian zone remains stable;</li> <li>Increased active channel width in 2015 – pooling at site</li> </ul>
12

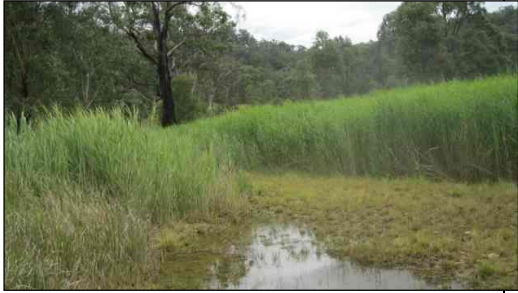
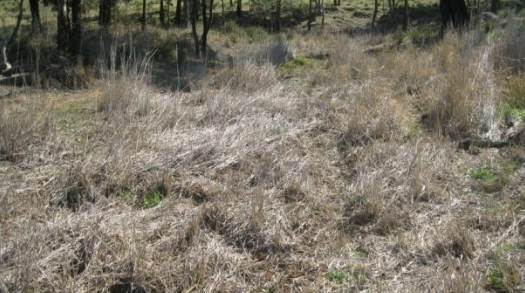
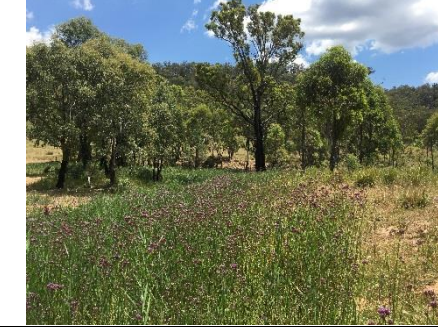
<ul style="list-style-type: none"> <li>Site remains relatively stable in 2015;</li> <li>Area has been fenced out allowing for natural regeneration to occur;</li> <li>Increased growth of flora species in the creek bed since 2014;</li> <li>Some reduction in ground coverage of grass species on the creek banks;</li> <li>Increased active channel width in 2015;</li> <li>Evidence of wombats in the area in 2015.</li> </ul>

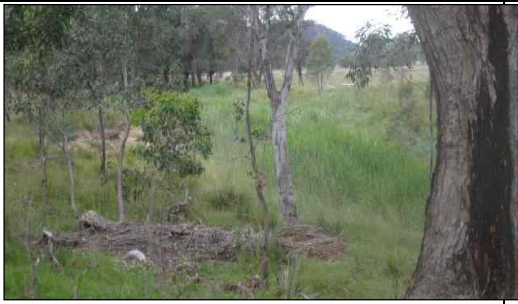
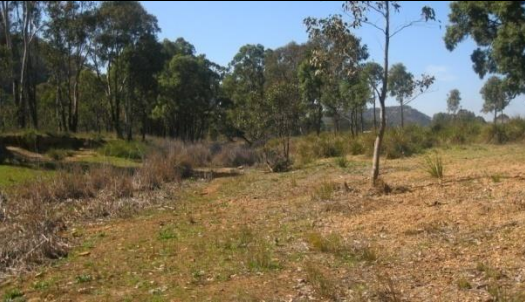
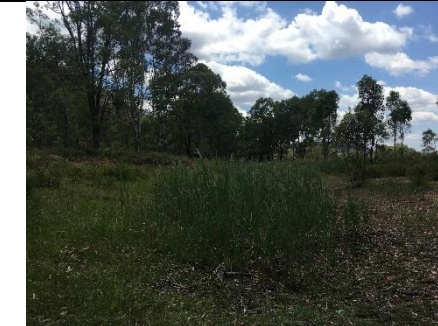
13

<ul style="list-style-type: none"> <li>Site remains relatively stable in 2015;</li> <li>Area has been fenced out allowing for natural regeneration to occur;</li> <li>Increased growth of flora species in the creek bed since 2014;</li> <li>Increased coverage of grass species on the creek banks – reduction in soil exposure;</li> <li>Increased pooling at site in 2015;</li> </ul>
14

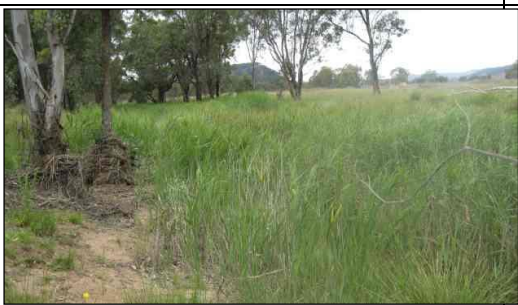
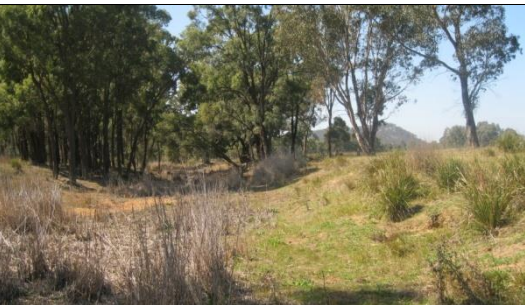
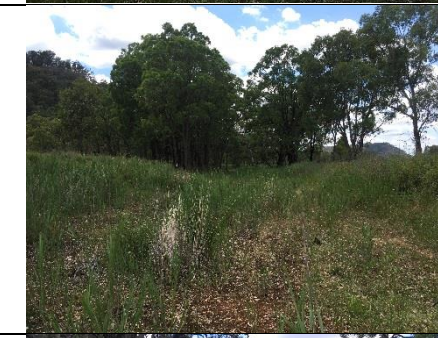
<ul style="list-style-type: none"> <li>Area has been fenced out allowing for natural regeneration to occur;</li> <li>Increased growth of flora species in the creek bed since 2014;</li> <li>Reduction of bank exposure in 2015;</li> <li>Increased coverage of grass species on the creek banks;</li> <li>Evidence of wombats in the area in 2015</li> </ul>
15

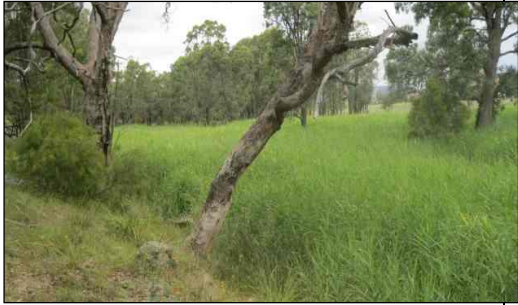
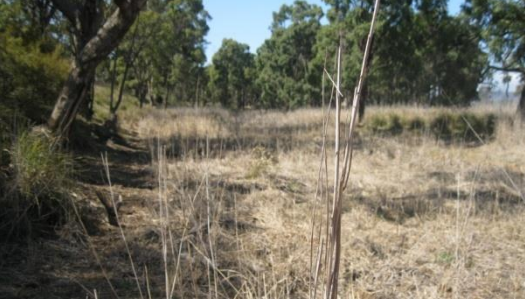
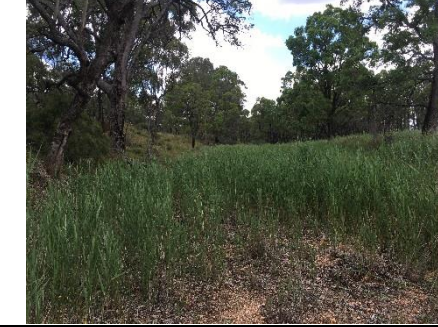
<ul style="list-style-type: none"> <li>Site remains relatively stable in 2015;</li> <li>Area has been fenced out allowing for natural regeneration to occur;</li> <li>Increased growth of flora species in the creek bed since 2014;</li> <li>Increased coverage of grass species on the creek banks;</li> <li>Increased active channel width in 2015;</li> <li>Evidence of wombats in the area in 2015</li> </ul>

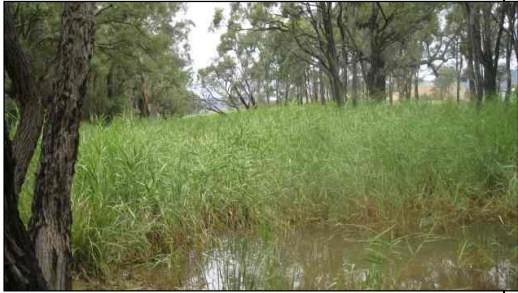
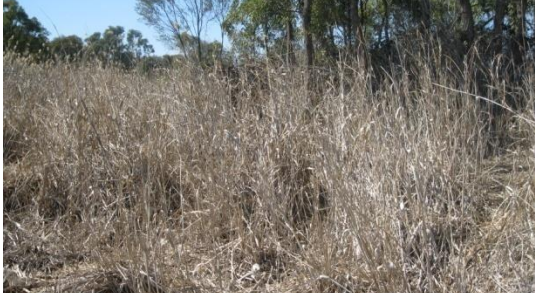
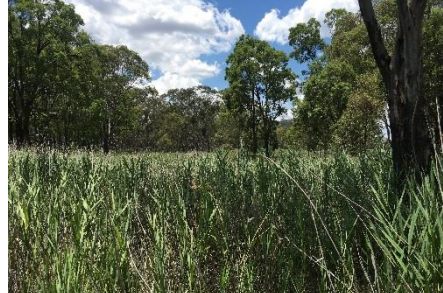
Sit e	Downstream December 2011	Downstream September 2014	Downstream December 2015	Main Comparisons
16

<ul style="list-style-type: none"> <li>Site remains relatively stable in 2015;</li> <li>Area has been fenced out allowing for natural regeneration to occur;</li> <li>Increased growth of flora species in the creek bed since 2014;</li> <li>Increased coverage of grass species on the creek banks;</li> <li>Increased active channel width in 2015;</li> <li>Evidence of wombats in the area in 2015</li> </ul>
17

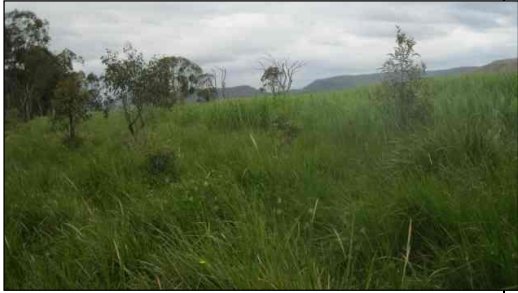
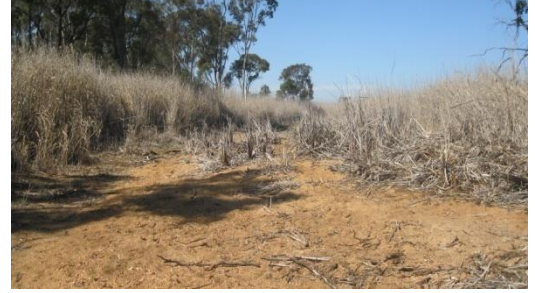
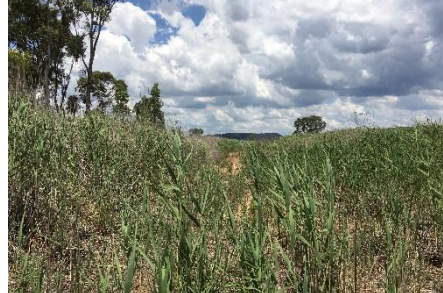
<ul style="list-style-type: none"> <li>Site moved due to lack of access in 2015;</li> <li>No evidence of stock in the location;</li> <li>Evidence of natural regeneration occurring at the site;</li> <li>Banks stable.</li> </ul>
18

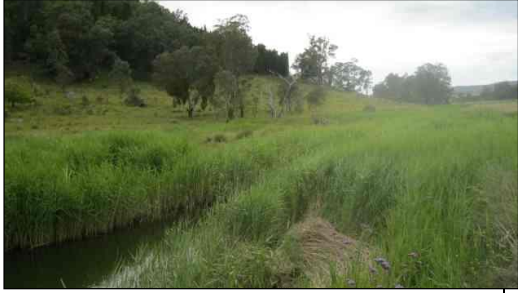
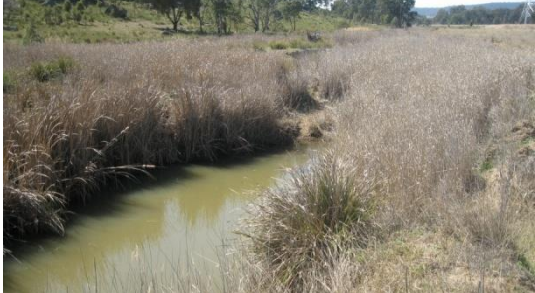
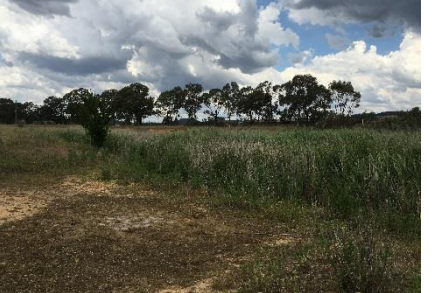
<ul style="list-style-type: none"> <li>Increased exposure of soils along access track and in the creek bed;</li> <li>Bank ground coverage 100%;</li> <li>Active sediment deposition zone;</li> <li>Little to no woody riparian zone.</li> </ul>

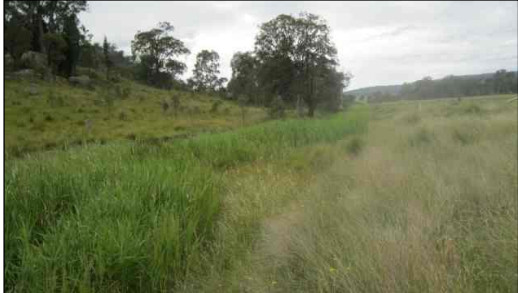
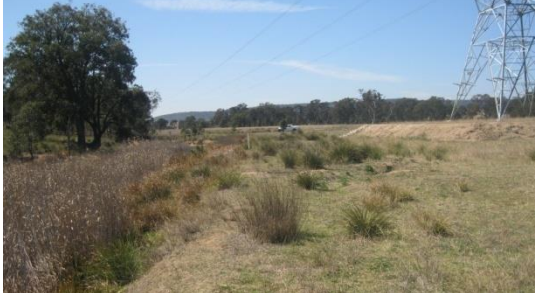
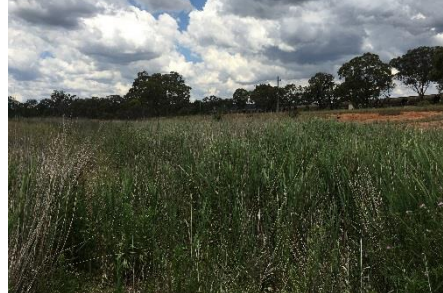
<ul style="list-style-type: none"> <li>Site remains relatively stable in 2015;</li> <li>Area has been fenced out allowing for natural regeneration to occur;</li> <li>Increased growth of flora species in the creek bed since 2014;</li> <li>Increased coverage of grass species on the creek banks;</li> </ul>
20

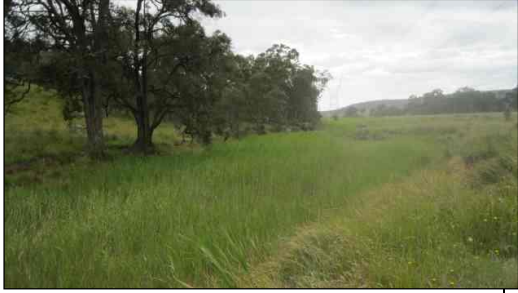
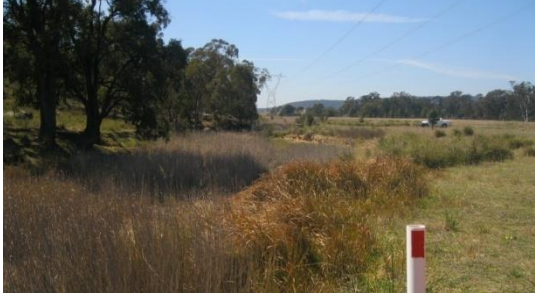
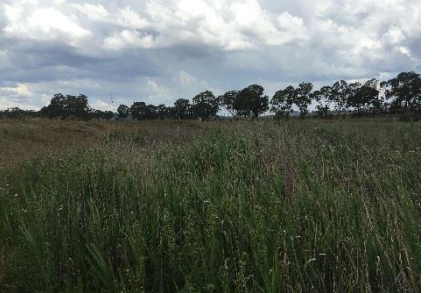
<ul style="list-style-type: none"> <li>Increase in healthy instream flora;</li> <li>Increased growth of flora species in the creek bed since 2014;</li> <li>Increased coverage of grass species on the creek bank;</li> <li>Little to no riparian zone.</li> </ul>

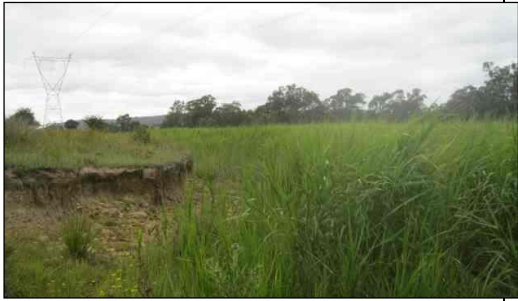
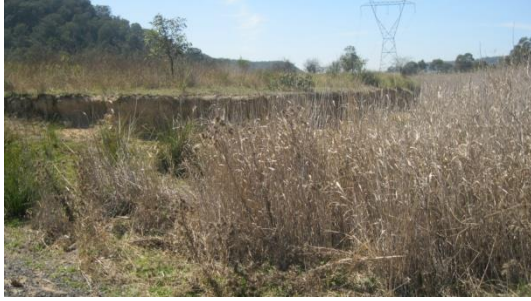
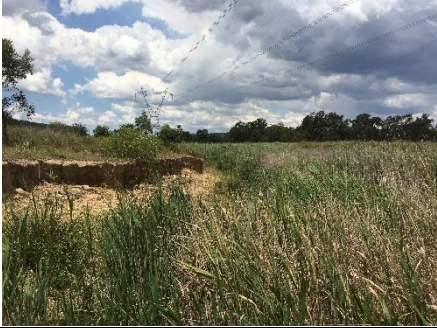
<ul style="list-style-type: none"> <li>Site remains relatively similar in 2015;</li> <li>Some increase in exposed soil on the left bank;</li> <li>Little to no riparian zone.</li> </ul>
22

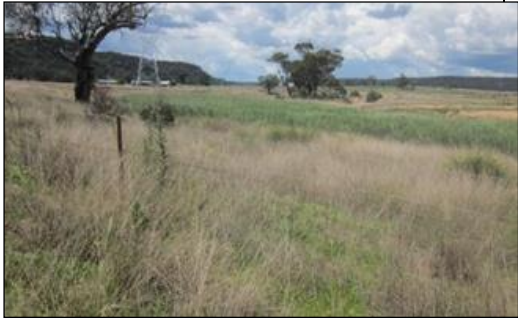
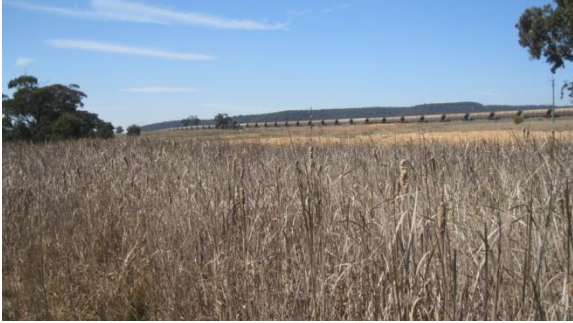
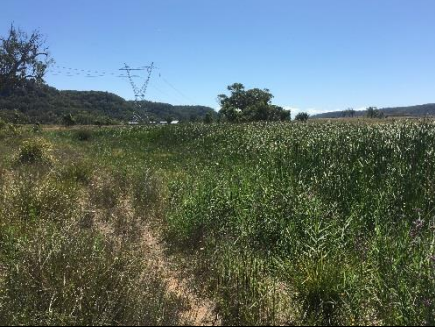
<ul style="list-style-type: none"> <li>Increase in healthy instream flora;</li> <li>Reduction in exposed soils on the right bank face – increased regeneration;</li> <li>An increase in sheet erosion of the right bank;</li> <li>Left bank remains stable;</li> <li>Active channel remains stable;</li> <li>Little to no riparian zone;</li> <li>Evidence of wombats.</li> </ul>
25

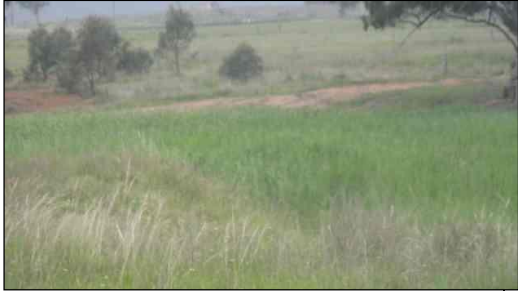
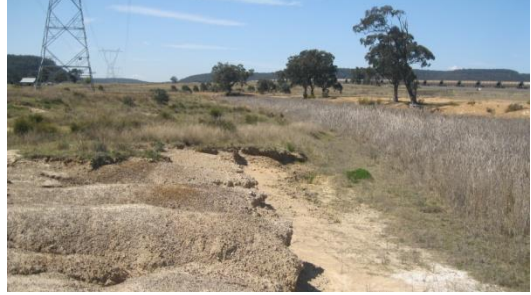
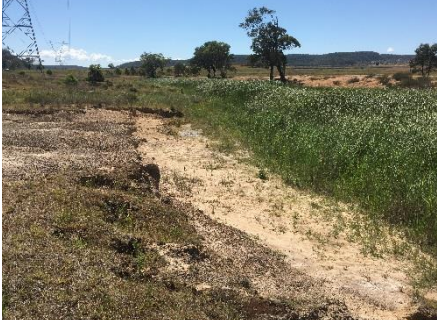
<ul style="list-style-type: none"> <li>Increase in growth of flora species in stream from 2014;</li> <li>An increase in sheet erosion of the exposed bank faces; ;</li> <li>Active channel remains stable;</li> <li>Little to no riparian zone;</li> <li>Evidence of wombats;</li> <li>Stabilisation of left bank erosion;</li> <li>Continued slumping and undercutting of the left bank.</li> </ul>

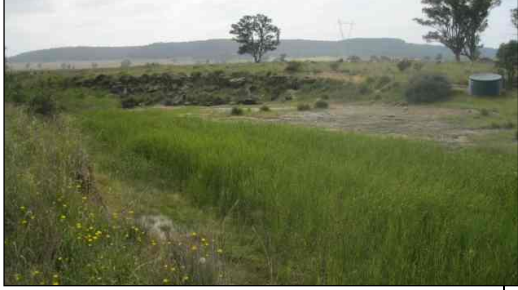
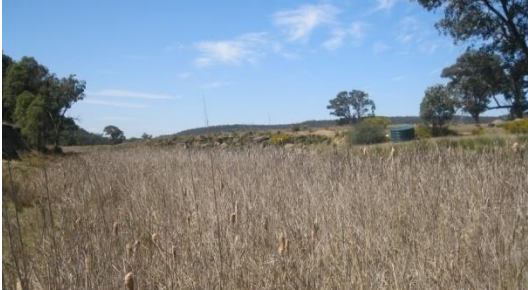
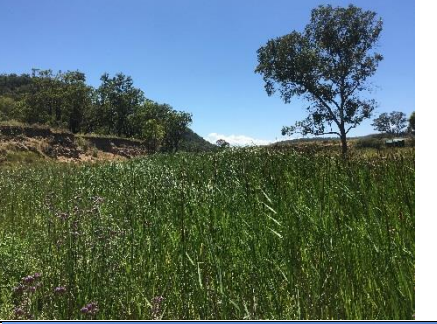
<ul style="list-style-type: none"> <li>▪ Increase in growth of flora species in stream from 2014;</li> <li>▪ An increase in sheet erosion of the exposed bank faces, especially the left bank;</li> <li>▪ Active channel remains stable;</li> <li>▪ Little to no riparian zone;</li> <li>▪ Evidence of wombats and rabbits;</li> <li>▪ Blackberry noted around the site</li> </ul>
29

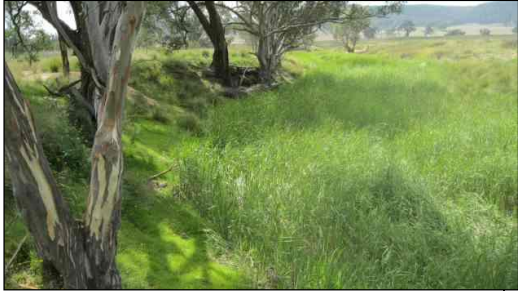
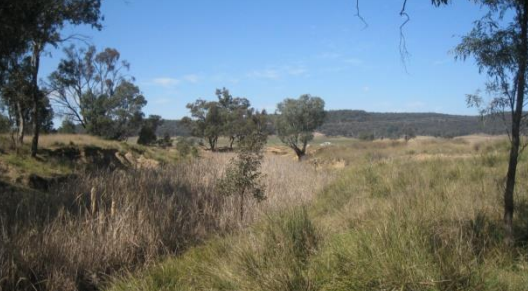
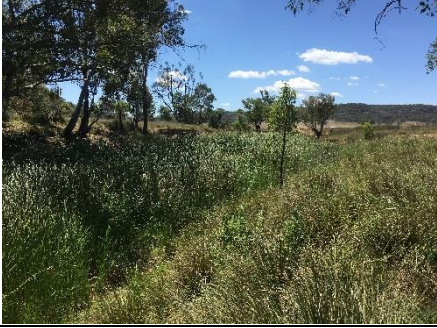
<ul style="list-style-type: none"> <li>▪ Evidence of natural regeneration occurring;</li> <li>▪ Good coverage of the creek bed and banks;</li> <li>▪ Riparian zone limited to non-woody vegetation;</li> <li>▪ Good general regeneration in the riparian areas as a result of destocking.</li> <li>▪ Increased bank stability of the right bank;</li> <li>▪ Left bank face continues to erode naturally as a result of steep slopes and lack of ground cover;</li> </ul>

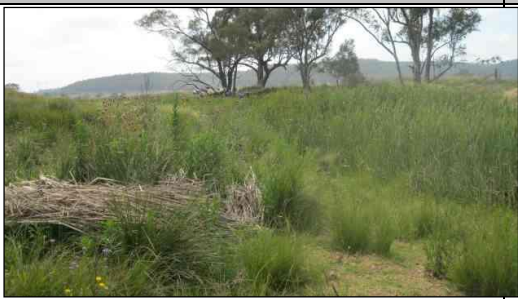
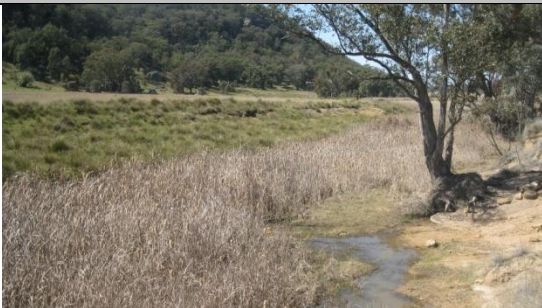
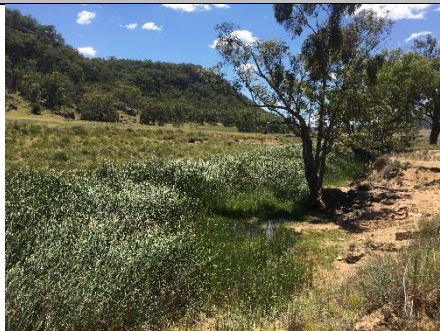
<ul style="list-style-type: none"> <li>▪ Increase in growth of flora species in stream from 2014;</li> <li>▪ An increase in sheet erosion of the exposed bank faces, especially the right bank;</li> <li>▪ Active channel remains stable;</li> <li>▪ Little to no riparian zone;</li> <li>▪ Evidence of wombats and rabbits;</li> <li>▪ Evidence of water ponding in the area in 2015;</li> <li>▪ No evidence of salt crystallisation on the right bank in exposed areas in 2015.</li> </ul>
32

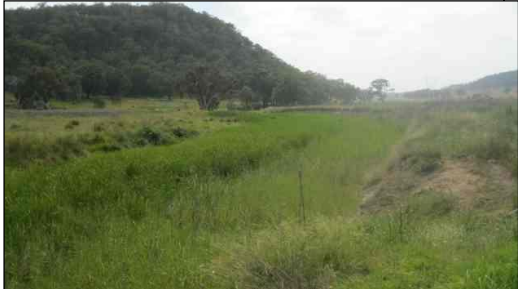
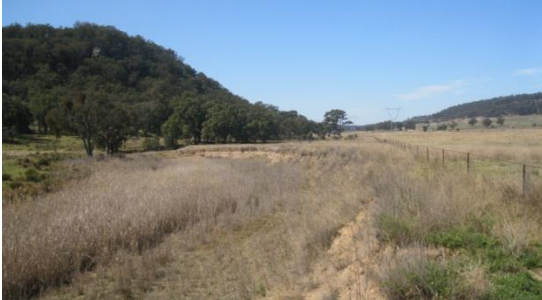
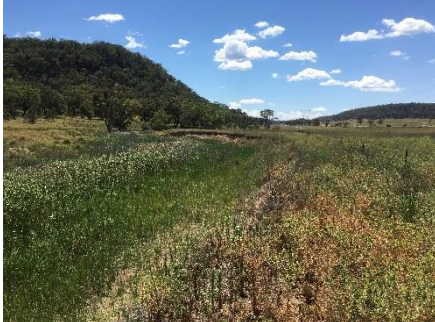
<ul style="list-style-type: none"> <li>▪ Increase in growth of flora species in stream from 2014;</li> <li>▪ An increase in sheet erosion of the exposed bank faces, Active channel remains stable;</li> <li>▪ Little to no riparian zone;</li> <li>▪ Evidence of water ponding in the area in 2015;</li> <li>▪ Continued regression and erosion of the right bank;</li> </ul>

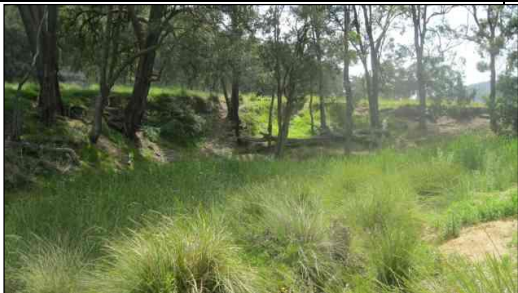
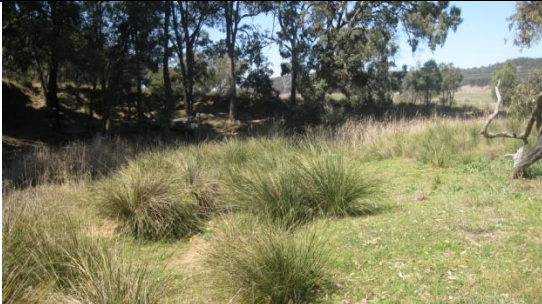
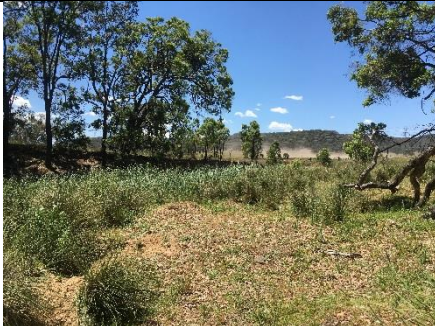
<ul style="list-style-type: none"> <li>▪ Similar growth of flora species in stream from 2014;</li> <li>▪ Active channel remains stable;</li> <li>▪ Little to no riparian zone;</li> <li>▪ Bank remains similar.</li> </ul>
34

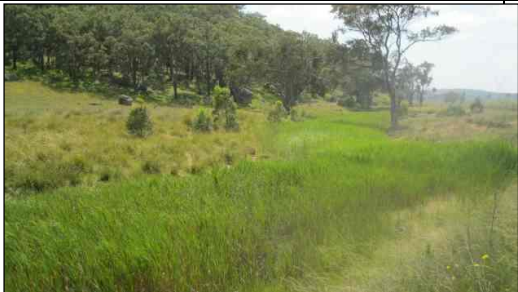
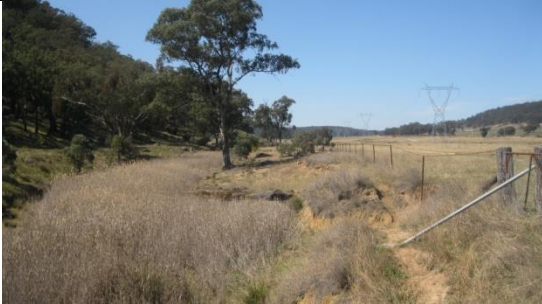
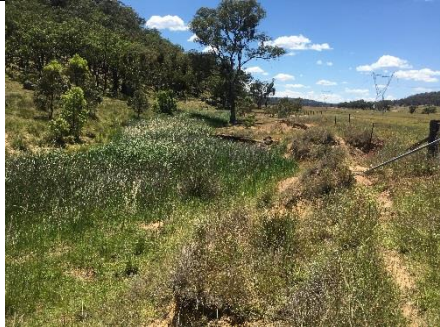
<ul style="list-style-type: none"> <li>▪ Reduction in healthy instream flora;</li> <li>▪ Soil exposure and erosion of the left bank remains stable;</li> <li>▪ Site remains similar.</li> </ul>
35

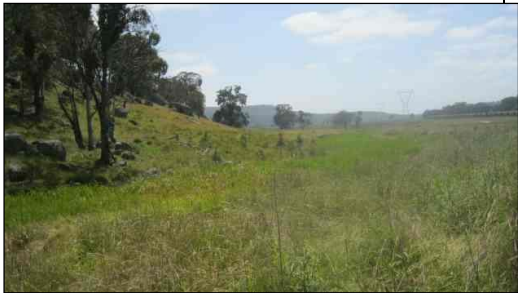
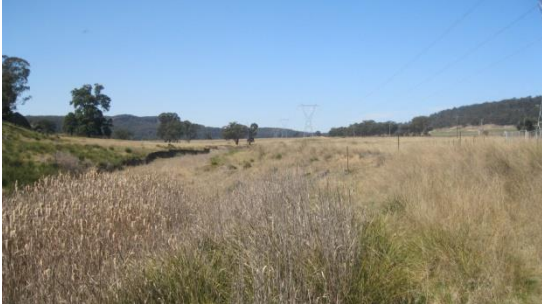
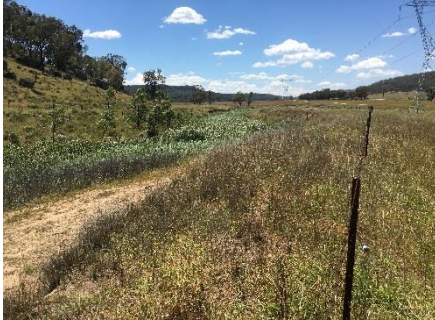
<ul style="list-style-type: none"> <li>▪ Reduction in growth of flora species in stream from 2014;</li> <li>▪ Increase in exposure on the bank surfaces, resulting in sheet erosion;</li> <li>▪ Site remains similar.</li> <li>▪ Little to no riparian zone;</li> </ul>

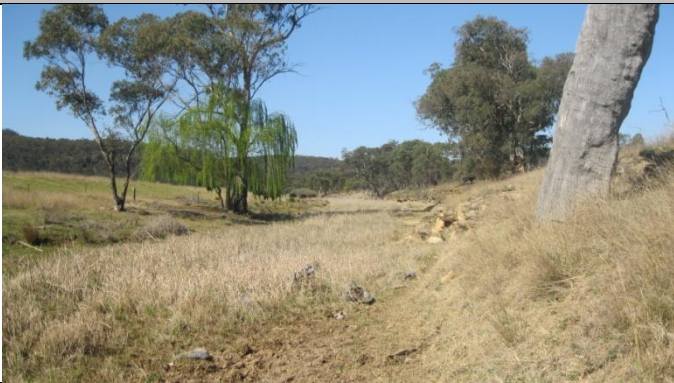
No Access – 2015 - cropping	<ul style="list-style-type: none"> <li>No comparison</li> </ul>
42

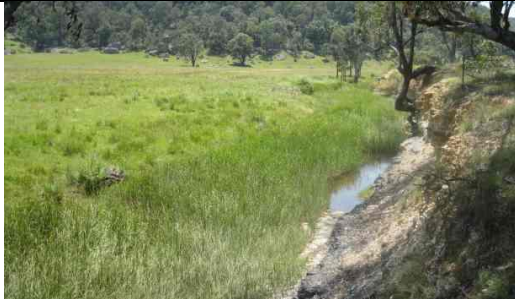
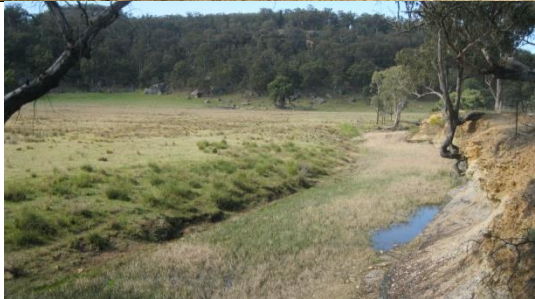
No Access – 2015 - cropping	<ul style="list-style-type: none"> <li>No comparison</li> </ul>
43

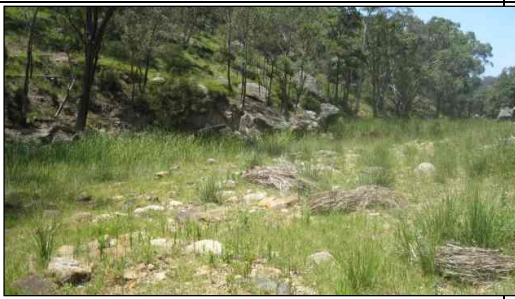
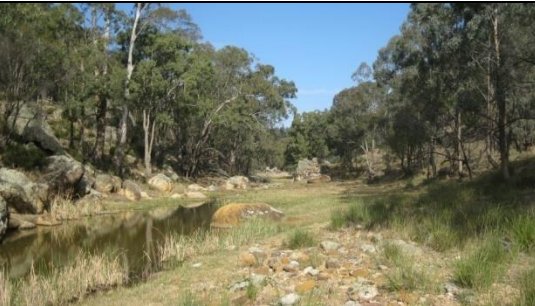
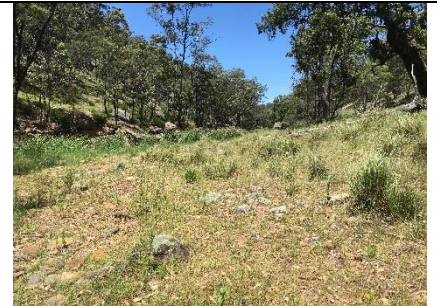
45

<ul style="list-style-type: none"> <li>Increase in instream flora growth in the creek bed;</li> <li>Bedrock material exposure appears to have reduced over the year;</li> <li>Creek bed width remains stable;</li> <li>Increased vegetation coverage and therefore a reduction in soil exposure on the left bank;</li> <li>Banks remains stable.</li> </ul>

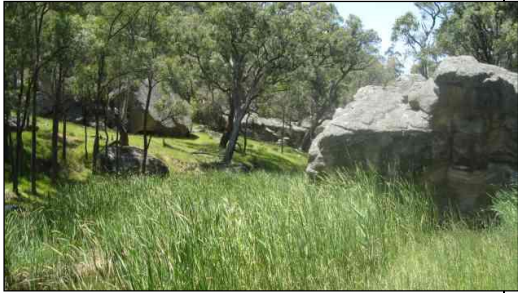
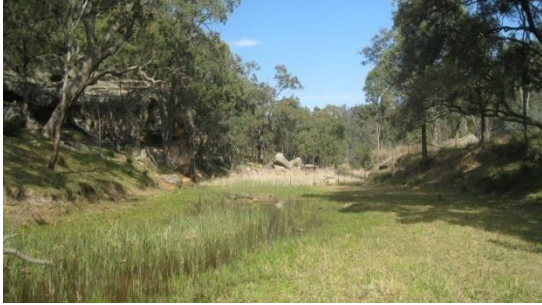
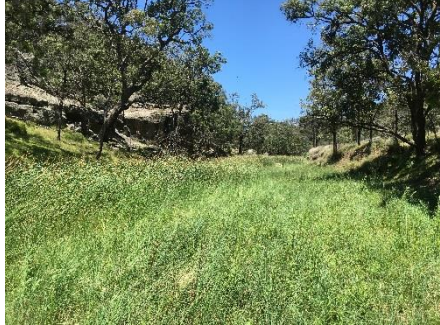
<ul style="list-style-type: none"> <li>▪ Creek bed is well vegetated with little to no exposure of the creek bed;</li> <li>▪ Both banks are well vegetated and stable;</li> <li>▪ There is an increase in the active channel width;</li> <li>▪ Some woody riparian zone – natural regeneration continuing. .</li> </ul>
47

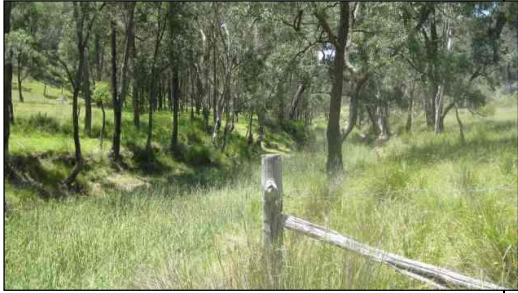
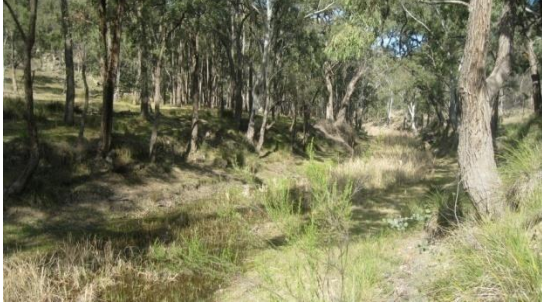
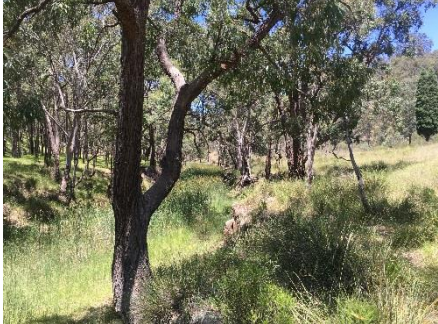
<ul style="list-style-type: none"> <li>▪ An increase in the in stream flora coverage, resulting in a reduction in creek bed exposure;</li> <li>▪ Both banks continue to regenerate as groundcover on the bank faces increases;</li> <li>▪ Site continues to stabilise.</li> </ul>
48

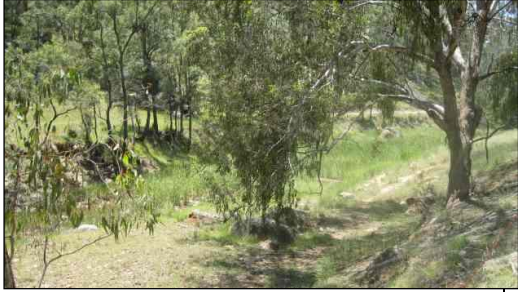
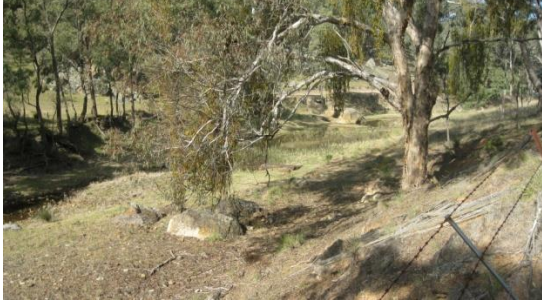
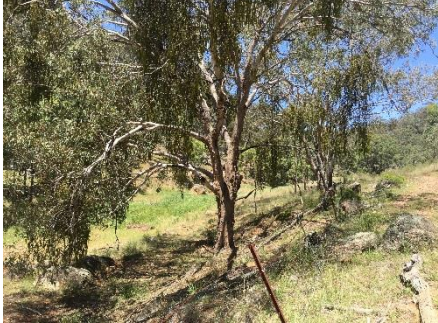
<ul style="list-style-type: none"> <li>▪ Reduction in the active channel width;</li> <li>▪ Increased undercutting and gullyng of the left bank face, as a result of reduced coverage;</li> <li>▪ Soil exposure reamins stable instream and on the right bank face.</li> <li>▪ Riparian zone naturally regenerating.</li> </ul>

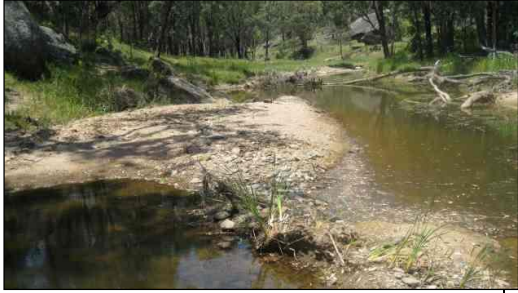
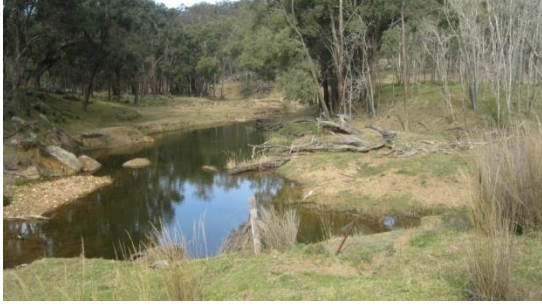
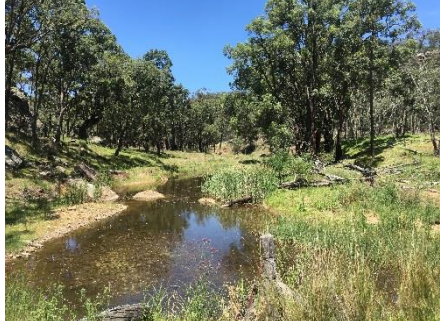
<ul style="list-style-type: none"> <li>▪ A reduction in the active channel width;</li> <li>▪ There has been an increase in groundcover within the creek bed, resulting in a reduction of soil and bed exposure;</li> <li>▪ There is an increase in groundcoverage on both bank faces, as a result of natural regeneration;</li> <li>▪ Site continues to regenerate.</li> </ul>

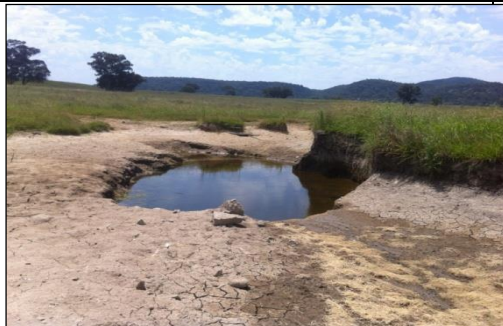
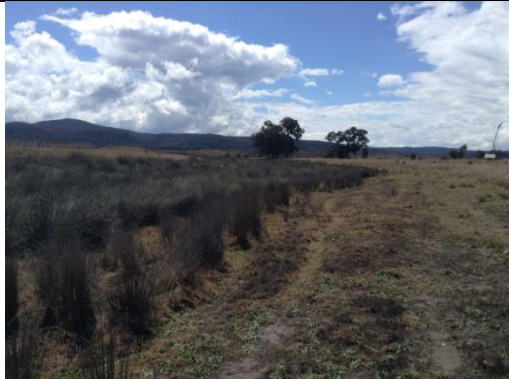
5

<ul style="list-style-type: none"><li>▪ Site remains well vegetated and stable;</li><li>▪ Lack of woody riparian zone.</li></ul>	
6

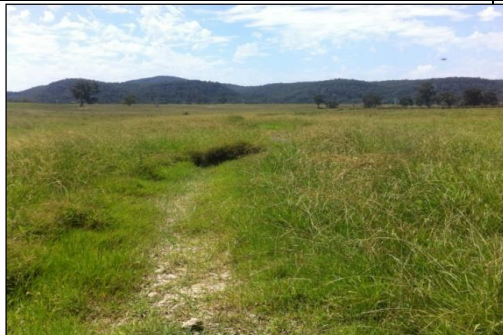
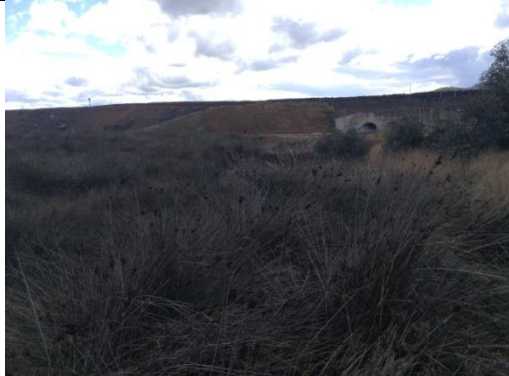
<ul style="list-style-type: none"><li>▪ Site remains well vegetated and stable;</li><li>▪ Lack of woody riparian zone.</li></ul>	
7	Removed from survey due to works in area.

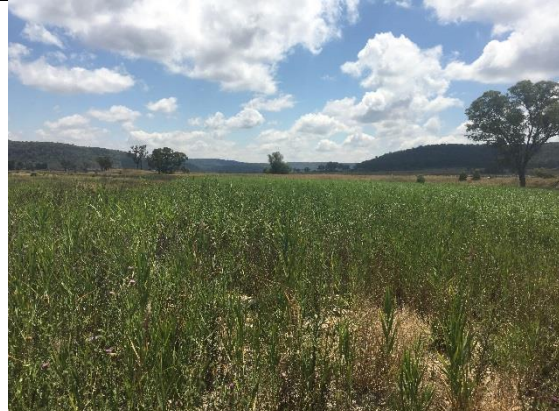
<ul style="list-style-type: none"><li>▪ Site remains well vegetated and stable;</li><li>▪ Lack of woody riparian zone.</li></ul>
8

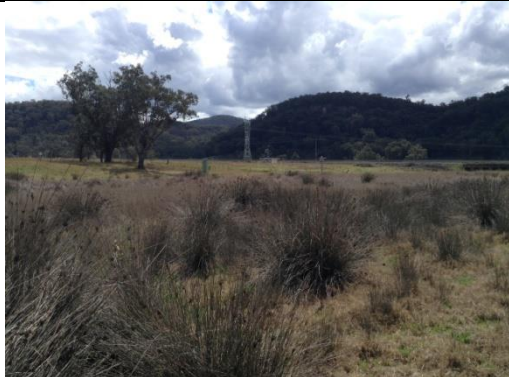
<ul style="list-style-type: none"><li>▪ Site remains well vegetated and stable;</li><li>▪ Lack of woody riparian zone.</li></ul>
