## **APPENDIX 3C – SURFACE WATER MONITORING**

# Wilpinjong & Cumbo Creek Stability Assessment, 2015

Wilpinjong Coal Mine

Mar-16  
(Our Reference: 23823\_E01\_Final)

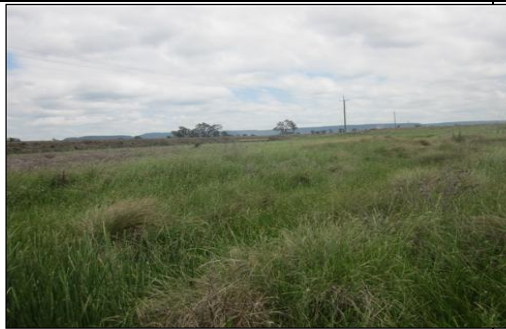
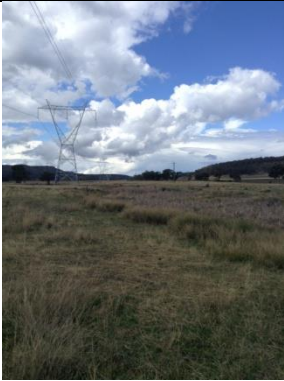
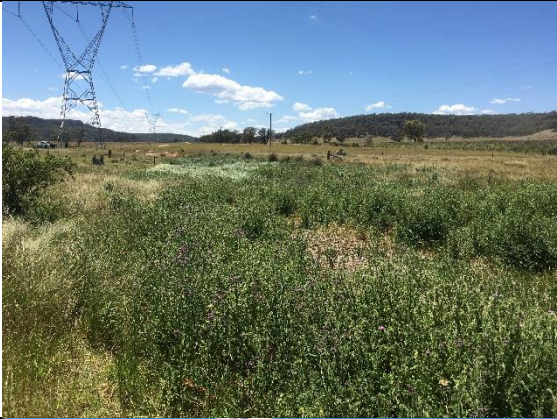
9

<ul style="list-style-type: none"><li>▪ Site remains well vegetated and stable;</li><li>▪ Lack of woody riparian zone.</li></ul>
10

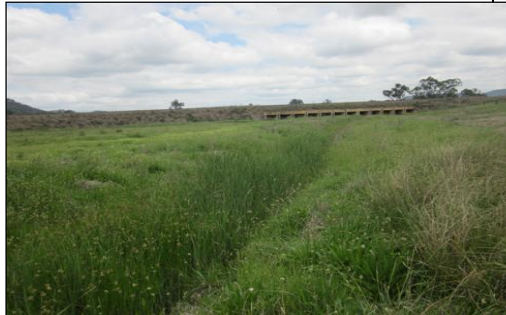
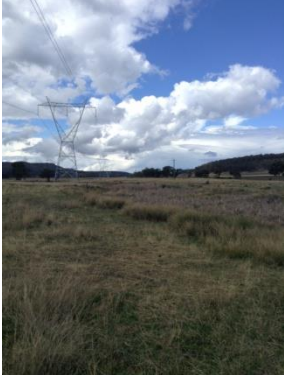
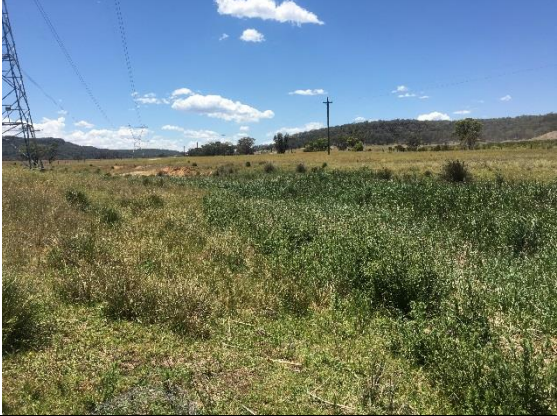
<ul style="list-style-type: none"><li>▪ Site remains well vegetated and stable;</li><li>▪ Lack of woody riparian zone.</li></ul>
