# Wilpinjong Coal Mine Aboriginal Rock Art Monitoring and Assessment Program

## Report on December 2014 site inspection

Wilpinjong, NSW

July 2015

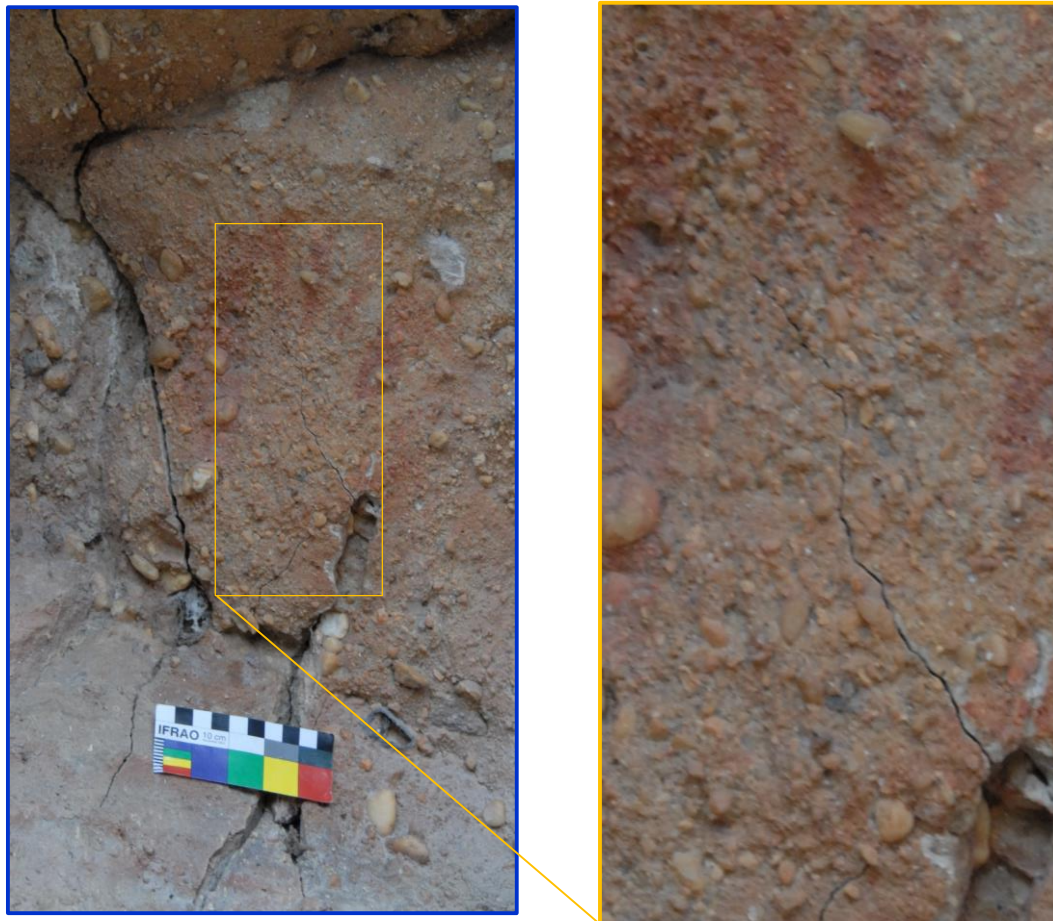
**Figures 4.1 and 4.2** 2006 baseline image and enlargement (WCP72:126).

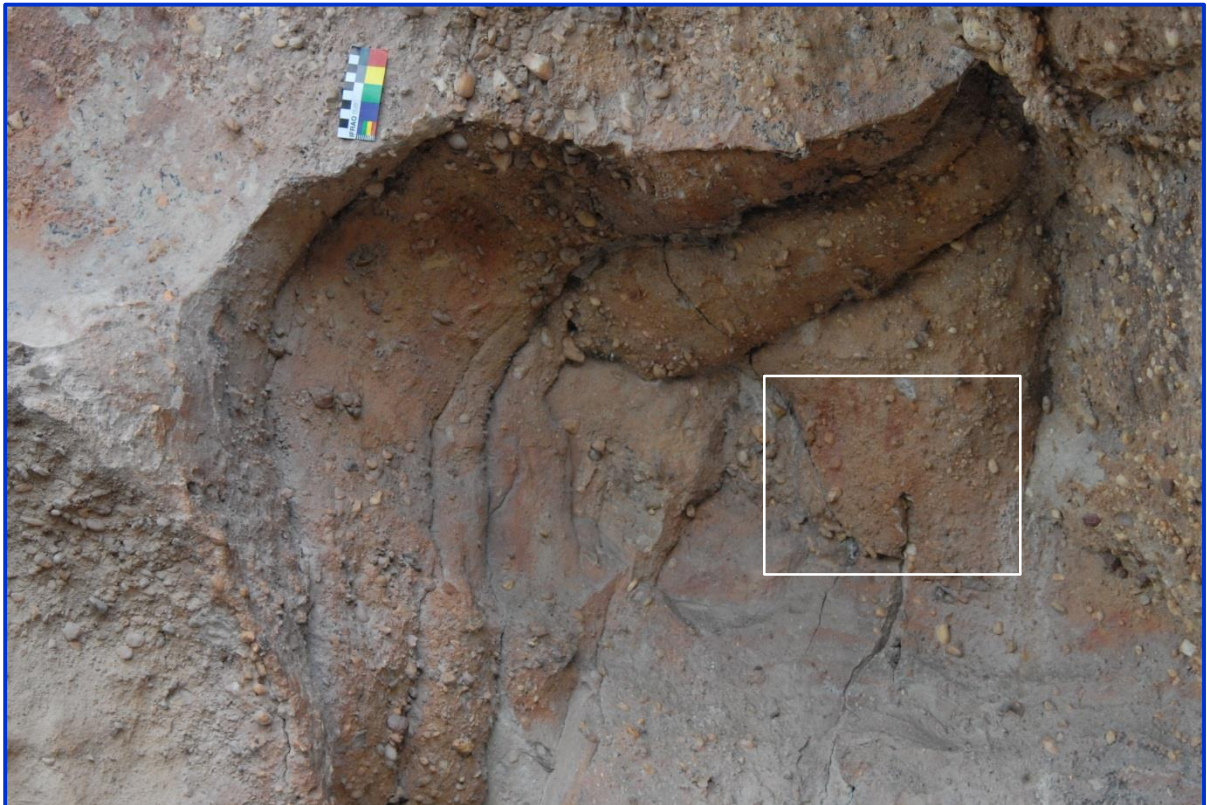
**Figures 4.3 and 4.4** 2014 image – a fine crack through a rock panel with a hand stencil. During the field inspection, this crack (indicated by the yellow dashed line), was provisionally identified as possibly post 2006 in origin. However close inspection of the baseline record indicates no discernible change in either the extent or width of the crack.

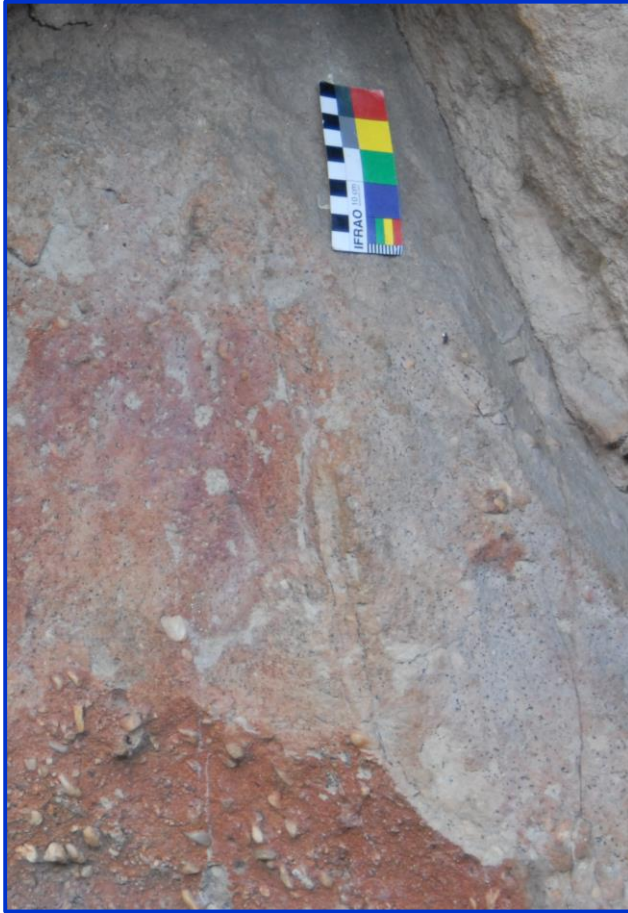
**Figures 4.6 and 4.7** 2014 images – showing the wider context of the cracks illustrated in Figure 4.3 (area indicated by white rectangle). The affected art panel is situated within a complex of cracks associated with a near vertical natural joint or fault line which extends the full height of the exposed rock escarpment near the southern end of the rock shelter (red dashed lines). The observed cracks across the art panel were evident in 2006 and are the result of (pre-mining) differential movement on either side of the rock joint.

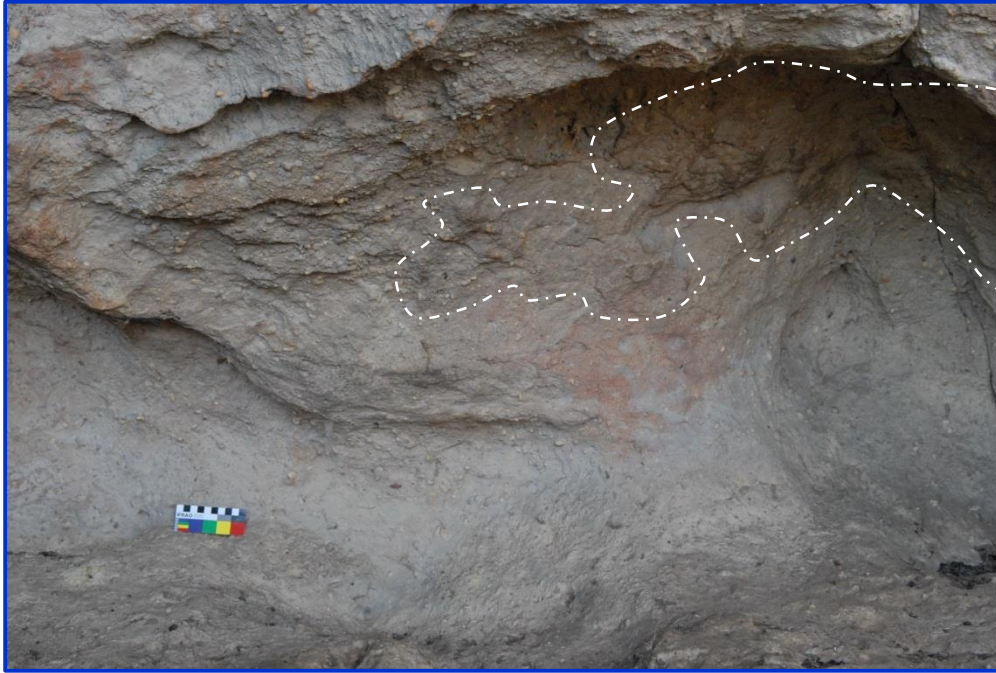
**Figures 4.12 and 4.13** 2014 image – fine crack through stencil panel (yellow dotted line on right). Comparison with the baseline record shows no change in the extent of the crack or its discernible width. Enlargements of the stencil area are present in Appendix 1.

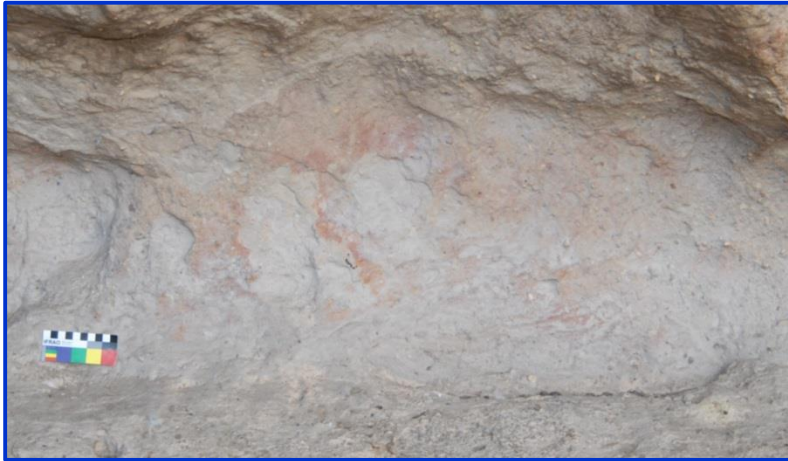
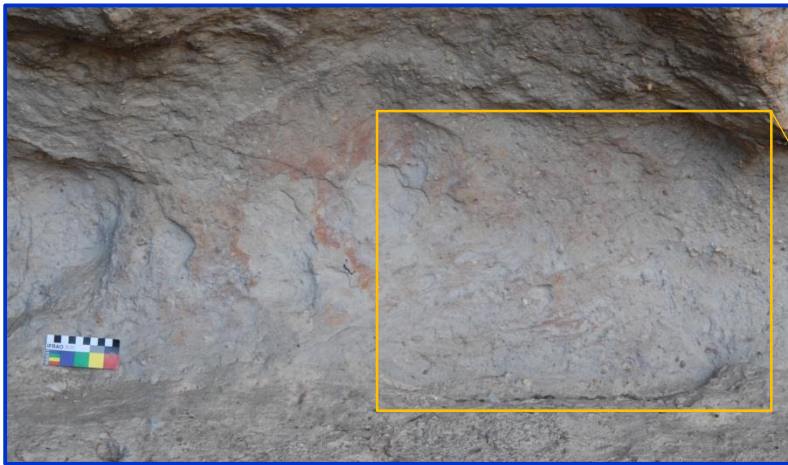
**Figure 4.15** 2014 image of same area shown in Figure 4.13, showing pre and post-2006 areas of animal rubbing with an associated dark grey/black surface residue including animal hair (outlined).

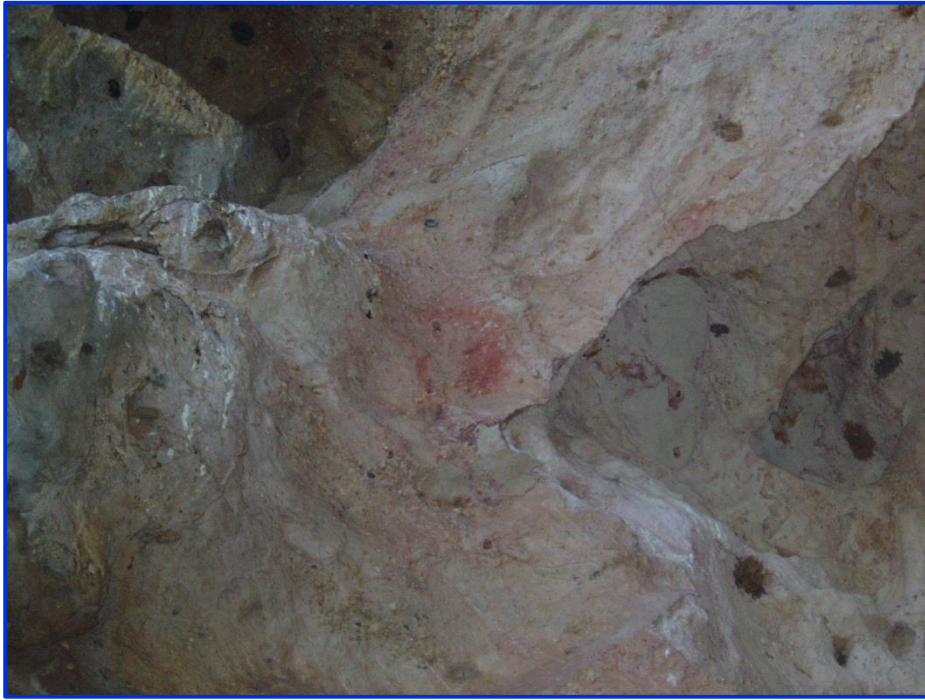
**Figure 4.18** 2014 image – post 2006 area of surface deposition. Although this feature looks similar to lichen growth found elsewhere in the shelter, it is more likely to be material deposited by animal rubbing (area outlined).

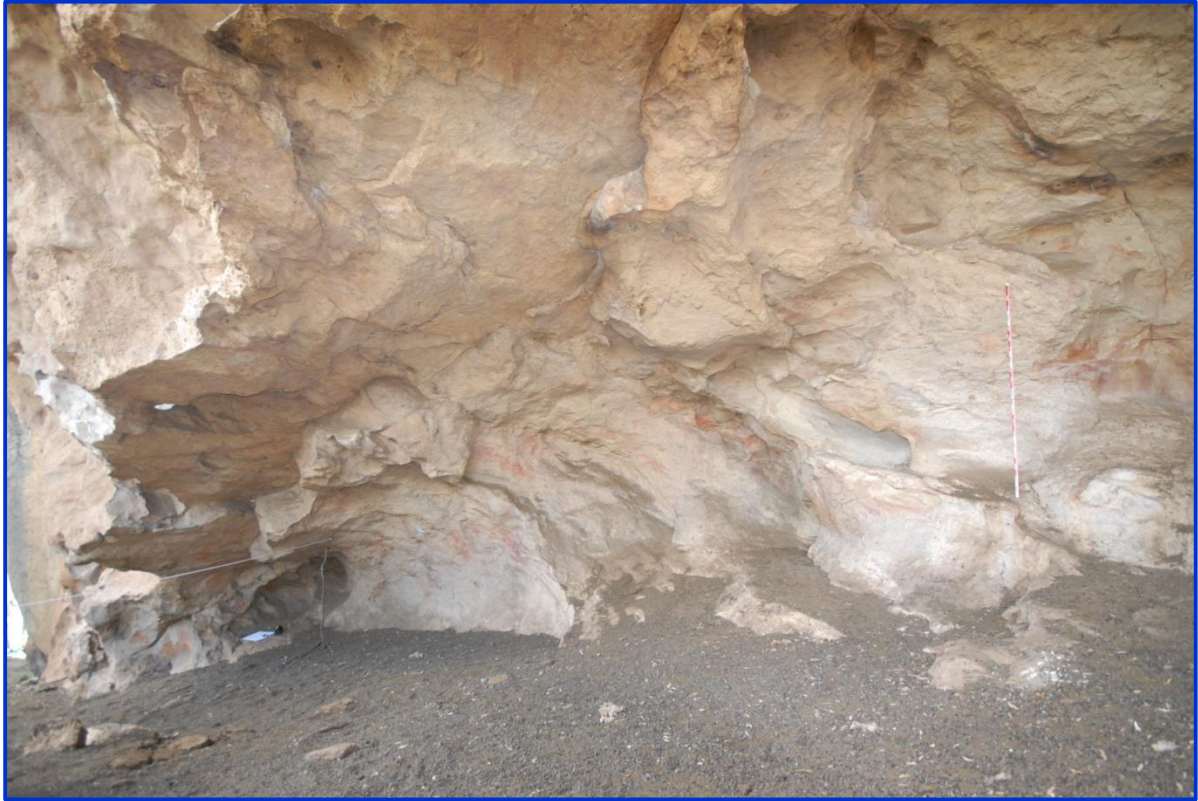
- The dust affected rock surfaces are visually darker in hue and colour than in 2006. The apparent change in colour is from a yellow-brown to a brown-grey. This creates a visually obtrusive effect, making it harder to see or appreciate the remaining visible rock art within the shelter;
- The spatial extent of the dust appears to be the same as in 2006.

1. A program of research be conducted with the objective of identifying:
  - a. The composition and source of the dust deposits present on rock art panels within WCP72;
  - b. The cause of the change in colour and hue in the dust deposits, noted since 2006;
  - c. The vectors involved in the generation and deposition of dust within WCP72 (for example wind, or animal treadage of the dung deposit);

- d. An effective method which could be used to remove loose dust deposits with no or minimal impact to the rock surface and rock art pigments.
- 2. Based on the findings of the program in recommendation one, and in consultation with the Aboriginal stakeholders, develop and conduct a management strategy with the objectives of managing dust deposition in WCP72, and minimising any associated risk to the site's rock art.
- 3. Continue regular monitoring and recording of dust and vibration levels at each of the three rock art sites.
- 4. Dismantle and remove the east-west fenceline which extends to the east of the WCP72 rock shelter.
- 5. Remove combustible material within or near the entrances to WCP72, WCP152 and 153.
- 6. Regularly monitor and remove any substantial build-up of combustible materials within or near each of the three rock art sites.

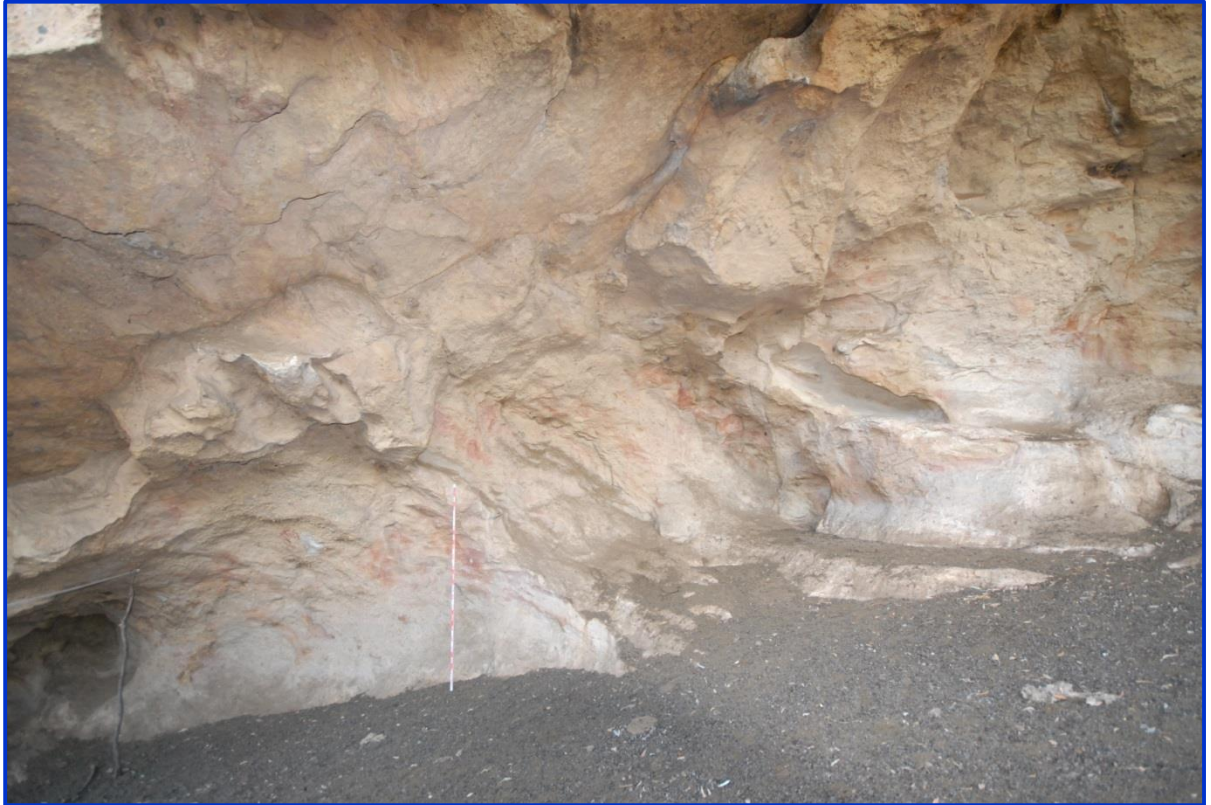
**Figure 4.22** 2014 image (using flash light source) – showing same area as shown in Figure 4.21. Note that the pattern and extent of dust affected rock surfaces is the same as shown in the baseline, but are now darker in colour and hue.

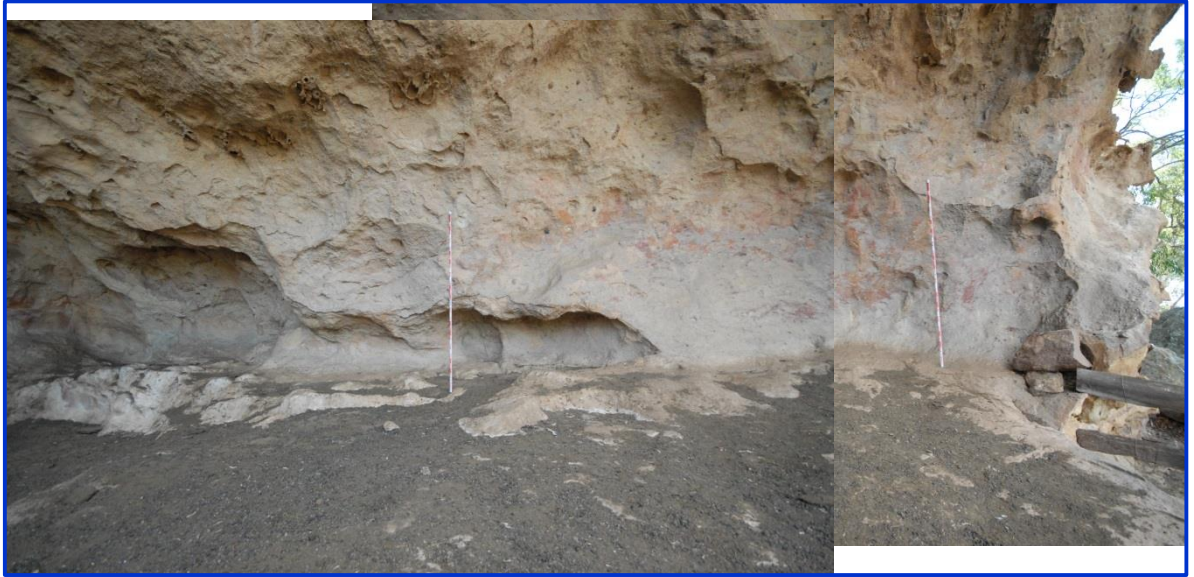
**Figure 4.24** 2014 image (using flash light source) – showing same area as shown in Figure 4.23. Note that the pattern and extent of dust affected rock surfaces is the same as shown in the baseline, but are now darker in colour and hue.

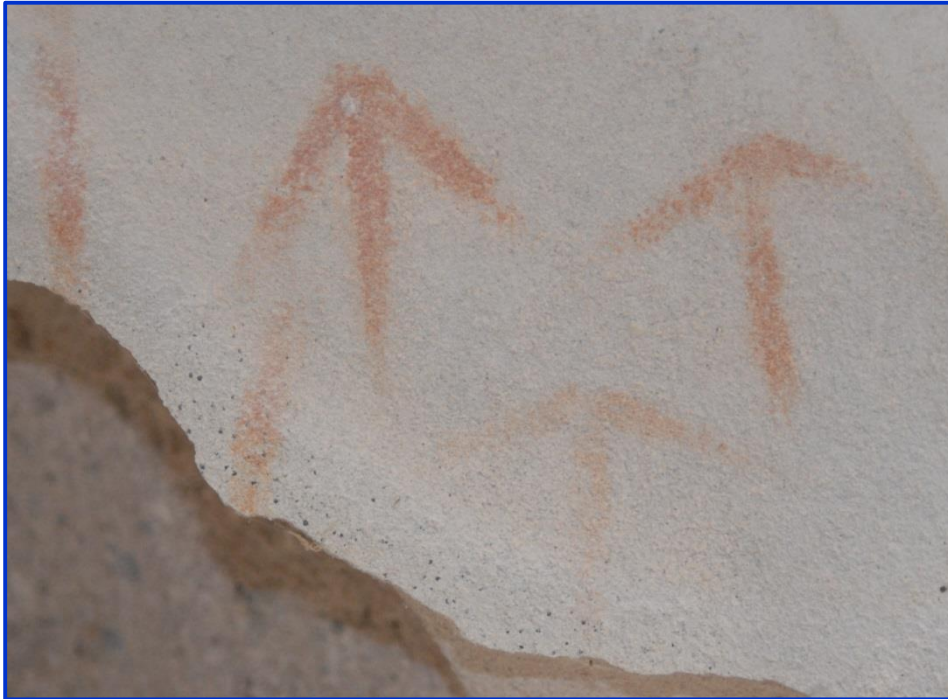
**Figure 4.34** 2006 baseline image (using flash light) of the lower edge of the 'bird print' (or 'trident') motif panel. The edge of this case-hardened panel surface was described as undercut, fragile, and vulnerable to cracking and dislodgement by animals and site visitors (refer Figure 4.38). There is no cracking evident in the 2006 record (WCP152:118).

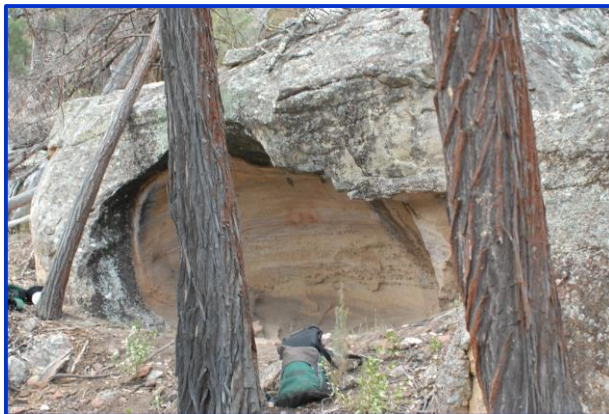
- A small amount of burnable forest litter is accumulating outside the shelter on the right;
- One tall tree leaning on the front left of the shelter has died since 2006 (Figure 4.44).
