# Wilpinjong & Cumbo Creek Stability Assessment, 2014

Wilpinjong Coal Mine

Mar-15  
(Our Reference: 21977\_E01)

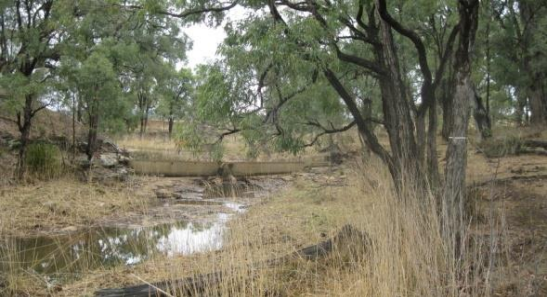
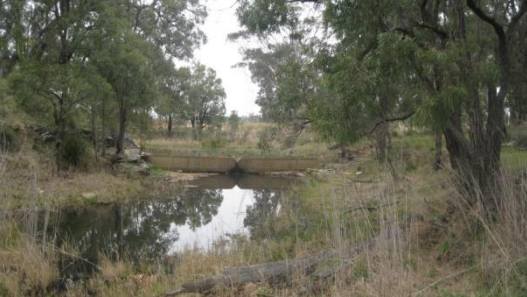
Site	Upstream December 2013	Upstream December 2014	Main Comparison
1

<ul style="list-style-type: none"> <li>• Increase in active channel creek width;</li> <li>• Increased sediment deposition midstream, creating a bar feature;</li> <li>• Increase in green groundcover on the bank faces and within the riparian zone between 2013-2014.</li> </ul>
2

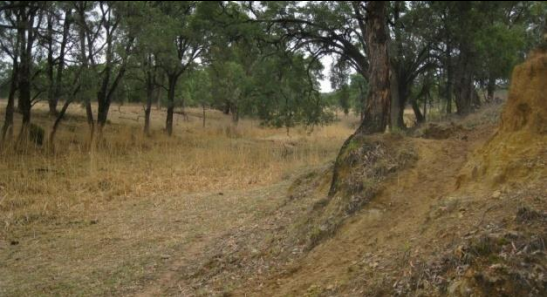
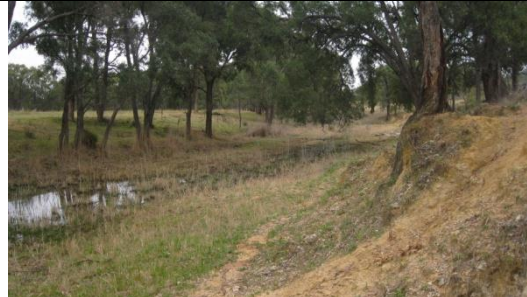
<ul style="list-style-type: none"> <li>• Increased soil exposure and erosion of the left bank;</li> <li>• Increased growth and regeneration of instream flora;</li> <li>• Reduction in leaf litter on the creek bank faces.</li> </ul>
4

<ul style="list-style-type: none"> <li>• Stabilisation on the right bank;</li> <li>• A reduction in instream flora;</li> <li>• An increase in the active channel;</li> <li>• Continued regression of the left bank.</li> </ul>

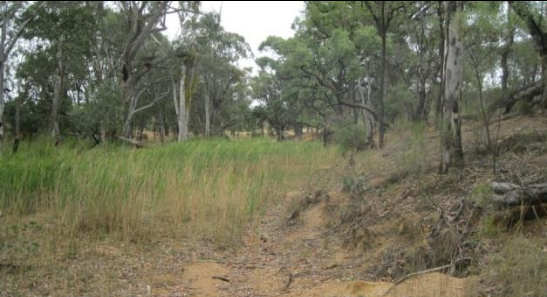
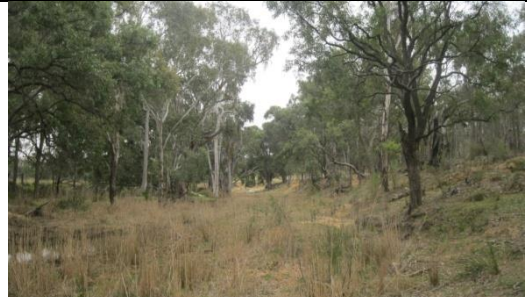
5

<ul style="list-style-type: none"> <li>• A reduction in in stream flora;</li> <li>• An increase in the active channel;</li> <li>• An increase in green groundcover on the creek bank faces;</li> <li>• A reduction in woody debris on the creek banks;</li> <li>• Increased stability of the left bank in this location.</li> </ul>

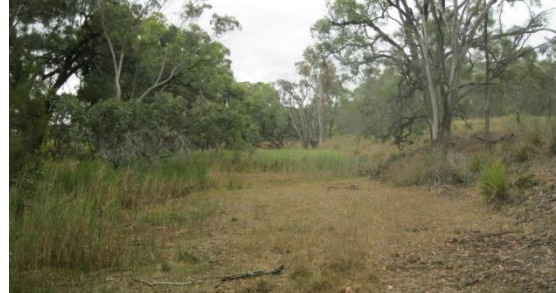
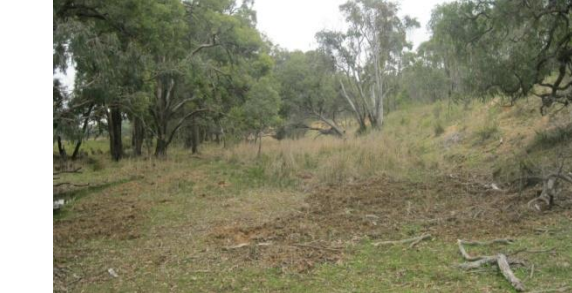
Site	Upstream December 2013		Upstream December 2014	Main Comparison
6

<ul style="list-style-type: none"> <li>• A reduction in in stream flora growth;</li> <li>• An increase in the active channel width;</li> <li>• Increased stability of the creek banks;</li> <li>• Increase in in stream debris;</li> <li>• Increased stock activity in the area;</li> <li>• Increase in blackberry.</li> </ul>
7

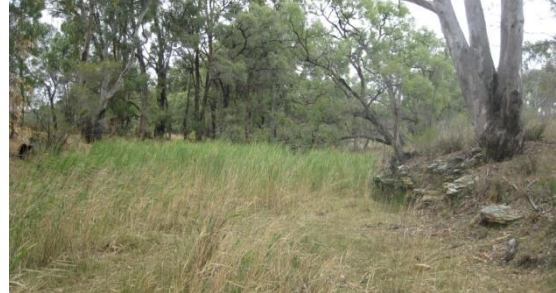
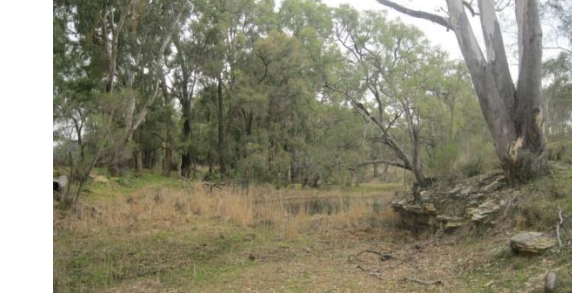
<ul style="list-style-type: none"> <li>• A reduction in instream flora growth;</li> <li>• Increase in bank undercutting;</li> <li>• Increase exposure of bedrock on the right bank.</li> </ul>
8

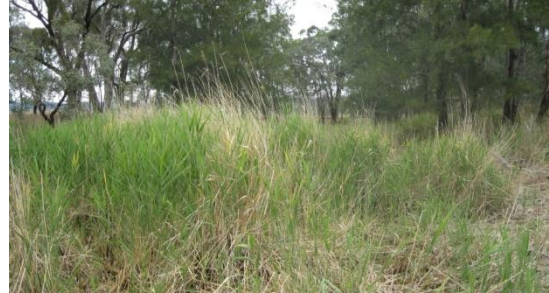
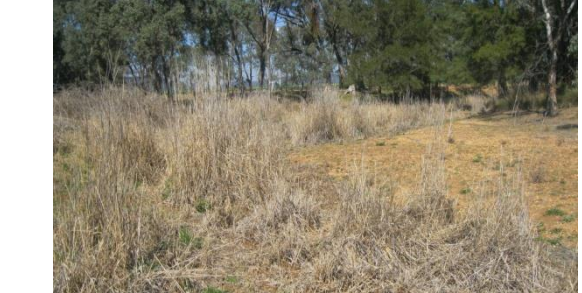
Site	Upstream December 2013		Upstream December 2014	Main Comparison
12

<ul style="list-style-type: none"> <li>• Large reduction in instream flora growth;</li> <li>• Reduction in green growth on the creek banks and in the riparian areas;</li> <li>• A reduction in the active creek width;</li> <li>• Increased exposure of the left bank face;</li> <li>• Site is relatively stable.</li> </ul>
13

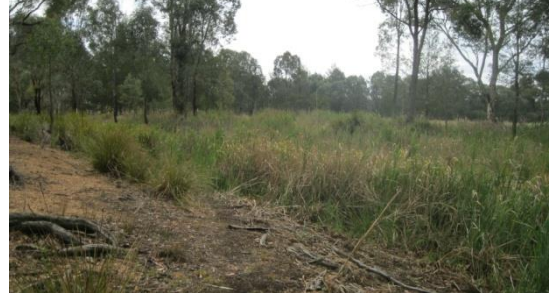
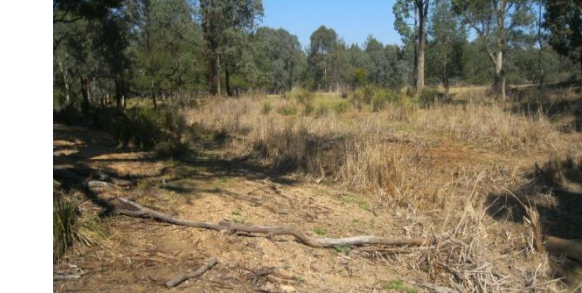
<ul style="list-style-type: none"> <li>• Large reduction in instream flora growth;</li> <li>• Reduction in green growth on the creek banks and in the riparian areas;</li> <li>• A reduction in the active creek width;</li> <li>• Increased exposure of the right bank face;</li> <li>• Reduction in leaf litter on the bank faces resulting in increased exposure of the surface soils.</li> </ul>
14

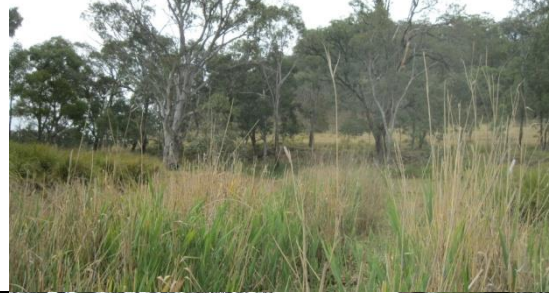
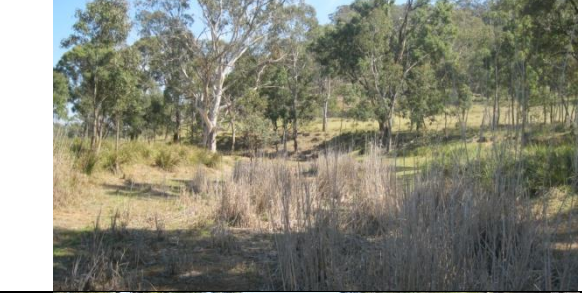
<ul style="list-style-type: none"> <li>• Large reduction in instream flora growth;</li> <li>• A reduction in the active creek width;</li> <li>• Increased exposure of the bank faces;</li> <li>• Banks relatively stable.</li> </ul>

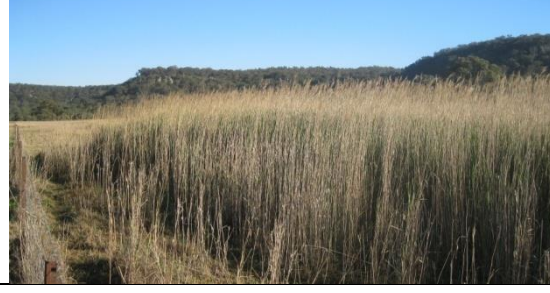
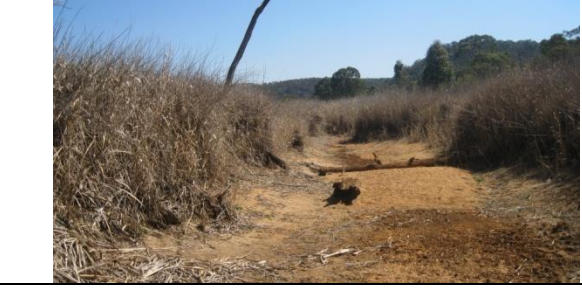
<ul style="list-style-type: none"> <li>• Large reduction in instream flora growth;</li> <li>• Increased exposure of the creek bed;</li> <li>• Banks stable.</li> </ul>
17

<ul style="list-style-type: none"> <li>• Slightly different location as a result of access;</li> <li>• Increased exposure of soils along access track;</li> <li>• Reduction in healthy instream flora growth;</li> <li>• Creek bank exposure almost 100% in areas as a result of low groundcover;</li> <li>• Little to no riparian zone.</li> </ul>

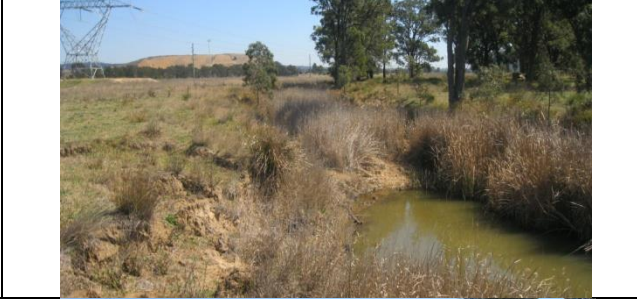
Site	Upstream December 2013	Upstream December 2014	Main Comparison
18

<ul style="list-style-type: none"> <li>• Reduction in instream flora health;</li> <li>• Reduction in green growth on the creek banks and in the riparian areas;</li> <li>• Increased exposure of the left bank face;</li> <li>• Right bank appears to be suffering slippage;</li> <li>• Little to no riparian zone.</li> </ul>
19

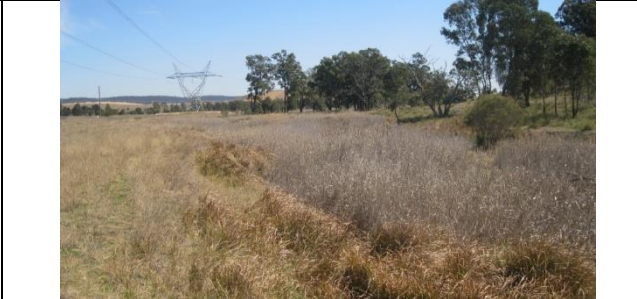
<ul style="list-style-type: none"> <li>• Reduction in healthy instream flora;</li> <li>• Sight remains stable;</li> <li>• Little to no riparian zone.</li> </ul>
20

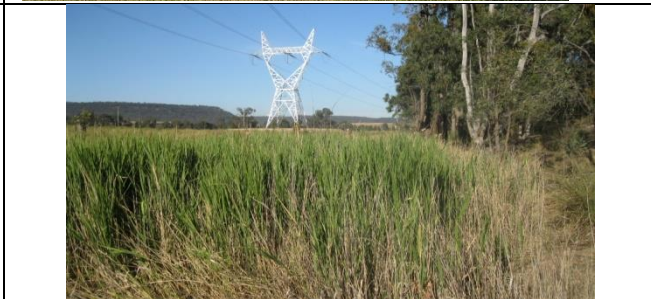
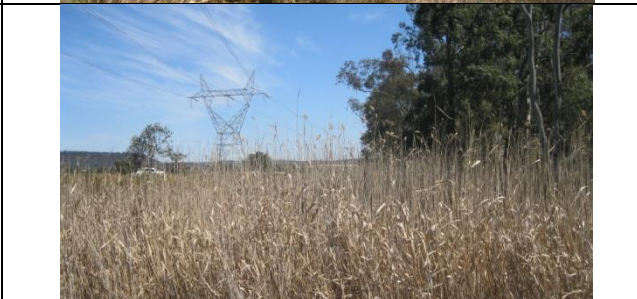
<ul style="list-style-type: none"> <li>• Reduction in healthy instream flora;</li> <li>• Increased bleaching of exposed soils on the left bank face;</li> <li>• Right bank remains stable;</li> <li>• Little to no riparian zone.</li> </ul>
21

<ul style="list-style-type: none"> <li>• Reduction in healthy instream flora;</li> <li>• Little to no riparian zone.</li> </ul>

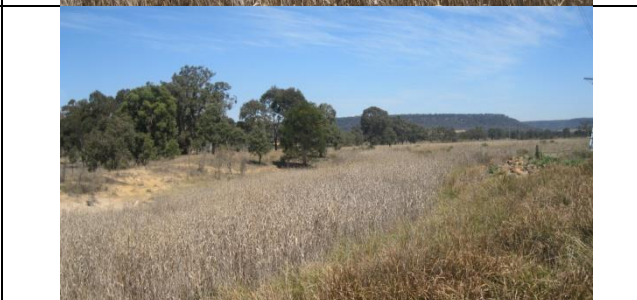
22

<ul style="list-style-type: none"> <li>• Reduction in healthy instream flora;</li> <li>• Increased bleaching of exposed soils on the right bank face;</li> <li>• Left bank remains stable;</li> <li>• Reduction of the active channel;</li> <li>• Little to no riparian zone.</li> </ul>
23

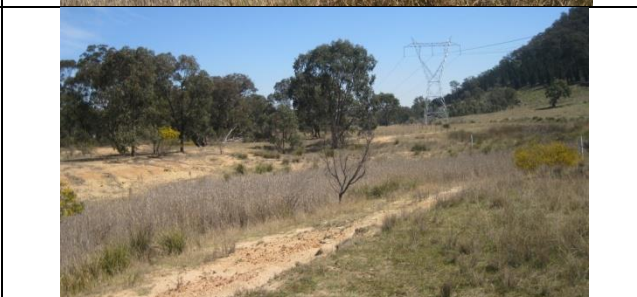
<ul style="list-style-type: none"> <li>• Reduction in healthy instream flora;</li> <li>• Increased bleaching of exposed soils on the bank faces;</li> <li>• An increase in sheet erosion;</li> <li>• Reduction of the active channel;</li> <li>• Little to no riparian zone.</li> </ul>

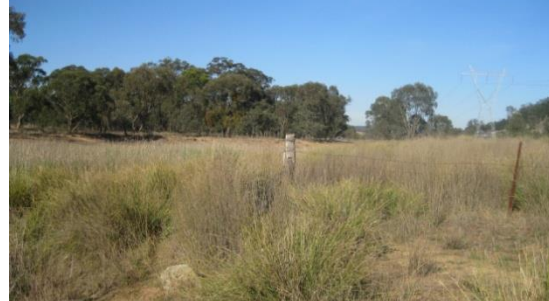
Site	Upstream December 2013	Upstream December 2014	Main Comparison
24

<ul style="list-style-type: none"> <li>• Reduction in healthy instream flora;</li> <li>• Increased bleaching of exposed soils on the right bank face;</li> <li>• An increase in sheet erosion of the right bank;</li> <li>• Left bank remains stable;</li> <li>• Reduction of the active channel;</li> <li>• Little to no riparian zone.</li> </ul>
25

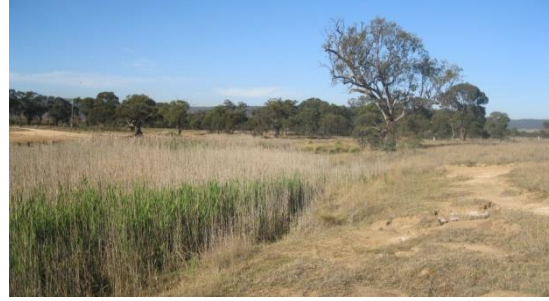
<ul style="list-style-type: none"> <li>• Reduction in healthy instream flora;</li> <li>• Site remains similar.</li> </ul>
26

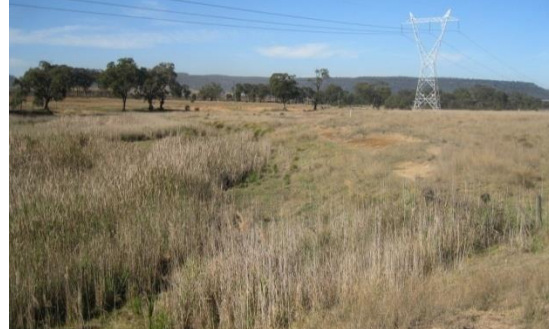
<ul style="list-style-type: none"> <li>• Reduction in healthy instream flora;</li> <li>• Stabilisation of the left bank face, with a minor decrease in groundcover;</li> <li>• Right bank exposure remains stable.</li> </ul>
27

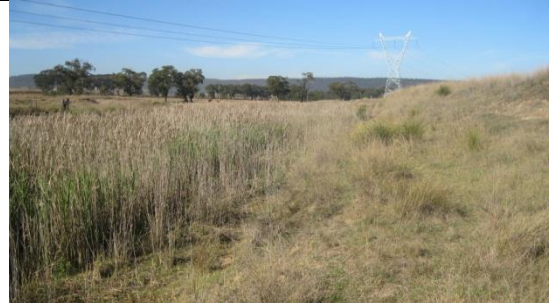
<ul style="list-style-type: none"> <li>• Reduction in healthy instream flora;</li> <li>• Site remains similar.</li> </ul>

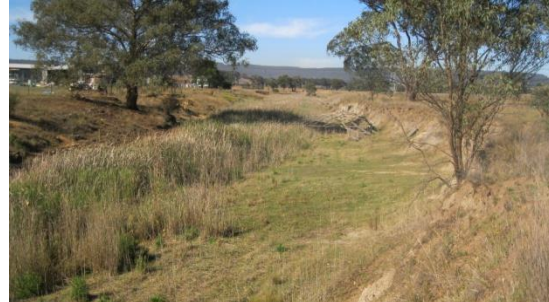
28

<ul style="list-style-type: none"> <li>• Reduction in healthy instream flora;</li> <li>• Increased stability of the right bank;</li> <li>• Site remains similar.</li> </ul>

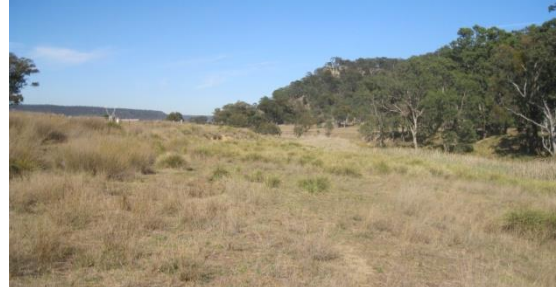
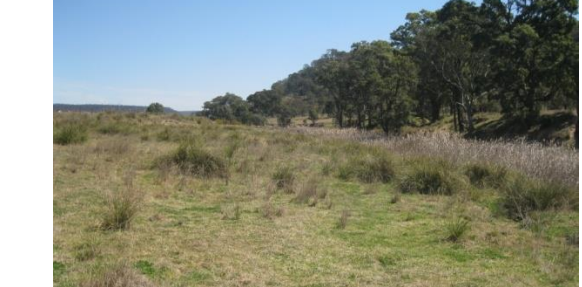
Site	Upstream December 2013		Upstream December 2014	Main Comparison
29

<ul style="list-style-type: none"> <li>• Reduction in healthy instream flora;</li> <li>• Increased stability of the right bank;</li> <li>• Site remains similar.</li> </ul>
30

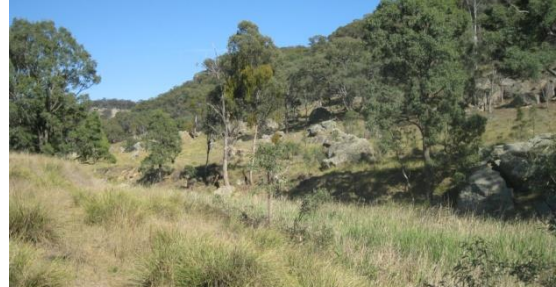
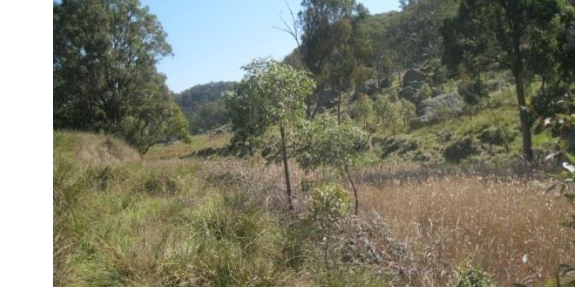
<ul style="list-style-type: none"> <li>• Reduction in healthy instream flora;</li> <li>• Increased stability of the right bank;</li> <li>• Site remains similar;</li> <li>• Good general regeneration in the riparian areas as a result of destocking.</li> </ul>
31

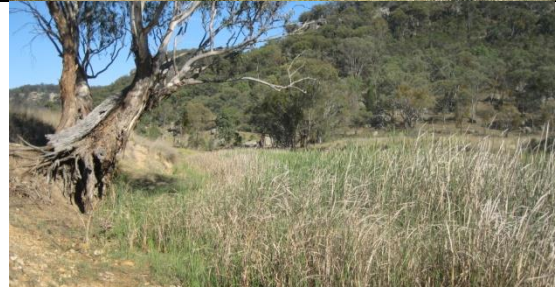
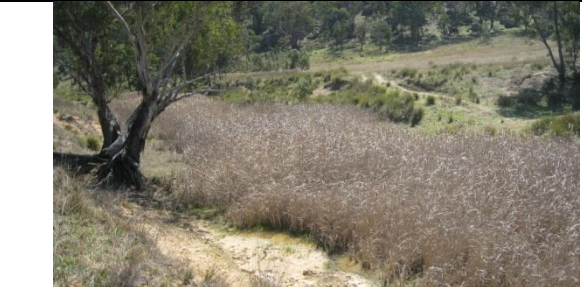
<ul style="list-style-type: none"> <li>• Reduction in healthy instream flora;</li> <li>• Increased soil exposure of the left bank due to increased dryness during 2014.</li> <li>• Salt crystallisation on the right bank in exposed areas.</li> </ul>
32

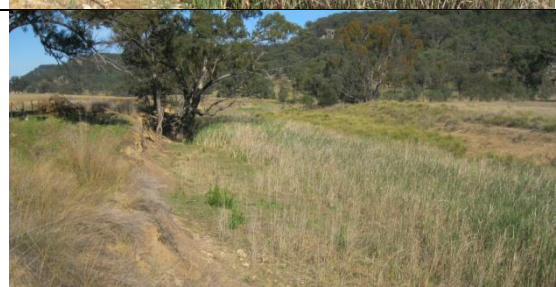
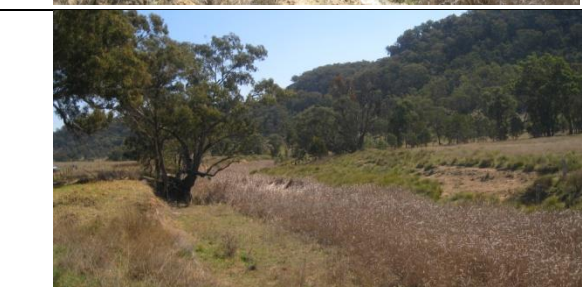
<ul style="list-style-type: none"> <li>• Reduction in healthy instream flora;</li> <li>• Reduction in the active channel width;</li> <li>• Continued regression and erosion of the right bank;</li> <li>• Continued exposure of surface soils on the left and right bank due to increased dryness during 2014;</li> </ul>

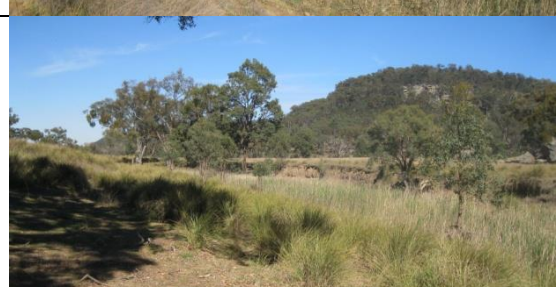
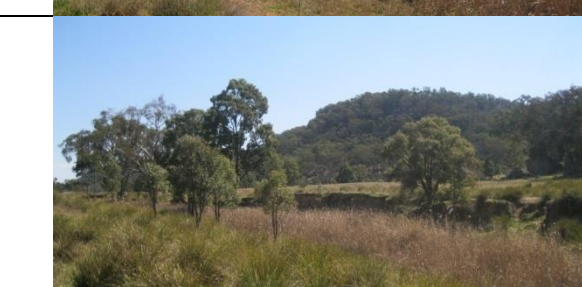
<ul style="list-style-type: none"> <li>• Reduction in healthy instream flora;</li> <li>• Reduction in the active channel width;</li> <li>• Continued regression and erosion of the left bank;</li> <li>• Right bank remains similar.</li> </ul>
34

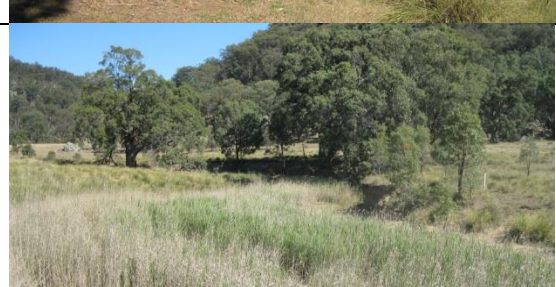
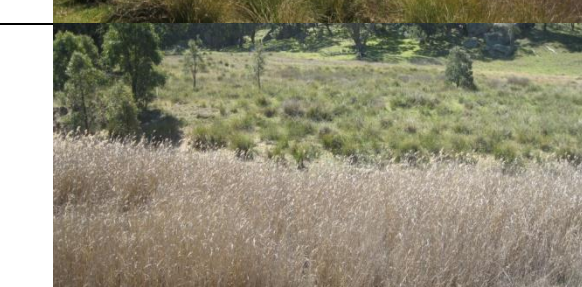
<ul style="list-style-type: none"> <li>• Reduction in healthy instream flora;</li> <li>• Site remains similar.</li> </ul>

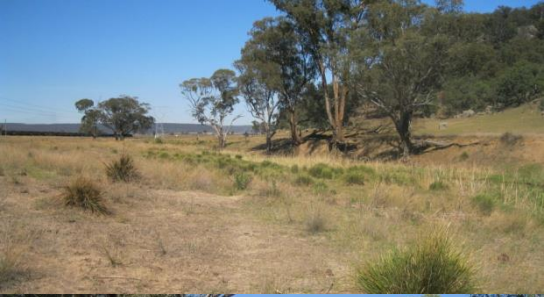
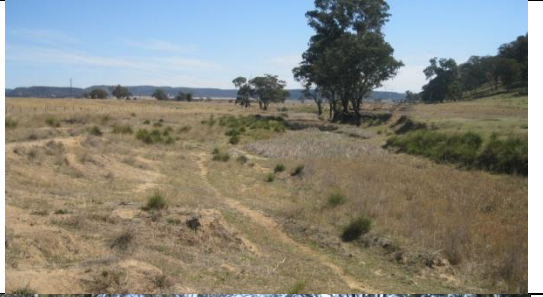
<ul style="list-style-type: none"> <li>• Reduction in healthy instream flora;</li> <li>• Reduction in the active channel width;</li> <li>• Continued regression and erosion of the right banks;</li> <li>• Continued exposure of surface soils on the right banks due to increased dryness during 2014;</li> <li>• Left bank remains well vegetated and stable.</li> </ul>

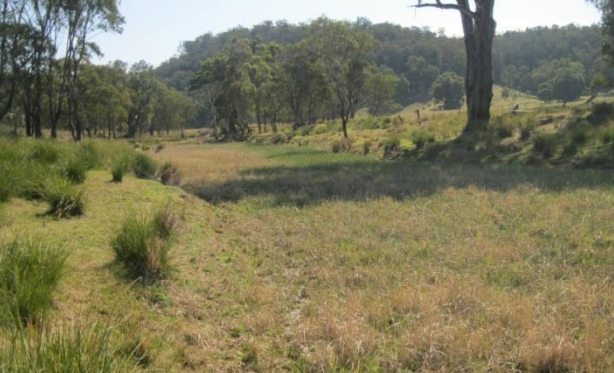
<ul style="list-style-type: none"> <li>• Creek bed is well vegetated with little to no exposure of the creek bed;</li> <li>• Both banks are well vegetated;</li> <li>• Blackberry noted close to the site.</li> </ul>

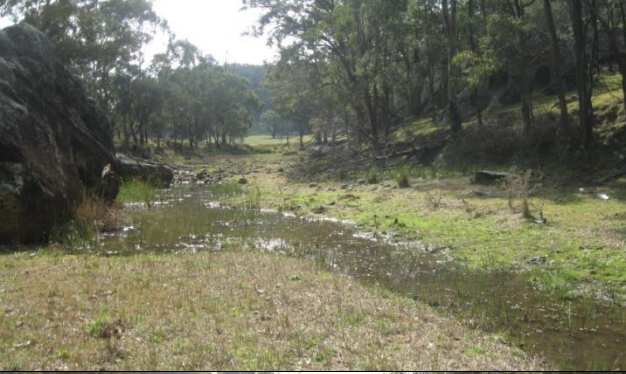
<ul style="list-style-type: none"> <li>• Creek bed is well vegetated with little to no exposure of the creek bed;</li> <li>• Both banks are well vegetated and stable;</li> <li>• There is an increase in the active channel width.</li> </ul>

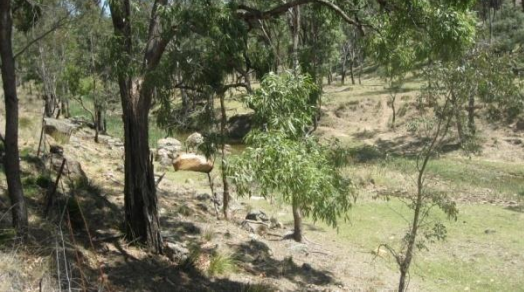
<ul style="list-style-type: none"> <li>• Reduction in the active channel width;</li> <li>• Increased undercutting and gullyng of the left bank face, however vegetation coverage has increased over the year;</li> <li>• Soil exposure remains stable instream and on the right bank face. There has been an increase in groundcover on the right bank face as result of natural regeneration;</li> </ul>
49

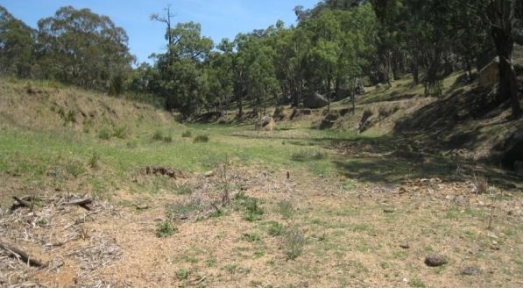
<ul style="list-style-type: none"> <li>• A reduction in the active channel width;</li> <li>• There has been a significant increase in groundcover within the creek bed, resulting in a reduction of soil and bed exposure;</li> <li>• There is an increase in groundcover on both bank faces, as a result of natural regeneration;</li> <li>• Site continues to regenerate.</li> </ul>

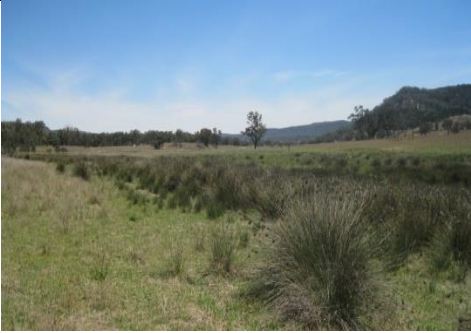
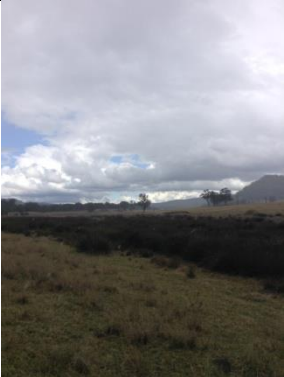
<ul style="list-style-type: none"> <li>• Site remains well vegetated and stable.</li> </ul>
2

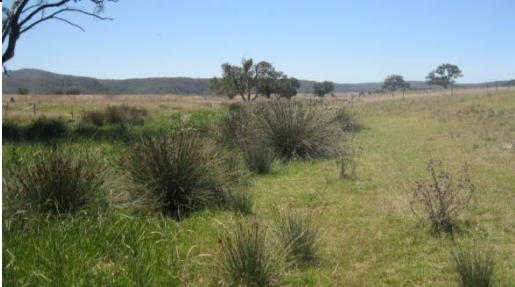
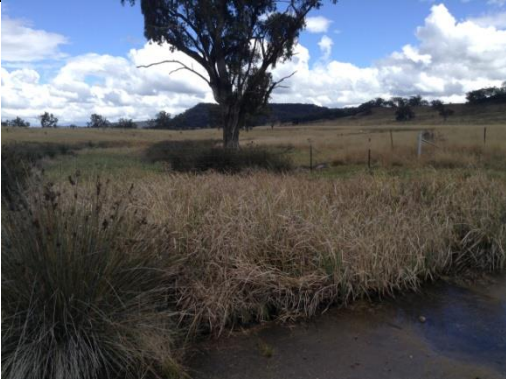
<ul style="list-style-type: none"> <li>• A reduction in 'green' groundcover within the creek bed, on the bank faces and within riparian areas between 2013-14.</li> <li>• Site remains well vegetated and stable.</li> </ul>
4

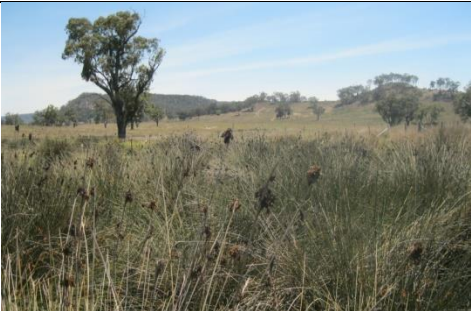
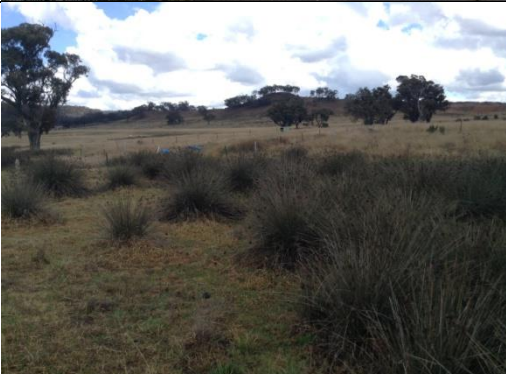
<ul style="list-style-type: none"> <li>• A reduction in 'green' groundcover within the creek bed, on the bank faces and within riparian areas between 2013-2014.</li> <li>• Site remains well vegetated and stable.</li> </ul>

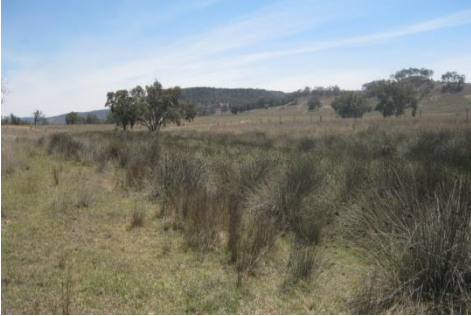
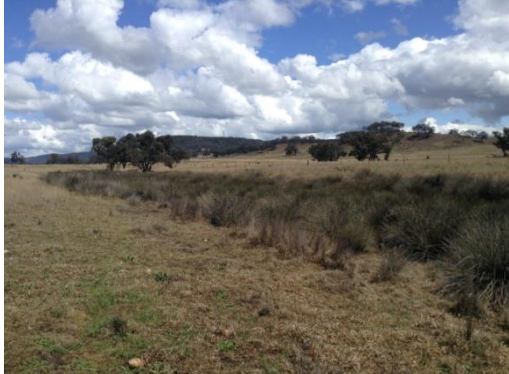
<ul style="list-style-type: none"> <li>• A reduction in 'green' groundcover on the bank faces and within riparian areas between 2013-14.</li> <li>• Site remains well vegetated and stable.</li> </ul>
6

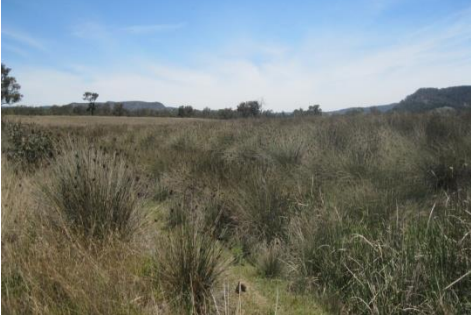
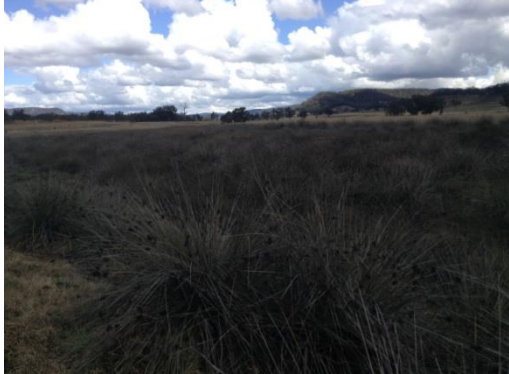
<ul style="list-style-type: none"> <li>• A reduction in 'green' groundcover on the bank faces and within riparian areas between 2013-2014.</li> <li>• Site remains well vegetated and stable.</li> </ul>
7	Removed from survey due to works in area.		
8

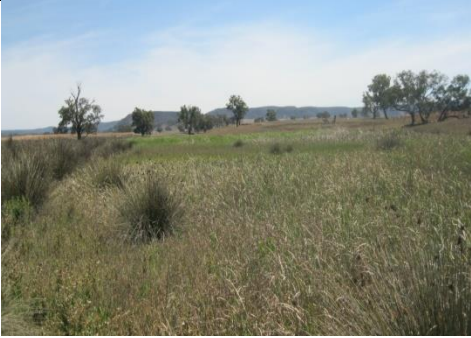
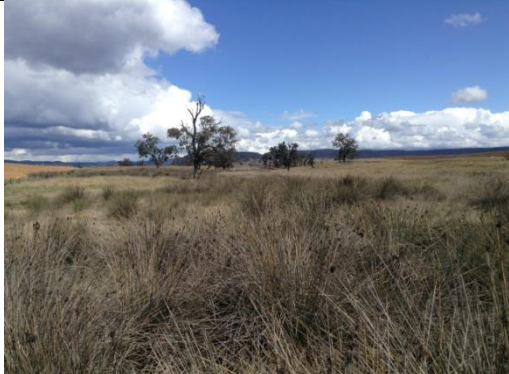
<ul style="list-style-type: none"> <li>• A reduction in 'green' groundcover on the bank faces and within riparian areas between 2013-2014.</li> <li>• Site remain well vegetated and stable.</li> </ul>
9

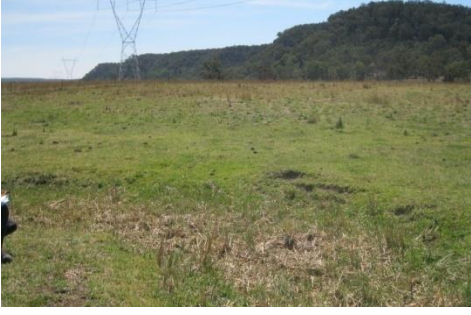
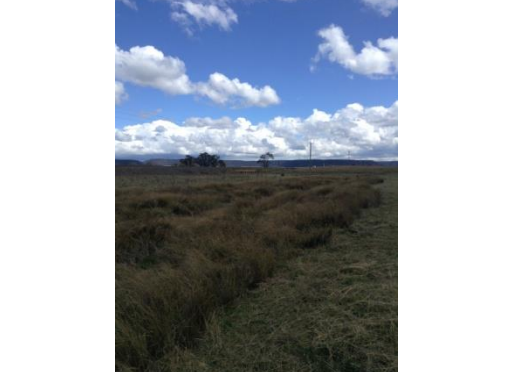
<ul style="list-style-type: none"> <li>• A reduction in 'green' groundcover on the bank faces and within riparian areas between 2013-2014</li> <li>• Site remain well vegetated and stable.</li> </ul>

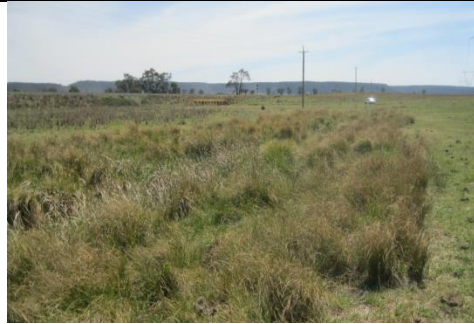
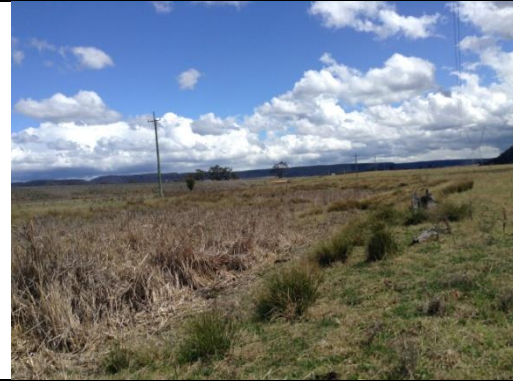
- A reduction in 'green' groundcover on the bank faces and within riparian areas between 2013-2014.
- Site remain well vegetated and stable.

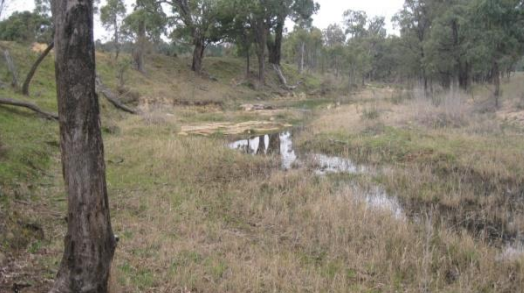
<ul style="list-style-type: none"> <li>• A reduction in instream plant growth;</li> <li>• An increase in green plant growth on the creek bank faces and in the riparian zone;</li> <li>• Stabilisation of bank erosion.</li> </ul>
2

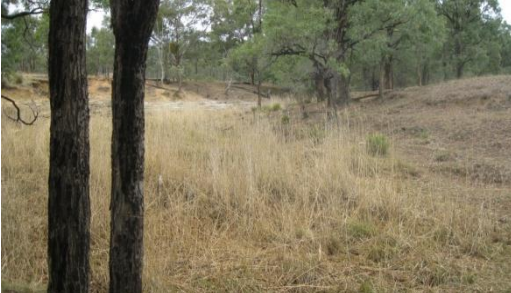
<ul style="list-style-type: none"> <li>• A reduction in instream plant growth;</li> <li>• Slight increase in groundcover on the creek bank faces;</li> <li>• Increase in wombat activity in the general area;</li> <li>• Stock activity noted.</li> </ul>
3

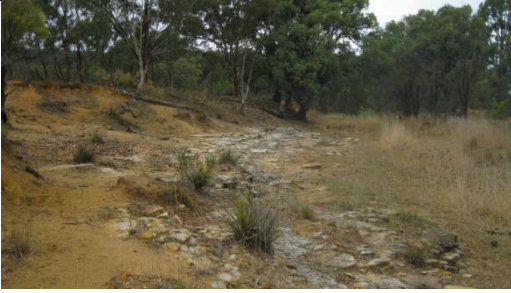
<ul style="list-style-type: none"> <li>• Increase in groundcover on the creek bank faces;</li> <li>• Continued bleaching of exposed soils within the bank faces;</li> </ul>
4

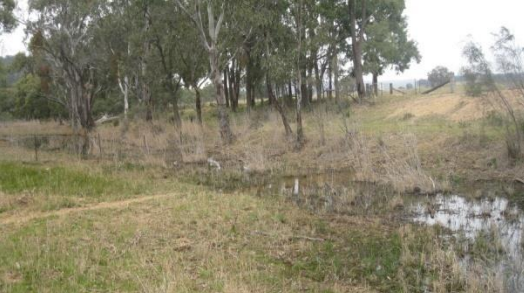
<ul style="list-style-type: none"> <li>• Increased soil exposure and erosion of the right bank;</li> <li>• An increase in green groundcover of the left bank;</li> <li>• An increase in active channel activity;</li> <li>• A reduction in instream flora.</li> </ul>

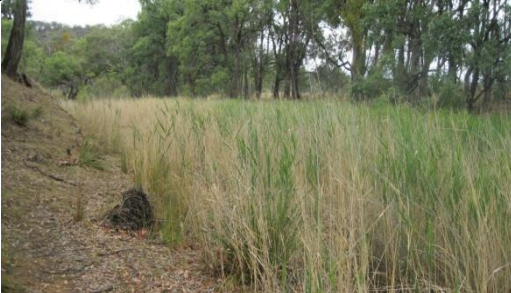
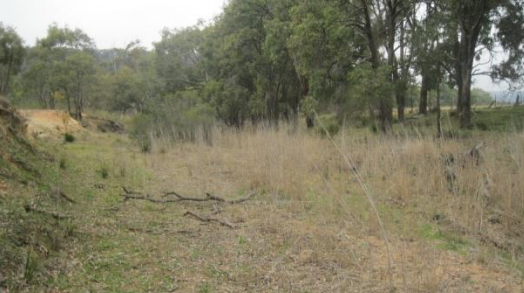
<ul style="list-style-type: none"> <li>• A reduction in instream plant growth;</li> <li>• An increase in the active channel;</li> <li>• An increase in green groundcover on the creek bank faces.</li> </ul>

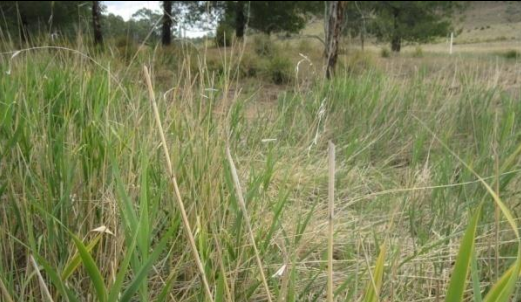
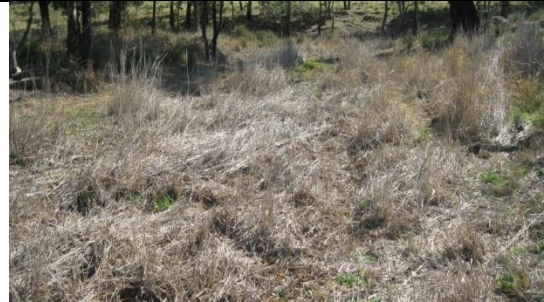
<ul style="list-style-type: none"> <li>• Large reduction in instream flora growth;</li> <li>• Reduction in green growth on the creek banks and in the riparian areas;</li> <li>• A reduction in the active creek width;</li> <li>• Site is relatively stable with good ground coverage.</li> </ul>
13

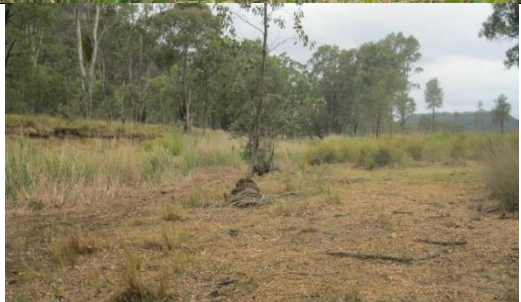
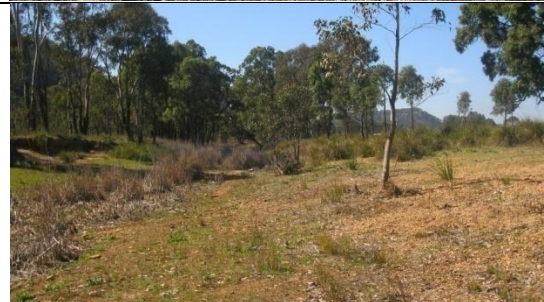
<ul style="list-style-type: none"> <li>• Large reduction in instream flora growth;</li> <li>• A reduction in the active creek width;</li> <li>• Increased exposure of the right bank face;</li> <li>• Reduction in leaf litter on the bank faces resulting in increased exposure of the surface soils.</li> </ul>
14

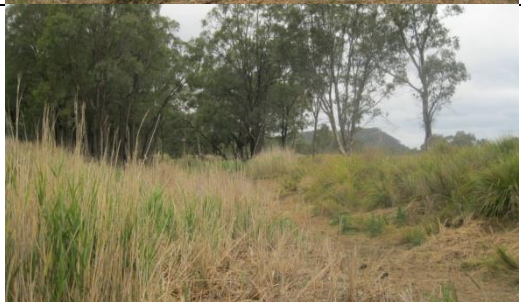
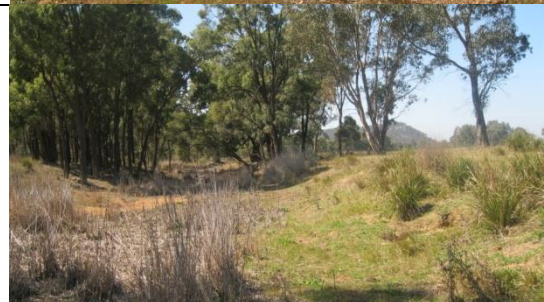
<ul style="list-style-type: none"> <li>• Large reduction in instream flora growth;</li> <li>• A reduction in the active creek width;</li> <li>• Increased exposure of the bank face;</li> <li>• Banks relatively stable.</li> </ul>
15

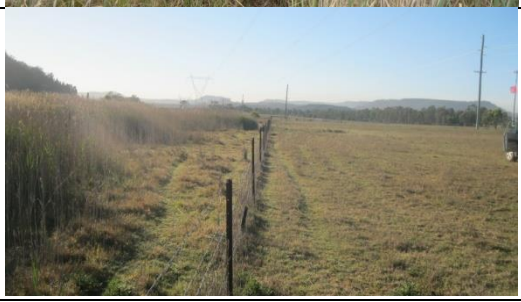
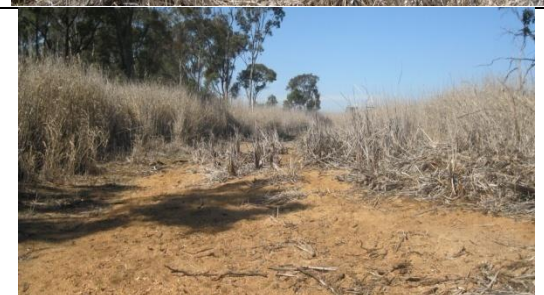
<ul style="list-style-type: none"> <li>• Slightly different location as a result of access;</li> <li>• Increased exposure of soils along access track;</li> <li>• Reduction in healthy instream flora growth;</li> <li>• Creek bank exposure almost 100% in areas as a result of low groundcover;</li> <li>• Little to no riparian zone.</li> </ul>

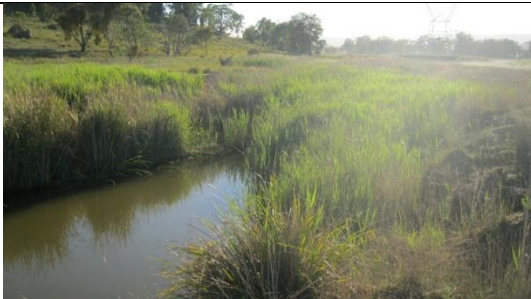
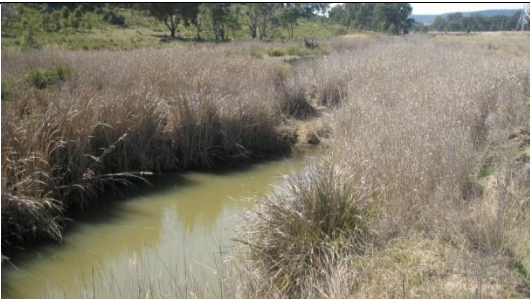
18

<ul style="list-style-type: none"> <li>• Reduction in instream flora health;</li> <li>• Reduction in green growth on the creek banks and in the riparian areas;</li> <li>• Increased exposure of the left bank face;</li> <li>• Right bank appears to be suffering slippage;</li> <li>• Little to no riparian zone.</li> </ul>
19

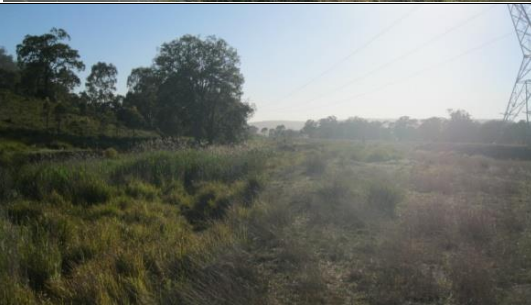
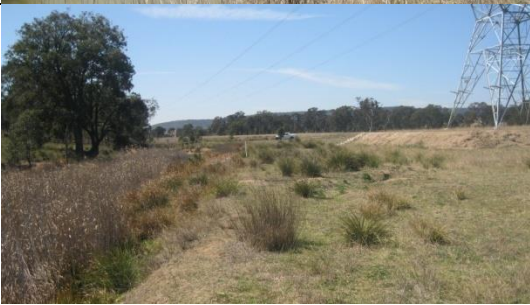
<ul style="list-style-type: none"> <li>• Reduction in healthy instream flora;</li> <li>• Increased exposure of the right bank as a result of a reduction in groundcover;</li> <li>• Sight remains stable;</li> <li>• Little to no riparian zone.</li> </ul>
20

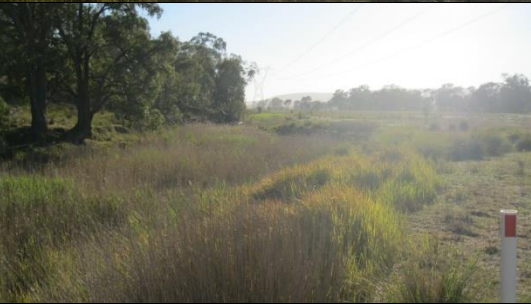
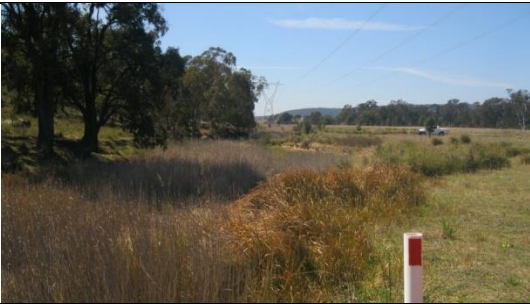
<ul style="list-style-type: none"> <li>• Reduction in healthy instream flora;</li> <li>• Increased bleaching of exposed soils on the left bank face;</li> <li>• Right bank remains stable;</li> <li>• Little to no riparian zone.</li> </ul>
21

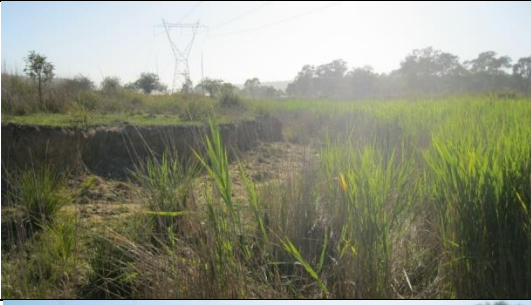
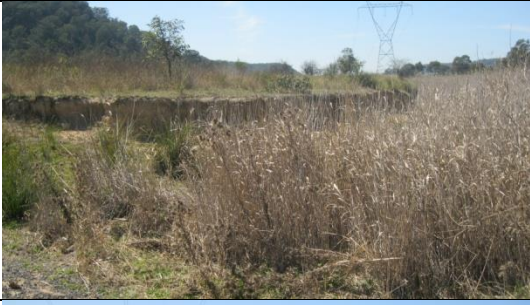
<ul style="list-style-type: none"> <li>• Reduction in healthy instream flora;</li> <li>• Increased bleaching of exposed soils on the bank faces;</li> <li>• Increased erosion and regression of the right bank;</li> <li>• Little to no riparian zone.</li> </ul>

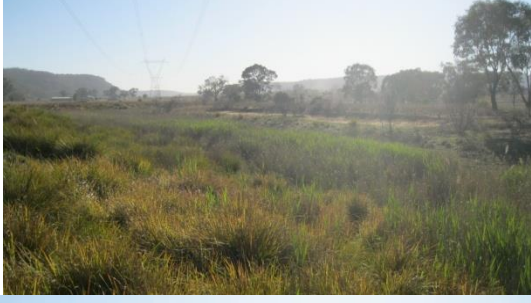
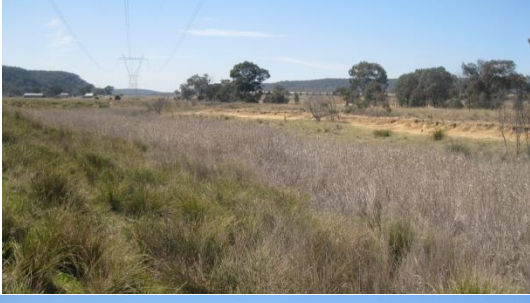
22

<ul style="list-style-type: none"> <li>• Reduction in healthy instream flora;</li> <li>• Increased bleaching of exposed soils on the right bank face;</li> <li>• Left bank remains stable;</li> <li>• Reduction of the active channel;</li> <li>• Little to no riparian zone.</li> </ul>
23

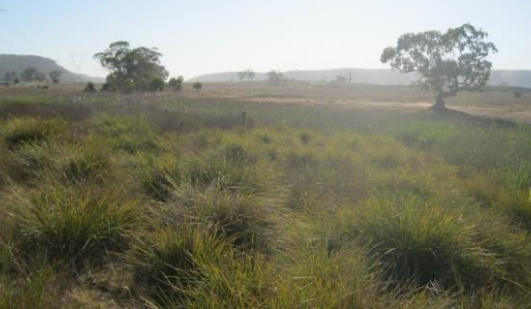
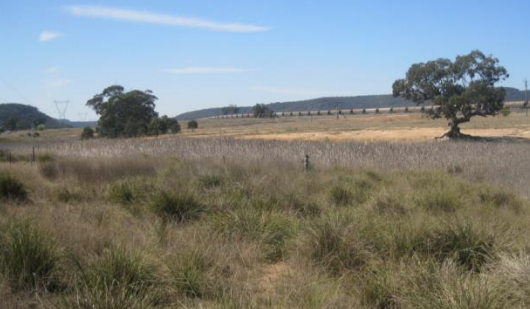
<ul style="list-style-type: none"> <li>• Reduction in healthy instream flora;</li> <li>• Increased bleaching of exposed soils on the right bank face;</li> <li>• Left bank remains stable;</li> <li>• Reduction of the active channel;</li> <li>• Little to no riparian zone.</li> </ul>

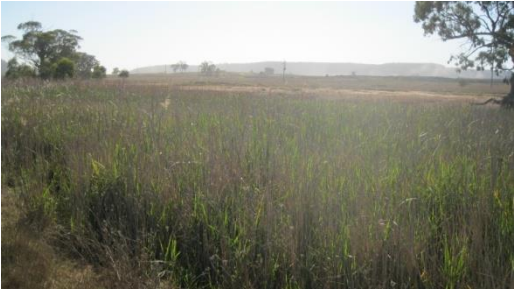
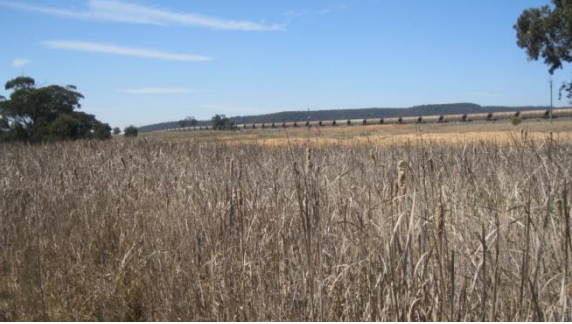
24

<ul style="list-style-type: none"> <li>• Reduction in healthy instream flora;</li> <li>• Increased bleaching of exposed soils on the right bank face;</li> <li>• An increase in sheet erosion of the right bank;</li> <li>• Left bank remains stable;</li> <li>• Reduction of the active channel;</li> <li>• Little to no riparian zone.</li> </ul>
25

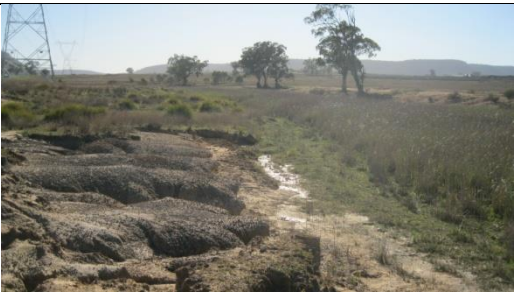
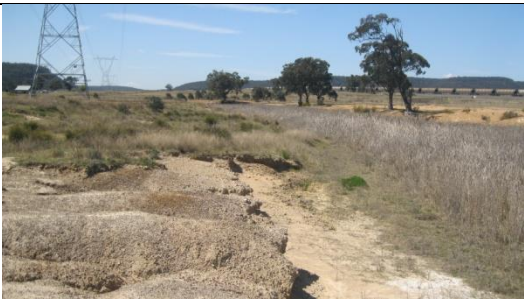
<ul style="list-style-type: none"> <li>• Reduction in healthy instream flora;</li> <li>• Stabilisation of left bank erosion, however an increase in salt crusting on the soil surfaces;</li> <li>• An increase in slumping and undercutting of the left bank;</li> <li>•</li> </ul>
26

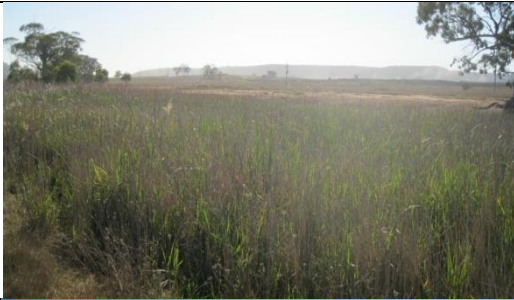
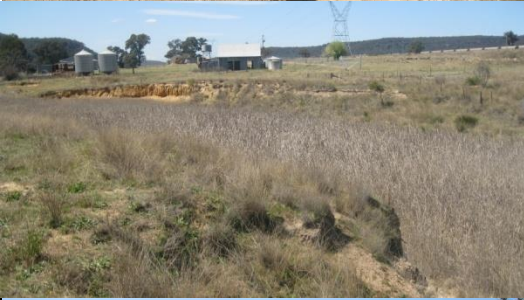
<ul style="list-style-type: none"> <li>• Reduction in healthy instream flora;</li> <li>• Stabilisation of the left bank face, with a minor decrease in groundcover;</li> <li>• Right bank exposure remains stable.</li> </ul>
27

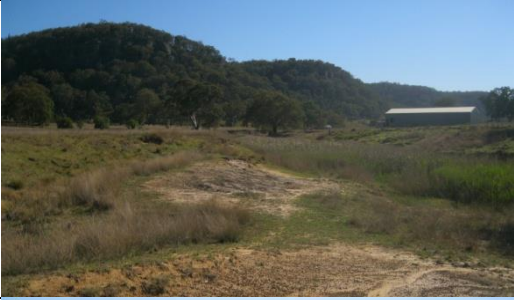
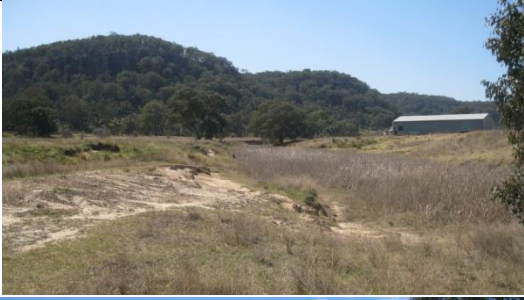
<ul style="list-style-type: none"> <li>• Reduction in healthy instream flora;</li> <li>• Stabilisation of the left bank face, with a minor decrease in groundcover;</li> <li>• Right bank exposure has increased as a result of a reduction in groundcover.</li> </ul>

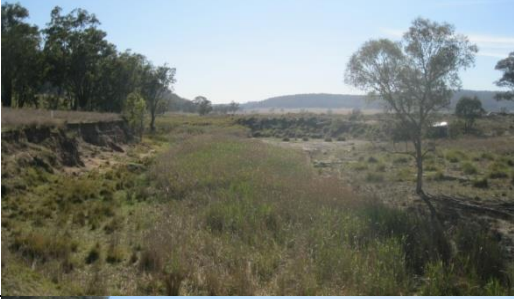
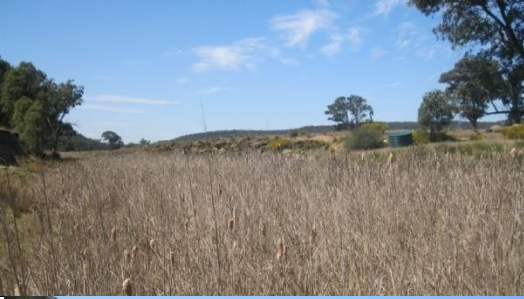
28

<ul style="list-style-type: none"> <li>• Reduction in healthy instream flora;</li> <li>• Increased bank stability of the right bank;</li> <li>• Site remains similar.</li> </ul>
29

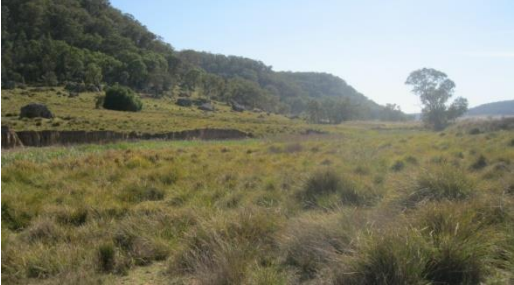
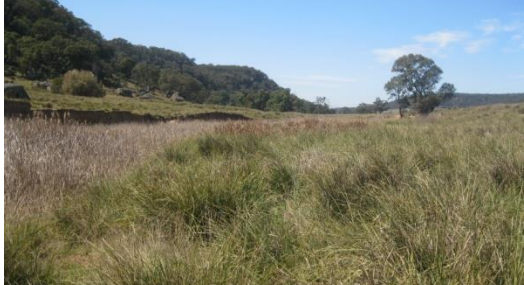
<ul style="list-style-type: none"> <li>• Reduction in healthy instream flora;</li> <li>• Increased bank stability of the right bank;</li> <li>• Erosion of the left bank continues as a result of with a lack of groundcover and steep slope.</li> <li>• Reduction in the active channel width in 2013.</li> </ul>

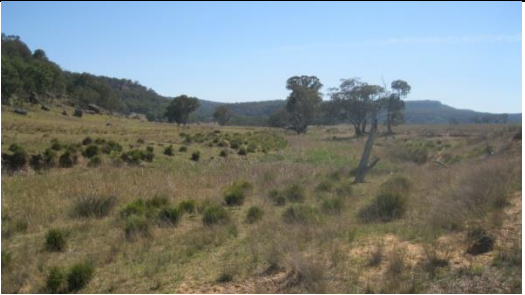
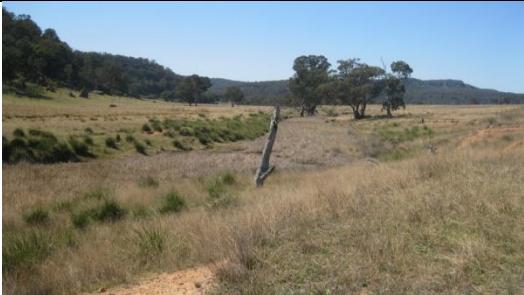
36

<ul style="list-style-type: none"> <li>• Right bank remains well vegetated;</li> <li>• Increased soil exposure of the left bank due to increased dryness during 2014;</li> <li>• Reduction in the active channel width;</li> <li>• Channel bed remains similar.</li> </ul>
37

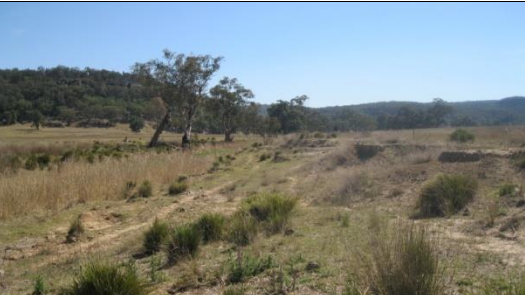
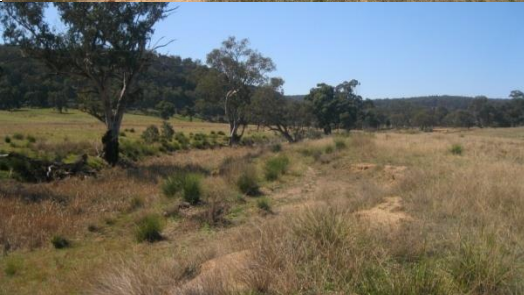
<ul style="list-style-type: none"> <li>• Increased exposure of the surface soils on the right bank resulting from increased dryness during 2014;</li> <li>• Left bank remains well vegetated and stable.</li> </ul>
38

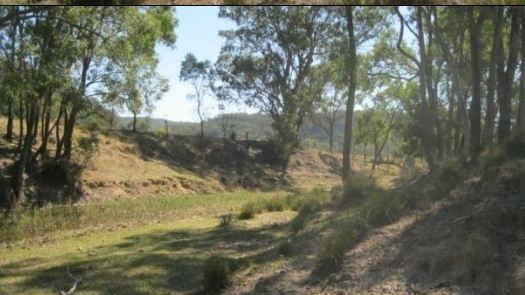
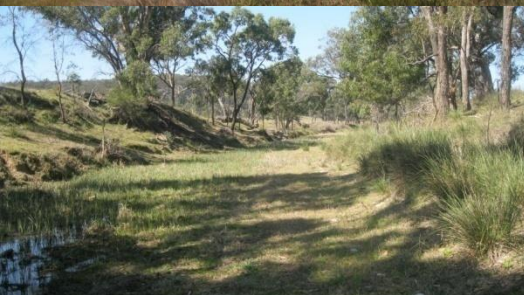
<ul style="list-style-type: none"> <li>• Reduction in abundance of instream flora at the site;</li> <li>• Increase in water pooling;</li> <li>• Both banks remain well vegetated and stable.</li> </ul>
39	No Access

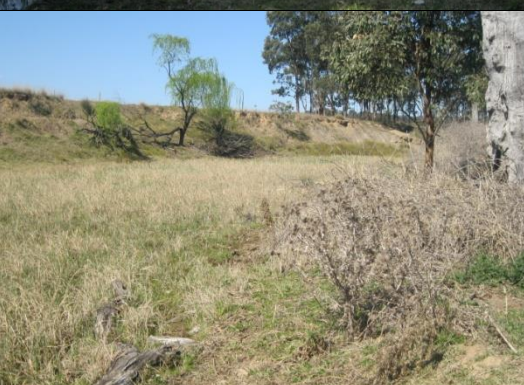
<ul style="list-style-type: none"> <li>• Creek bed is well vegetated with little to no exposure of the creek bed;</li> <li>• Right bank well vegetated;</li> <li>• Left bank suffering from soil exposure and minor sheet erosion;</li> <li>• Blackberry noted close to the site;</li> <li>• Lack of riparian zone on both banks.</li> </ul>

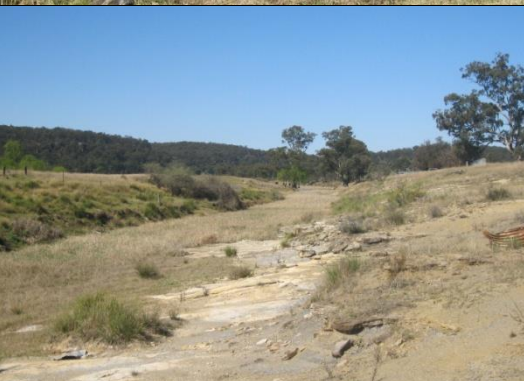
40	No Access

<ul style="list-style-type: none"> <li>• Creek bed is well vegetated with little to no exposure of the creek bed;</li> <li>• Left bank is well vegetated;</li> <li>• Right bank suffering from soil exposure and sheet erosion;</li> <li>• Lack of riparian zone on both banks.</li> </ul>
