# Wilpinjong & Cumbo Creek Stability Assessment, 2014

Wilpinjong Coal Mine

Mar-15  
(Our Reference: 21977\_E01)

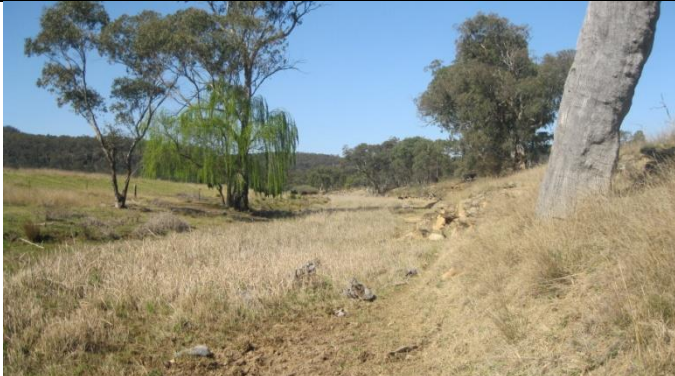
41	No Access

<ul style="list-style-type: none"> <li>• Creek bed is well vegetated with little to no exposure of the creek bed;</li> <li>• Left bank is well vegetated;</li> <li>• Right bank suffering from minor soil exposure and erosion;</li> <li>• Lack of riparian zone on both banks;</li> <li>• Evidence of stock in the creek bed.</li> </ul>
42

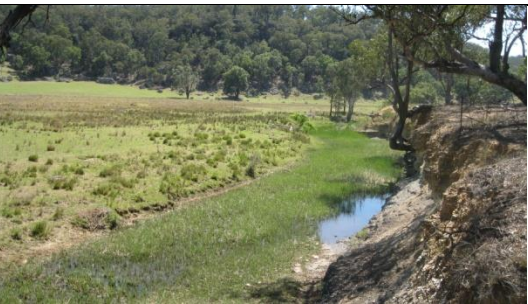
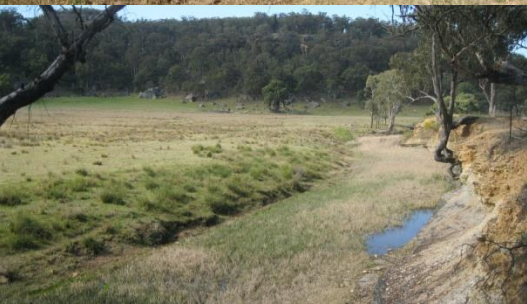
<ul style="list-style-type: none"> <li>• Creek bed is well vegetated with little exposure of the creek bed;</li> <li>• Left bank is well vegetated;</li> <li>• Increase in soil exposure, erosion and regrowth of the right bank, as noted by an increase in bank steepness and rootlet exposure in 2014;</li> <li>• An increase in undercutting of the inner right bank;</li> <li>• Lack of riparian zone on both banks.</li> <li>• Channel width has remained similar.</li> </ul>
43

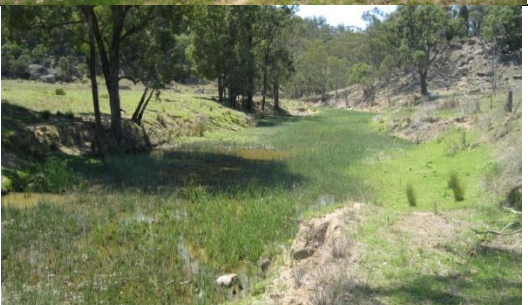
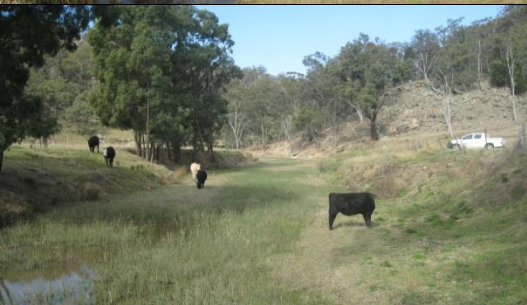
44

<ul style="list-style-type: none"> <li>• Instream flora abundance and coverage remains similar over the year;</li> <li>• Active channel width appears to have increased';</li> <li>• Bank face exposure and vegetation coverage remains similar on both banks over the year;</li> <li>• Stock evident in the creek bed.</li> </ul>
45

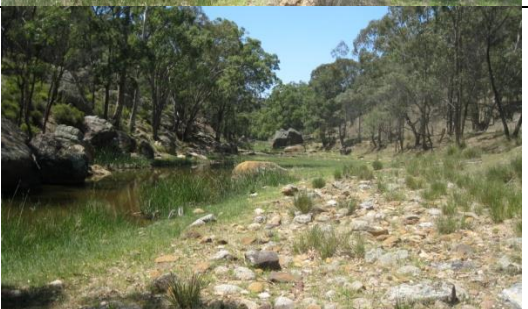
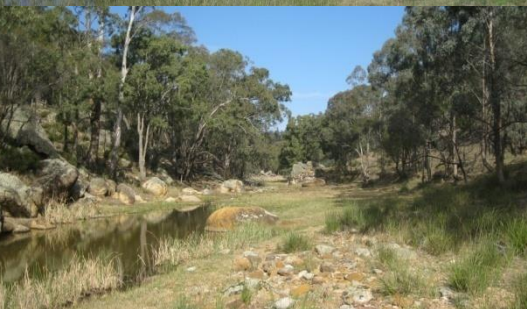
<ul style="list-style-type: none"> <li>• Creek bed width remains stable;</li> <li>• Increased vegetation coverage and therefore a reduction in soil exposure on the right bank;</li> <li>• Right bank remains stable, as largely bedrock.</li> </ul>

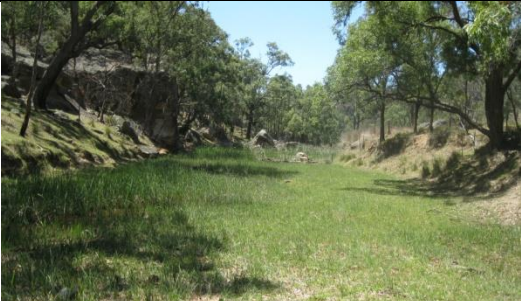
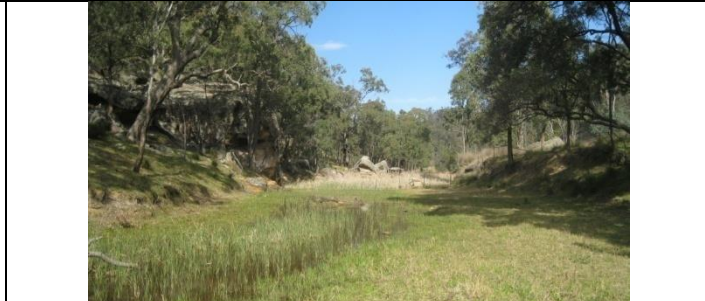
46

<ul style="list-style-type: none"> <li>• Creek bed is well vegetated with little to no exposure of the creek bed;</li> <li>• Both banks are well vegetated and stable;</li> <li>• Site continues to stabilise.</li> </ul>
47

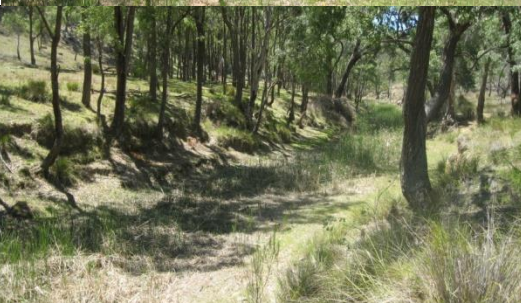
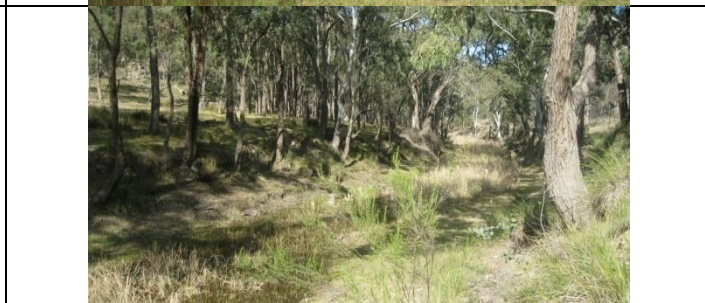
<ul style="list-style-type: none"> <li>• An increase in the in stream flora coverage, resulting in a reduction in creek bed exposure;</li> <li>• Both banks continue to regenerate as groundcover on the bank faces increases;</li> <li>• Site continues to stabilise.</li> </ul>
48

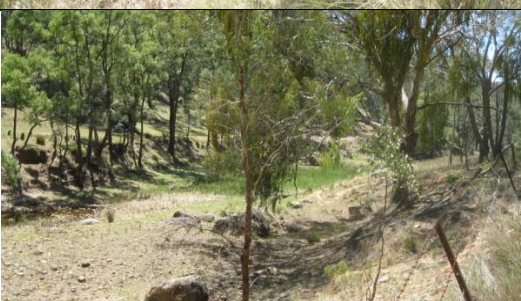
<ul style="list-style-type: none"> <li>• Reduction in the active channel width;</li> <li>• Increased undercutting of the left inner bank, however the outer embankment is well vegetated;</li> <li>• Soil exposure remains stable instream and on the right bank face. There has been an increase in groundcover on the right bank face as result of natural regeneration;</li> </ul>

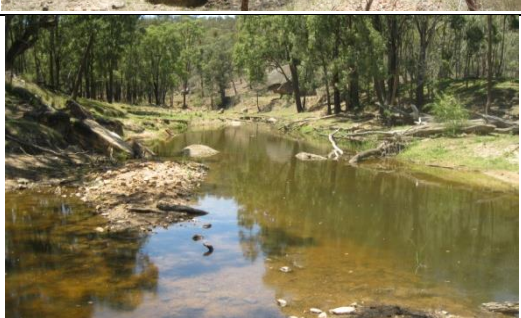
<ul style="list-style-type: none"> <li>• A reduction in the active channel width;</li> <li>• Instream flora remains minimal with continued deposition of sands and pebbles;</li> <li>• Inner banks remain sparsely vegetated as a result of a dry 2014;</li> </ul>

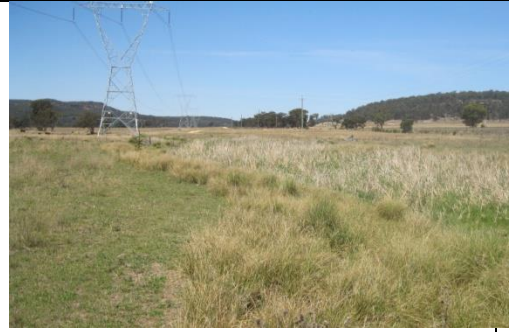
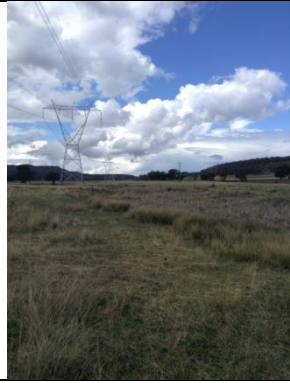
10

- A reduction in 'green' groundcover on the bank faces and within riparian areas between 2013-2014.
- Site remain well vegetated and stable.
