# Wilpinjong & Cumbo Creek Stability Assessment, 2012-2013

Wilpinjong Coal Mine

Mar-14  
(Our Reference: 20366\_E02)

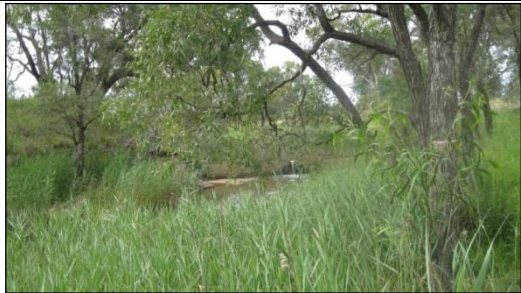
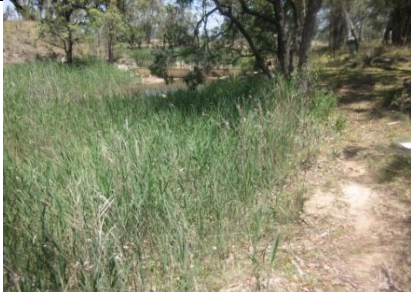
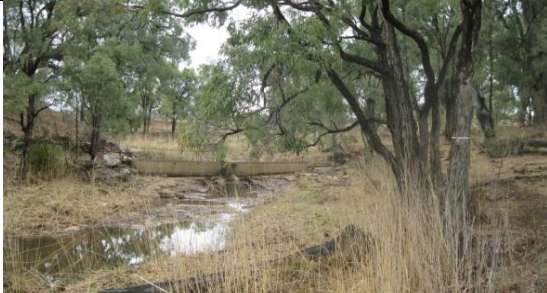
| Site | Upstream December 2011 | Upstream December 2012 | Upstream December 2013 | Main Comparison |
|---|---|---|---|---|
| 1 | | | | <ul style="list-style-type: none"> <li>• A reduction in 'green' groundcover within the creek bed, on the bank faces and within riparian areas between 2011-13.</li> <li>• An increase in soil exposure on the bank face between 2011-2012.</li> <li>• A reduction in creek width over the 2 year period.</li> </ul> |

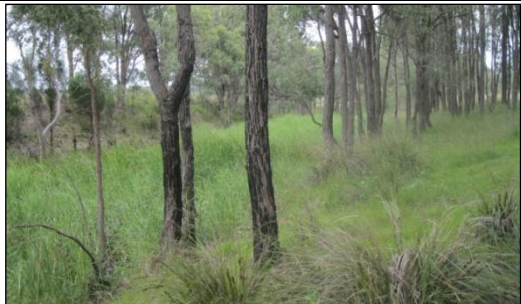
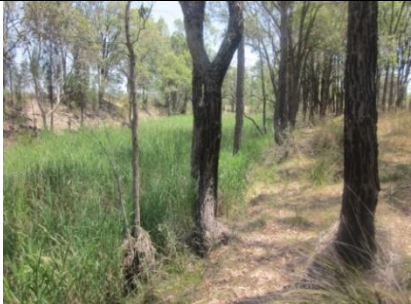
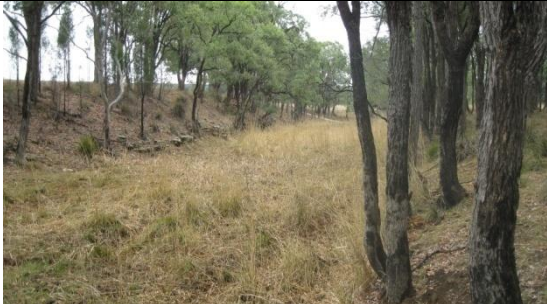
| Site | Upstream December 2011 | Upstream December 2012 | Upstream December 2013 | Main Comparison |
|---|---|---|---|---|
| 2 | | | | <ul style="list-style-type: none"> <li>• A reduction in 'green' groundcover within the creek bed, on the bank faces and within riparian areas between 2011-13.</li> <li>• An increase in tree snagging in 2012. Snags were clear in 2013.</li> <li>• An increase in soil exposure on the bank face between 2011-2012.</li> <li>• A reduction in creek width over the 2 year period.</li> </ul> |

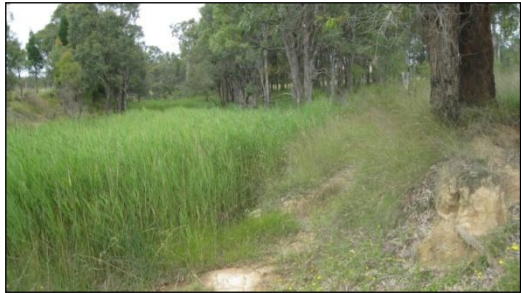
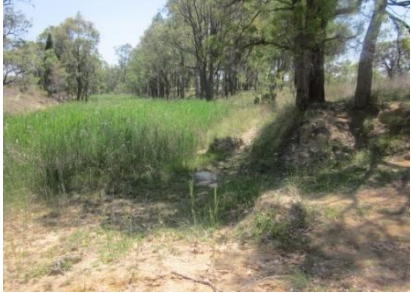
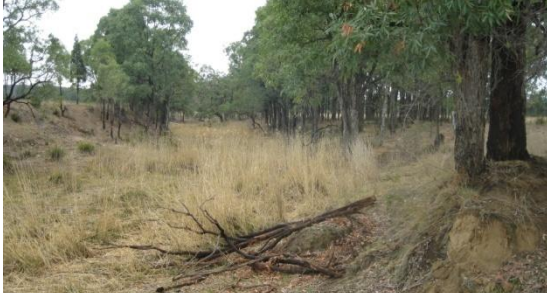
| Site | Upstream December 2011 | Upstream December 2012 | Upstream December 2013 | Main Comparison |
|---|---|---|---|---|
| 3 | | | | <ul style="list-style-type: none"> <li>• A reduction in 'green' groundcover within the creek bed, on the bank faces and within riparian areas between 2011-13.</li> <li>• An increase in soil exposure and debris on the bank face between 2011-2012.</li> <li>• A reduction in creek width over the 2 year period. A reduction in groundcover and in stream vegetation between 2011-2012.</li> <li>• In increase in bank erodeability during 2013.</li> </ul> |

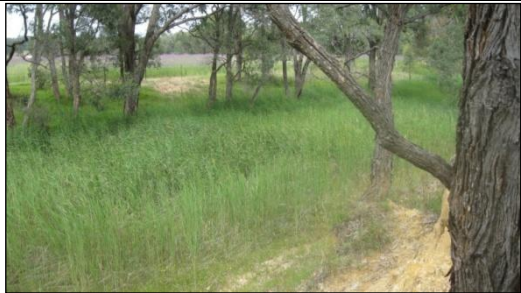
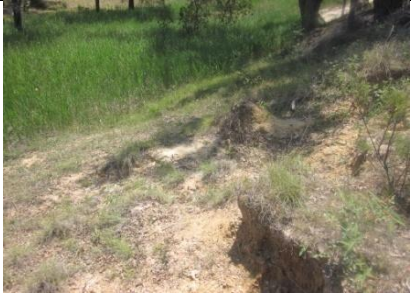
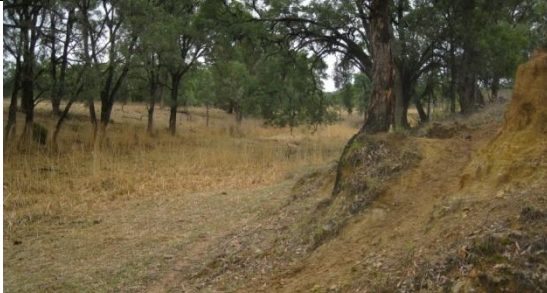
| Site | Upstream December 2011 | Upstream December 2012 | Upstream December 2013 | Main Comparison |
|---|---|---|---|---|
| 4 | | | | <ul style="list-style-type: none"> <li>• A reduction in 'green' groundcover within the creek bed, on the bank faces and within riparian areas between 2011-13.</li> <li>• An increase in soil exposure, bank undercutting and erosion of the bank face between 2011-2012.</li> <li>• Continued erosion of the left bank and bank slumping during 2013 as a result of minimal groundcover.</li> <li>• In increase in bank erodeability during 2013.</li> </ul> |

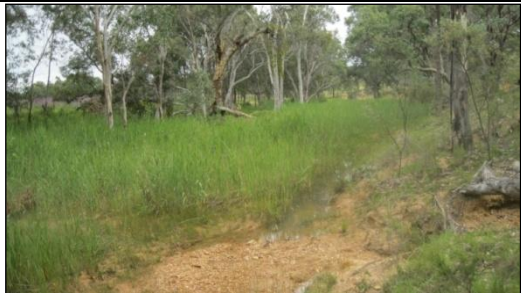
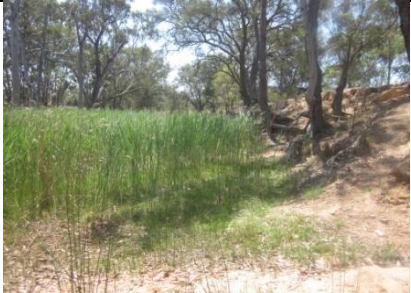
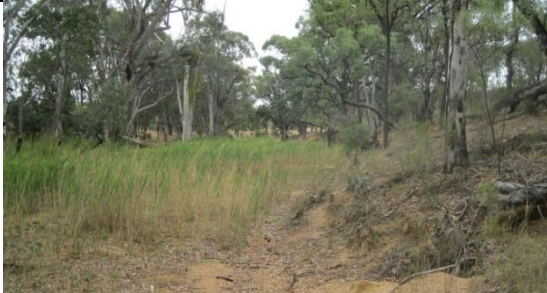
| Site | Upstream December 2011 | Upstream December 2012 | Upstream December 2013 | Main Comparison |
|---|---|---|---|---|
| 5 | | | | <ul style="list-style-type: none"> <li>• A reduction in groundcover within the creek bed and on the creek bed during 2011-2012.</li> <li>• An increase in soil exposure during 2011-2012.</li> <li>• Sites remained similar in terms of stability and groundcover during 2012-2013.</li> </ul> |

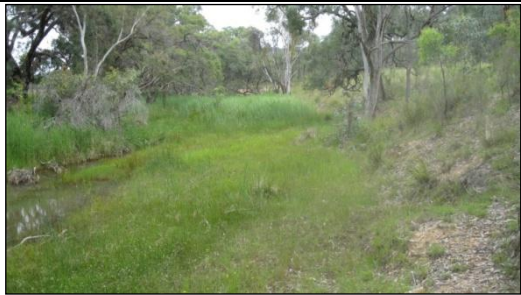
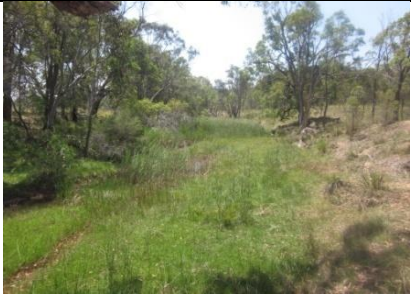
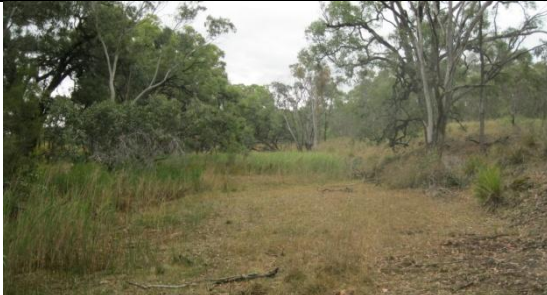
| 6 | | | | <ul style="list-style-type: none"> <li>• A reduction in 'green' groundcover within the creek bed, on the bank faces and within riparian areas between 2011-13.</li> <li>• An increase in soil exposure of the creek bed and bank face between 2012-2013.</li> <li>• A reduction in the active channel width during 2012-2013.</li> <li>• An increase in bed debris and woody material during 2012-2013.</li> </ul> |

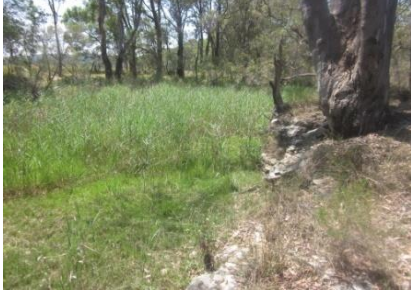
| 7 | | | | <ul style="list-style-type: none"> <li>• A reduction in 'green' groundcover within the creek bed, on the bank faces and within riparian areas between 2011-13.</li> <li>• An increase in soil exposure of the creek bed and bank face between 2012-2013.</li> <li>• A reduction in the active channel width during 2012-2013.</li> <li>• An increase in bed debris and woody material during 2012-2013.</li> </ul> |

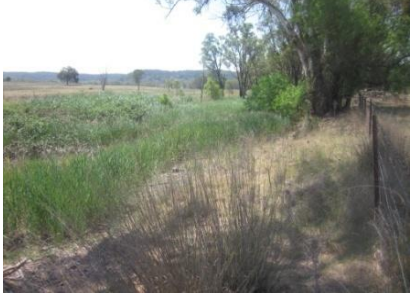
| 8 | | | | <ul style="list-style-type: none"> <li>• A reduction in 'green' groundcover within the creek bed, on the bank faces and within riparian areas between 2011-12.</li> <li>• In increase in plant growth within the creek bed and on the creek bank during 2013.</li> <li>• An increase in groundcover on the creek banks during 2013.</li> </ul> |

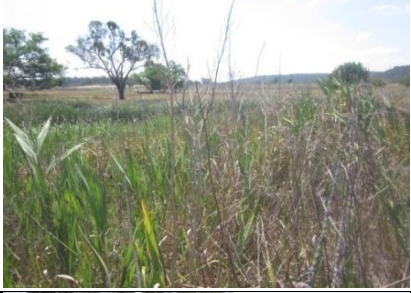
| 9 | | | | <ul style="list-style-type: none"> <li>• No considerable differences in the creek bed or bank observed at this site during 2011-2013.</li> </ul> |

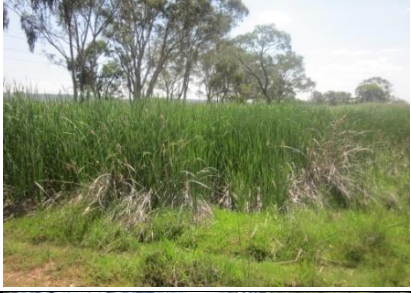
| 10 | | | | <ul style="list-style-type: none"> <li>• No considerable differences in the creek bed or bank observed at this site during 2011-2013.</li> </ul> |

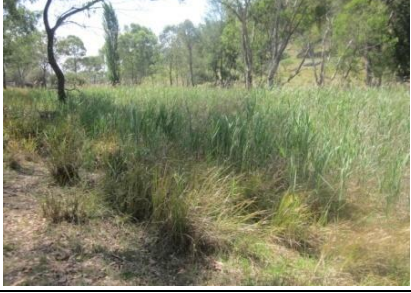
| 11 | | | | <ul style="list-style-type: none"> <li>• A reduction in 'green' groundcover within the creek bed, on the bank faces and within riparian areas between 2011-13.</li> <li>• A reduction in the active channel between 2011-2013.</li> </ul> |

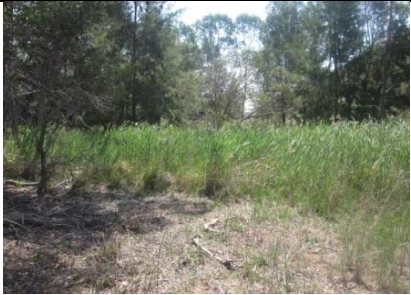
| 12 | | | | <ul style="list-style-type: none"> <li>• A reduction in 'green' groundcover within the creek bed, on the bank faces and within riparian areas between 2011-13.</li> <li>• An increase in soil exposure of the creek bed and bank face between 2011-2013.</li> <li>• A reduction in the active channel width during 2012-2013.</li> <li>• An increase in bed debris during 2011-2013.</li> </ul> |

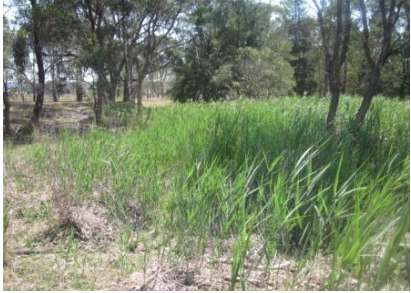
| 13 | | | | <ul style="list-style-type: none"> <li>• A reduction in 'green' groundcover within the creek bed, on the bank faces and within riparian areas between 2011-13.</li> <li>• An increase in soil exposure of the creek bank face between 2012-2013.</li> <li>• A reduction in the active channel width during 2012-2013.</li> <li>• An increase in bank debris and woody material during 2012-2013.</li> </ul> |

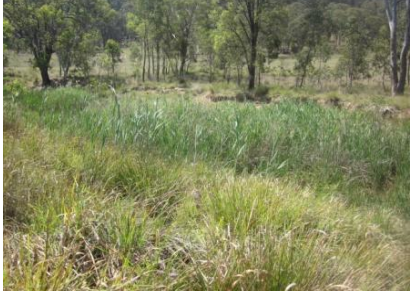
| 14 | | | | <ul style="list-style-type: none"> <li>• No considerable differences in the creek bed or bank observed at this site during 2011-2013</li> </ul> |

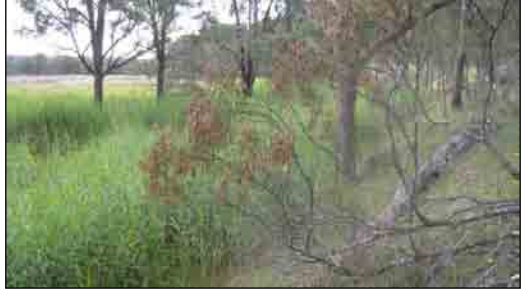
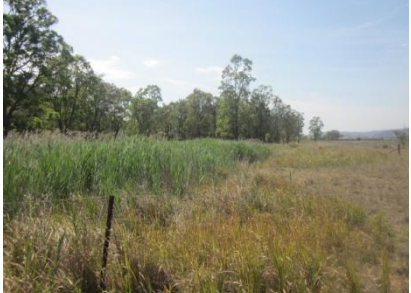
| 15 | | | | <ul style="list-style-type: none"> <li>• Slightly different locations in 2012 to 2011 and 2013.</li> <li>• A reduction in 'green' groundcover within the creek bed, on the bank faces and within riparian areas between 2011-13.</li> <li>• An increase in soil exposure of the creek bank face between 2012-2013.</li> <li>• A reduction in the active channel width during 2012-2013.</li> </ul> |

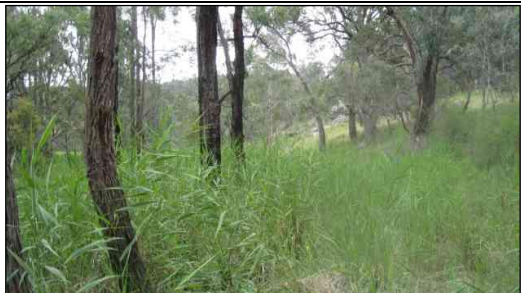
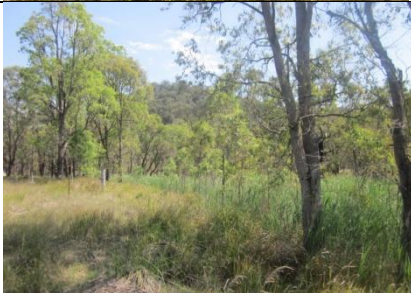
| 16 | | | | <ul style="list-style-type: none"> <li>• A reduction in 'green' groundcover within the creek bed, on the bank faces and within riparian areas between 2012-13.</li> <li>• No considerable differences in the creek bed or bank observed at this site during 2012-2013</li> </ul> |

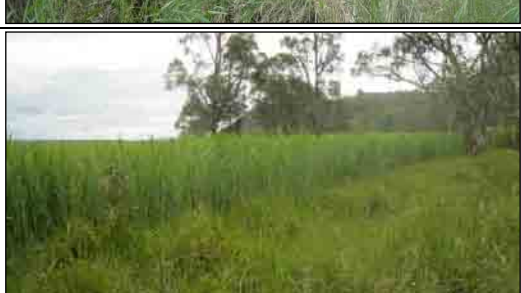
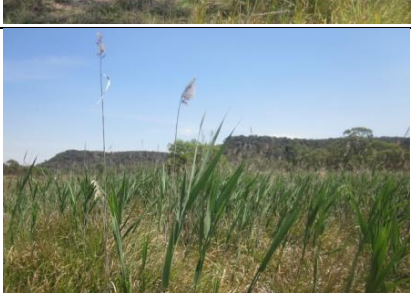
| 17 | | | | <ul style="list-style-type: none"> <li>• A reduction in 'green' groundcover within the creek bed, on the bank faces and within riparian areas between 2011-13.</li> <li>• Creek bed and banks remain stable.</li> </ul> |

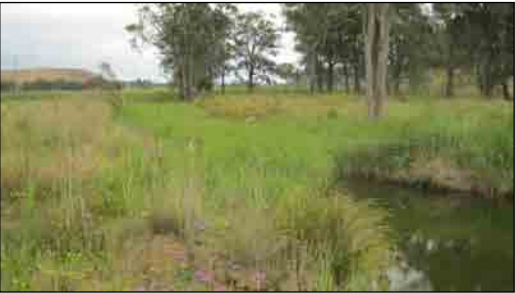
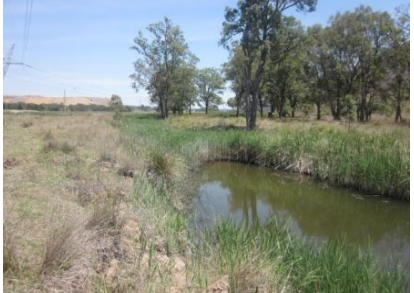
| 18 | | | | <ul style="list-style-type: none"> <li>• A reduction in 'green' groundcover within the creek bed, on the bank faces and within riparian areas between 2011-13.</li> <li>• Increase soil exposure during 2012. However this remained stable in 2013.</li> <li>• A reduction in the active channel width during 2012-2013.</li> </ul> |

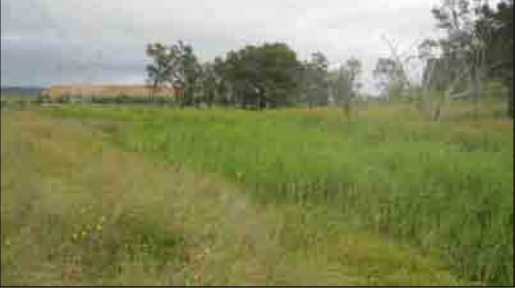
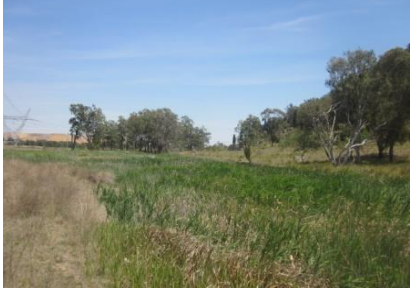
| 19 | | | | <ul style="list-style-type: none"> <li>• A reduction in 'green' groundcover within the creek bed, on the bank faces and within riparian areas between 2011-13.</li> <li>• A reduction in the active channel width during 2011-2013.</li> </ul> |

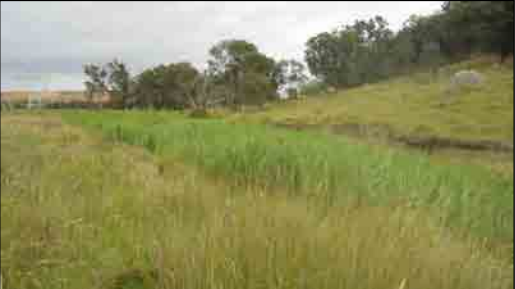
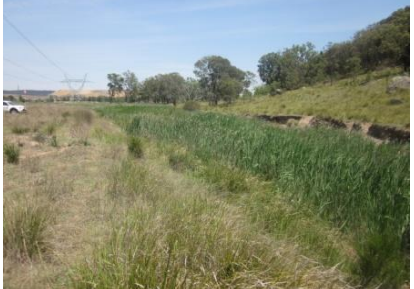
| 20 | | | | <ul style="list-style-type: none"> <li>• A reduction in 'green' groundcover within the creek bed, on the bank faces and within riparian areas between 2011-13.</li> <li>• Increase soil exposure and erosion of the right bank during 2012. This continued in 2013.</li> <li>• A reduction in the active channel width during 2012-2013.</li> </ul> |

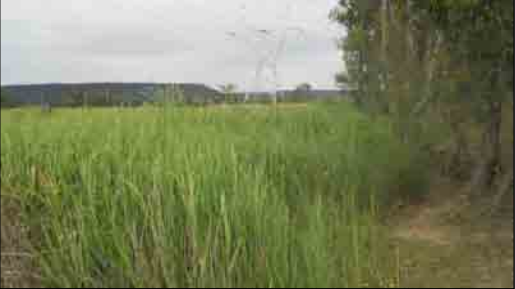
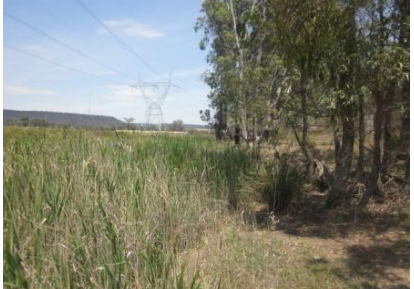
| 21 | | | | <ul style="list-style-type: none"> <li>• A reduction in 'green' groundcover within the creek bed, on the bank faces and within riparian areas between 2011-12.</li> <li>• A reduction in the active channel width during 2011-2012.</li> <li>• No considerable differences in the creek bed or bank observed at this site during 2012-2013.</li> </ul> |

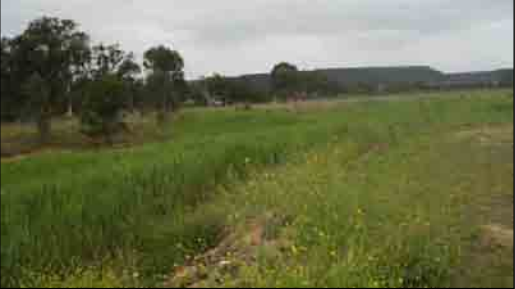
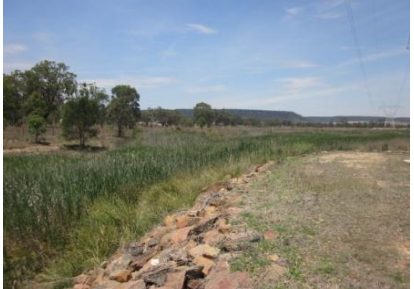
| 22 | | | | <ul style="list-style-type: none"> <li>• A reduction in 'green' groundcover within the creek bed, on the bank faces and within riparian areas between 2011-12.</li> <li>• Increase soil exposure on the creek bank faces during 2012. However this remained stable in 2013, with an increase in groundcover observed in 2013.</li> <li>• A reduction in the active channel width during 2011-2012.</li> </ul> |

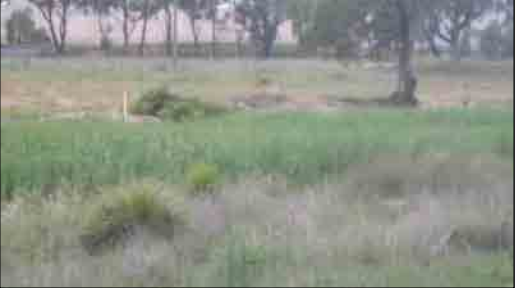
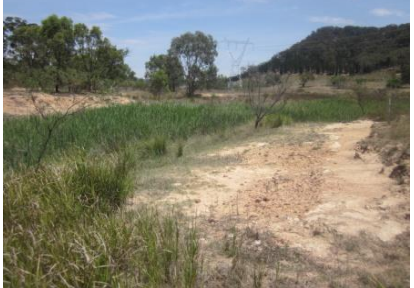
| 23 | | | | <ul style="list-style-type: none"> <li>• A reduction in 'green' groundcover within the creek bed, on the bank faces and within riparian areas between 2011-12.</li> <li>• Increase soil exposure on the left creek bank face during 2012, which is evident by an area of surface sheet erosion. A reduction of sheet erosion in 2013, with an increase in groundcover noted.</li> <li>• An increase in soil exposure on the right bank resulting in sheet erosion and gulying between 2011-2012. This remained stable in 2013.</li> </ul> |

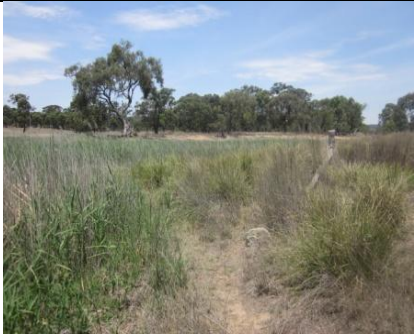
| 24 | | | | <ul style="list-style-type: none"> <li>• A reduction in 'green' groundcover within the creek bed, on the bank faces and within riparian areas between 2011-12.</li> <li>• Increase soil exposure on the left top of bank during 2012, which is evident by an area of surface sheet erosion. This is reduced in 2013.</li> </ul> |

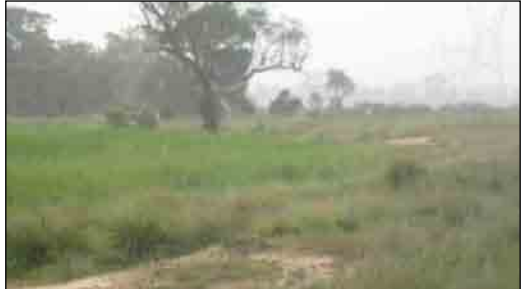
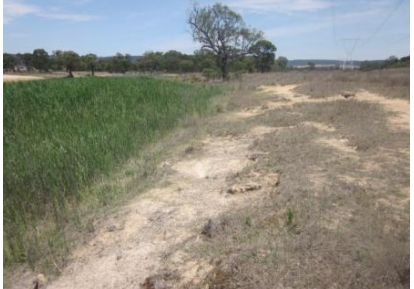
| 25 | | | | <ul style="list-style-type: none"> <li>• A reduction in 'green' groundcover within the creek bed, on the bank faces and within riparian areas between 2011-12.</li> <li>• Increase soil exposure on the left creek bank face during 2012, which is evident by an area of surface sheet erosion along the bank face. This has reduced in 2013, with an increase in groundcover noted.</li> </ul> |

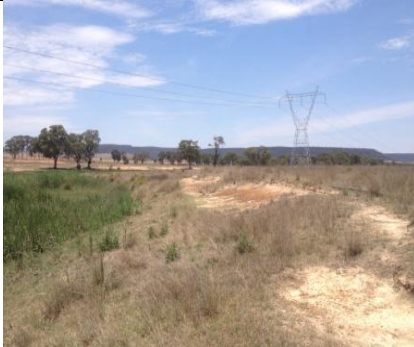
| 26 | | | | <ul style="list-style-type: none"> <li>• A reduction in 'green' groundcover within the creek bed, on the bank faces and within riparian areas between 2011-12.</li> <li>• An increase in active channel width in 2013, as noted by an increase in instream flora from 2012.</li> <li>• Increase soil exposure on the left creek bank face during 2012, which is evident by an area of surface sheet erosion along the bank face. This has reduced in 2013, with an increase in groundcover noted.</li> </ul> |

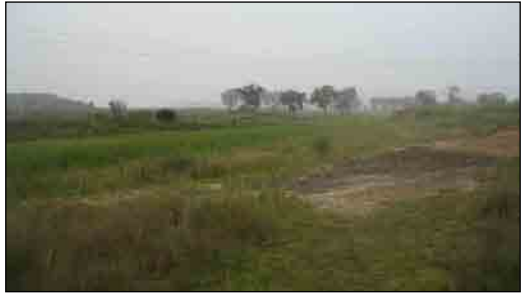
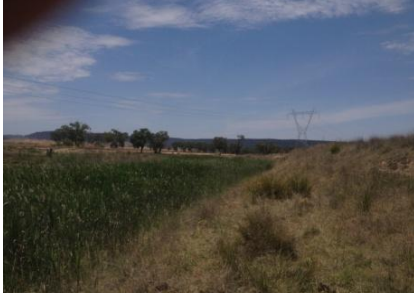
| 27 | | | | <ul style="list-style-type: none"> <li>• A reduction in 'green' groundcover within the creek bed, on the bank faces and within riparian areas between 2011-12.</li> <li>• No considerable differences in the creek bed or bank observed at this site during 2012-2013.</li> </ul> |

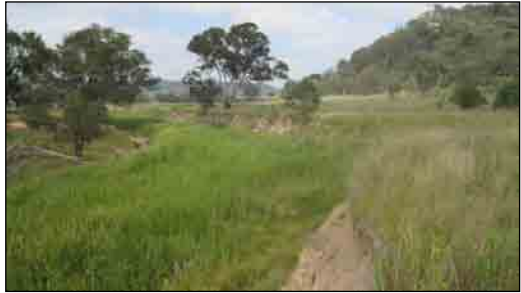
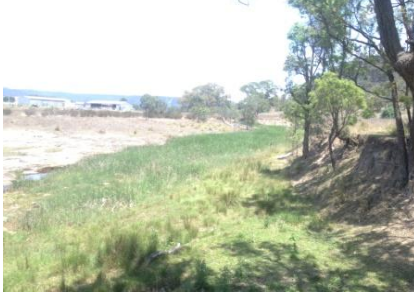
| 28 | | | | <ul style="list-style-type: none"> <li>• A reduction in 'green' groundcover within the creek bed, on the bank faces and within riparian areas between 2011-12.</li> <li>• Increase soil exposure and erosion on both creek bank faces during 2012. This has reduced in 2013, with an increase in groundcover noted.</li> <li>• A reduction in the active channel width during 2011-2013.</li> </ul> |

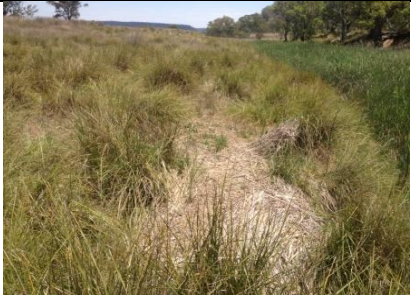
| 29 | | | | <ul style="list-style-type: none"> <li>• A reduction in 'green' groundcover within the creek bed, on the bank faces and within riparian areas between 2011-12.</li> <li>• No considerable differences in the creek bed or bank observed at this site during 2012-2013.</li> </ul> |

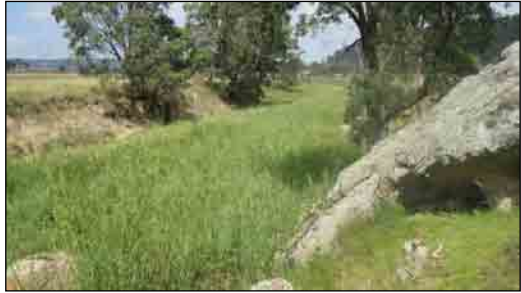
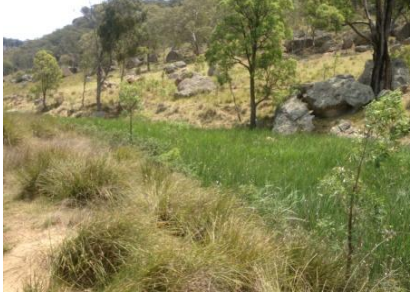
| 30 | | | | <ul style="list-style-type: none"> <li>• A reduction in 'green' groundcover within the creek bed, on the bank faces and within riparian areas between 2011-13.</li> <li>• Site relatively stable between 2011-2013 with good ground cover and minimal exposed surfaces.</li> </ul> |

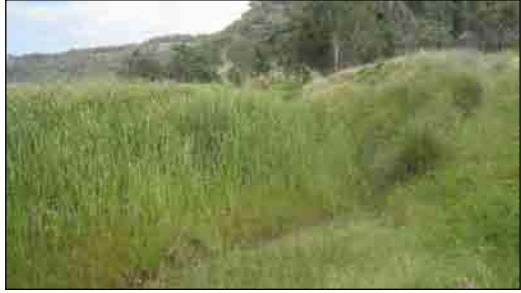
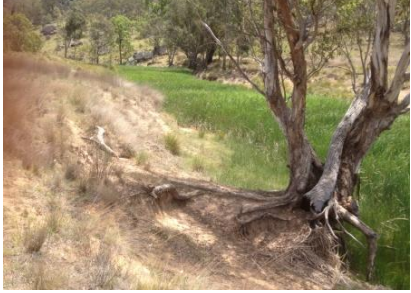
| 31 | | | | <ul style="list-style-type: none"> <li>• A reduction in 'green' groundcover within the creek bed, on the bank faces and within riparian areas between 2011-13.</li> <li>• Increase soil exposure on the right creek bank face during 2013, however site remains stable.</li> </ul> |

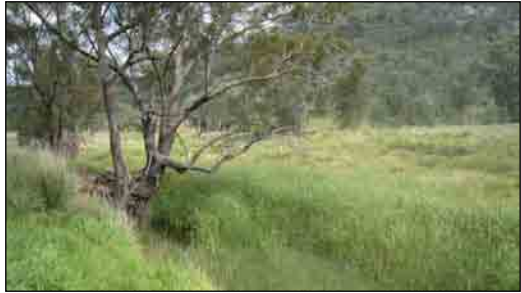
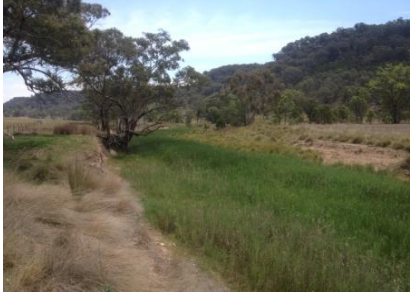
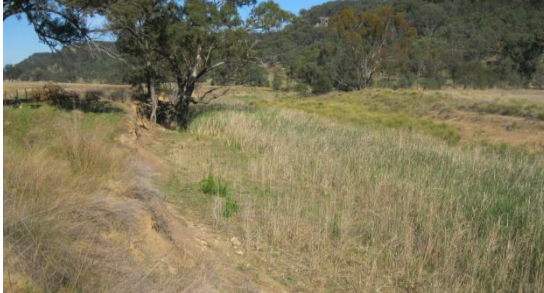
| 32 | | | | <ul style="list-style-type: none"> <li>• A reduction in 'green' groundcover within the creek bed, on the bank faces and within riparian areas between 2011-13.</li> <li>• Increase soil exposure on the right creek bank face during 2013, however site remains stable.</li> <li>• A reduction in the active channel width during 2011-2013.</li> </ul> |

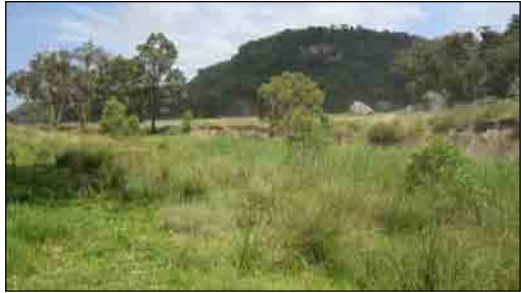
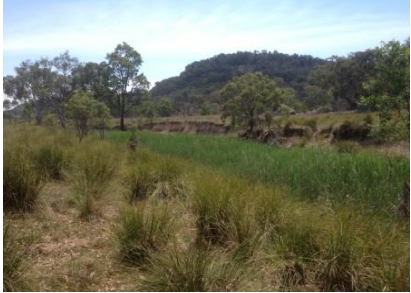
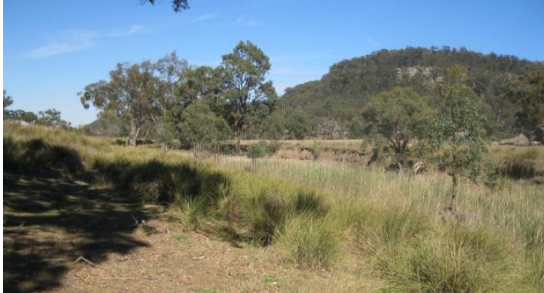
| 33 | | | | <ul style="list-style-type: none"> <li>• A reduction in 'green' groundcover within the creek bed, on the bank faces and within riparian areas between 2011-13.</li> <li>• Increase soil exposure on the right creek bank face during 2013, however site remains stable.</li> <li>• A reduction in the active channel width during 2011-2013.</li> </ul> |

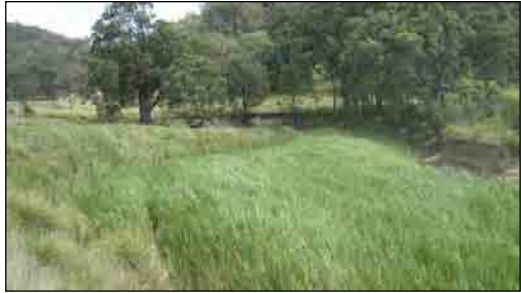
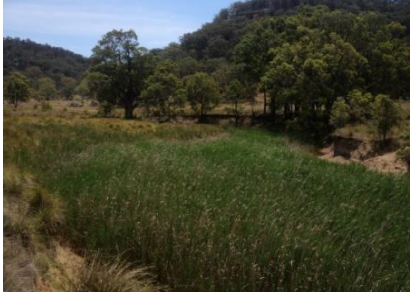
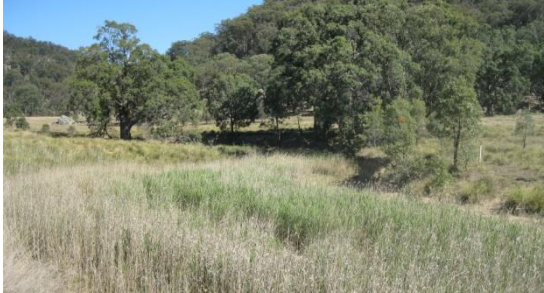
| 34 | | | | <ul style="list-style-type: none"> <li>• A reduction in 'green' groundcover within the creek bed, on the bank faces and within riparian areas between 2011-13.</li> <li>• Increase soil exposure on the left creek bank face during 2012, however regeneration occurred during 2013 with the bank being more stable.</li> <li>• A reduction in the active channel width during 2011-2013.</li> </ul> |

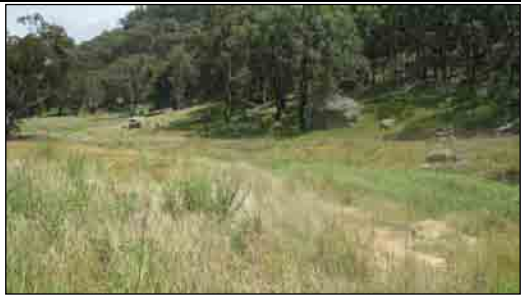
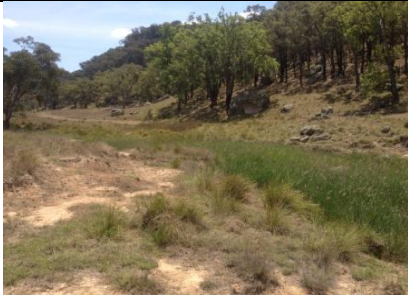
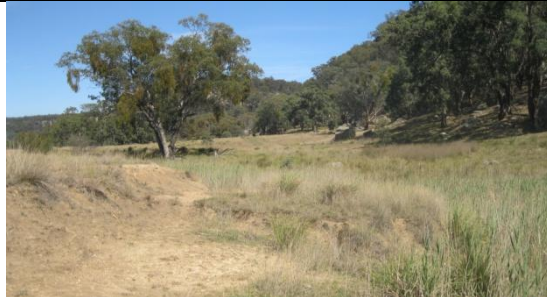
| 35 | | | | <ul style="list-style-type: none"> <li>• A reduction in 'green' groundcover within the creek bed, on the bank faces and within riparian areas between 2011-13.</li> <li>• Increase soil exposure on the right creek bank face during 2012, and this exposure continued during 2013.</li> <li>• A reduction in the active channel width during 2011-2013.</li> </ul> |

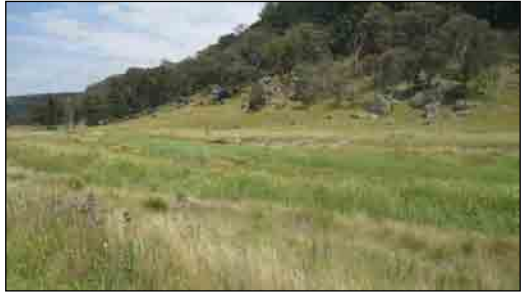
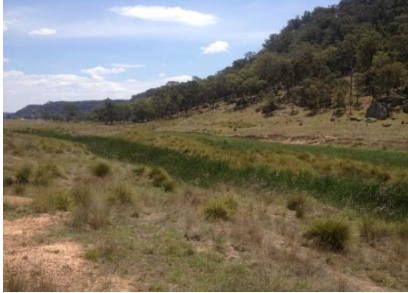
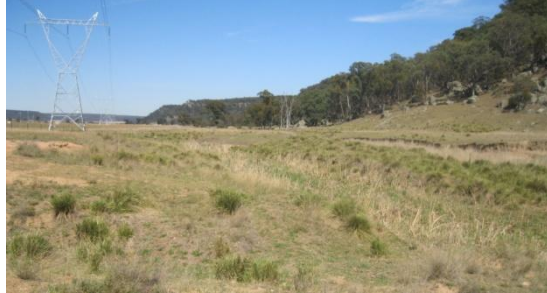
| 36 | | | | <ul style="list-style-type: none"> <li>• A reduction in 'green' groundcover within the creek bed, on the bank faces and within riparian areas between 2011-13.</li> <li>• Increase soil exposure on the right creek bank face during 2012, however regeneration occurred during 2013 with the bank being more stable.</li> <li>• A reduction in the active channel width during 2011-2013.</li> </ul> |

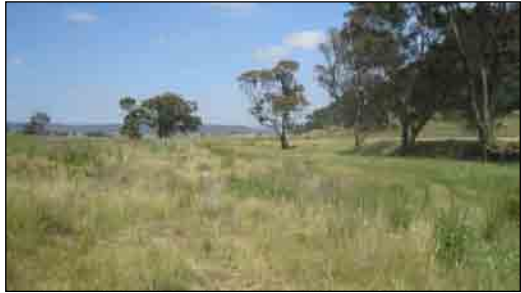
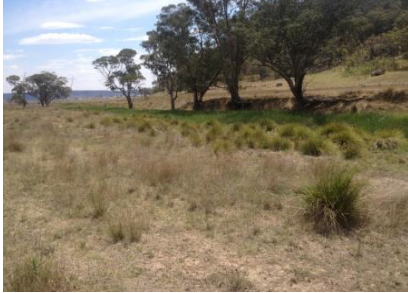
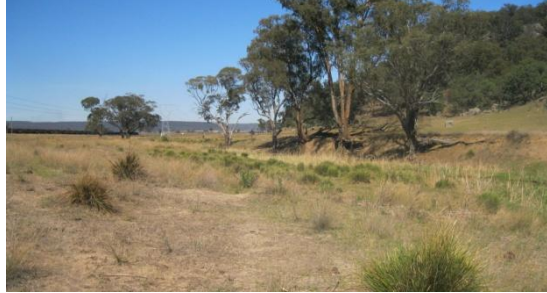
| 37 | | | | <ul style="list-style-type: none"> <li>• A reduction in 'green' groundcover within the creek bed, on the bank faces and within riparian areas between 2011-13.</li> <li>• Increase soil exposure on the right creek bank face during 2012, and this exposure continued during 2013.</li> <li>• A reduction in the active channel width during 2011-2013.</li> </ul> |

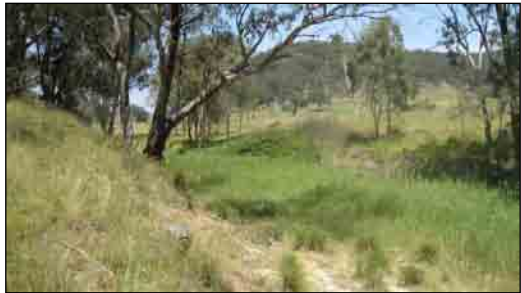
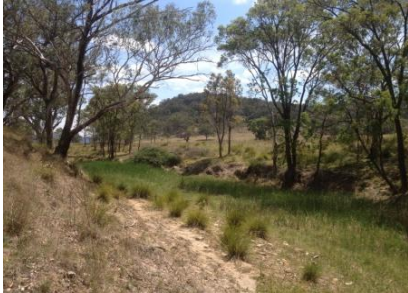
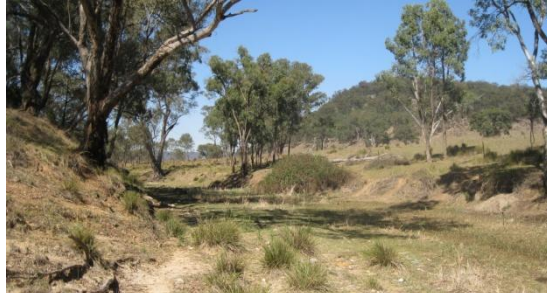
| 38 | | | | <ul style="list-style-type: none"> <li>• A reduction in 'green' groundcover within the creek bed, on the bank faces and within riparian areas between 2011-13.</li> <li>• Increase soil exposure of both creek bank faces during 2012, and this exposure continued during 2013.</li> <li>• A reduction in the active channel width during 2011-2013.</li> </ul> |

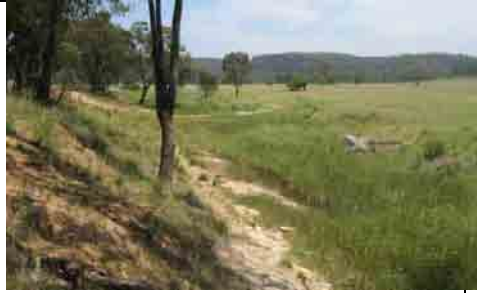
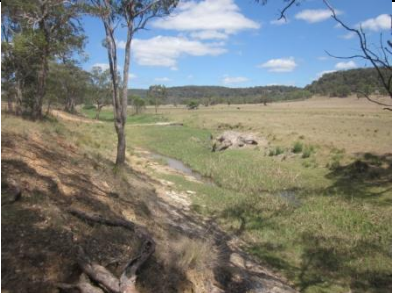
| 42 | | | | <ul style="list-style-type: none"> <li>• A reduction in 'green' groundcover within the creek bed, on the bank faces and within riparian areas between 2011-13.</li> <li>• Increase soil exposure of both creek bank faces during 2012, and this exposure remains stable during 2013.</li> <li>• Continued increase in debris within the creek channel with woody material during 2012 and 2013.</li> </ul> |

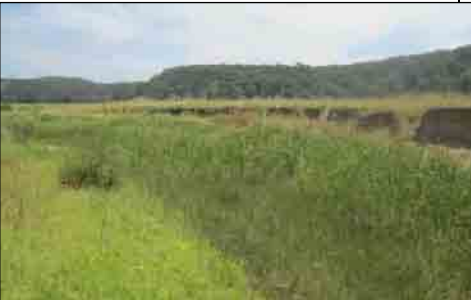
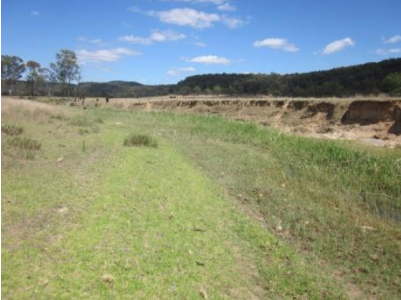
| 43 | | | | <ul style="list-style-type: none"> <li>• A reduction in 'green' groundcover within the creek bed, on the bank faces and within riparian areas between 2011-13.</li> <li>• Increase soil exposure of the left creek bank faces during 2012, however regeneration occurred during 2013 with the bank being more stable as a result of an increase in groundcover.</li> <li>• and this exposure</li> <li>• A reduction in the active channel width during 2011-2013.</li> </ul> |

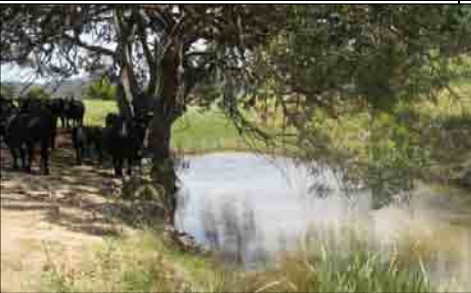
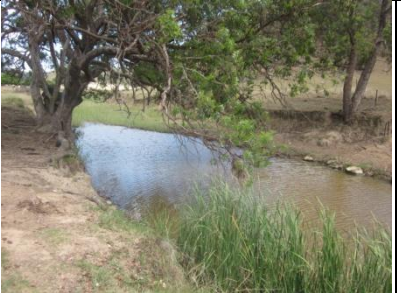
| 44 | | | | <ul style="list-style-type: none"> <li>• Photo is slightly downstream of previous location.</li> <li>• A reduction in 'green' groundcover within the creek bed, on the bank faces and within riparian areas between 2011-13.</li> <li>• Increase soil exposure of both creek bank faces during 2012, however regeneration occurred during 2013 with the bank being more stable as a result of an increase in groundcover.</li> <li>• Increase in inner bank undercutting noted during 2013 of the left bank.</li> </ul> |

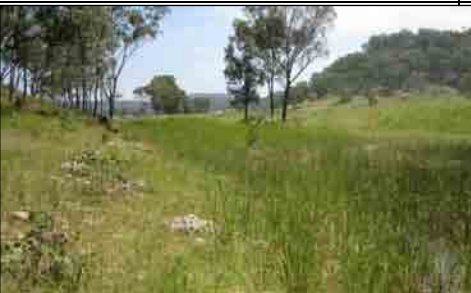
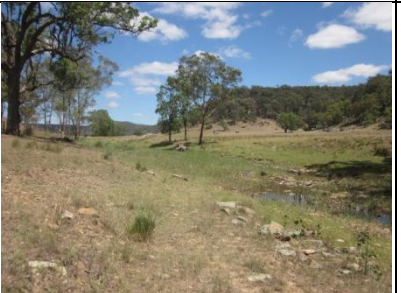
| 45 | | | | <ul style="list-style-type: none"> <li>• A reduction in 'green' groundcover within the creek bed, on the bank faces and within riparian areas between 2011-13.</li> <li>• Increase soil exposure of both creek bank faces during 2012, and this exposure remains stable during 2013.</li> <li>• Bedrock material exposure remains stable.</li> </ul> |

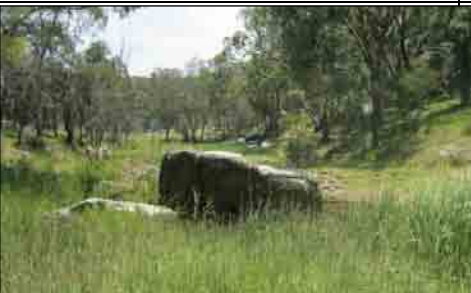
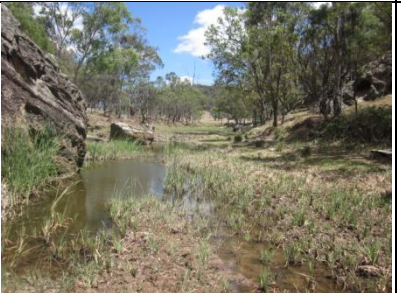
| 46 | | | | <ul style="list-style-type: none"> <li>• A reduction in 'green' groundcover within the creek bed, on the bank faces and within riparian areas between 2011-12.</li> <li>• A reduction in the active channel width during 2012-2013.</li> <li>• An increase in woody debris deposition during 2013.</li> </ul> |

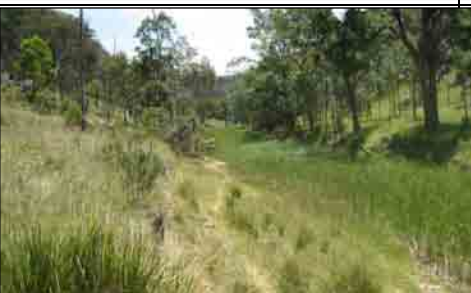
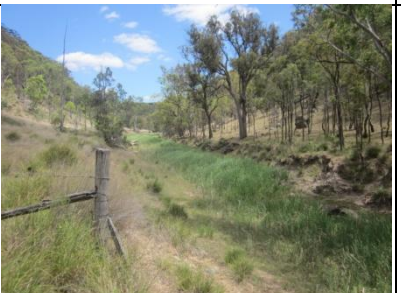
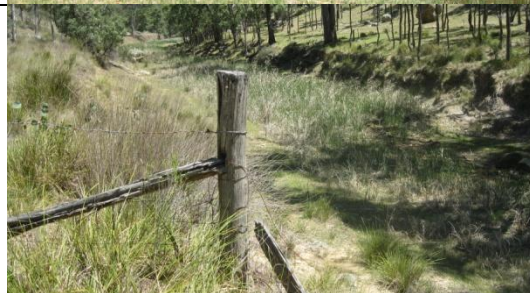
| 47 | | | | <ul style="list-style-type: none"> <li>• A reduction in 'green' groundcover within the creek bed, on the bank faces and within riparian areas between 2011-13.</li> <li>• Increase soil exposure of both creek bank faces during 2012, and this exposure remains stable during 2013.</li> <li>• A reduction in the active channel width during 2012-2013.</li> </ul> |

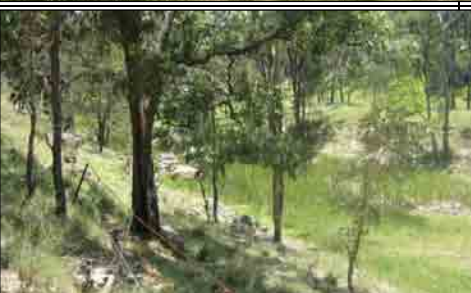
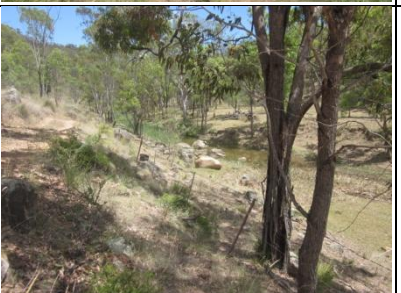
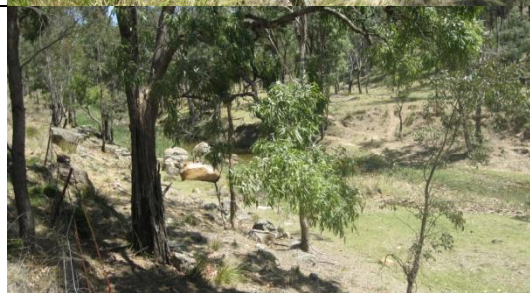
| 48 | | | | <ul style="list-style-type: none"> <li>• A reduction in 'green' groundcover within the creek bed, on the bank faces and within riparian areas between 2011-12.</li> <li>• Increase soil exposure of both creek bank faces during 2012, and this exposure remains stable during 2013, with a slight increase in groundcover as a result of an increase in debris on the banks.</li> </ul> |

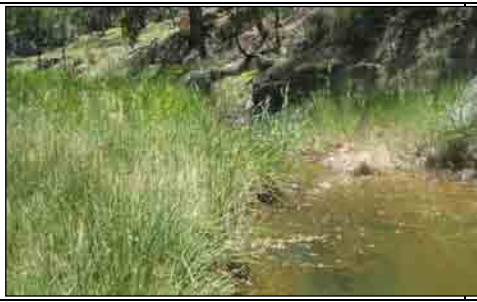
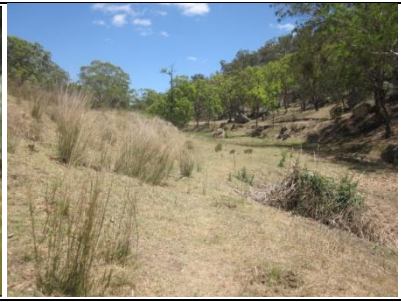
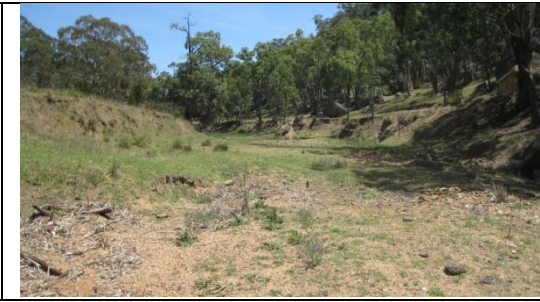
| 49 | <div data-bbox="172 195 617 476"> </div> <div data-bbox="617 195 991 476"> </div> <div data-bbox="991 195 1495 476"> </div> <div data-bbox="1495 195 2706 476"> <ul style="list-style-type: none"> <li>• A reduction in 'green' groundcover within the creek bed, on the bank faces and within riparian areas between 2011-12.</li> <li>• Increase soil exposure of both creek bank faces during 2012, however regeneration occurred during 2013 with the bank being more stable as a result of an increase in groundcover.</li> </ul> </div> |

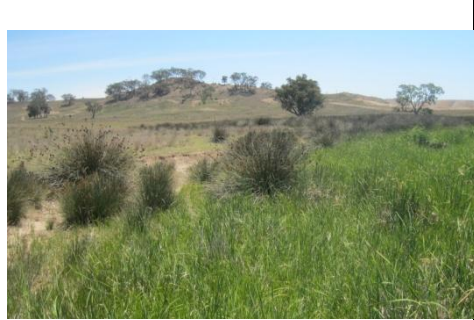
| Site | Upstream December 2011 | Upstream December 2012 | Upstream December 2013 | Main Comparison |
|---|---|---|---|---|
| 2 | | | | <ul style="list-style-type: none"> <li>Slightly different location in 2012.</li> <li>A reduction in 'green' groundcover within the creek bed, on the bank faces and within riparian areas between 2011-13.</li> <li>An increase in soil exposure of both bank faces is noted during 2013.</li> </ul> |

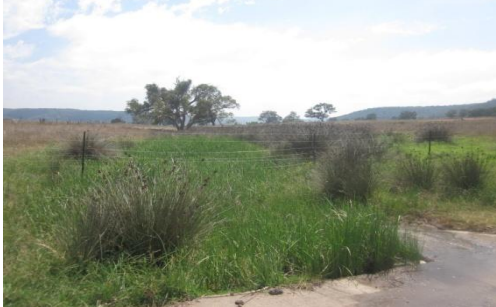
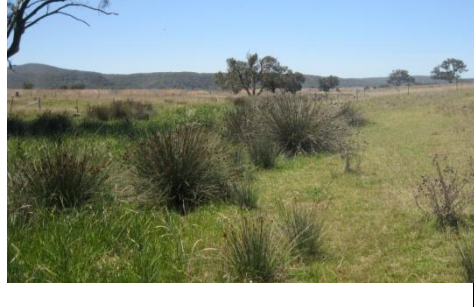
| Site | Upstream December 2011 | Upstream December 2012 | Upstream December 2013 | Main Comparison |
|---|---|---|---|---|
| 3 | | | | <ul style="list-style-type: none"> <li>A reduction in 'green' groundcover within the creek bed, on the bank faces and within riparian areas between 2011-13.</li> <li>A reduction in the active channel width during 2012-2013.</li> <li>Site remains well vegetated and stable.</li> </ul> |

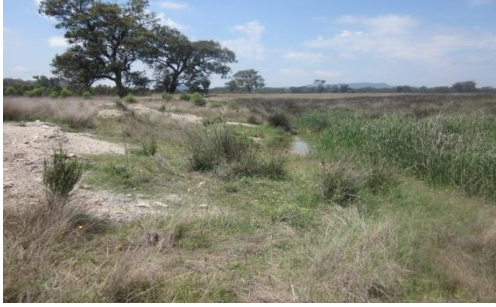
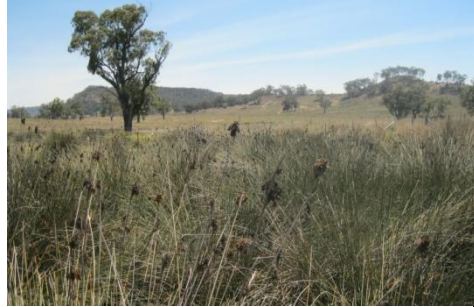
| Site | Upstream December 2011 | Upstream December 2012 | Upstream December 2013 | Main Comparison |
|---|---|---|---|---|
| 4 | | | | <ul style="list-style-type: none"> <li>A reduction in 'green' groundcover within the creek bed, on the bank faces and within riparian areas between 2011-13.</li> <li>An increase in soil exposure and instability is noted on the right bank in 2012. This is reduced in 2013.</li> <li>A reduction in the active channel width during 2012-2013.</li> </ul> |

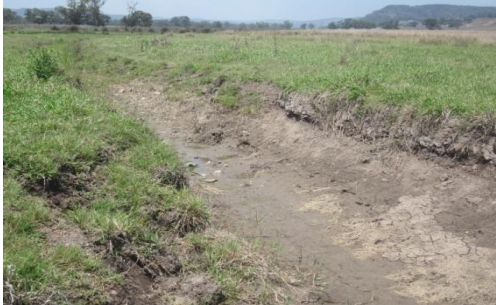
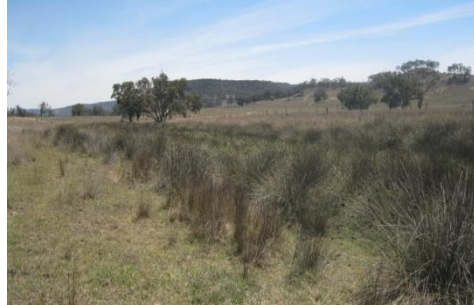
| Site | Upstream December 2011 | Upstream December 2012 | Upstream December 2013 | Main Comparison |
|---|---|---|---|---|
| 5 | | | | <ul style="list-style-type: none"> <li>A reduction in 'green' groundcover on the bank faces and within riparian areas between 2011-12.</li> <li>An increase in soil exposure and instability is noted on the bank faces in 2012. This is reduced in 2013.</li> <li>A reduction in the active channel width during 2012-2013, with an increase in revegetation.</li> </ul> |

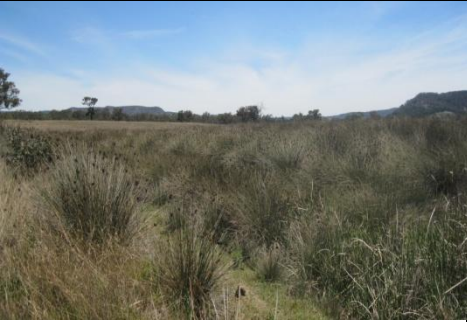
| 6 | | | | <ul style="list-style-type: none"> <li>• A reduction in 'green' groundcover on the bank faces and within riparian areas between 2011-12.</li> <li>• An increase in soil exposure and instability is noted on the bank faces in 2012. This is reduced in 2013.</li> <li>• A reduction in the active channel width during 2012-2013, with an increase in revegetation.</li> </ul> |

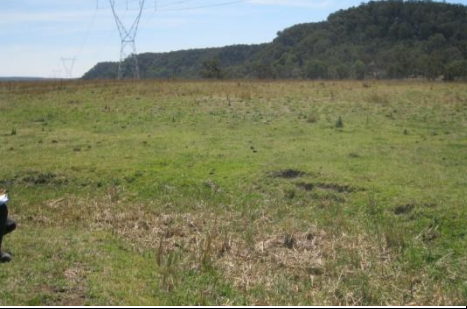
| 9 | | | | <ul style="list-style-type: none"> <li>• A reduction in 'green' groundcover on the bank faces and within riparian areas between 2011-12.</li> <li>• Site remain well vegetated and stable.</li> </ul> |

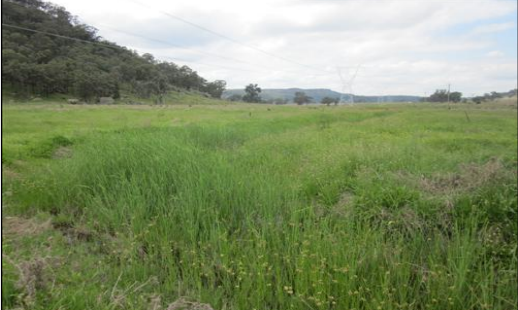
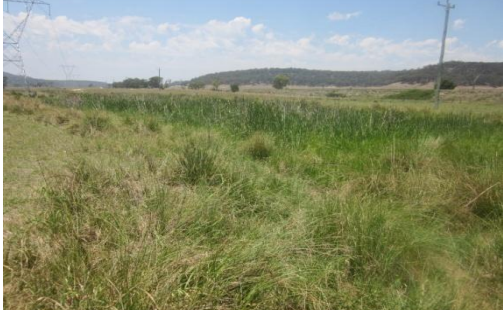
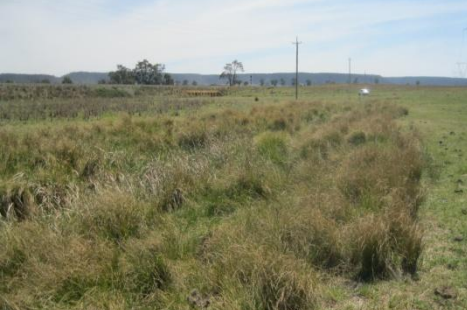
| 10 | | | | <ul style="list-style-type: none"> <li>• A reduction in 'green' groundcover on the bank faces and within riparian areas between 2011-12.</li> <li>• Site remain well vegetated and stable.</li> </ul> |

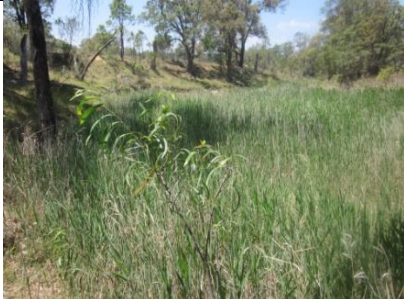
| Site | Downstream December 2011 | Downstream December 2012 | Downstream December 2013 | Main Comparisons |
|---|---|---|---|---|
| 1 | | | | <ul style="list-style-type: none"> <li>A reduction in 'green' groundcover within the creek bed, on the bank faces and within riparian areas between 2011-13.</li> <li>An increase in soil exposure on the bank face between 2011-2012.</li> <li>A reduction in creek width over the 2 year period.</li> <li>An increase in woody snags over the two year period.</li> </ul> |

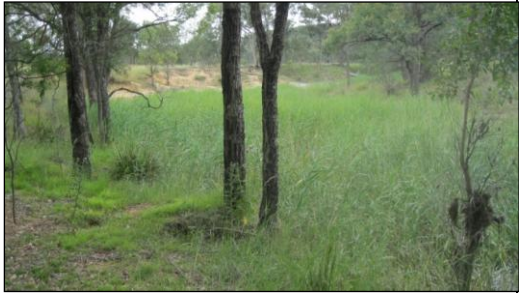
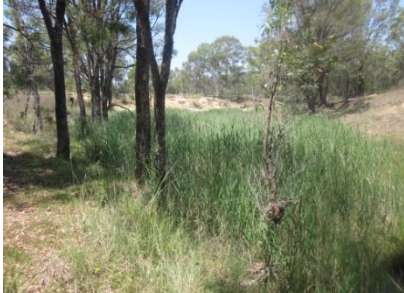
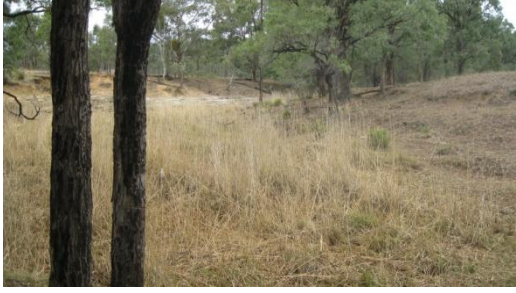
| Site | Downstream December 2011 | Downstream December 2012 | Downstream December 2013 | Main Comparisons |
|---|---|---|---|---|
| 2 | | | | <ul style="list-style-type: none"> <li>A reduction in 'green' groundcover within the creek bed, on the bank faces and within riparian areas between 2011-13.</li> <li>An increase in soil exposure on the left bank top between 2011-2012. This has reduced in 2013, with an increase in groundcover noted in 2013.</li> <li>A reduction in the active creek width over the 2 year period.</li> </ul> |

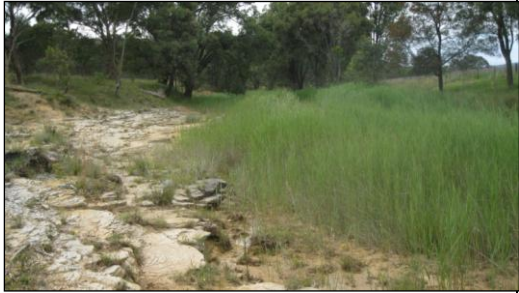
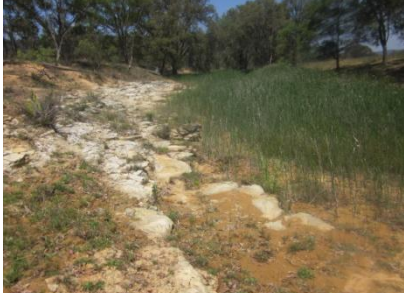
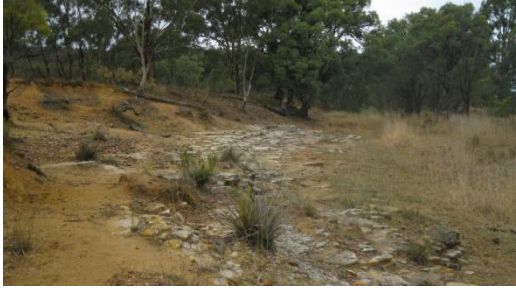
| Site | Downstream December 2011 | Downstream December 2012 | Downstream December 2013 | Main Comparisons |
|---|---|---|---|---|
| 3 | | | | <ul style="list-style-type: none"> <li>A reduction in 'green' groundcover within the creek bed, on the bank faces and within riparian areas between 2011-13.</li> <li>An increase in soil exposure on the left bank top between 2011-2012, which has continued during 2013.</li> <li>An increase in deposition of sediment on the left bank bend in 2013.</li> <li>A reduction in the active creek width over the 2 year period.</li> </ul> |
