# Wilpinjong & Cumbo Creek Stability Assessment, 2012-2013

Wilpinjong Coal Mine

Mar-14  
(Our Reference: 20366\_E02)

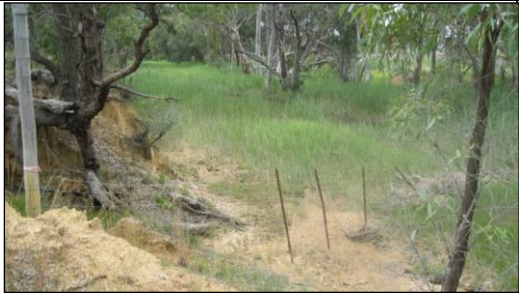
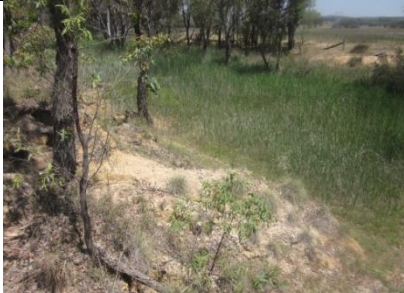
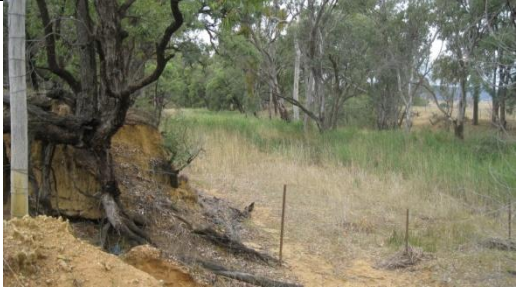
| Site | Downstream December 2011 | Downstream December 2012 | Downstream December 2013 | Main Comparisons |
|---|---|---|---|---|
| 4 | | | | <ul style="list-style-type: none"> <li>A reduction in 'green' groundcover within the creek bed, on the bank faces and within riparian areas between 2011-13.</li> <li>An increase in soil exposure on the left bank top between 2011-2012, which has continued during 2013, as noted by an increase in rootlet exposure.</li> <li>A reduction in the active creek width over the 2 year period.</li> <li>An increase in woody debris on the creek banks between 2012-2013.</li> </ul> |

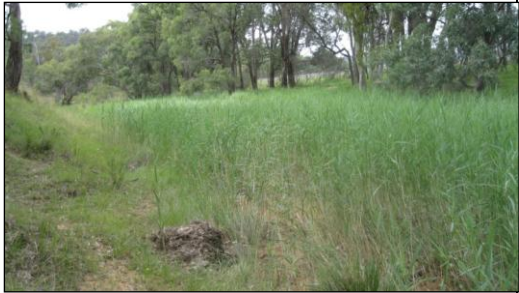
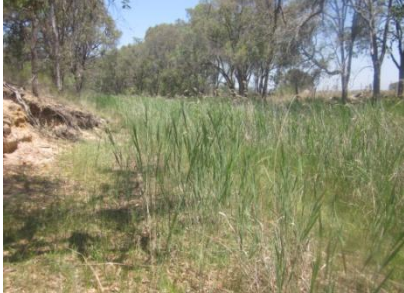
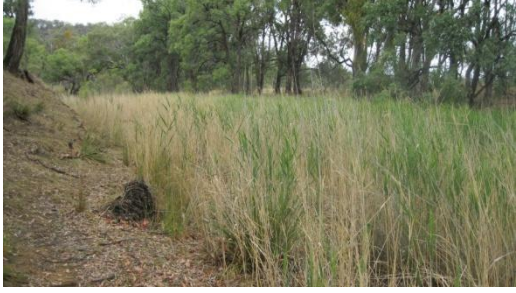
| Site | Downstream December 2011 | Downstream December 2012 | Downstream December 2013 | Main Comparisons |
|---|---|---|---|---|
| 5 | | | | <ul style="list-style-type: none"> <li>A reduction in 'green' groundcover within the creek bed, on the bank faces and within riparian areas between 2011-13.</li> <li>An increase in soil exposure on the left bank top between 2011-2012. This has reduced in 2013, with an increase in groundcover noted in 2013.</li> <li>A reduction in the active creek width over the 2 year period.</li> <li>An increase in woody debris and leaf litter on the creek banks between 2012-2013.</li> </ul> |

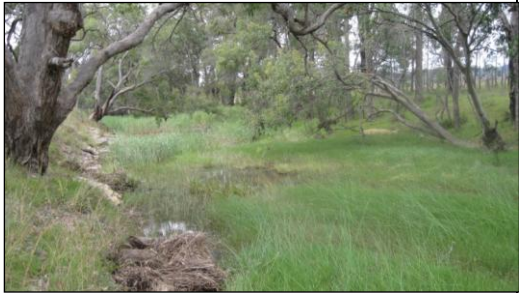
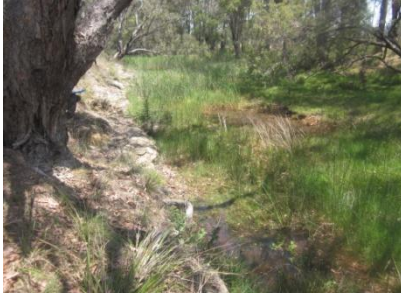
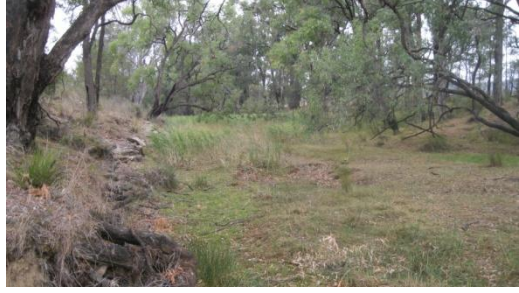
| 6 | | | | <ul style="list-style-type: none"> <li>• A reduction in 'green' groundcover within the creek bed, on the bank faces and within riparian areas between 2011-13.</li> <li>• An increase in soil exposure on the left bank top between 2011-2012, which has stabilised in 2013.</li> <li>• An increase in inner bank undercutting of the left bank in 2013.</li> <li>• A reduction in the active creek width over the 2 year period.</li> </ul> |

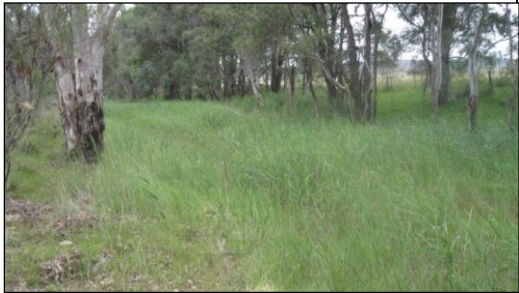
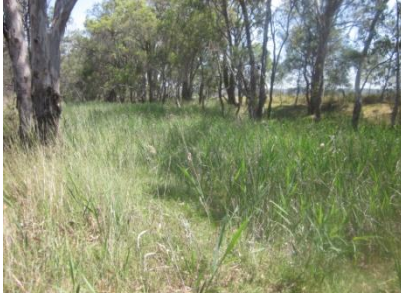
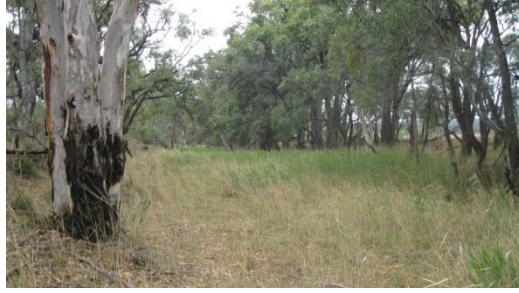
| 7 | | | | <ul style="list-style-type: none"> <li>• A reduction in 'green' groundcover within the creek bed, on the bank faces and within riparian areas between 2011-13.</li> <li>• A clear reduction in groundcover coverage between 2011-2012, which continued in 2013.</li> <li>• A reduction in the active creek width over the 2 year period.</li> </ul> |

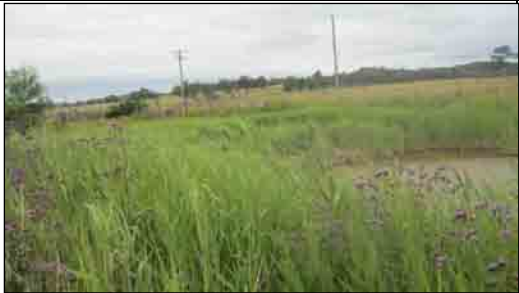
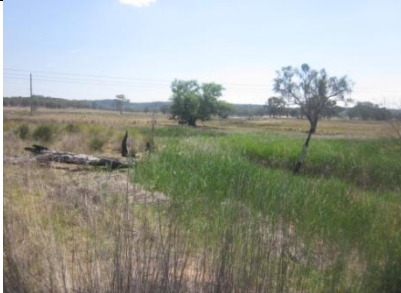
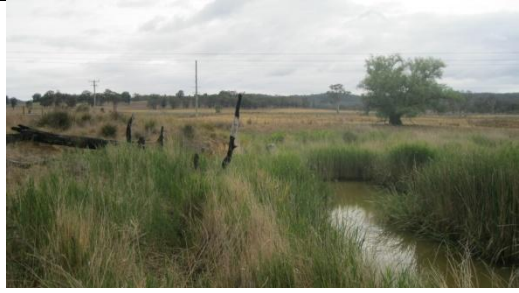
| 8 | | | | <ul style="list-style-type: none"> <li>• A reduction in 'green' groundcover within the creek bed, on the bank faces and within riparian areas between 2011-12.</li> <li>• A clear reduction in groundcover between 2011-2012. However, in 2013 groundcover growth increased in this area.</li> <li>• An increase in woody debris and snags in 2012 and 2013.</li> </ul> |

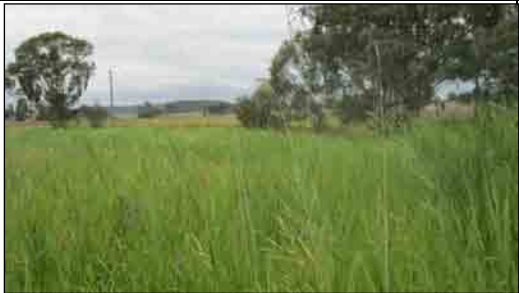
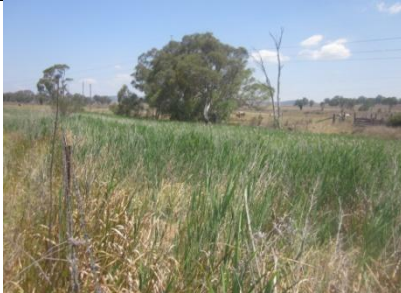
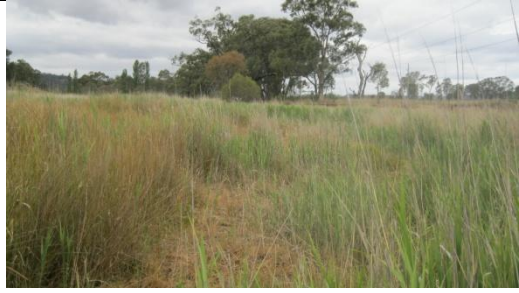
| 9 | | | | <ul style="list-style-type: none"> <li>• A reduction in 'green' groundcover within the creek bed, on the bank faces and within riparian areas between 2011-13.</li> <li>• Good ground coverage and stability was maintained between 2011-13.</li> <li>• No substantial changes in ground coverage or soil exposure between 2012 and 2013.</li> </ul> |

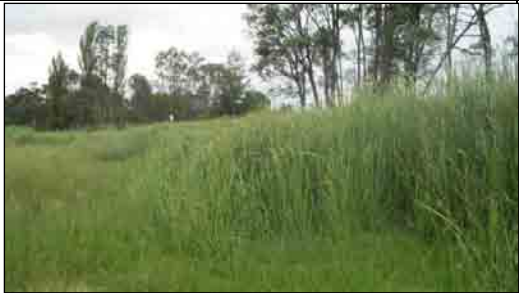
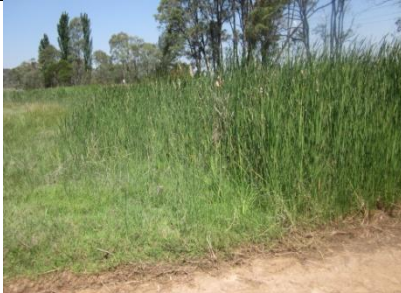
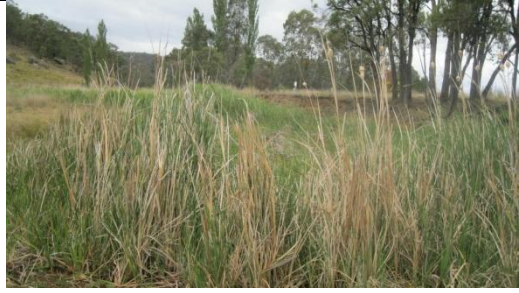
| 10 | | | | <ul style="list-style-type: none"> <li>• A reduction in 'green' groundcover within the creek bed, on the bank faces and within riparian areas between 2011-13.</li> <li>• No substantial changes in ground coverage or soil exposure between 2012 and 2013.</li> </ul> |

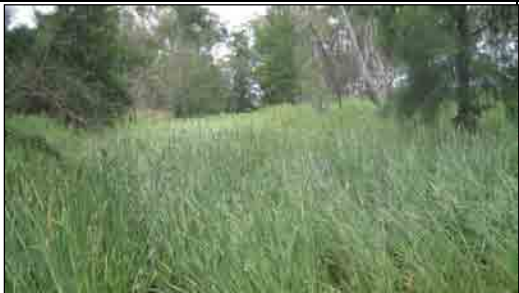
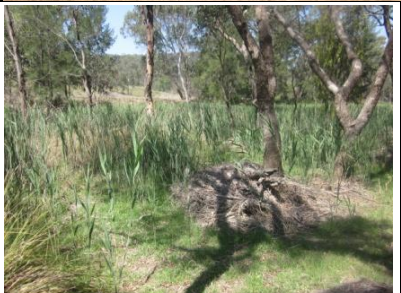
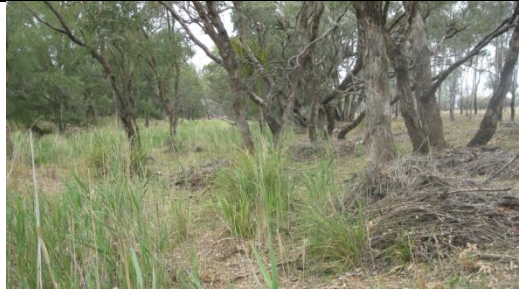
| 11 | | | | <ul style="list-style-type: none"> <li>• A reduction in 'green' groundcover within the creek bed, on the bank faces and within riparian areas between 2011-13.</li> <li>• A clear reduction in groundcover between 2011-2013.</li> <li>• An increase in woody debris and snags in 2012 and 2013.</li> <li>• Site remains relatively stable.</li> </ul> |

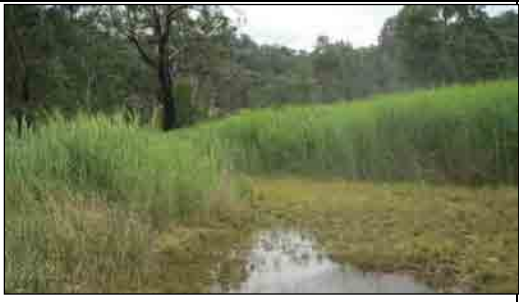
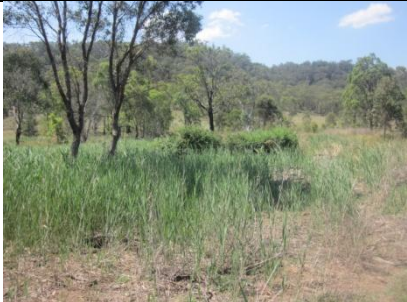
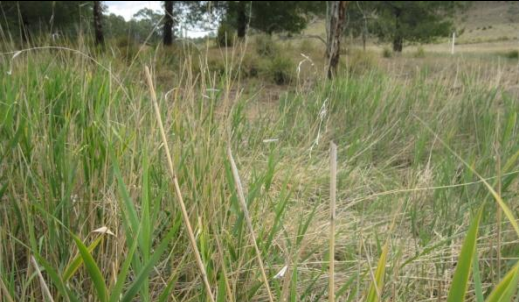
| 12 | | | | <ul style="list-style-type: none"> <li>• A reduction in 'green' groundcover within the creek bed, on the bank faces and within riparian areas between 2011-13.</li> <li>• A reduction in the active creek width over the 2 year period.</li> <li>• Site is relatively stable with good ground coverage.</li> </ul> |

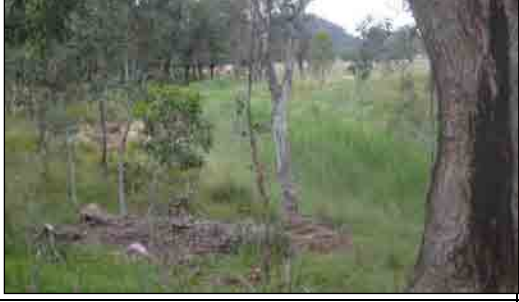
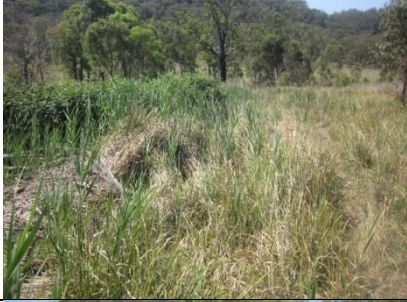
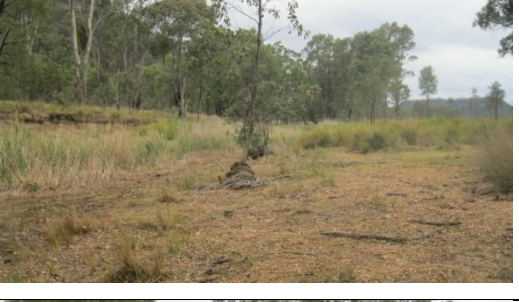
| 13 | | | | <ul style="list-style-type: none"> <li>• A reduction in 'green' groundcover within the creek bed, on the bank faces and within riparian areas between 2011-13.</li> <li>• A reduction in the active creek width over the 2 year period.</li> <li>• An increase in soil exposure on both bank faces between 2011-2013.</li> </ul> |

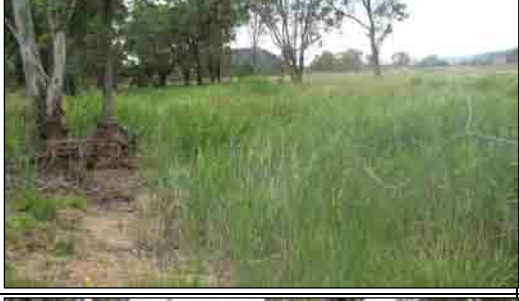
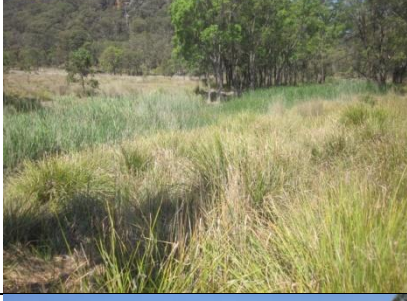
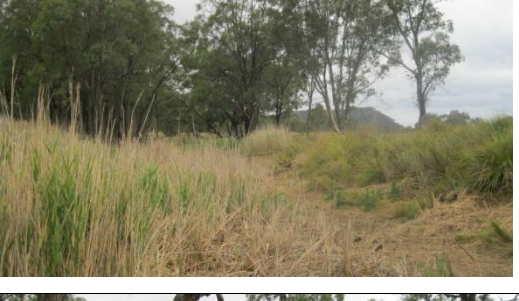
| 14 | | | | <ul style="list-style-type: none"> <li>• A reduction in 'green' groundcover within the creek bed, on the bank faces and within riparian areas between 2011-13.</li> <li>• Area remains relatively well vegetated and stable.</li> </ul> |

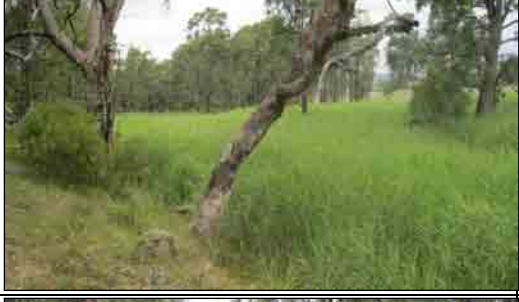
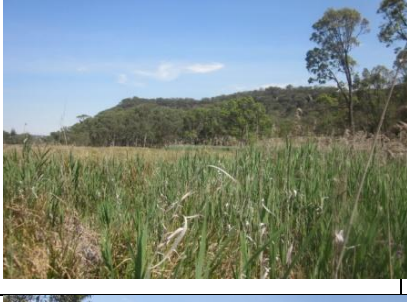
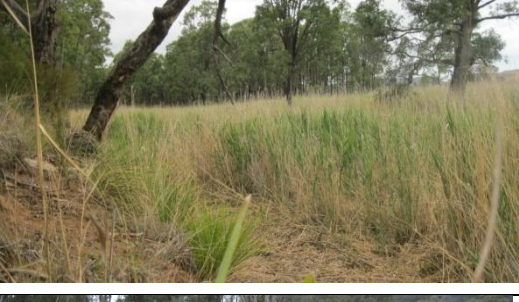
| 15 | | | | <ul style="list-style-type: none"> <li>• Slightly different locations in 2012 to 2011 and 2013.</li> <li>• A reduction in 'green' groundcover within the creek bed, on the bank faces and within riparian areas between 2011-13.</li> <li>• An increase in soil exposure and sheet erosion of the right bank between 2011 and 2013.</li> <li>• A reduction of the active channel width in 2013.</li> </ul> |

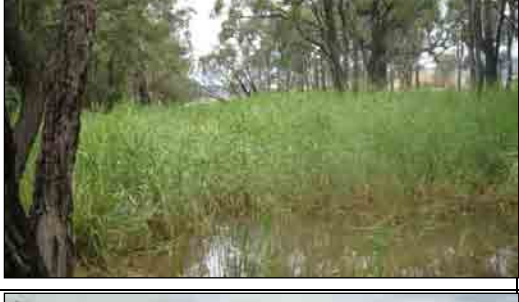
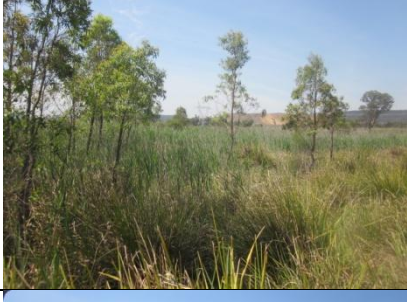
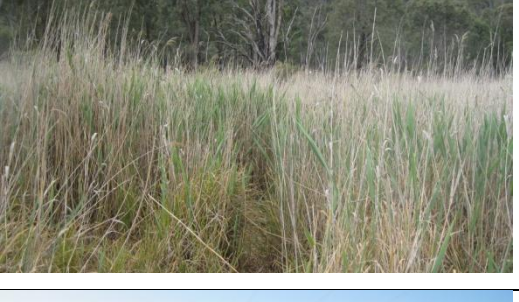
| 16 | | | | <ul style="list-style-type: none"> <li>• Slightly different locations due to access, however general area remains well vegetated and stable.</li> </ul> |

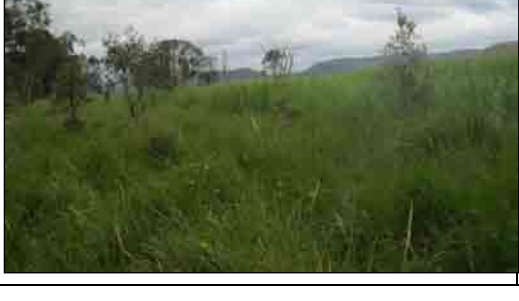
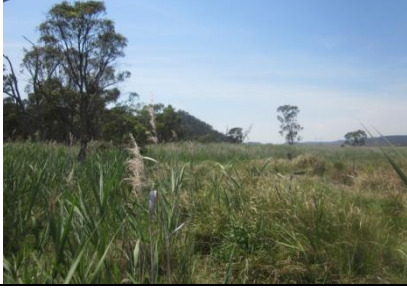
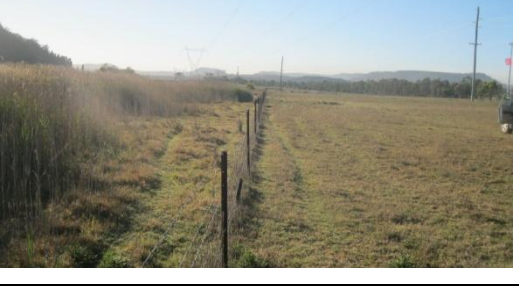
| 17 | | | | <ul style="list-style-type: none"> <li>• Slightly different locations due to access, however general area remains well vegetated and stable.</li> </ul> |

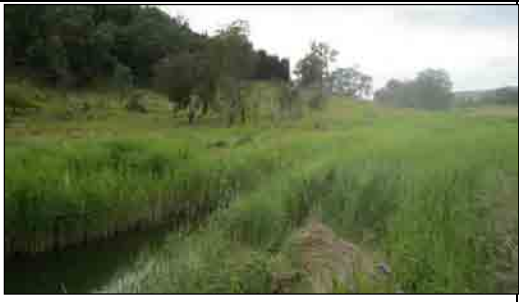
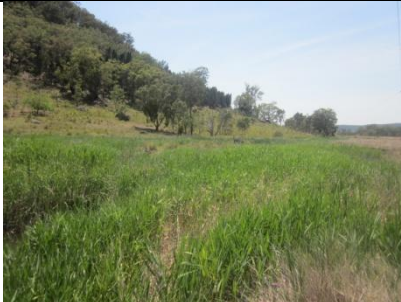
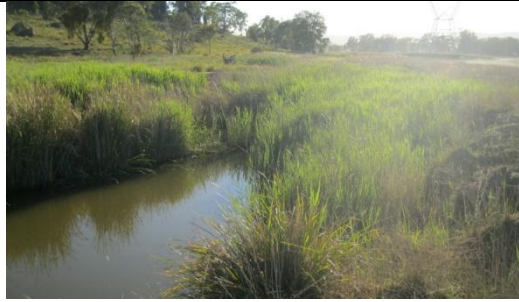
| 18 | | | | <ul style="list-style-type: none"> <li>• A slight reduction in 'green' groundcover within the creek bed, on the bank faces and within riparian areas between 2011-13.</li> <li>• Area has remained stable with good groundcover between 2011 and 2013.</li> </ul> |

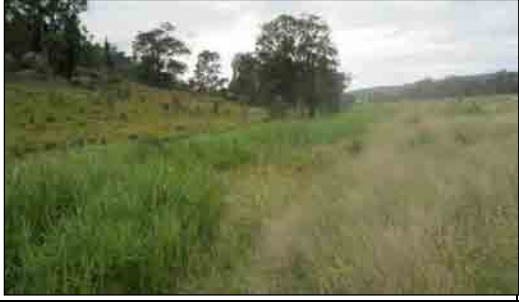
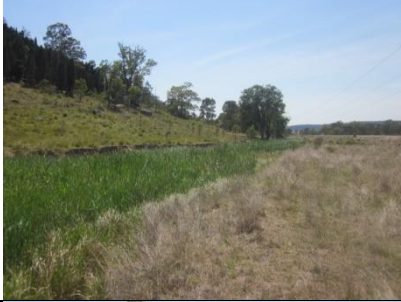
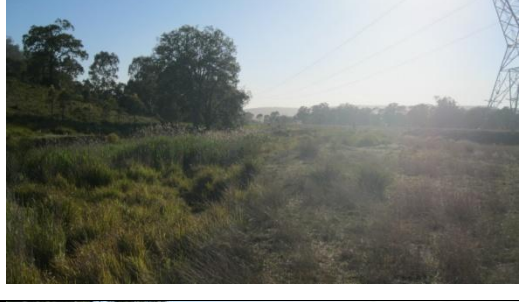
| 19 | | | | <ul style="list-style-type: none"> <li>• A slight reduction in 'green' groundcover within the creek bed, on the bank faces and within riparian areas between 2011-13.</li> <li>• Area has remained stable with good groundcover between 2011 and 2013.</li> </ul> |

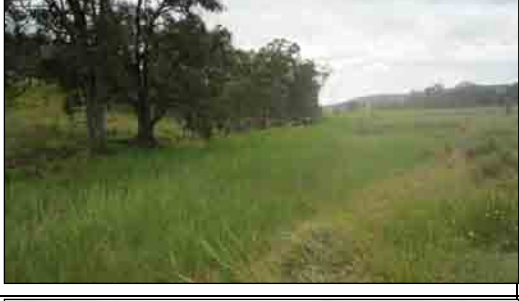
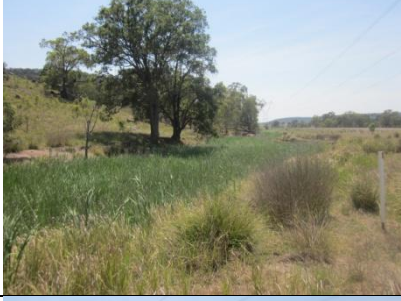
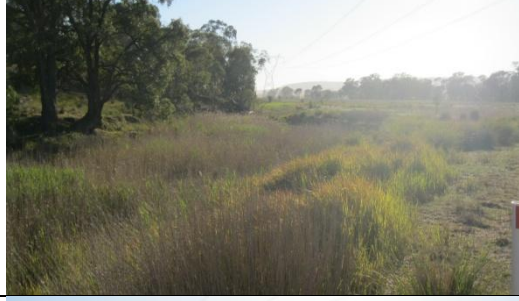
| 20 | | | | <ul style="list-style-type: none"> <li>• A slight reduction in 'green' groundcover within the creek bed, on the bank faces and within riparian areas between 2011-13.</li> <li>• Area has remained stable with good groundcover between 2011 and 2013.</li> </ul> |

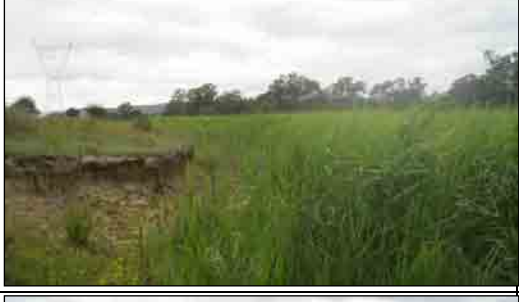
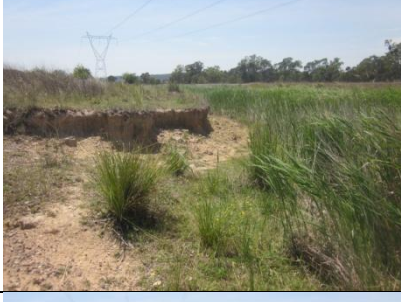
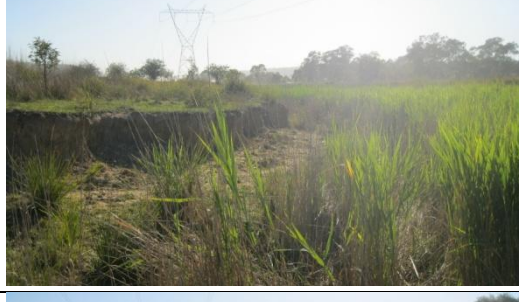
| 21 | | | | <ul style="list-style-type: none"> <li>• A slight reduction in 'green' groundcover within the creek bed, on the bank faces and within riparian areas between 2011-13.</li> <li>• Area has remained stable with good groundcover between 2011 and 2013.</li> </ul> |

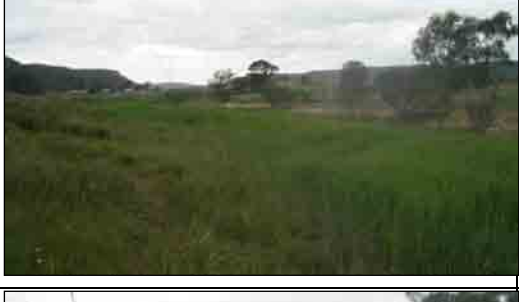
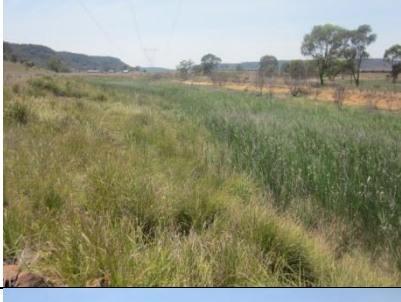
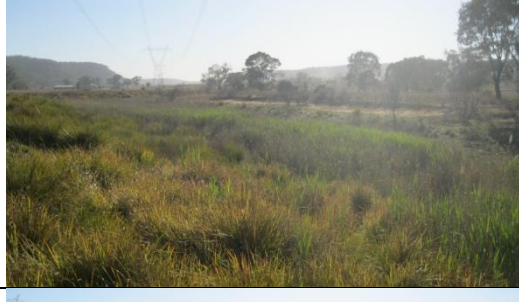
| 22 | | | | <ul style="list-style-type: none"> <li>• A slight reduction in 'green' groundcover within the creek bed, on the bank faces and within riparian areas between 2011-13.</li> <li>• Area has remained stable with good groundcover between 2011 and 2013.</li> </ul> |

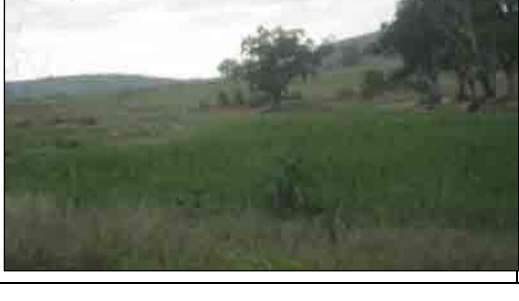
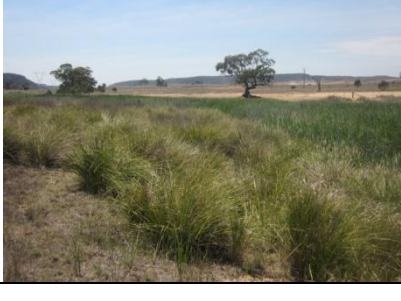
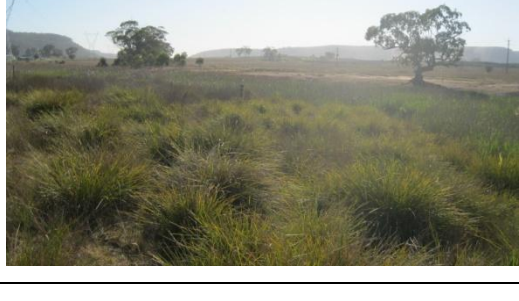
| 23 | | | | <ul style="list-style-type: none"> <li>• A slight reduction in 'green' groundcover within the creek bed, on the bank faces and within riparian areas between 2011-13.</li> <li>• Area has remained stable with good groundcover between 2011 and 2013.</li> </ul> |

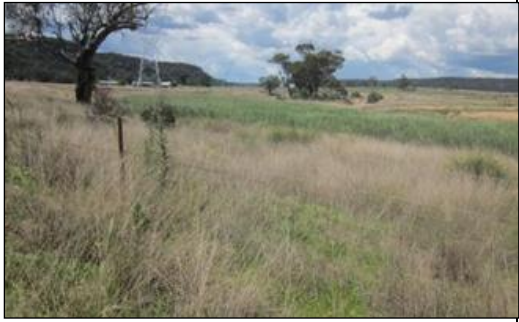
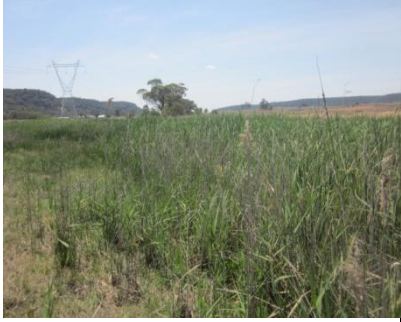
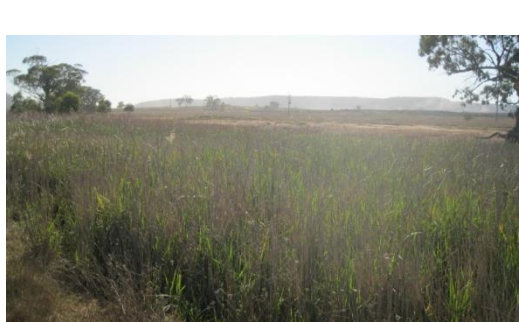
| 24 | | | | <ul style="list-style-type: none"> <li>• A slight reduction in 'green' groundcover within the creek bed, on the bank faces and within riparian areas between 2011-13.</li> <li>• Area has remained stable with good groundcover between 2011 and 2013.</li> </ul> |

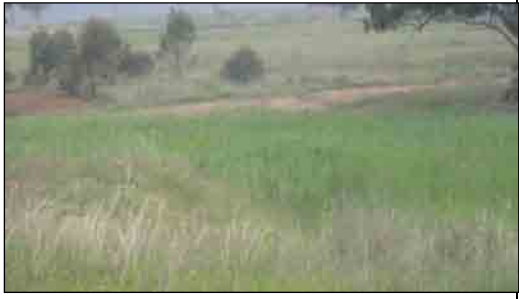
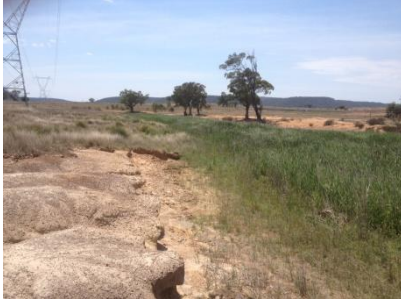
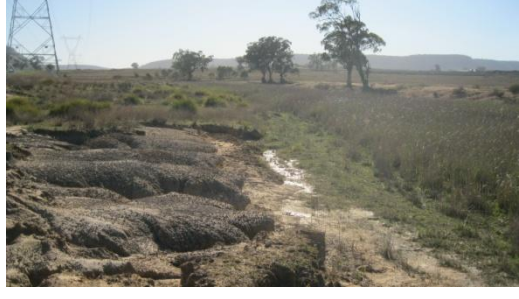
| 25 | | | | <ul style="list-style-type: none"> <li>• Slightly different locations in 2011 to 2012-2013 - opposite banks.</li> <li>• A reduction in 'green' groundcover within the creek bed, on the bank faces and within riparian areas between 2011-13.</li> <li>• An increase in bedrock exposure and undercutting of the left bank between 2012 and 2013.</li> <li>• A reduction in the active channel in 2013.</li> </ul> |

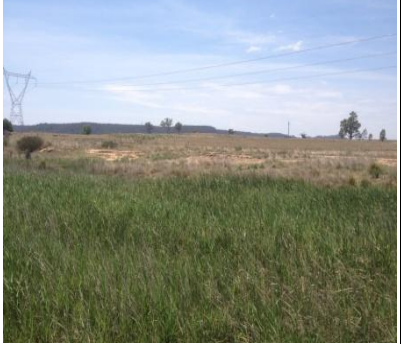
| 26 | | | | <ul style="list-style-type: none"> <li>• Area has remained stable with good groundcover between 2011 and 2013.</li> </ul> |

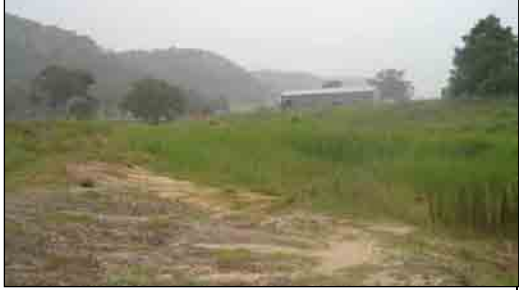
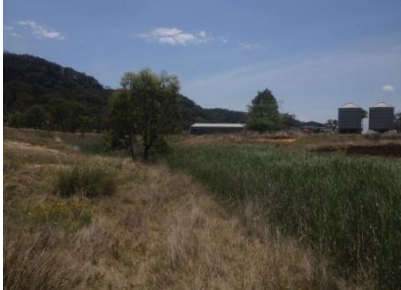
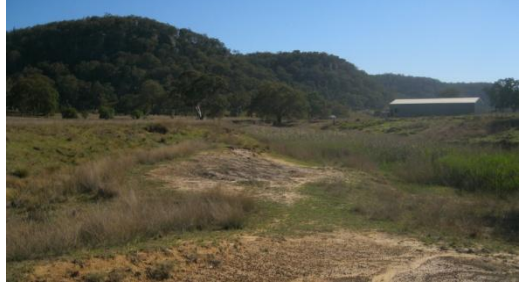
| 27 | | | | <ul style="list-style-type: none"> <li>• A reduction in 'green' groundcover within the creek bed, on the bank faces and within riparian areas between 2011-13.</li> <li>• Increase in soil exposure and sheet erosion of the left bank over the 2 year period.</li> <li>• Reduction in the active channel width in 2013.</li> </ul> |

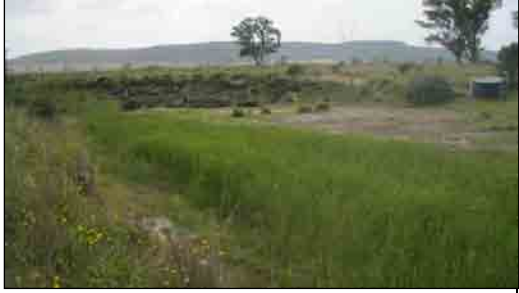
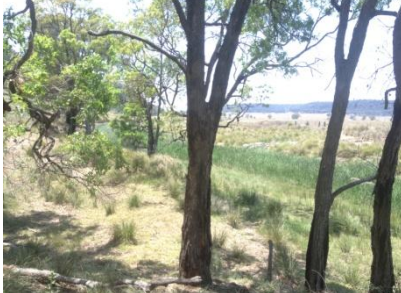
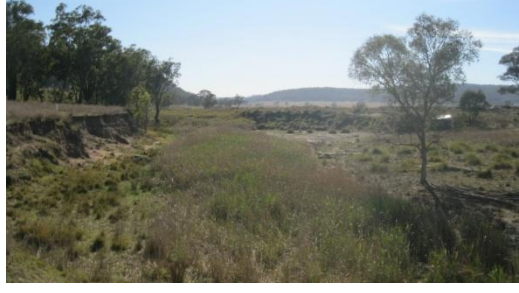
| 28 | | | | <ul style="list-style-type: none"> <li>• Site is slightly downstream of 2011 site.</li> <li>• A reduction in 'green' groundcover within the creek bed, on the bank faces and within riparian areas between 2011-13.</li> <li>• Increase in soil exposure and sheet erosion of the left bank over the 2 year period, with an increase in gullying and slumping noted in 2013.</li> <li>• Reduction in the active channel width in 2013.</li> </ul> |

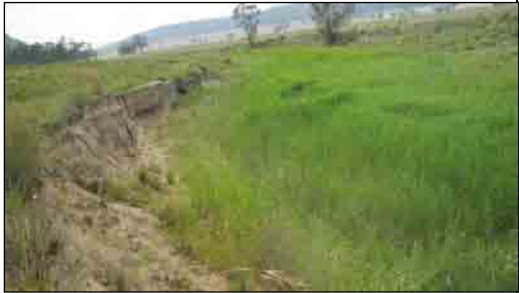
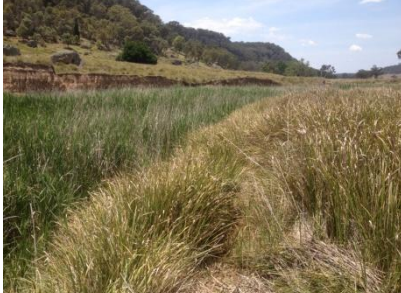
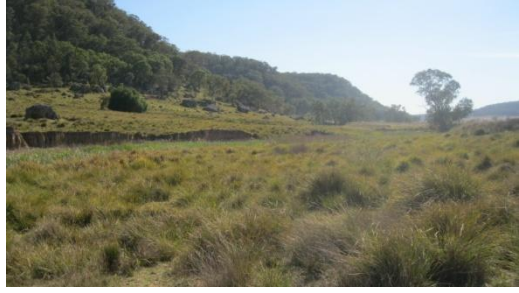
| 29 | | | | <ul style="list-style-type: none"> <li>• Site is on opposite bank in 2013 to 2011.</li> <li>• A slight reduction in 'green' groundcover within the creek bed, on the bank faces and within riparian areas between 2011-13.</li> <li>• Erosion of the left bank continues over the 2 year period, with a lack of groundcover and steep slope maintained.</li> <li>• Reduction in the active channel width in 2013.</li> </ul> |

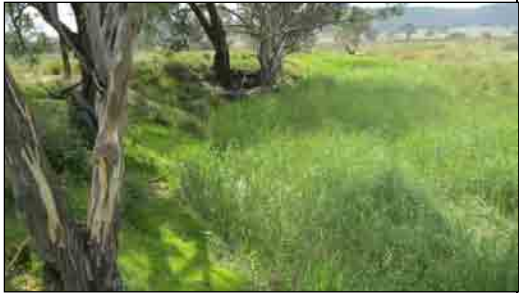
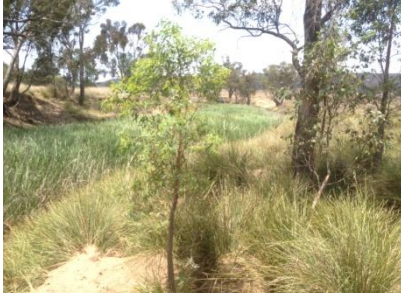
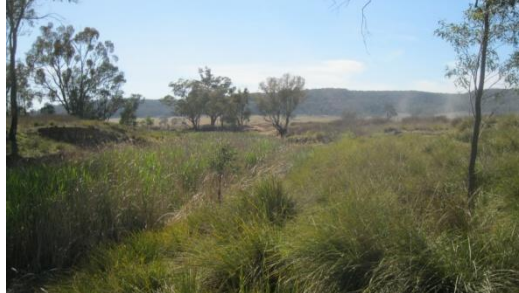
| 30 | | | | <ul style="list-style-type: none"> <li>• Site is on opposite bank in 2013 to 2011.</li> <li>• A slight reduction in 'green' groundcover within the creek bed, on the bank faces and within riparian areas between 2011-13.</li> <li>• Area has remained stable with good groundcover and general stability between 2011 and 2013.</li> </ul> |

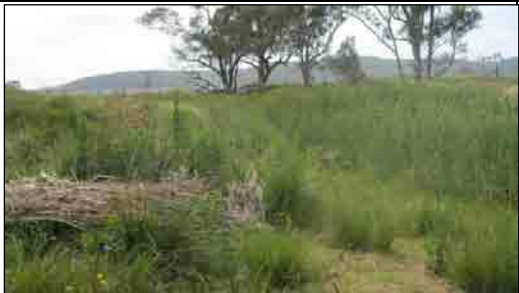
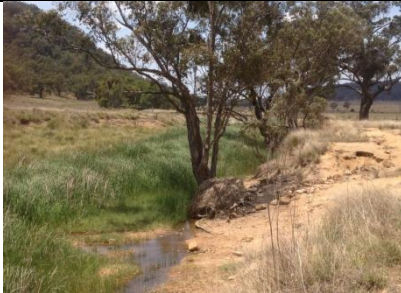
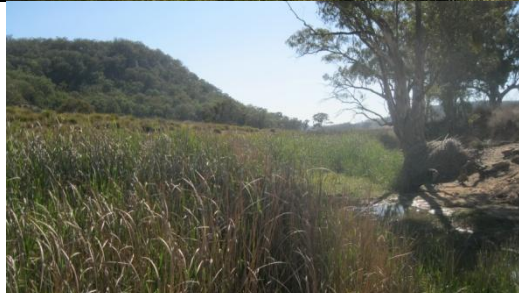
| 31 | | | | <ul style="list-style-type: none"> <li>• A reduction in 'green' groundcover within the creek bed, on the bank faces and within riparian areas between 2011-13.</li> <li>• Increase in soil exposure and sheet erosion of the right bank in 2012, which has regenerated with an increase in groundcover in 2013.</li> <li>• Reduction in the active channel width in 2013.</li> </ul> |

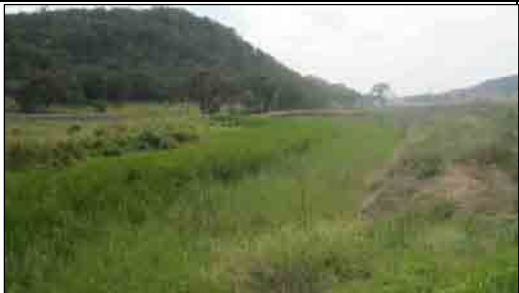
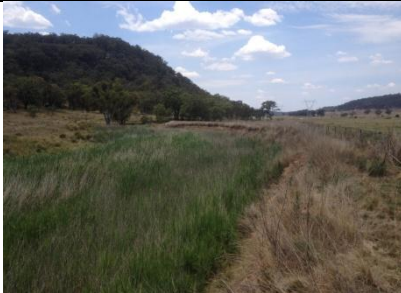
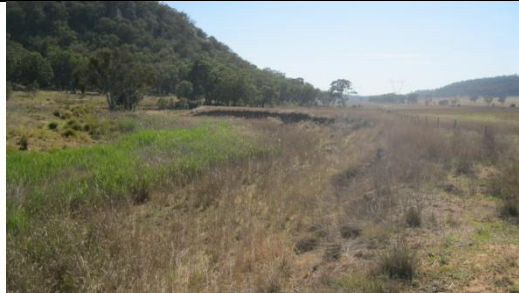
| 32 | | | | <ul style="list-style-type: none"> <li>• A reduction in 'green' groundcover within the creek bed, on the bank faces and within riparian areas between 2011-13.</li> <li>• Increase in soil exposure and sheet erosion of the right bank in 2012, which has stabilised in 2013.</li> <li>• Reduction in the active channel width in 2013.</li> </ul> |

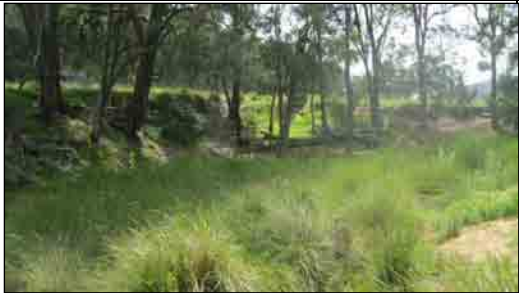
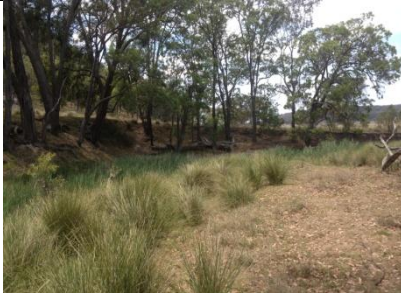
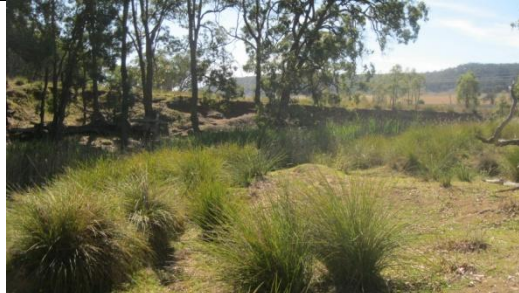
| 33 | | | | <ul style="list-style-type: none"> <li>• A reduction in 'green' groundcover within the creek bed, on the bank faces and within riparian areas between 2011-12.</li> <li>• Increase in soil exposure and sheet erosion of the right bank in 2012, which has stabilised in 2013.</li> </ul> |

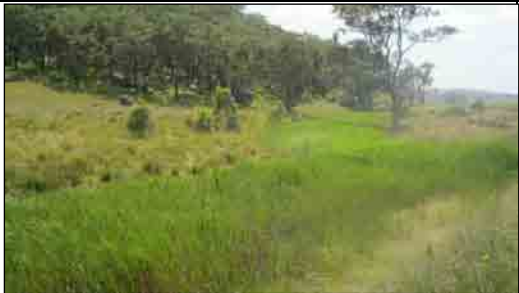
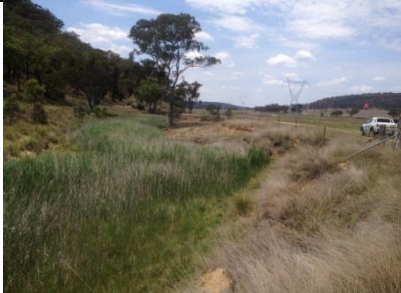
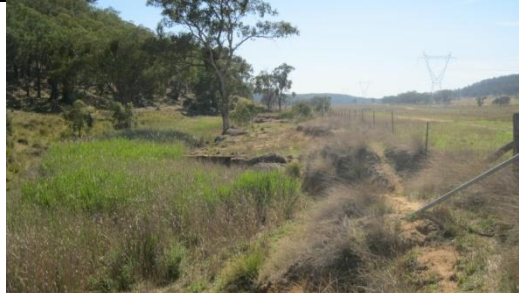
| 34 | | | | <ul style="list-style-type: none"> <li>• A reduction in 'green' groundcover within the creek bed, on the bank faces and within riparian areas between 2011-13.</li> <li>• Increase in soil exposure and sheet erosion of the right bank in 2012, which has stabilised in 2013.</li> <li>• Reduction of the active channel width in 2013.</li> </ul> |

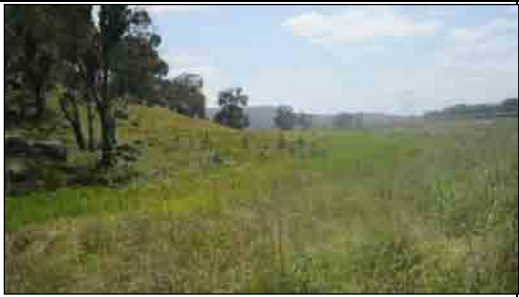
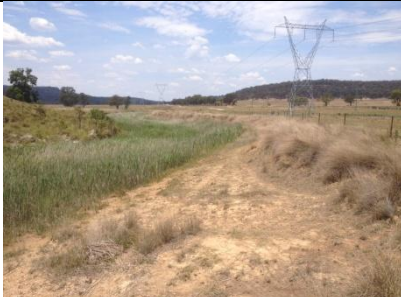
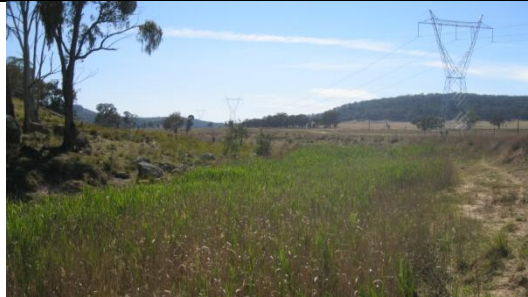
| 35 | | | | <ul style="list-style-type: none"> <li>• A reduction in 'green' groundcover within the creek bed, on the bank faces and within riparian areas between 2011-12.</li> <li>• Increase in soil exposure and sheet erosion of the right bank in 2012, which has regenerated with an increase in groundcover in 2013.</li> </ul> |

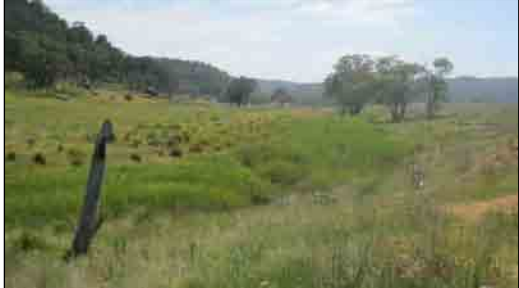
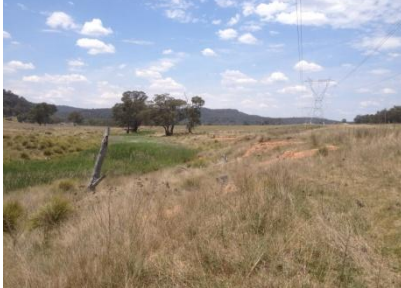
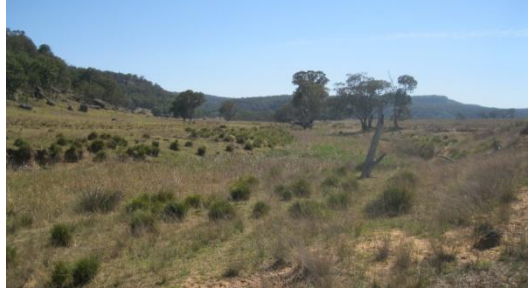
| 36 | | | | <ul style="list-style-type: none"> <li>• A reduction in 'green' groundcover within the creek bed, on the bank faces and within riparian areas between 2011-12.</li> <li>• Increase in soil exposure and sheet erosion of the right bank in 2012, which has regenerated with an increase in groundcover in 2013.</li> </ul> |

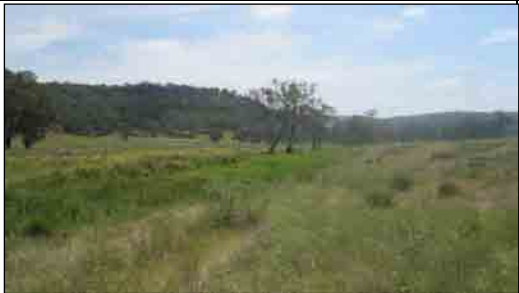
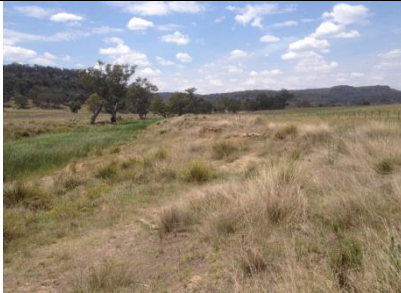
| 37 | | | | <ul style="list-style-type: none"> <li>• A reduction in 'green' groundcover within the creek bed, on the bank faces and within riparian areas between 2011-12.</li> <li>• Increase in soil exposure and sheet erosion of the right bank in 2012, which has stabilised in 2013.</li> <li>• Reduction of the active channel width in 2013.</li> </ul> |

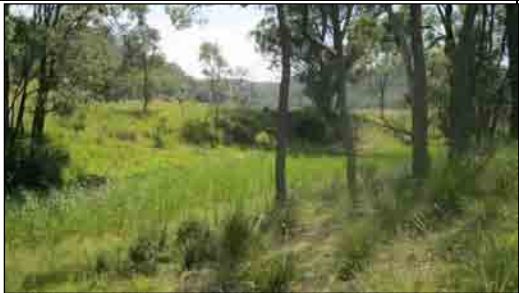
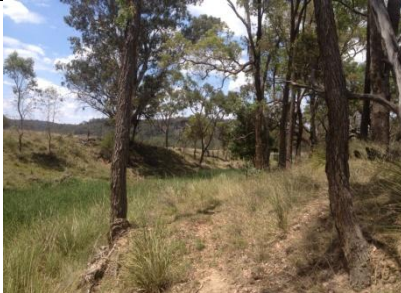
| 38 | | | | <ul style="list-style-type: none"> <li>• A reduction in 'green' groundcover within the creek bed, on the bank faces and within riparian areas between 2011-12.</li> <li>• Increase in soil exposure and sheet erosion of the right bank in 2012, which has regenerated with an increase in groundcover in 2013.</li> <li>• An increase in erosion of the left bank, with evidence of sheet erosion noted on the lower banks in 2013.</li> </ul> |

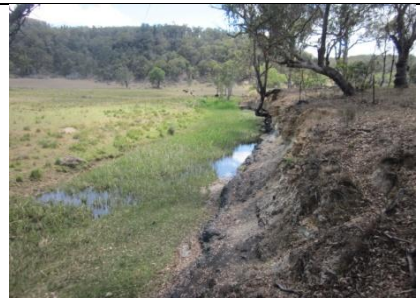
| 42 | | | | <ul style="list-style-type: none"> <li>• A reduction in 'green' groundcover within the creek bed, on the bank faces and within riparian areas between 2011-12. Site remains similar in 2013.</li> <li>• Increase in soil exposure, erosion and regrowth of the right bank, as noted by an increase in bank steepness and rootlet exposure in 2013.</li> <li>• An increase in undercutting of the left bank in 2013.</li> <li>• Channel width has remained similar.</li> </ul> |

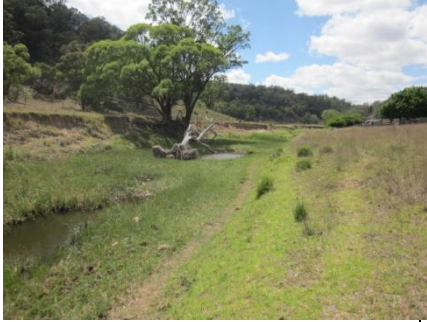
| 43 | | | | <ul style="list-style-type: none"> <li>• A reduction in 'green' groundcover within the creek bed, on the bank faces and within riparian areas between 2011-13.</li> <li>• Increase soil exposure of the left creek bank faces during 2012, however this has stabilised in 2013.</li> <li>• A reduction in the active channel width during 2011-2013.</li> </ul> |

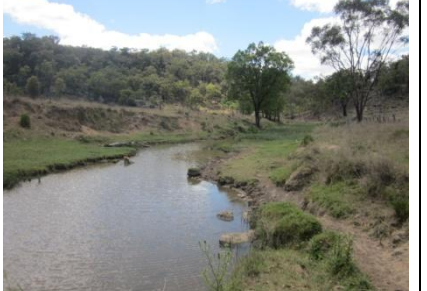
| 44 | | | | <ul style="list-style-type: none"> <li>• Photo is slightly downstream of previous location.</li> <li>• A reduction in 'green' groundcover on the creek bank faces and within riparian areas between 2011-12.</li> <li>• An increase in bank undercutting in 2012 in comparison to 2011, however this has stabilised in 2013.</li> <li>• An increase in instream vegetation growth in 2013.</li> </ul> |

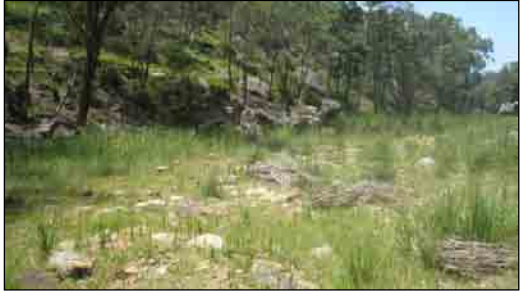
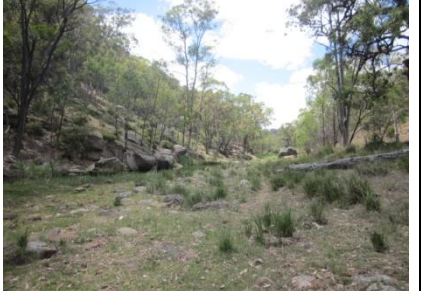
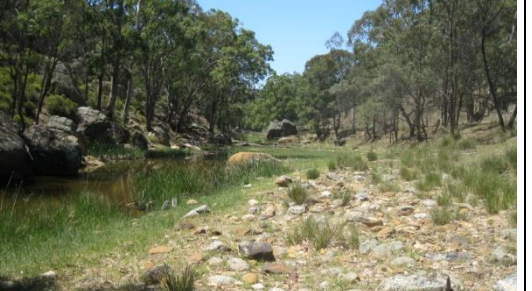
| 45 | | | | <ul style="list-style-type: none"> <li>• A reduction in 'green' groundcover within the creek bed, on the bank faces and within riparian areas between 2011-12.</li> <li>• Increase soil exposure of both creek bank faces during 2012 and 2013, with an increase in soil and rocky exposure/deposition.</li> </ul> |

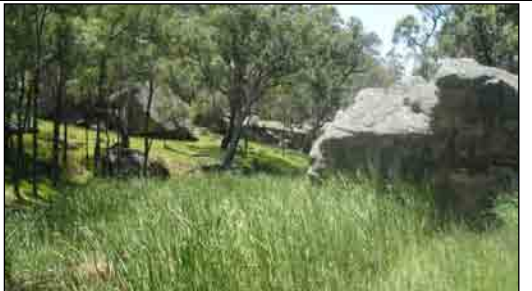
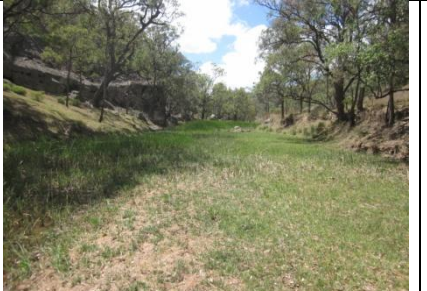
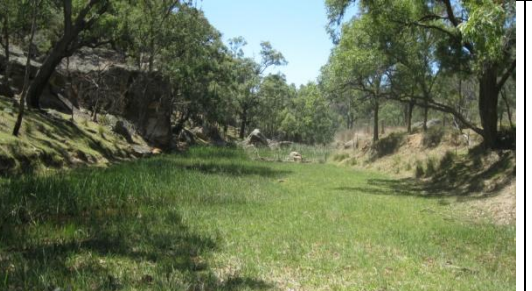
| 46 | | | | <ul style="list-style-type: none"> <li>• A reduction in 'green' groundcover within the creek bed, on the bank faces and within riparian areas between 2011-12.</li> <li>• Site has stabilised in 2013.</li> </ul> |

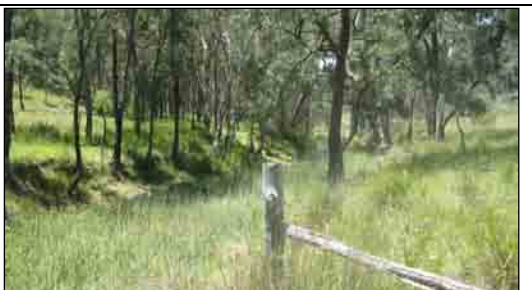
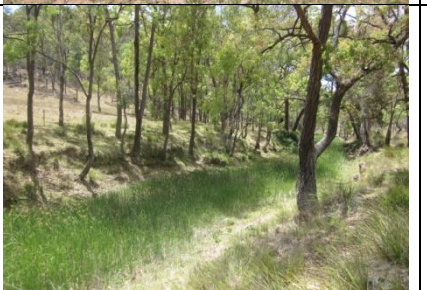
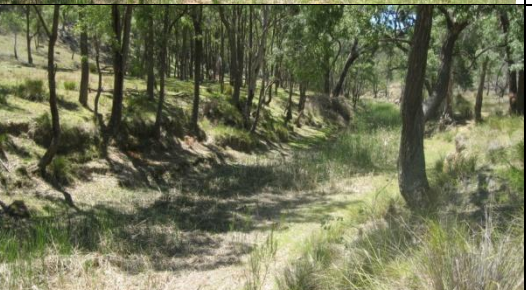
| 47 | | | | <ul style="list-style-type: none"> <li>• A reduction in 'green' groundcover within the creek bed, on the bank faces and within riparian areas between 2011-12.</li> <li>• Site has stabilised in 2013.</li> </ul> |

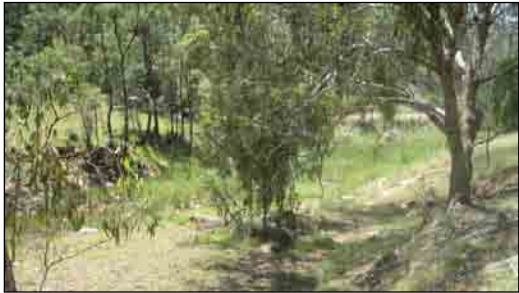
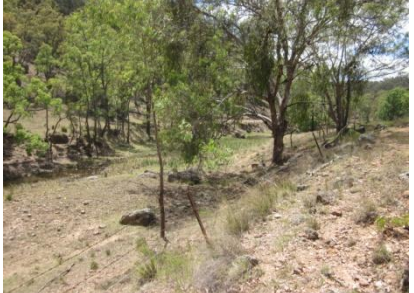
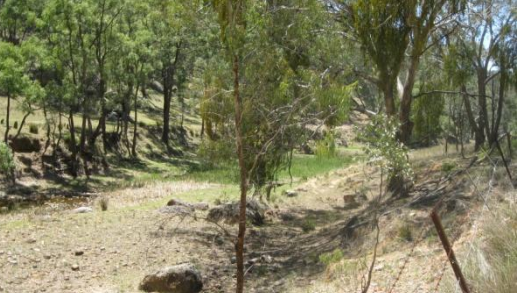
| 48 | | | | <ul style="list-style-type: none"> <li>• A reduction in 'green' groundcover within the creek bed, on the bank faces and within riparian areas between 2011-12.</li> <li>• An increase in soil exposure and erosion in 2012, however this has stabilised in 2013 with an increase in groundcover.</li> </ul> |

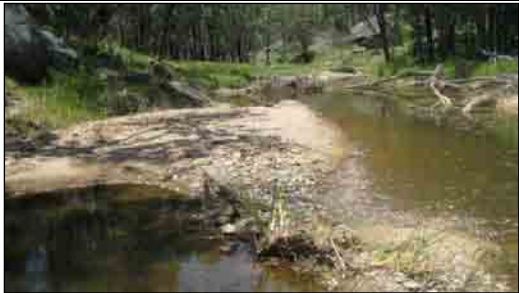
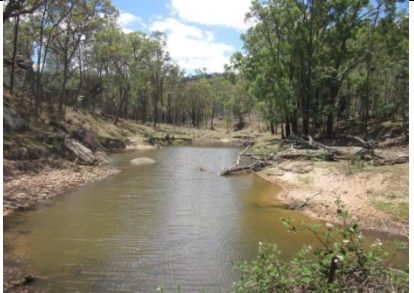
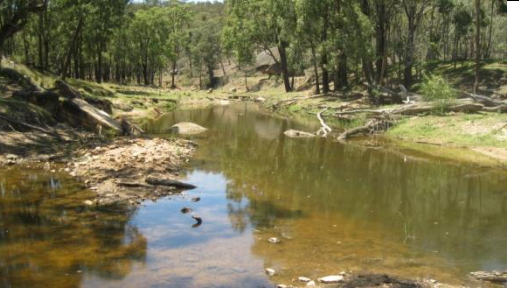
| 49 | | | | <ul style="list-style-type: none"> <li>• A reduction in 'green' groundcover within the creek bed, on the bank faces and within riparian areas between 2011-12.</li> <li>• An increase in soil exposure and erosion in 2012, however this has stabilised in 2013 with an increase in groundcover.</li> </ul> |

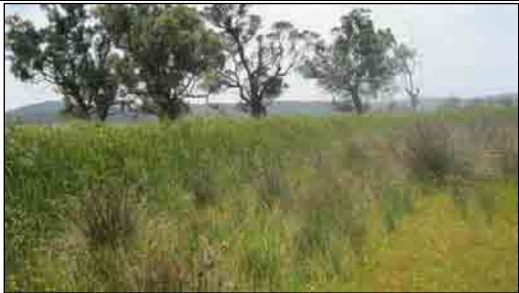
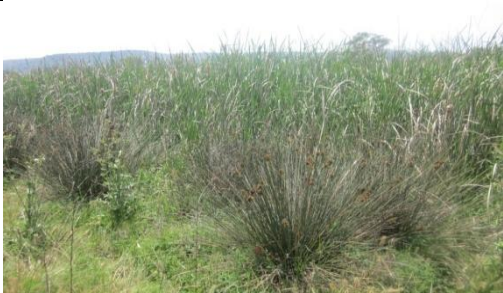
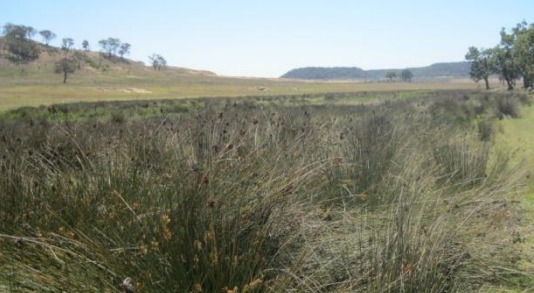
| Site | Downstream January 2011 | Downstream December 2012 | Downstream December 2013 | Main Comparisons |
|---|---|---|---|---|
| 1 | | | | <ul style="list-style-type: none"> <li>A slight reduction in 'green' groundcover within the creek bed, on the bank faces and within riparian areas between 2011-13.</li> <li>Site remains well vegetated and stable.</li> </ul> |

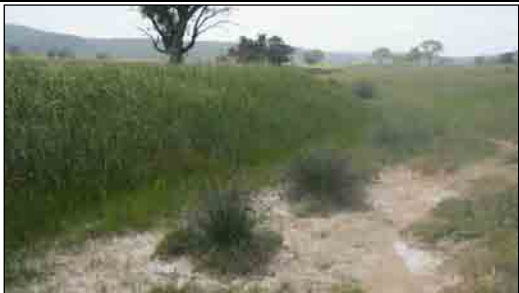
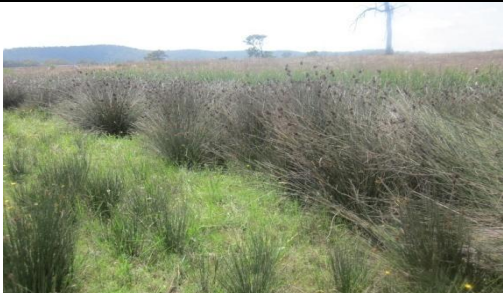
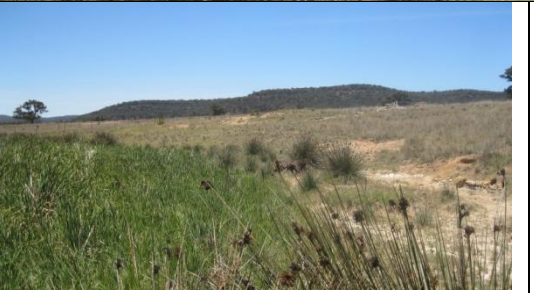
| Site | Downstream January 2011 | Downstream December 2012 | Downstream December 2013 | Main Comparisons |
|---|---|---|---|---|
| 2 | | | | <ul style="list-style-type: none"> <li>A slight reduction in 'green' groundcover within the creek bed, on the bank faces and within riparian areas between 2011-13.</li> <li>An increase in right bank soil exposure and sheet erosion of the right bank in 2013.</li> </ul> |

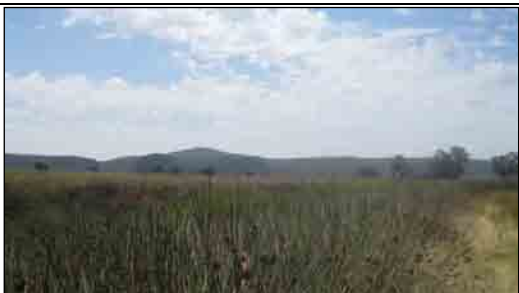
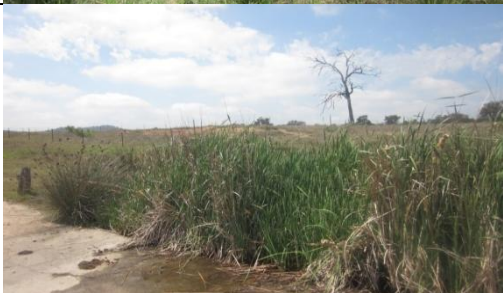
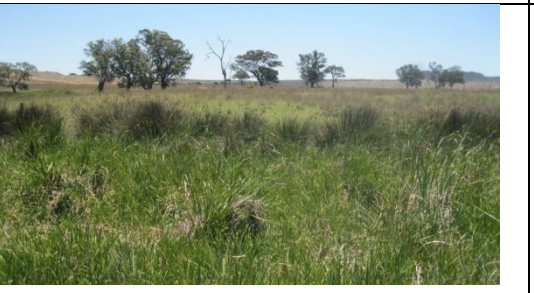
| Site | Downstream January 2011 | Downstream December 2012 | Downstream December 2013 | Main Comparisons |
|---|---|---|---|---|
| 3 | | | | <ul style="list-style-type: none"> <li>Site is slightly in a different location to previous surveys.</li> <li>Site remains well vegetated and stable.</li> </ul> |
