# Wilpinjong & Cumbo Creek Stability Assessment, 2012-2013

Wilpinjong Coal Mine

Mar-14  
(Our Reference: 20366\_E02)

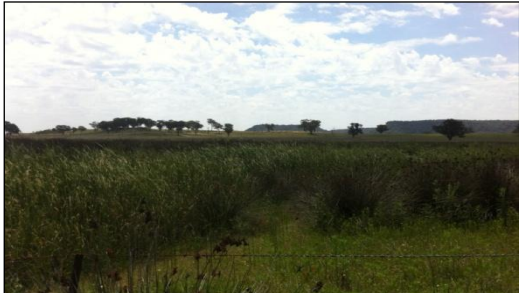
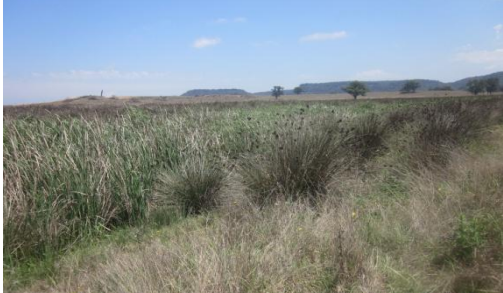
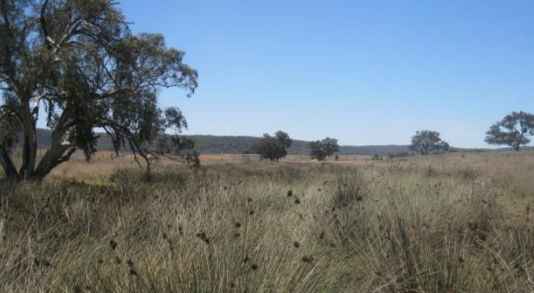
| Site | Downstream January 2011 | Downstream December 2012 | Downstream December 2013 | Main Comparisons |
|---|---|---|---|---|
| 4 | | | | <ul style="list-style-type: none"> <li>Site is slightly in a different location to previous surveys.</li> <li>Site remains well vegetated and stable.</li> </ul> |

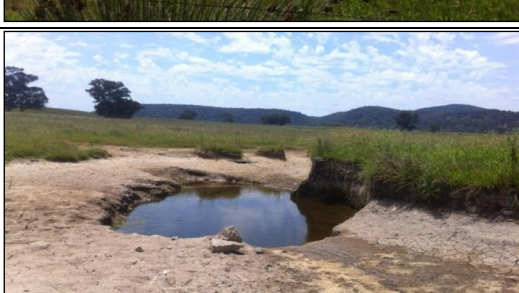
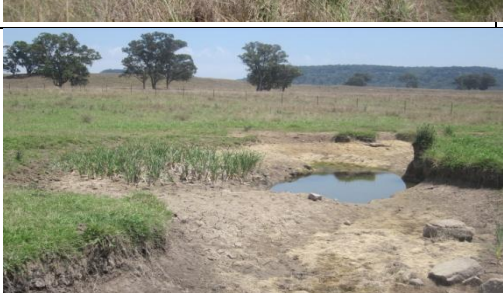
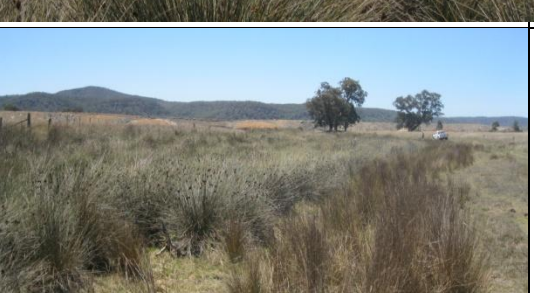
| Site | Downstream January 2011 | Downstream December 2012 | Downstream December 2013 | Main Comparisons |
|---|---|---|---|---|
| 5 | | | | <ul style="list-style-type: none"> <li>Site is slightly in a different location to previous surveys.</li> <li>Pond feature reduced in site between 2011 and 2012.</li> <li>An increase in instream vegetation growth and coverage in 2013.</li> <li>Site is currently well vegetated and stable.</li> </ul> |

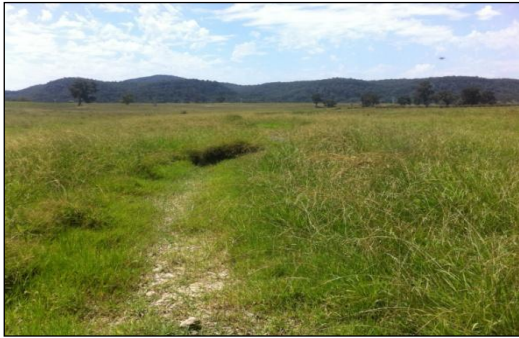
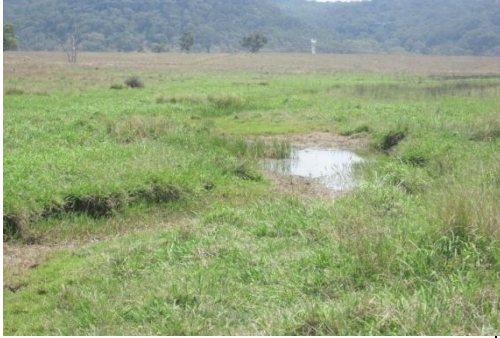
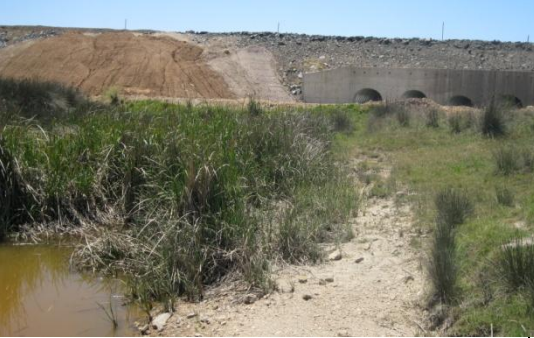
| 6 | | | | <ul style="list-style-type: none"> <li>• A slight reduction in 'green' groundcover on the bank faces and within riparian areas between 2011-13.</li> <li>• There has been an increase in instream vegetated growth in 2013.</li> <li>• Site remains well vegetated and stable.</li> </ul> |

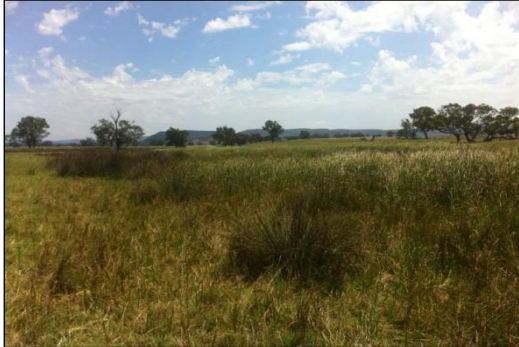
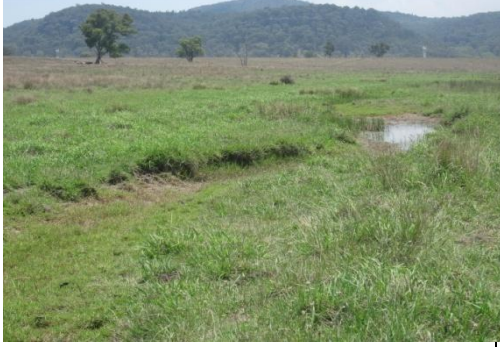
| 7 | | | Removed from survey due to works in area. | <ul style="list-style-type: none"> <li>• A slight reduction in 'green' groundcover on the bank faces and within riparian areas between 2011-12.</li> </ul> |

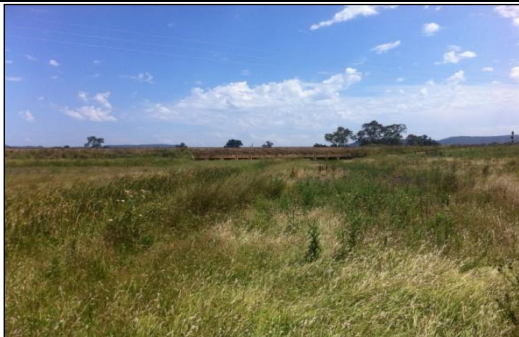
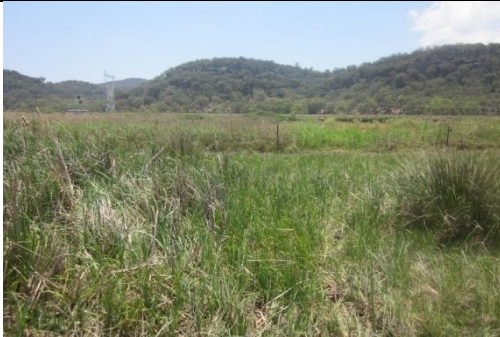
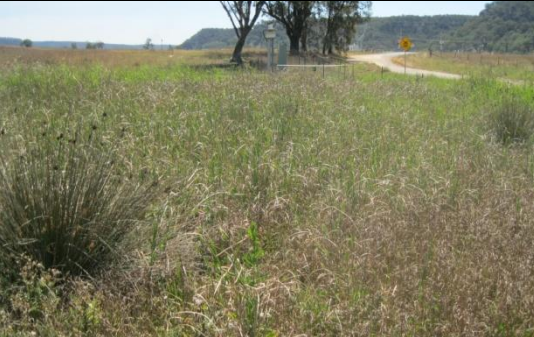
| 8 | | | | <ul style="list-style-type: none"> <li>• A reduction in 'green' groundcover on the bank faces and within riparian areas between 2011-12.</li> <li>• Site remain well vegetated and stable.</li> </ul> |

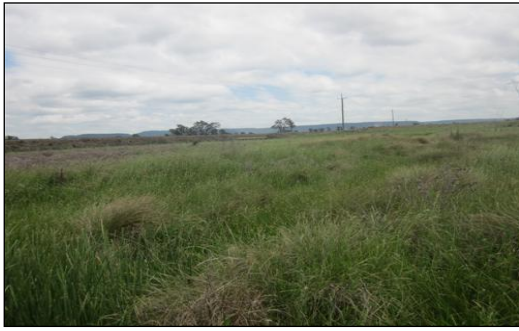
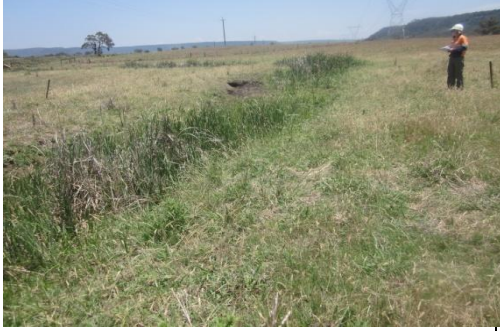
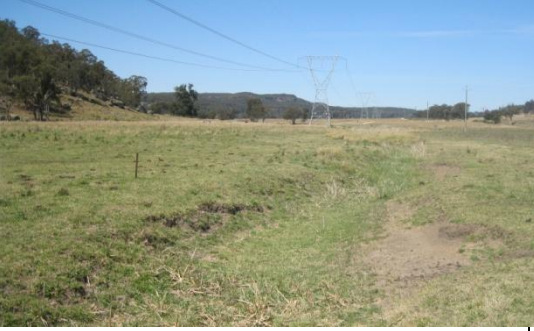
| 9 | | | | <ul style="list-style-type: none"> <li>• A reduction in 'green' groundcover on the bank faces and within riparian areas between 2011-12.</li> <li>• Site remain well vegetated and stable.</li> </ul> |

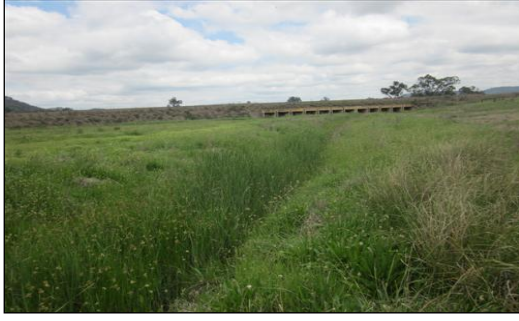
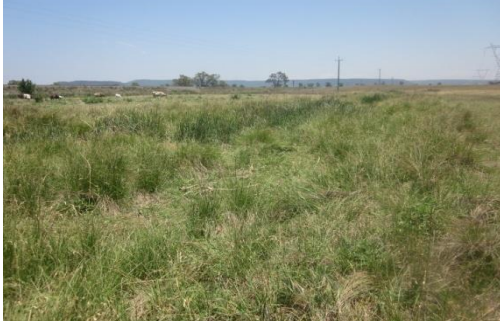
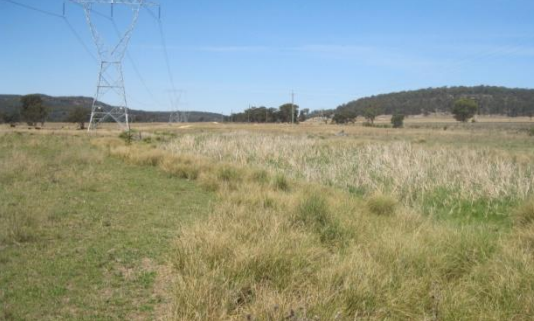
| 10 | | | | <ul style="list-style-type: none"> <li>• A reduction in 'green' groundcover on the bank faces and within riparian areas between 2011-12.</li> <li>• Site remain well vegetated and stable.</li> </ul> |
