Land

METROPOLITAN COAL - ENVIRONMENTAL MONITORING SUMMARY

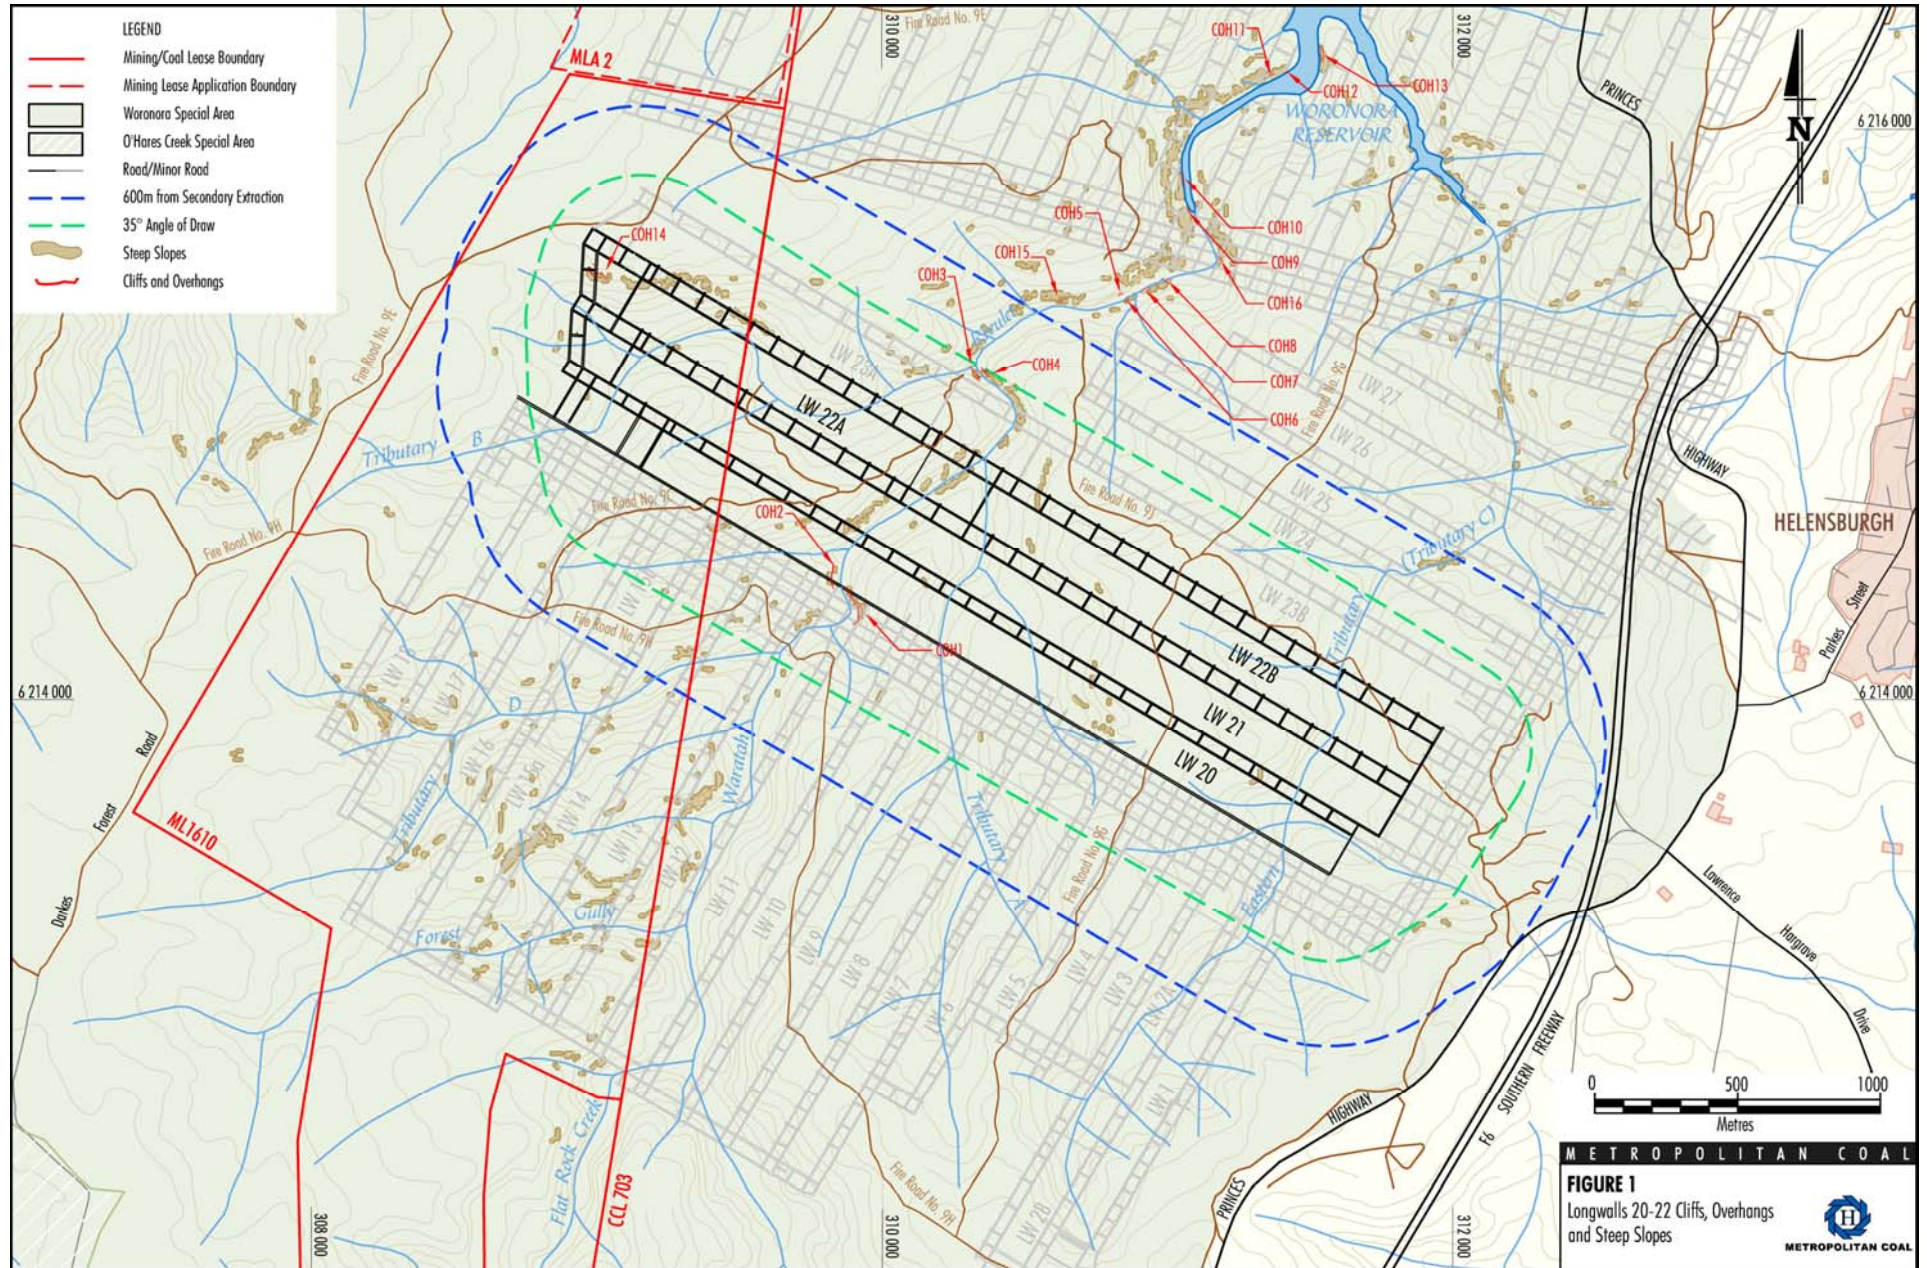
Five cliffs and overhangs have been identified within 600 metres (m) of Longwalls 20-22 secondary extraction and are shown on Figure 1, namely, sites COH1, COH2, COH3, COH4 and COH14.
