## Aboriginal Heritage

## METROPOLITAN COAL - ENVIRONMENTAL MONITORING SUMMARY

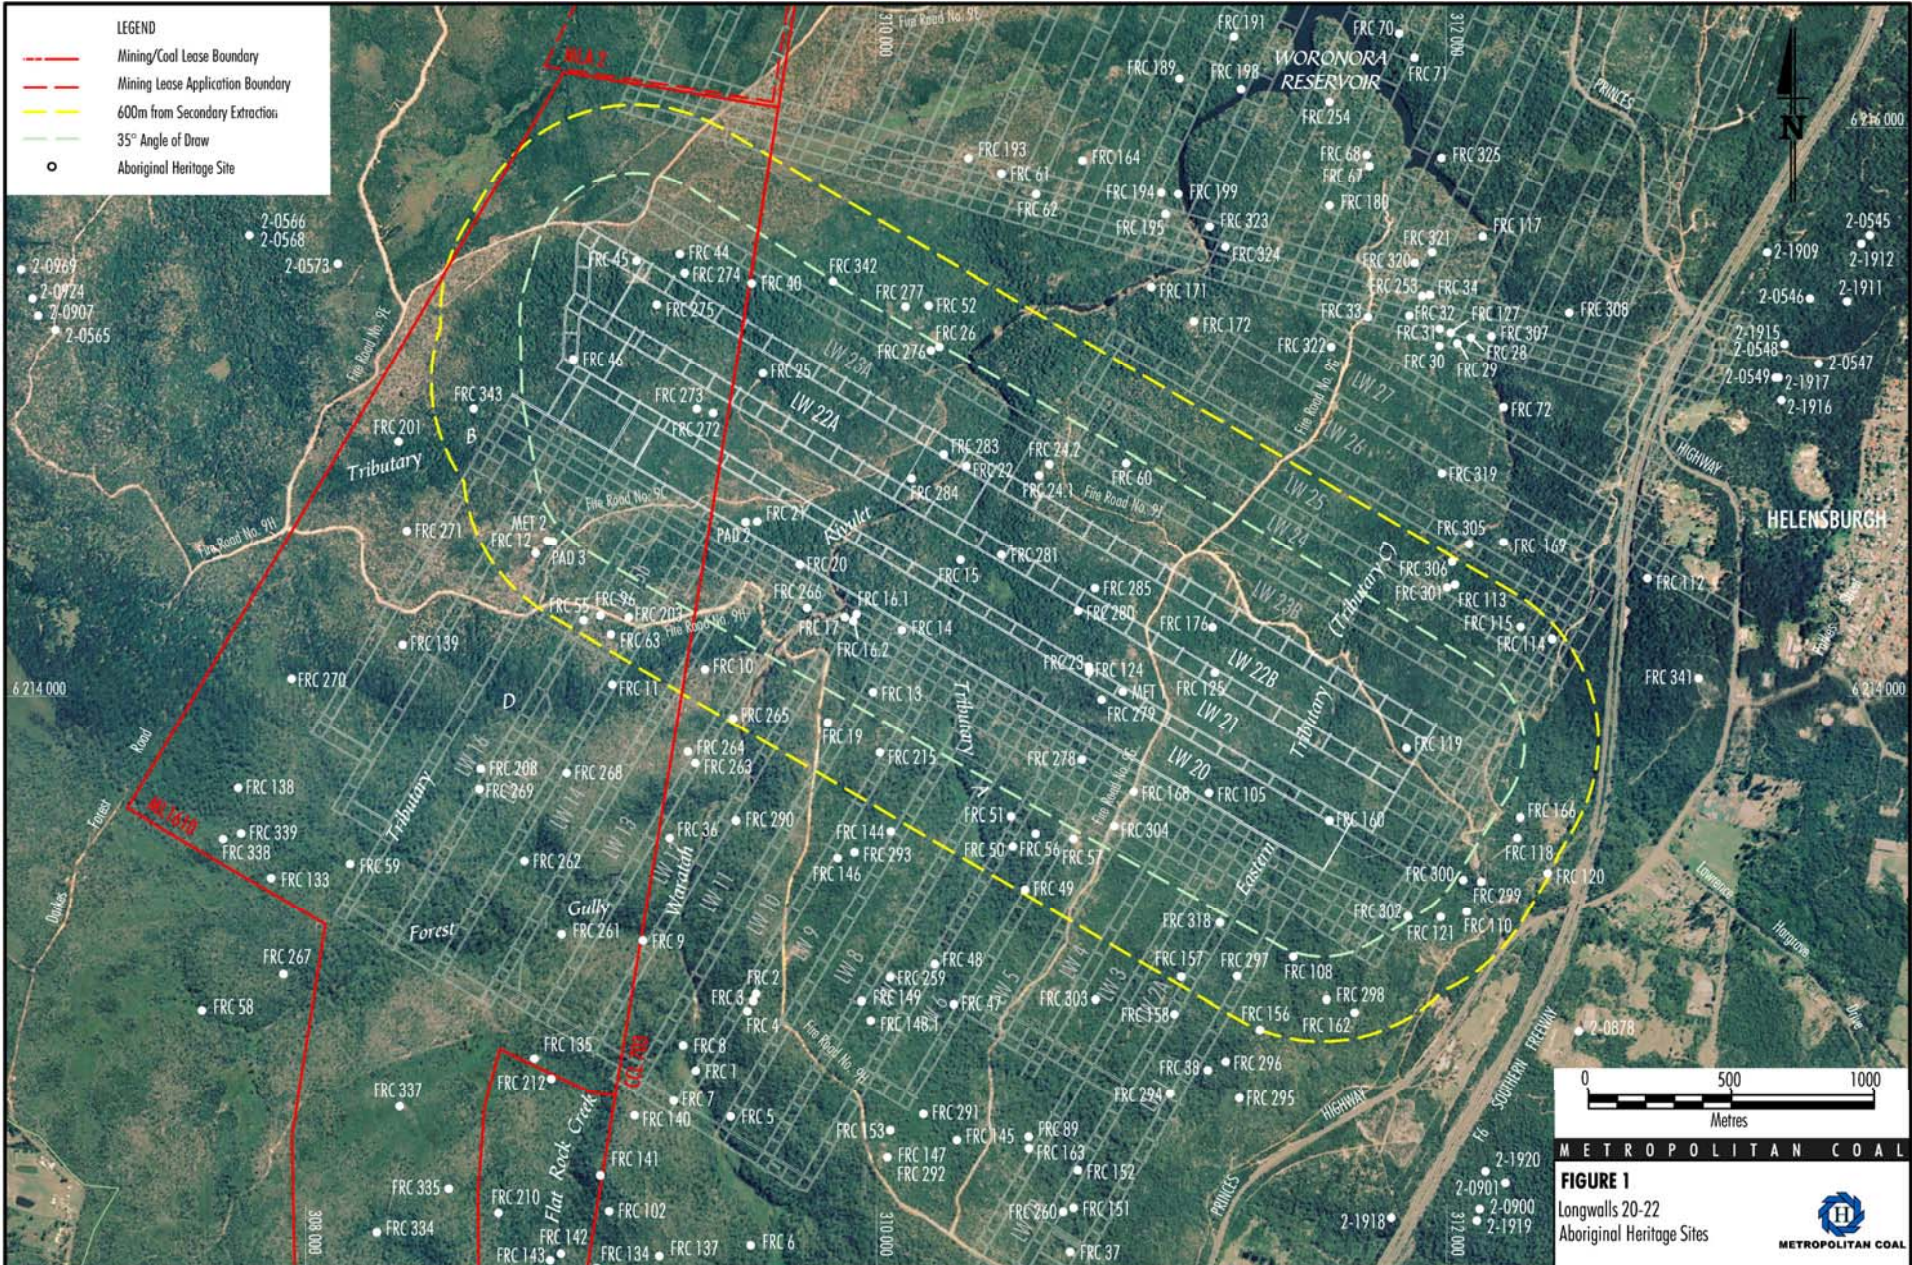
A number of Aboriginal heritage sites have been identified within 600 metres of Longwalls 20-22 secondary extraction and are shown on Figure 1.

The first round monitoring (Round 1) was conducted in January 2012 and March 2012 and included all aboriginal heritage sites located within the 35° Angle of Draw for Longwall 20 (Figure 1).

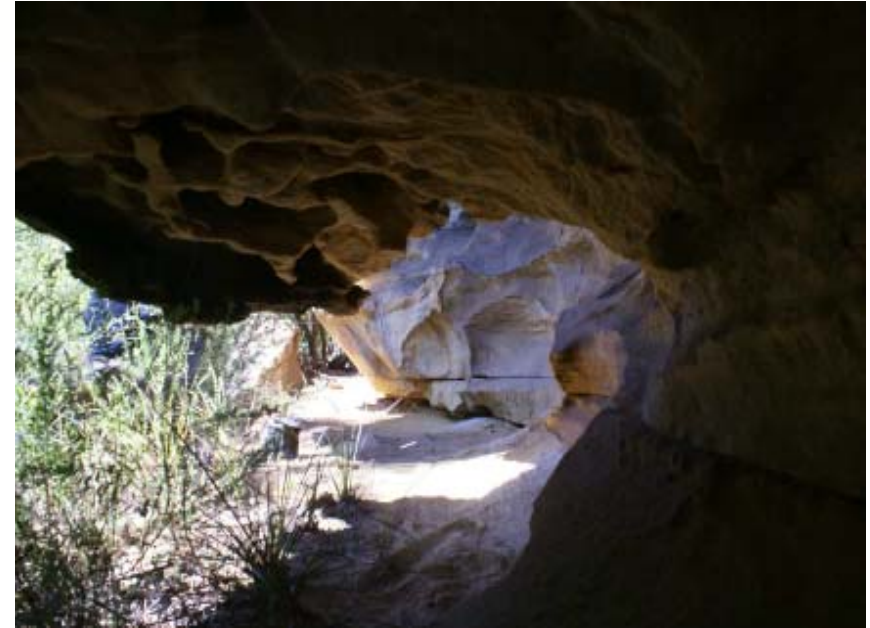
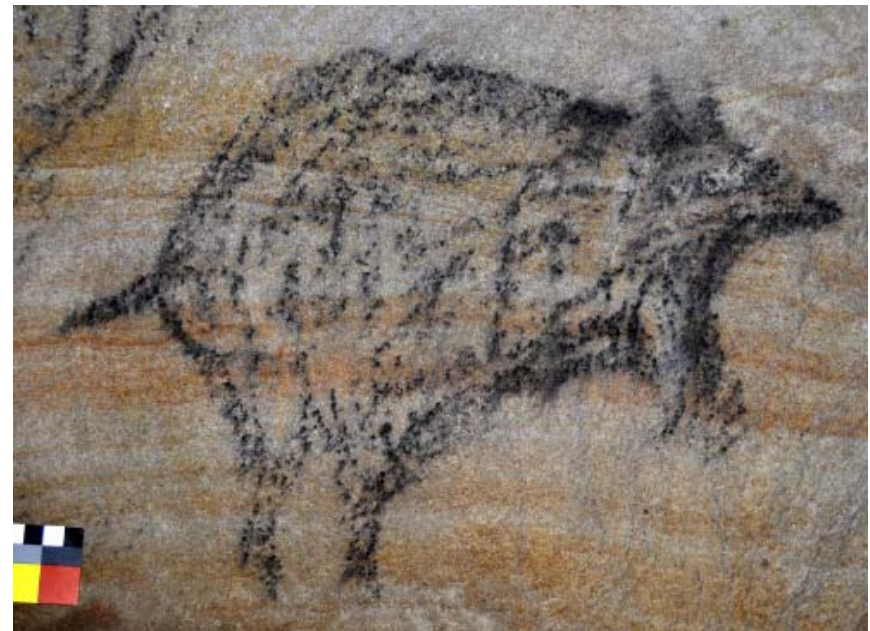
- At site FRC 281 (an overhang with art, artefacts and deposit) multiple cracks ranging from large, medium and small were recorded in the shelter wall either running through or next to motifs. These cracks varied in length but were all approximately 0.4 centimetres wide. The majority of the art recorded shows no evidence of damage or major changes. While cracks were noted in the 2009 baseline survey of this site, additional cracks (not recorded in the baseline) are considered to have resulted from subsidence.
